| Case study two | Location | Address | Room | Element | Cost | Unit | Quantity | Condition | Total cost | Replacement year | Priority | Comments | Required action | Photo Reference |

by Aidan Chappell-Smith

Project Forge Fach, Clydach

Case Study 1 –  
Photo schedule

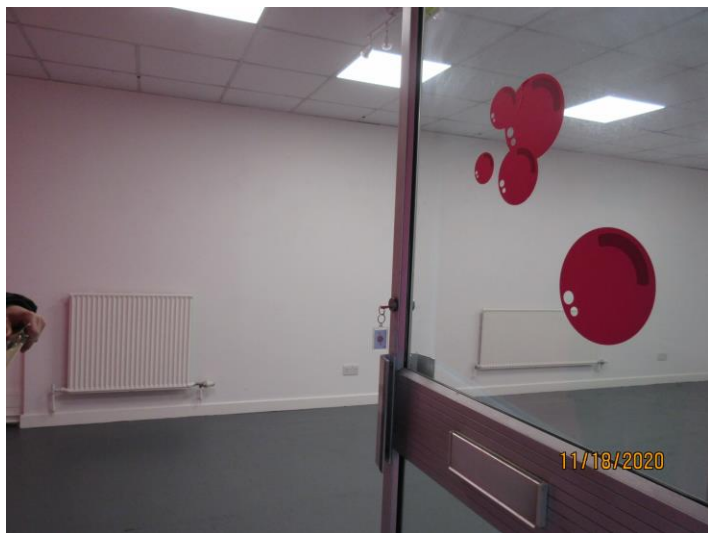
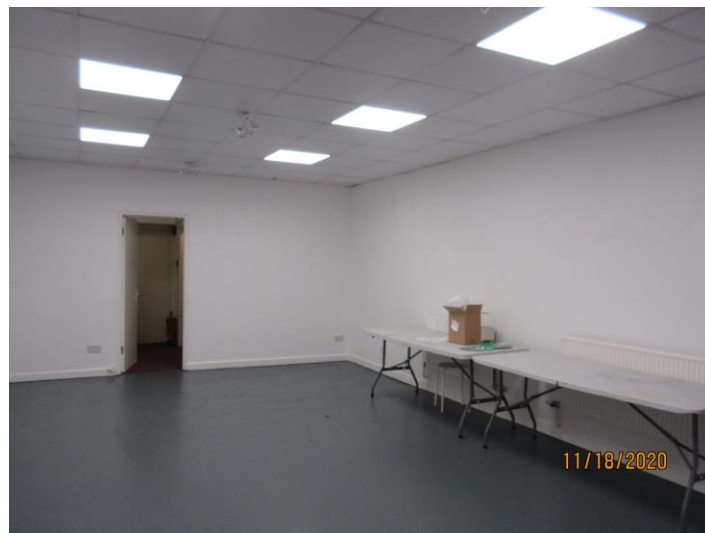
| Case study two | Location | Address | Room | Element | Cost | Unit | Quantity | Condition | Total cost | Replacement year | Priority | Comments | Required action | Photo Reference |
|---|---|---|---|---|---|---|---|---|---|---|---|---|---|---|
| Case study two | Swansea | 13 Craddock Street, Swansea | Shop floor | Suspended - Mineral Fibre ceiling | £36.00 | Square Metre | | B | | | 4 | Fair condition. | | 1 & 2 |
| Case study two | Swansea | 13 Craddock Street, Swansea | Shop floor | Concrete floor | £137.00 | Square Metre | | B | | | 4 | Fair condition. | | 1 & 2 |
| Case study two | Swansea | 13 Craddock Street, Swansea | Shop floor | Plaster walls - Smooth Finish | £42.00 | Square Metre | | B | | | 4 | Fair condition. | | 1 & 2 |
| Case study two | Swansea | 13 Craddock Street, Swansea | Shop floor | Aluminium doors | £555.00 | Square Metre | 1 | B | £555.00 | 2023 | 3 | Upgrade. Some minor damage. | Replacement required. | 1 & 2 |
| Case study two | Swansea | 13 Craddock Street, Swansea | Shop floor | Fire/Solid Core - Single door | £650.00 | Item | 2 | C | £1,300.00 | 2021 | 2 | Replace doors. | Replacement required. | 1 & 2 |

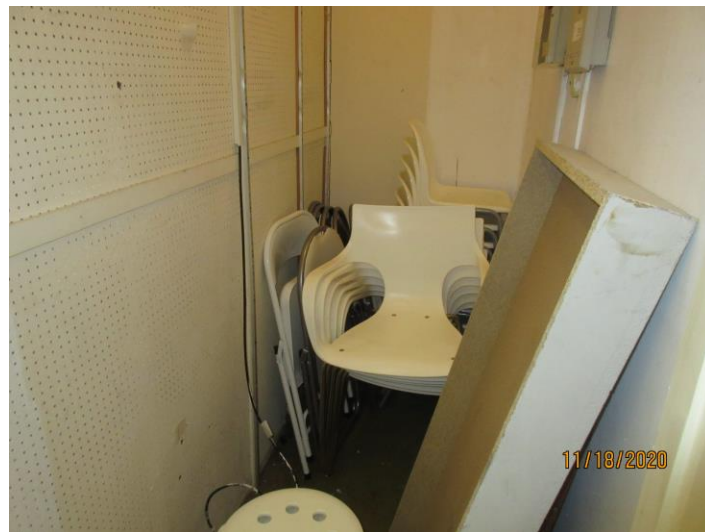
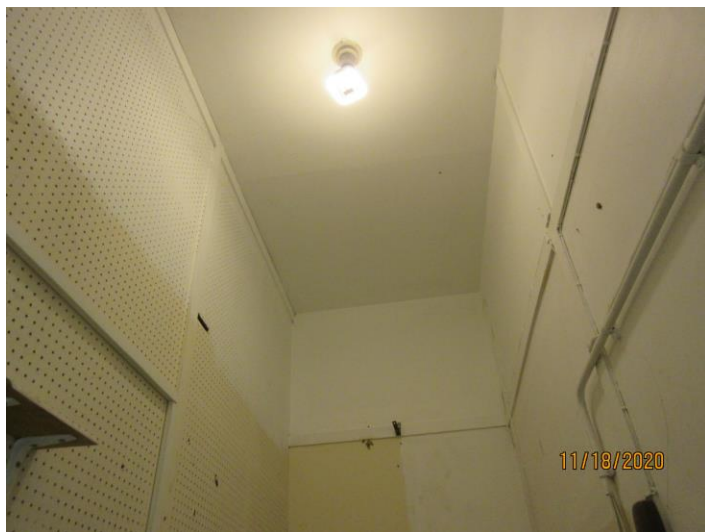
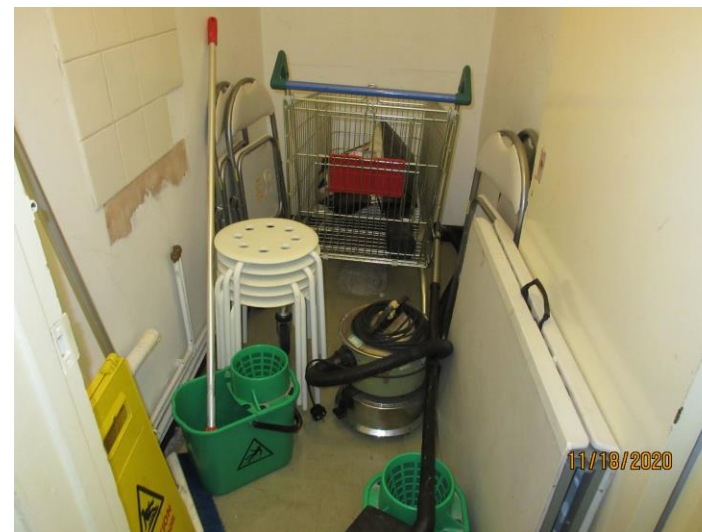
| Case study two | Location | Address | Room | Element | Cost | Unit | Quantity | Condition | Total cost | Replacement year | Priority | Comments | Required action | Photo Reference |
|---|---|---|---|---|---|---|---|---|---|---|---|---|---|---|
| Case study two | Swansea | 13 Craddock Street, Swansea | Store cupboard 1 | Plaster - Skim Finish | £12.35 | Square Metre | | B | | | 4 | Fair condition. | | 4, 5 & 6 |
| Case study two | Swansea | 13 Craddock Street, Swansea | Store cupboard 1 | Plaster - Smooth Finish | £42.00 | Square Metre | | B | | | 4 | Fair condition. | | 4, 5 & 6 |
| Case study two | Swansea | 13 Craddock Street, Swansea | Store cupboard 1 | Vinyl Tiles | £40.00 | Square Metre | 2.3 | C | £92.00 | 2022 | 2 | Replace within specified year. | Replacement required. | 4, 5 & 6 |
| Case study two | Swansea | 13 Craddock Street, Swansea | Store cupboard 1 | Fire/Solid Core - Single | £650.00 | Item | 1 | D | £650.00 | 2021 | 2 | Upgrade/provide. | Replacement required. | 4, 5 & 6 |

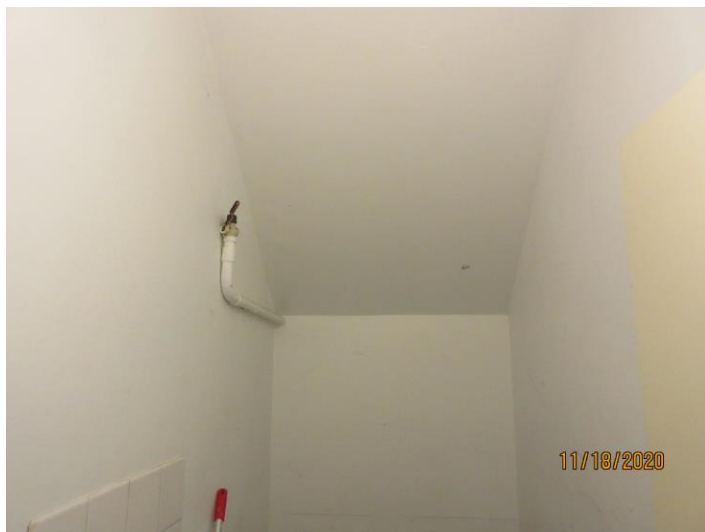
| Case study two | Location | Address | Room | Element | Cost | Unit | Quantity | Condition | Total cost | Replacement year | Priority | Comments | Required action | Photo Reference |
|---|---|---|---|---|---|---|---|---|---|---|---|---|---|---|
| Case study two | Swansea | 13 Craddock Street, Swansea | Store cupboard 2 | Plaster - Skim Finish | £12.35 | Square Metre | | B | | | 4 | Fair condition. | | 7 |
| Case study two | Swansea | 13 Craddock Street, Swansea | Store cupboard 2 | Plaster - Smooth Finish | £42.00 | Square Metre | | B | | | 4 | Fair condition. | | 7 |
| Case study two | Swansea | 13 Craddock Street, Swansea | Store cupboard 2 | Vinyl Tiles | £40.00 | Square Metre | 2 | C | £80.00 | 2022 | 2 | Replace within specified year. | Replacement required. | 7 |
| Case study two | Swansea | 13 Craddock Street, Swansea | Store cupboard 2 | Fire/Solid Core - Single | £650.00 | Item | 1 | D | £650.00 | 2022 | 2 | Upgrade/provide. | Replacement required. | 7 |

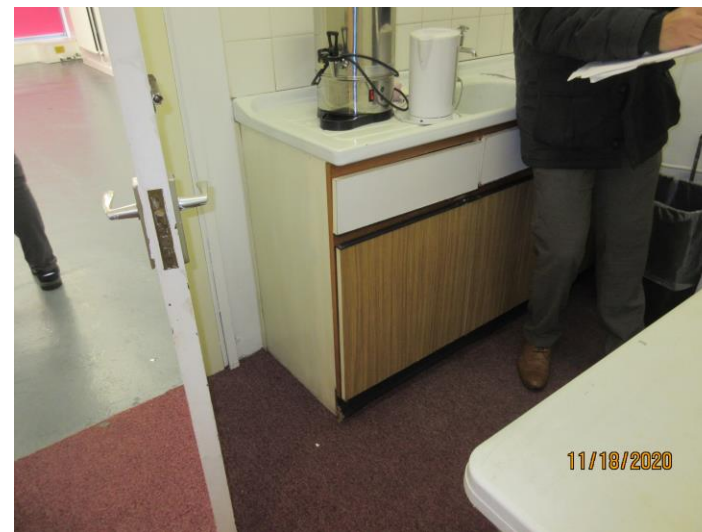
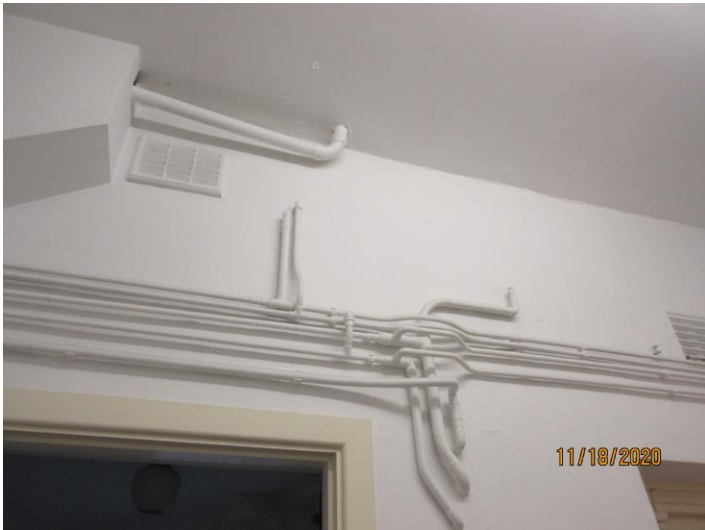
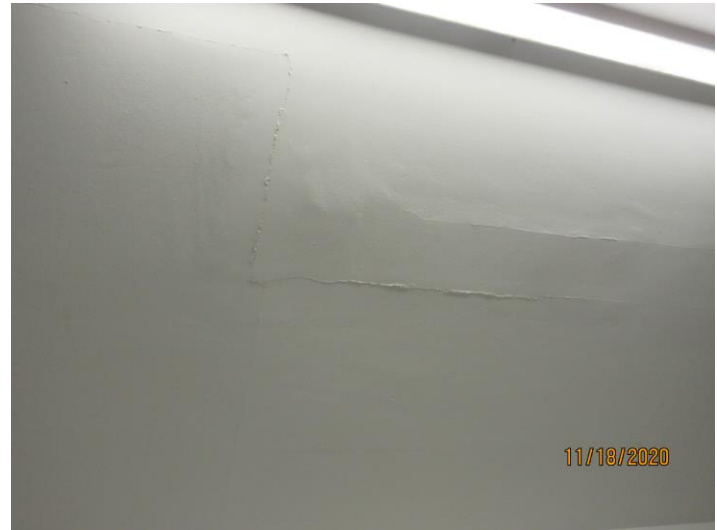
| Case study two | Location | Address | Room | Element | Cost | Unit | Quantity | Condition | Total cost | Replacement year | Priority | Comments | Required action | Photo Reference |
|---|---|---|---|---|---|---|---|---|---|---|---|---|---|---|
| Case study two | Swansea | 13 Craddock Street, Swansea | Kitchen | Plaster - Smooth Finish walls | £42.00 | Square Metre | | B | | | 4 | Fair condition. | | 8, 11 & 12 |
| Case study two | Swansea | 13 Craddock Street, Swansea | Kitchen | Plaster - Skim Finish ceiling | £12.35 | Square Metre | 6.3 | D | £77.81 | 2022 | 2 | Fair/poor, replace within specified year. | Replacement required. | 8, 11 & 12 |
| Case study two | Swansea | 13 Craddock Street, Swansea | Kitchen | Carpet/Tiles Flooring | £43.00 | Square Metre | 6.3 | C | £270.90 | 2022 | 2 | Replace within specified period. | Replacement required. | 8, 11 & 12 |
| Case study two | Swansea | 13 Craddock Street, Swansea | Kitchen | Decorate All Areas | £9.50 | Square Metre | 33.3 | C | £316.35 | 2022 | 2 | Replace within specified year. | Internal decoration. | 8, 11 & 12 |
| Case study two | Swansea | 13 Craddock Street, Swansea | Kitchen | Fire/Solid Core - Single Door | £650.00 | Item | 2 | D | £1,300.00 | 2021 | 2 | Upgrade. | Replacement required. | 8, 11 & 12 |
| Case study two | Swansea | 13 Craddock Street, Swansea | Kitchen | Kitchen Units - With Sink | £1,500.00 | Item | 1 | D | £1,500.00 | 2021 | 2 | Upgrade. | Replacement required. | 8, 11 & 12 |

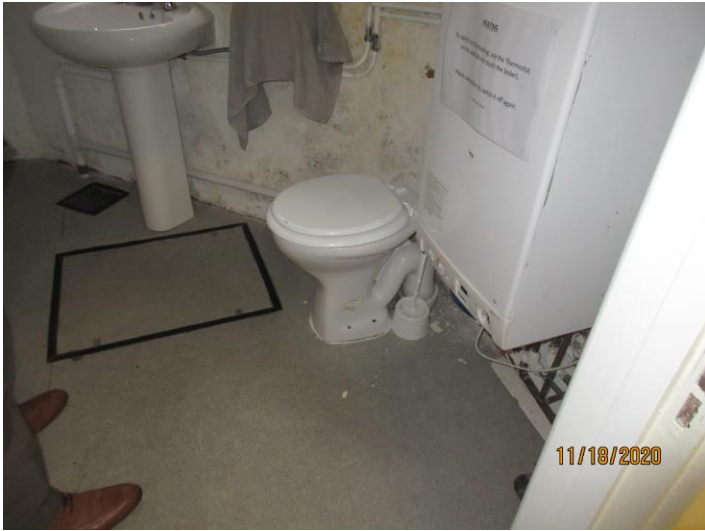
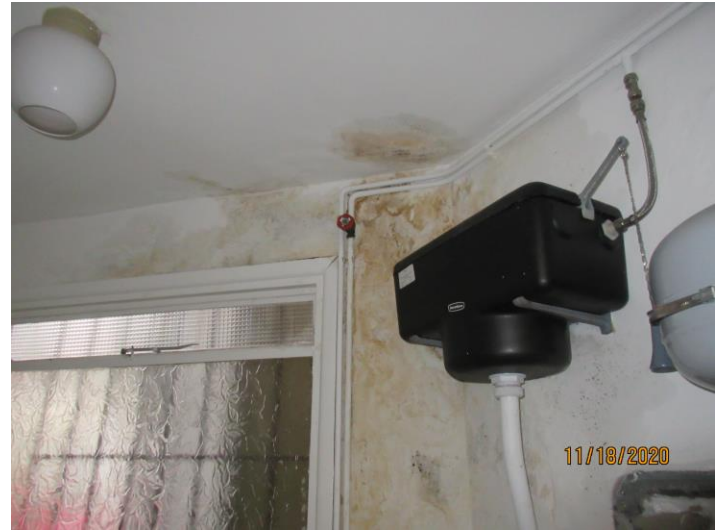
| Case study two | Location | Address | Room | Element | Cost | Unit | Quantity | Condition | Total cost | Replacement year | Priority | Comments | Required action | Photo Reference |
|---|---|---|---|---|---|---|---|---|---|---|---|---|---|---|
| Case study two | Swansea | 13 Craddock Street, Swansea | Toilet | Plasterboard - Plaster ceiling | £39.75 | Square Metre | 3.2 | C | £127.20 | 2021 | 2 | Replace ceiling. Investigate leak. | Replacement required. | 9 & 10 |
| Case study two | Swansea | 13 Craddock Street, Swansea | Toilet | Vinyl Sheet flooring | £45.32 | Square Metre | 3.2 | C | £145.02 | 2021 | 2 | Replace within specified year. | Replacement required. | 9 & 10 |
| Case study two | Swansea | 13 Craddock Street, Swansea | Toilet | Plaster - Smooth Finish walls | £42.00 | Square Metre | 19.4 | C | £814.80 | 2021 | 2 | Replaster. | Repairs required. | 9 & 10 |
| Case study two | Swansea | 13 Craddock Street, Swansea | Toilet | Lthw Boilers | | Item | | B | £2,000.00 | 2023 | 3 | Biast wall mounted boiler. | Ongoing maintenance required until replacement. | 9 & 10 |

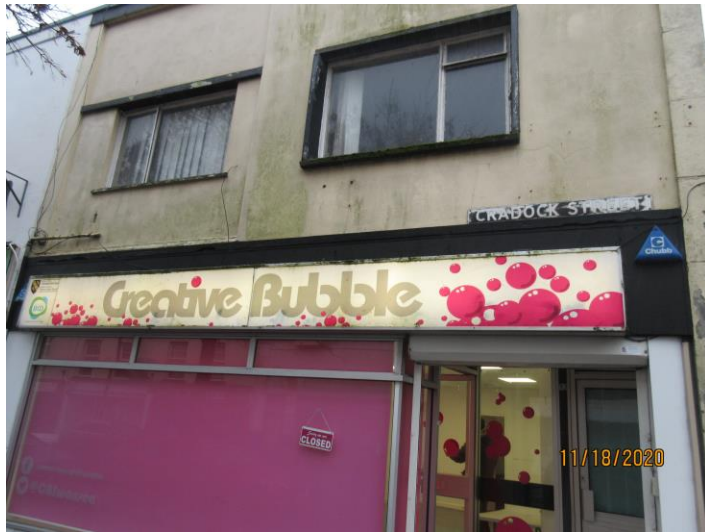
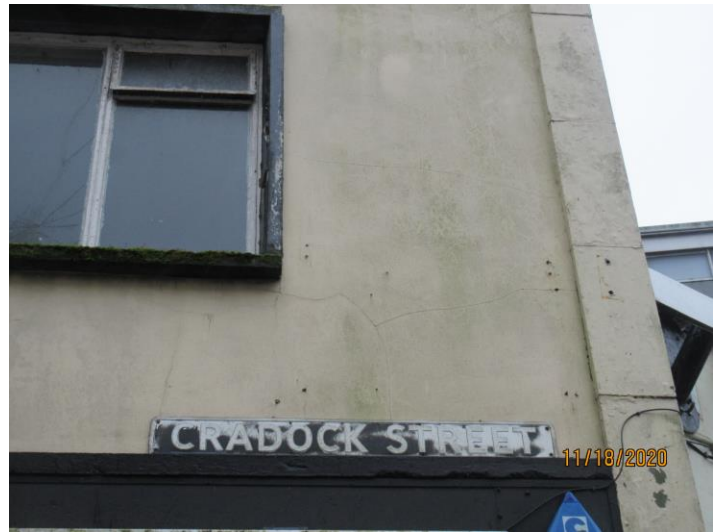
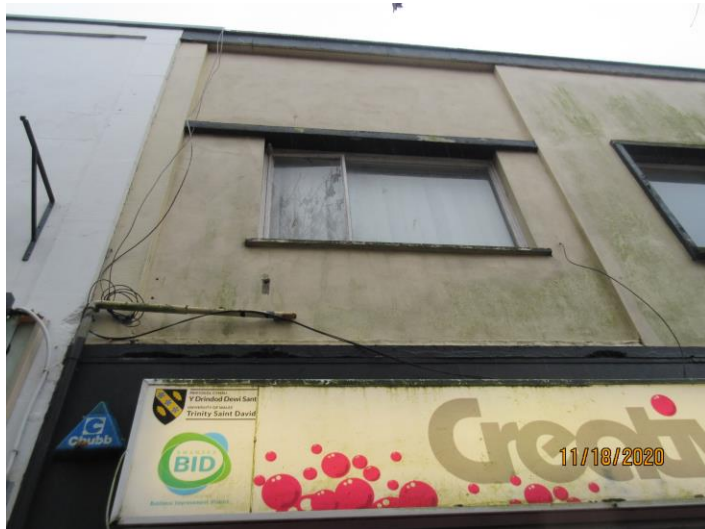
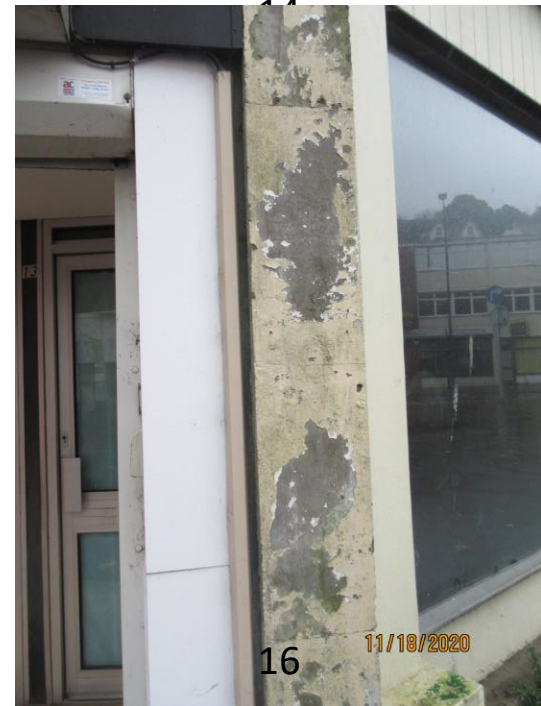
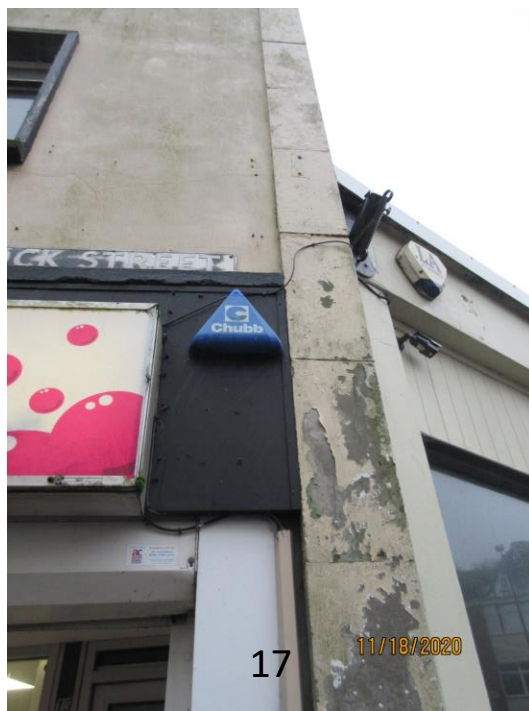
| Case study two | Location | Address | Room | Element | Cost | Unit | Quantity | Condition | Total cost | Replacement year | Priority | Comments | Required action | Photo Reference |
|---|---|---|---|---|---|---|---|---|---|---|---|---|---|---|
| Case study two | Swansea | 13 Craddock Street, Swansea | Externals | Windows | £65.00 | Square Metre | | B | | | 4 | Fair condition. Clean down glazing. | | 13 - 17 |
| Case study two | Swansea | 13 Craddock Street, Swansea | Externals | Decoration - General | | Square Metre | 30 | C/D | Dependant on works | 2021 | 2 | Clean down and redecorate render. Possibly re-render entire front elevation. | Replacement required. | 13 - 17 |
| Case study two | Swansea | 13 Craddock Street, Swansea | Externals | Windows | £450.00 | Square Metre | 1 | C | £450.00 | 2021 | 3 | Upgrade window to rear WC. | Replacement required. | 13 - 17 |
| Case study two | Swansea | 13 Craddock Street, Swansea | Externals | Steel - Single | £1,200.00 | Item | 1 | C | £1,200.00 | 2021 | 2 | Provide suitable door to rear of property. Existing poor. | Replacement required. | 13 - 17 |

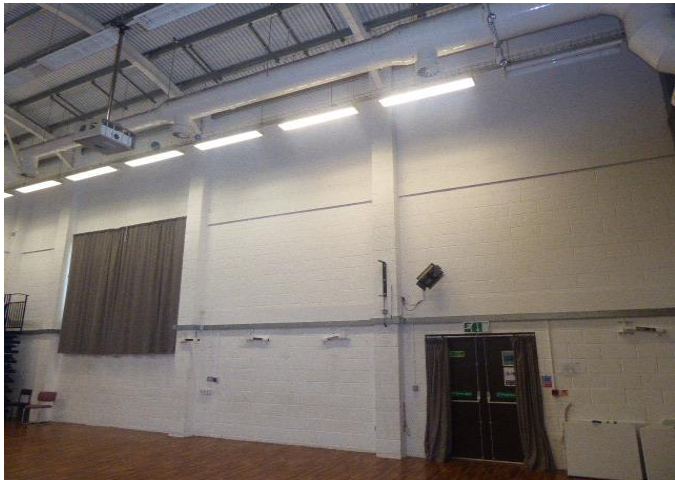
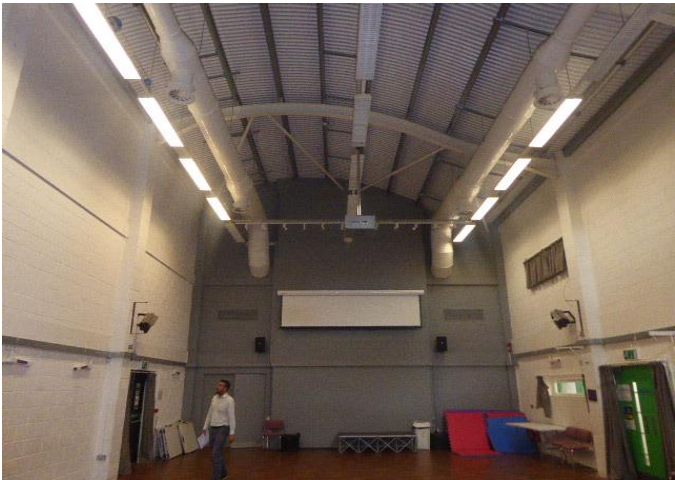
| Element | Sub Element | Description | Condition | Recommendation | Condition (A - D) | Priority (1 - 4) | Remaining Life Expectancy (Yrs) | Photo Ref: |
|---|---|---|---|---|---|---|---|---|
| Structure | Structure | Exposed steel frame structure to the main hall. | Fair condition. Structurally in good order. However, isolated signs of surface corrosion need treatment works as noted to the exterior. | Treat isolated surface corrosion to exposed steel frame to the exterior of the main hall. | C | 2 | 1 | 1-2 |

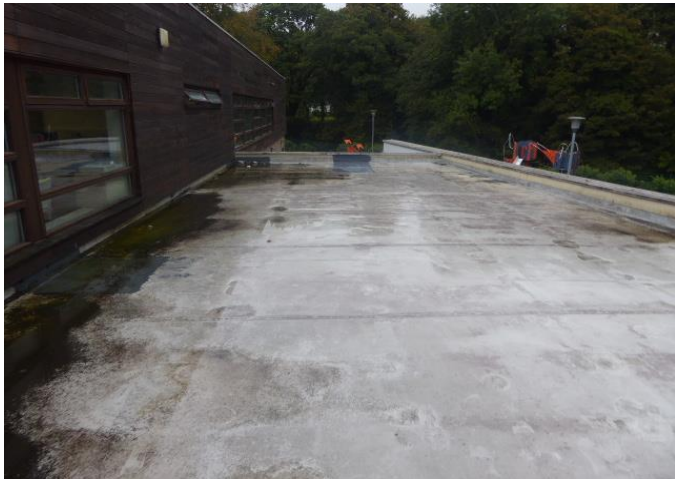
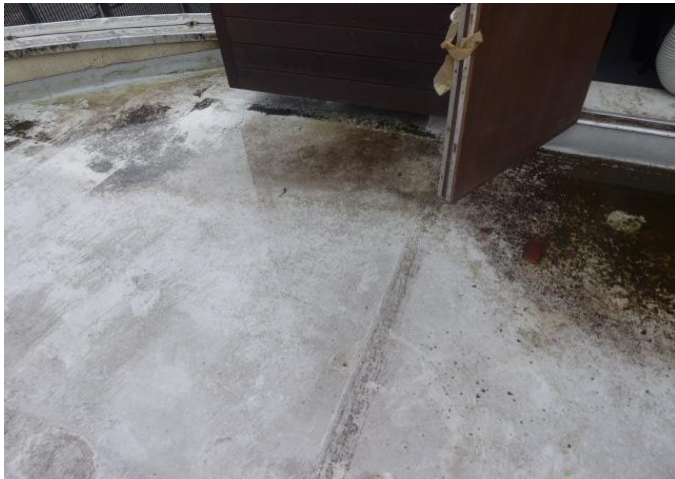
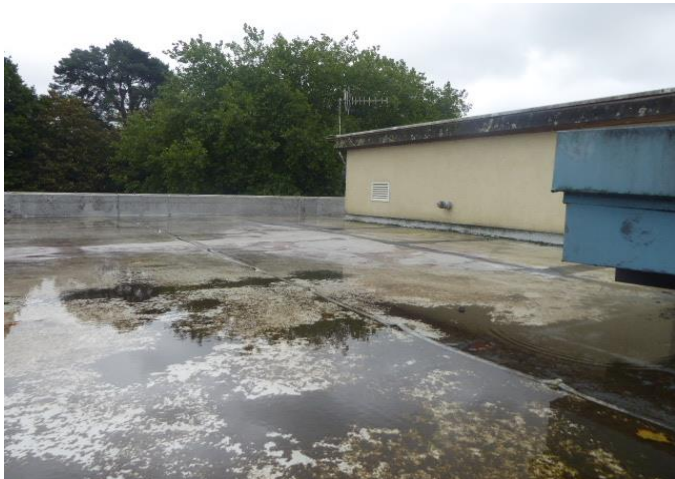
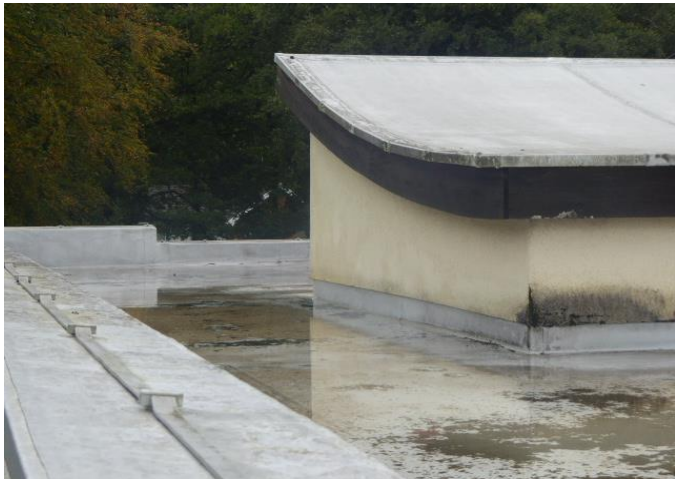
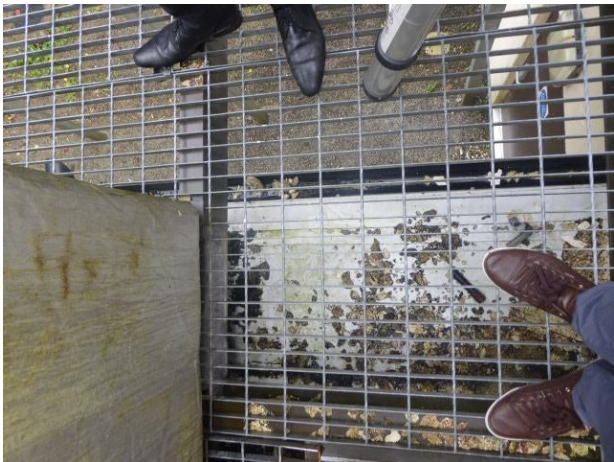
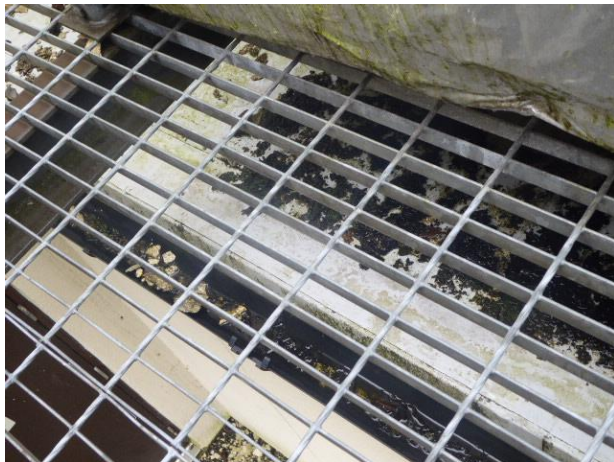
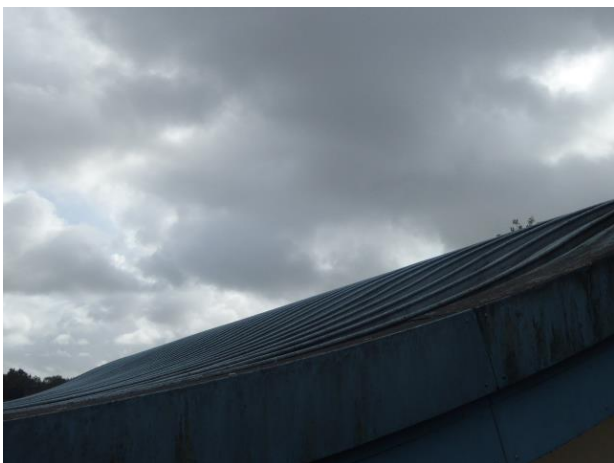
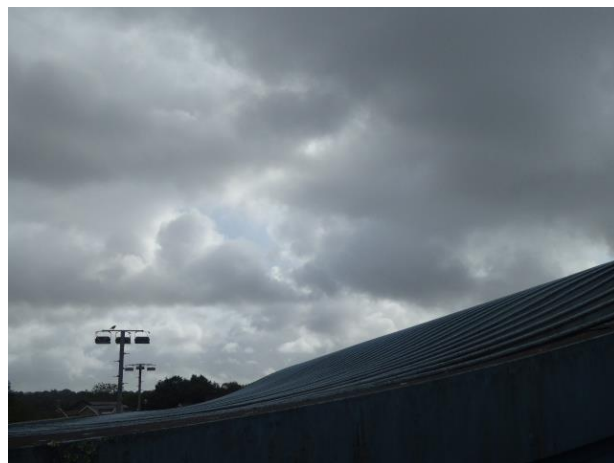
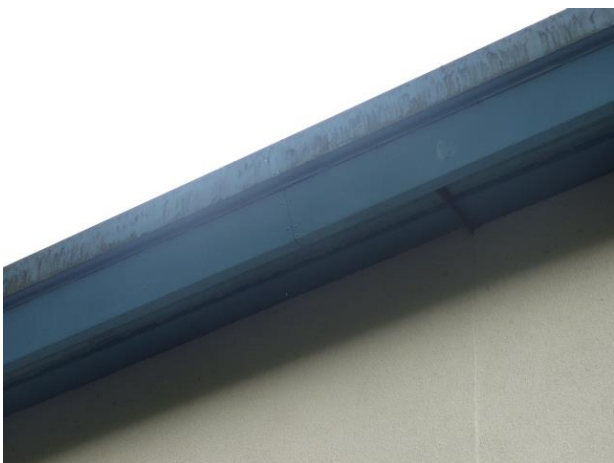
| Element | Sub Element | Description | Condition | Recommendation | Condition (A - D) | Priority (1 - 4) | Remaining Life Expectancy (Yrs) | Photo Ref: |
|---|---|---|---|---|---|---|---|---|
| Roof and Associated Elements | Roof Coverings | Single ply roof membrane to flat roof over ground floor café and meeting room. | Fair/poor condition. Significant water pooling to roof surface at time of inspection, suggests roof possibly not laid to fall correctly. Water staining noted internally to ceiling within the meeting room. Recent repairs appear to have been undertaken. Only 2No. drainage outlets provided to roof area. Grating missing to 1No. drainage outlet. | Programme replacement of roof covering in the near future. Roof to comply fully with current regulations, include for all suitable flashing, insulation, laid to correct fall etc. Consideration should be given to upgrading all flat roofs at the same time. | B | 3 | 4 | 3-11 |
| | | | | Monitor condition of roof covering over coming years prior to future replacement. Determine water ingress issues have been rectified with recent repairs. Investigate the provision of 2No. drainage outlets is adequate for the roof area. Refit missing grating over 1No. drainage outlet. | | 1 | 0 | |

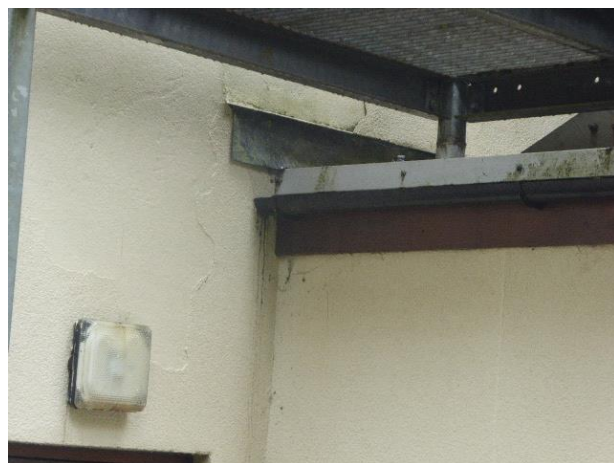
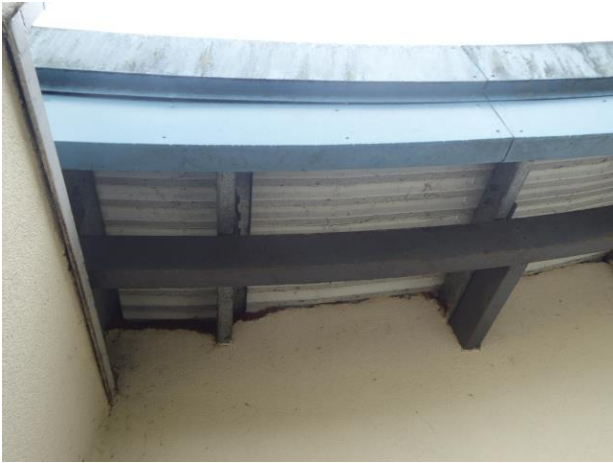
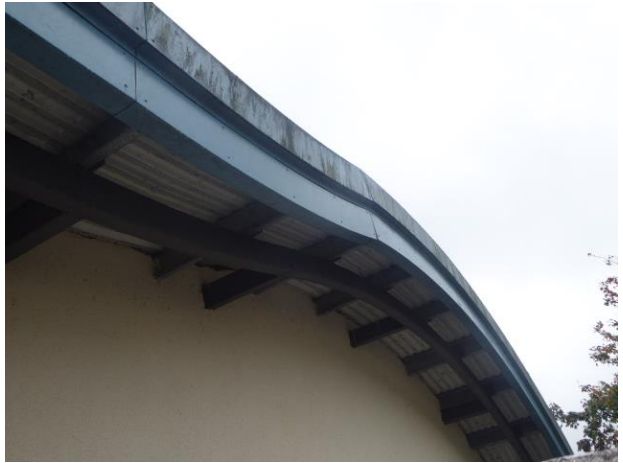
| Element | Sub Element | Description | Condition | Recommendation | Condition (A - D) | Priority (1 - 4) | Remaining Life Expectancy (Yrs) | Photo Ref: |
|---|---|---|---|---|---|---|---|---|
| | Fascias, soffits and bargeboards | Timber fascia boards along plant room and to raised sections on main roof area. | Fair condition. Lack of maintenance evident to fascia boards installed to raised section at roof level. | Monitor condition following recommended repainting works. Programme for replacement in conjunction with future re-roofing works. | B | 4 | 6 | 11-14 |

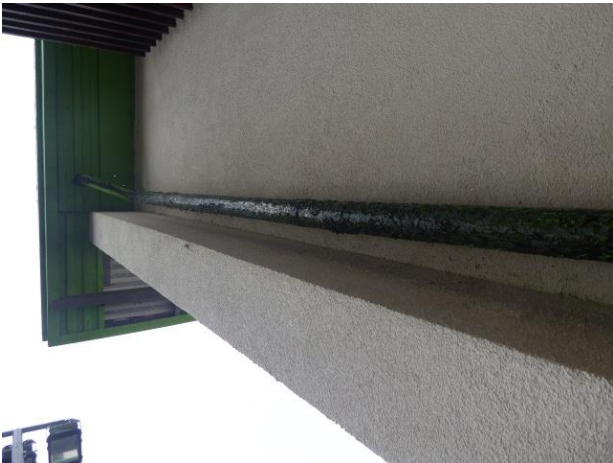
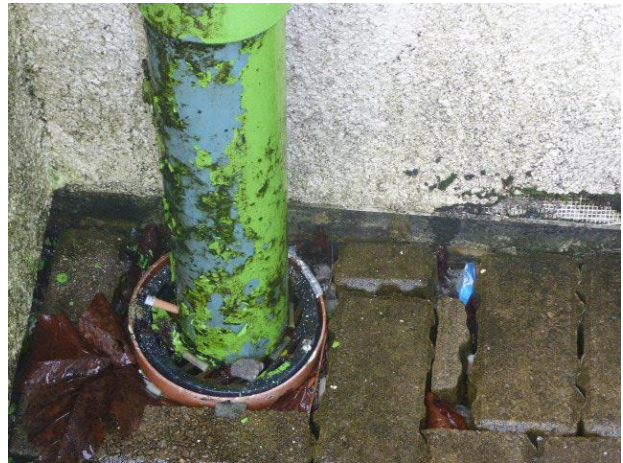
| Element | Sub Element | Description | Condition | Recommendation | Condition (A - D) | Priority (1 - 4) | Remaining Life Expectancy (Yrs) | Photo Ref: |
|---|---|---|---|---|---|---|---|---|
| | Rainwater Goods | Metal box guttering and circular downpipes installed to the main hall. | Poor condition. Lack of maintenance evident. Vegetation growth to guttering, leaks to some joints. Downpipes leaking and stained throughout. | Undertake immediate maintenance works. Clean out all channels, repair joints and connections throughout rainwater goods. Allow for annual maintenance works to all rainwater goods. | C | 1 | 0 | 15-16 |

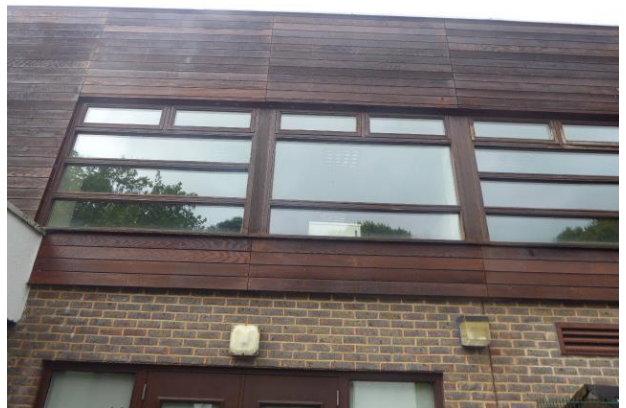
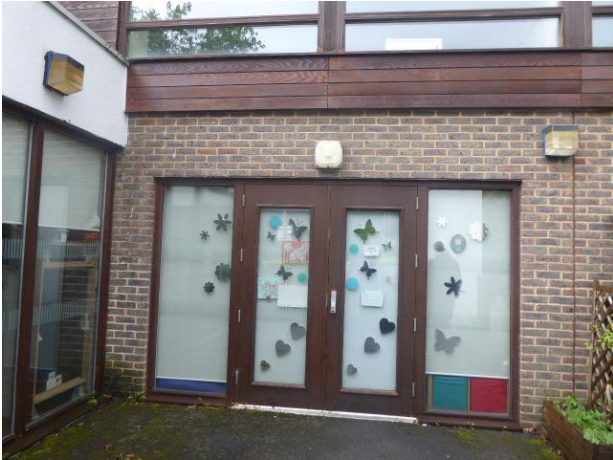
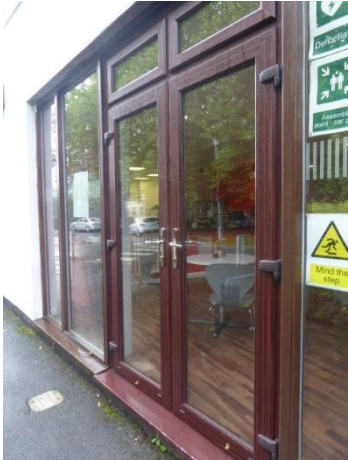
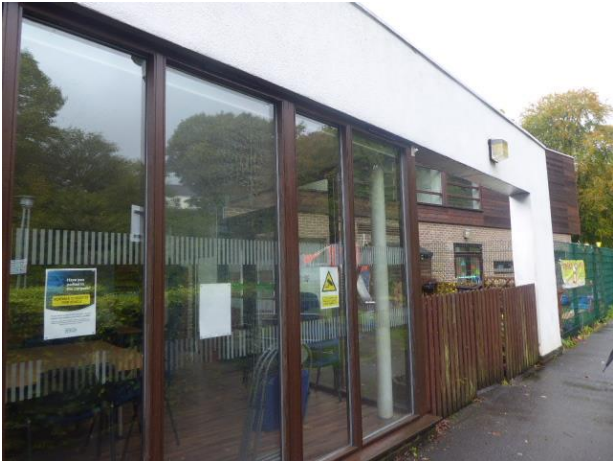
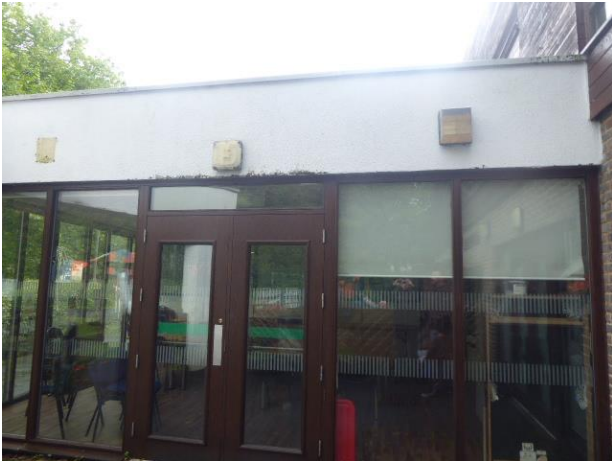
| Element | Sub Element | Description | Condition | Recommendation | Condition (A - D) | Priority (1 - 4) | Remaining Life Expectancy (Yrs) | Photo Ref: |
|---|---|---|---|---|---|---|---|---|
| External Fabric | External Windows and Doors | Timber double glazed windows. | Fair condition. Random testing of windows indicate some operational issues. Frames fading in places. | Carry out a minor overhaul throughout the windows, improving operational performance. Allow for regular maintenance. | B | 4 | | 18-22 |

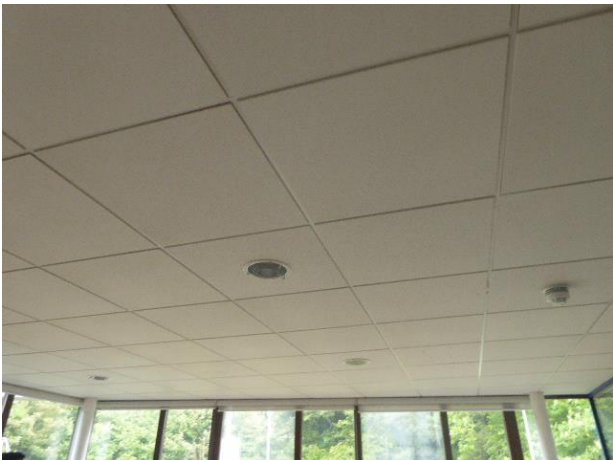
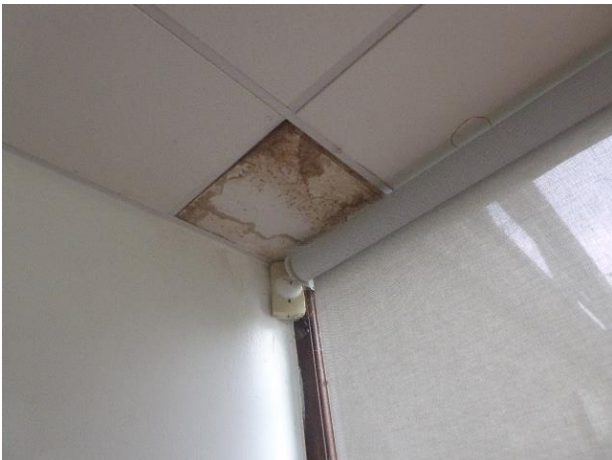
| Element | Sub Element | Description | Condition | Recommendation | Condition (A - D) | Priority (1 - 4) | Remaining Life Expectancy (Yrs) | Photo Ref: |
|---|---|---|---|---|---|---|---|---|
| Internal Fabric | Ceilings | Suspended ceiling grid with mineral fibre tiles. | Fair condition. Marked and scratched in places. Some staining and minor damage. | Programme replacement of suspended ceilings throughout within specified period. | B | 4 | 7 | 23-24 |
| | | | | Replace any stained/damaged ceiling tiles. | | 2 | 1 | |

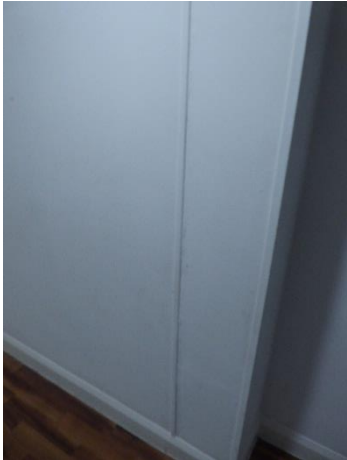
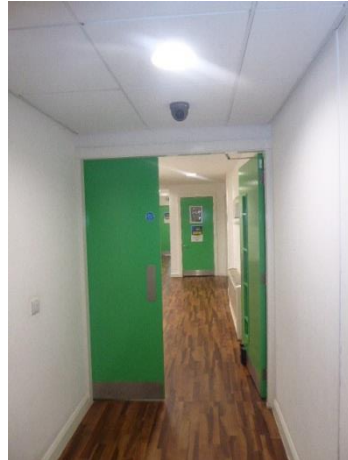
| Element | Sub Element | Description | Condition | Recommendation | Condition (A - D) | Priority (1 - 4) | Remaining Life Expectancy (Yrs) | Photo Ref: |
|---|---|---|---|---|---|---|---|---|
| | Internal Walls and Finishes | Plastered walls to majority of area, wallpaper finish to small number of rooms. | Fair condition. General wear and tear. | Allowance for minor repairs to internal wall areas in line with redecoration works. | C | 2 | 1 | 25-26 |

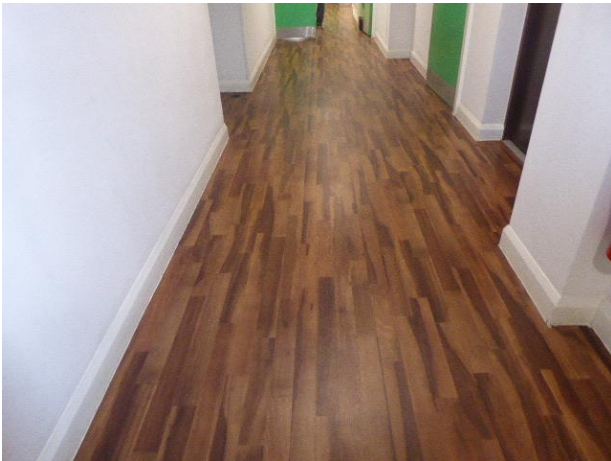
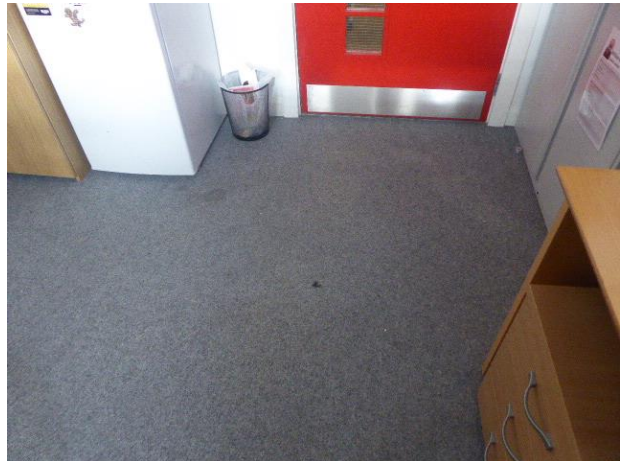
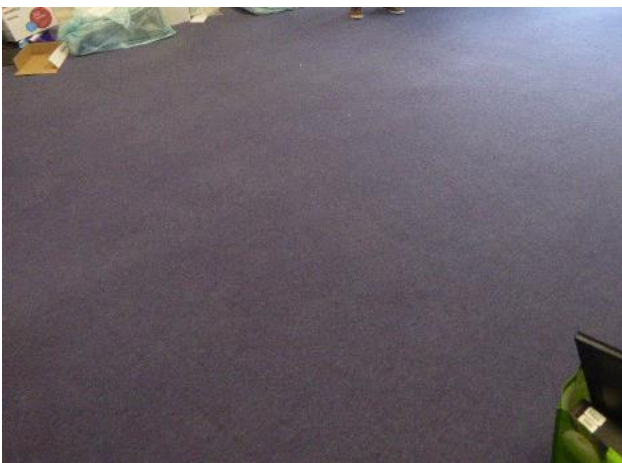
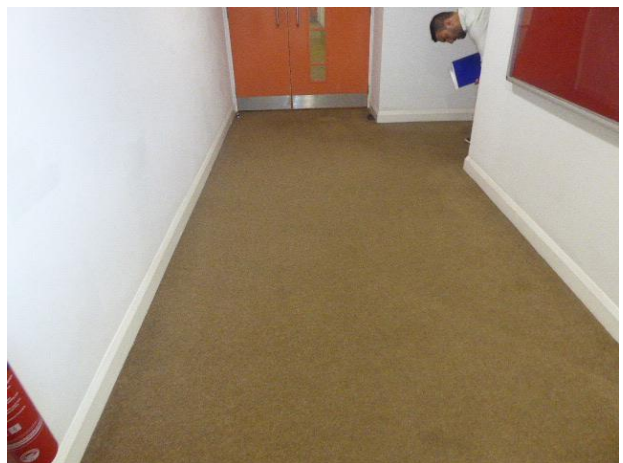
| Element | Sub Element | Description | Condition | Recommendation | Condition (A - D) | Priority (1 - 4) | Remaining Life Expectancy (Yrs) | Photo Ref: |
|---|---|---|---|---|---|---|---|---|
| Internal Fabric | Floor Coverings | Vinyl coverings throughout Nursery and Play room. | Poor condition. Heavy wear in places, surface starting to split. | Upgrade vinyl coverings to these areas in the short term. | C | 2 | 2 | 27-30 |

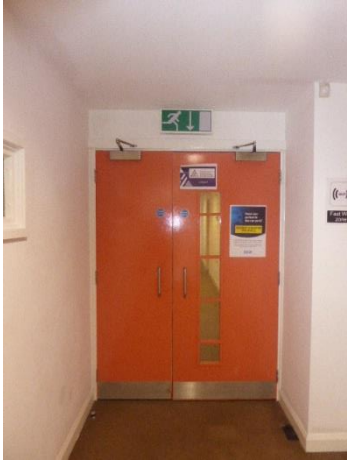
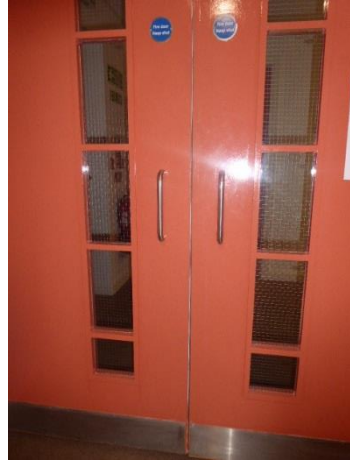
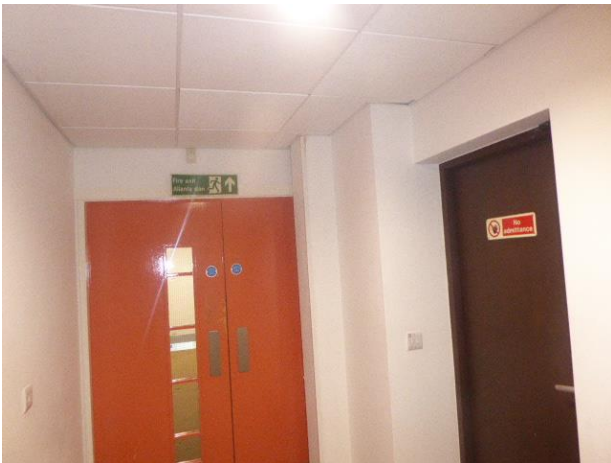
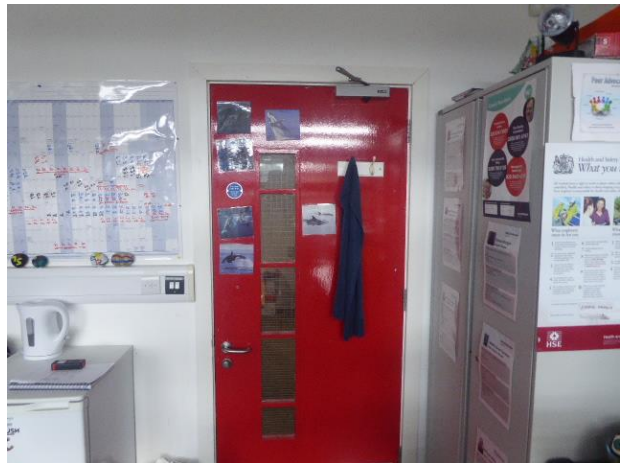
| Element | Sub Element | Description | Condition | Recommendation | Condition (A - D) | Priority (1 - 4) | Remaining Life Expectancy (Yrs) | Photo Ref: |
|---|---|---|---|---|---|---|---|---|
| | Internal Woodwork, joinery and Doors | Timber doors and associated framework installed throughout. | Poor condition. Generally most doors don't comply with current fire regulations. | Allow for upgrading of all internal doors. Carry out regular maintenance of doors. | C | 1 | 1 | 31-34 |

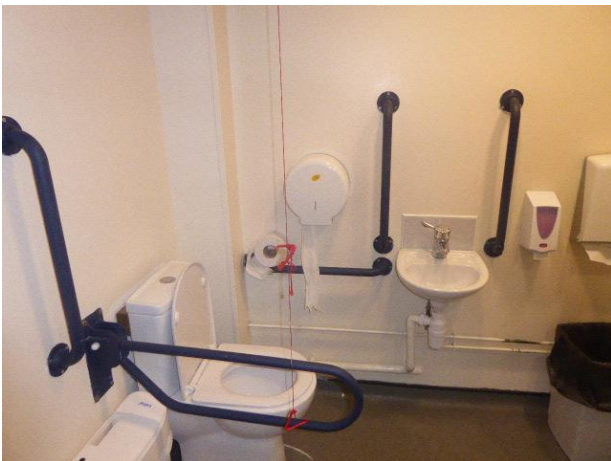
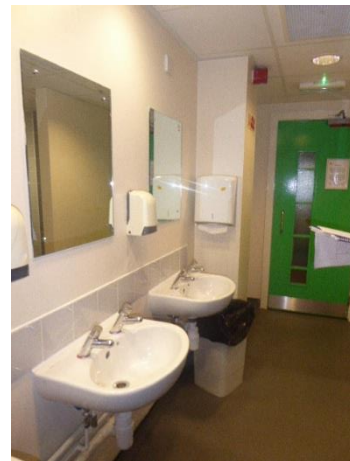
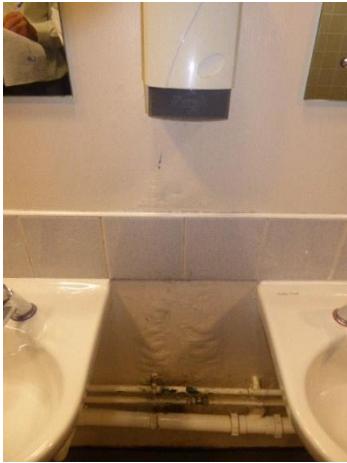
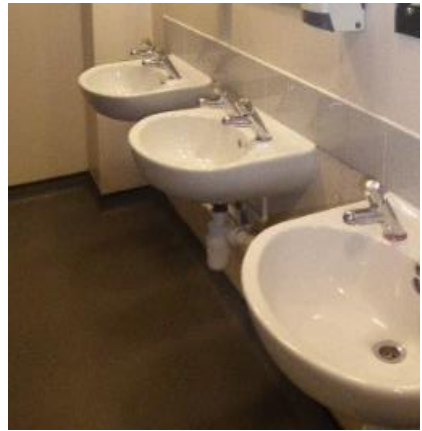
| Element | Sub Element | Description | Condition | Recommendation | Condition (A - D) | Priority (1 - 4) | Remaining Life Expectancy (Yrs) | Photo Ref: |
|---|---|---|---|---|---|---|---|---|
| Sanitary Fittings | Sanitary Fittings | White ceramic sanitary fittings including WC's, urinals, basins, showers, disabled fittings etc. PVCu wastepipes. | Fair condition. No apparent issues. | Regularly maintain and monitor condition. Allowance to upgrade in medium to long term. | B | 4 | 12 | 35-38 |

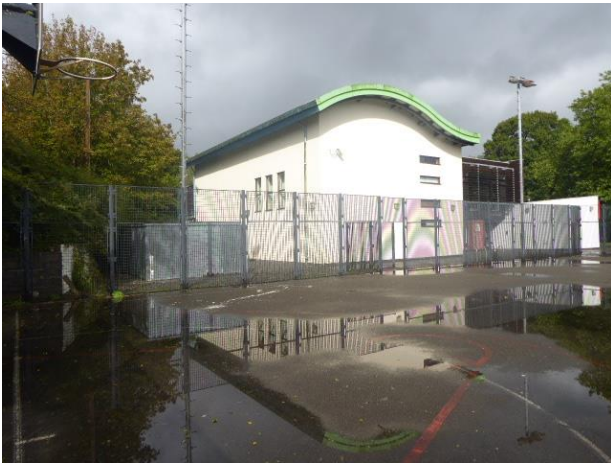
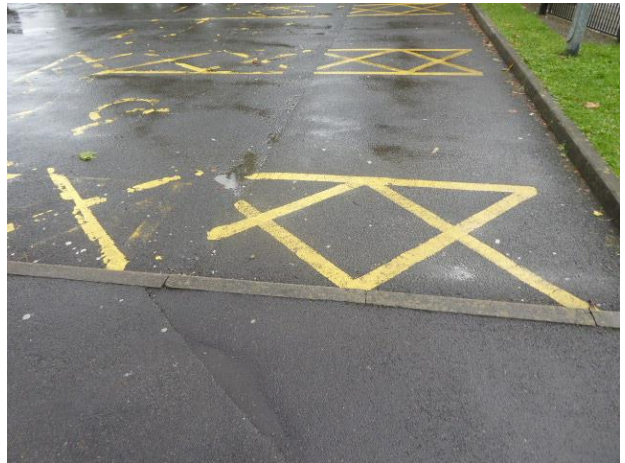
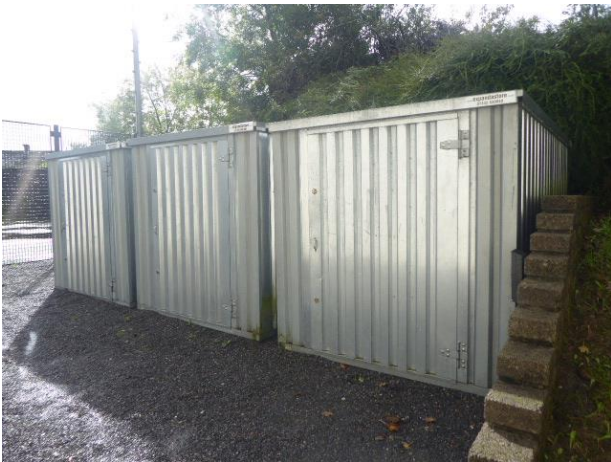
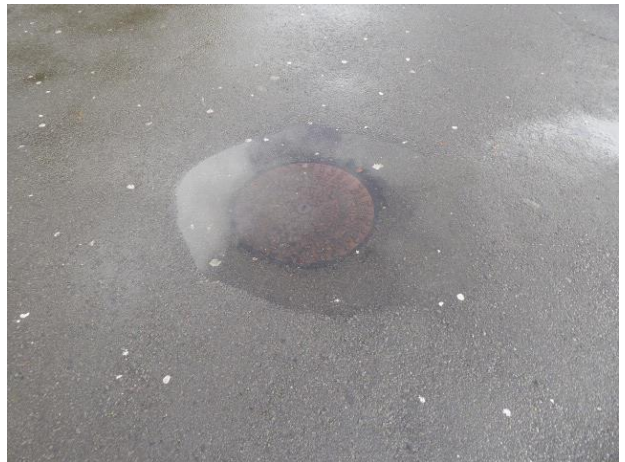
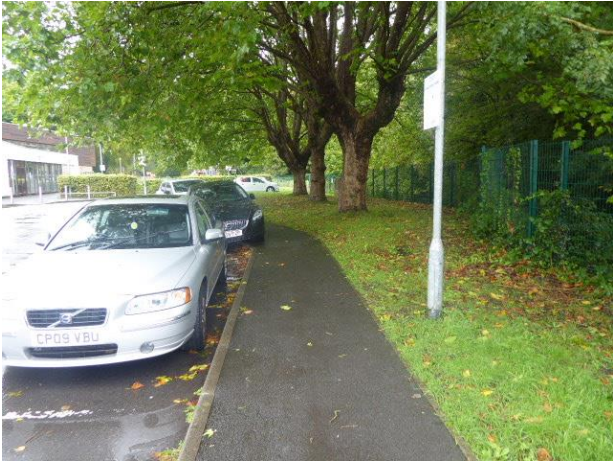
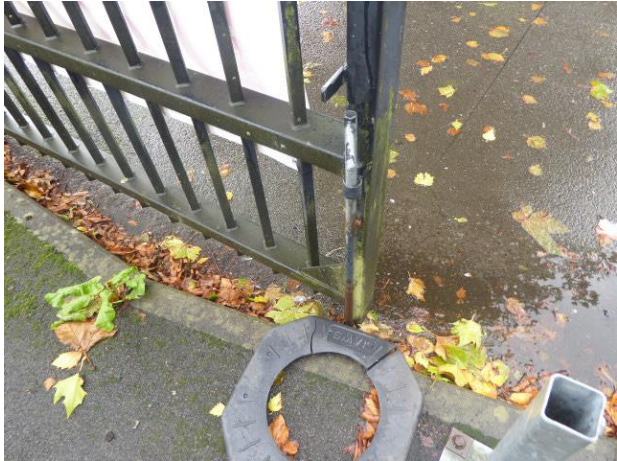
| Element | Sub Element | Description | Condition | Recommendation | Condition<br>(A - D) | Priority<br>(1 - 4) | Remaining<br>Life<br>Expectancy<br>(Yrs) | Photo Ref: |
|---|---|---|---|---|---|---|---|---|
| External Areas | Roads, Car Park,<br>Pathways etc. | Line marking to car<br>park/roadways. | Poor condition. Generally deteriorated. | Repaint line marking throughout site.<br>Allow to undertake repainting works at<br>regular intervals throughout the<br>maintenance period. | C | 2 | 1 | 39-48 |
