| Brynamman Community Centre | | | | | | | |

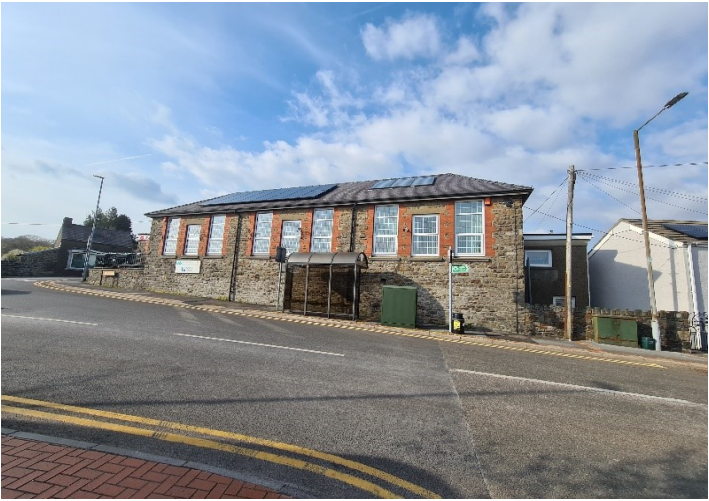
| Brynamman Community Centre | | | | | | | |
|---|---|---|---|---|---|---|---|
| Original Building | 1.1 | The three main Roofs for the bilding are pitched Slate tile roofs. | The Slate is showing some signs of ageing such as discolorisation and there are three tiles on the South slope that have cracked. | Overall the rooves are in good and safe condition. | Replace the three cracked slate tiles and carry out an inspection of the roof space to ensure no water damage has been caused as a result of this. | | |

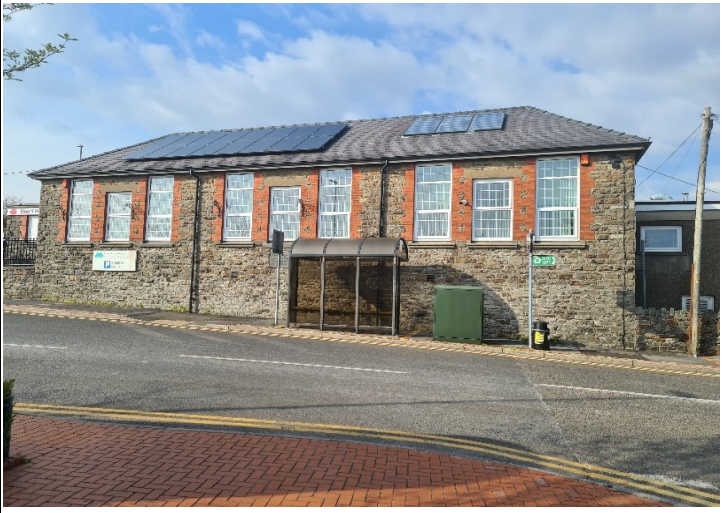
| Brynamman Community Centre | | | | | | | |
|---|---|---|---|---|---|---|---|
| Coverings (incl. glazed roof lights) | 1.2 | Solar Panels installed on the South Pitch of the South Roof. | All look to be in good condition but showing some signs of discolorisation. | Good and Safe condition. | | Inspect in accordance with Manufacturers & installers reccomentdations. | |

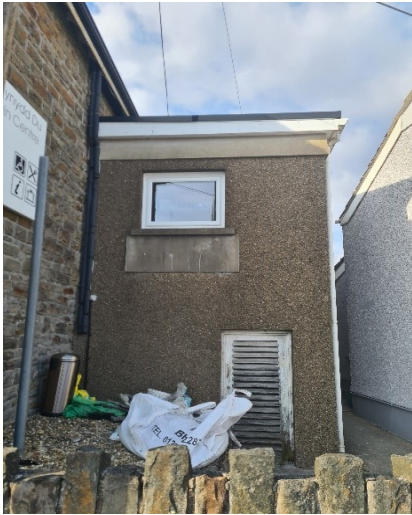
| Rear Extension (East Side) | 1.3 | The rear extension has a flat roof construction. | From Ground Level the condition cannot be fully assessed. | Unknown | None. | Roof should be inspected from above. | |

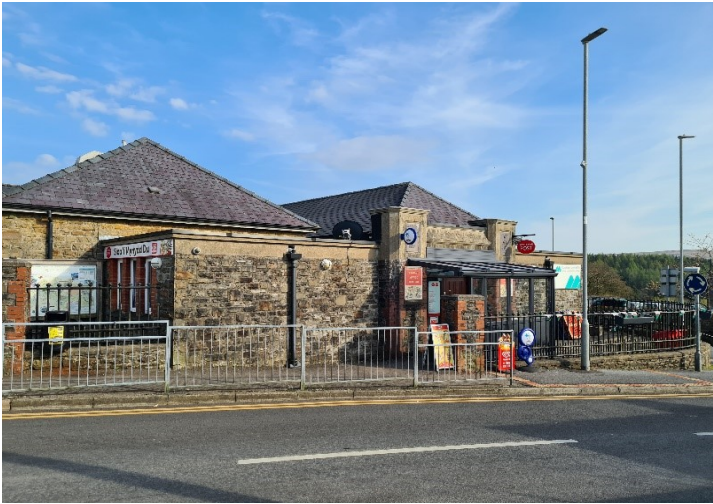
| Front & Centre Flat Roof Areas | 1.4 | To the Front (West Elevation) of the Original building is where the main entrance was when it was originally built as a school. | Unable to access to ascertain its condition. | Unknown | Ensure the area is inspected regularly to maintain its condition. | Roof should be inspected from above. | |

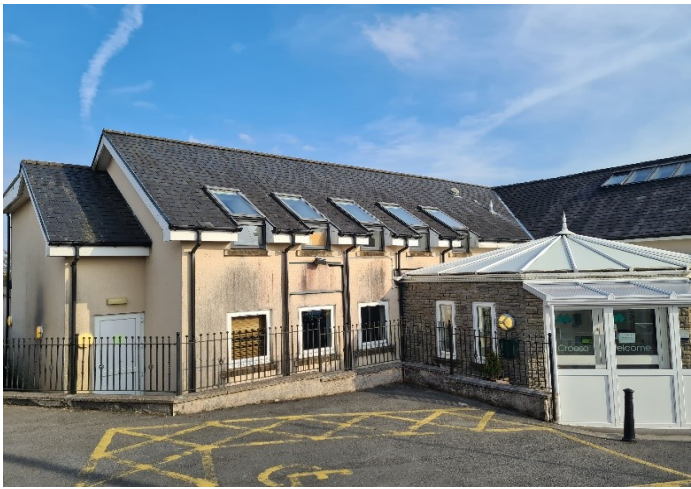
| Northern Extension | 1.5 | Slate tile construction with multiple windows and a roof light. | Condition of slates seem to be okay with flashings visible sound around all pretrusions. | Overall the rooves are in good and safe condition. | None. | | |

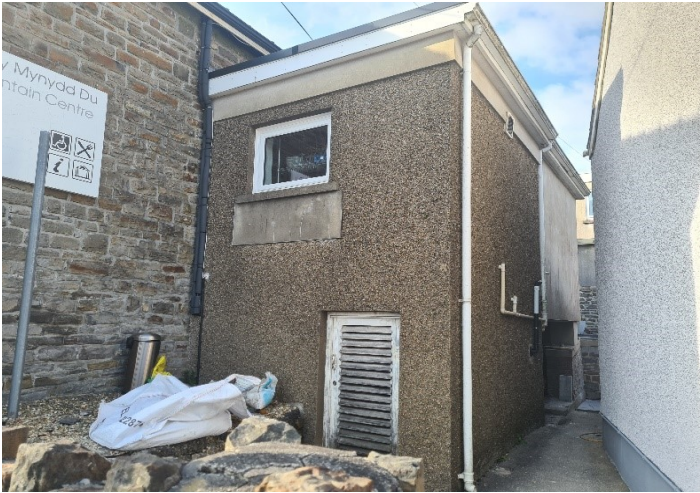
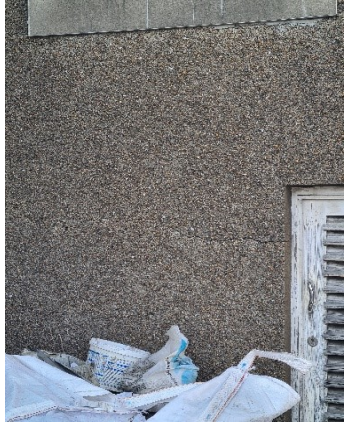
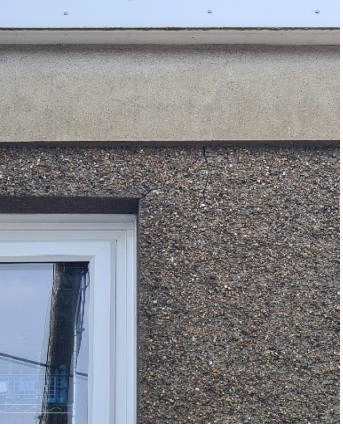
| Rear Extension (East Side) | 2.2 | Unknown constriction but is rendered with a pebble dash finish. | There are mulptie cracks in the South wall of the Extension. | In a safe condition but the cracks need to be monitored to see if they progress. Suspected settlement in the South East corner may have caused the cracks | Monitor and investigate cracks. Replaster may be required. | | <br><br> |

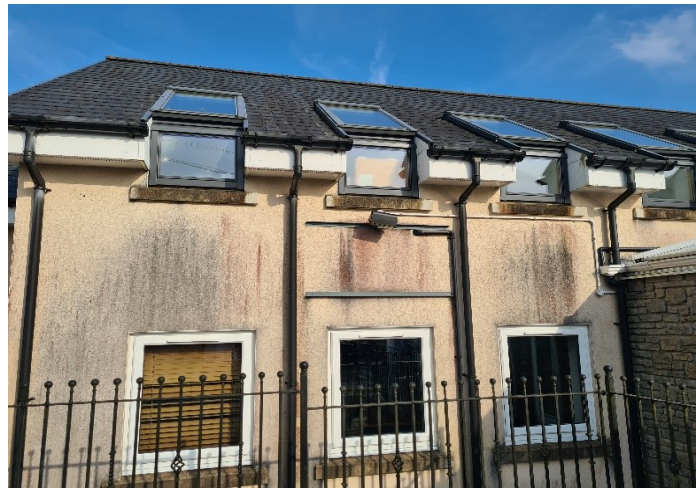
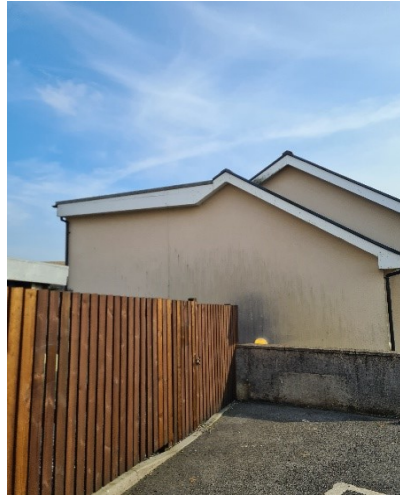
| Northern Extension | 2.3 | Masonary Block Construcionand has a Scratch Render finish on the outside. | The structure and integrity of the building seems to be in a good condition with the only defe t being the change in colour in some locations where the render has turned dark red / black. | Good and Safe condition. | Clean the reder bringing it back to its original colour and seal. | |

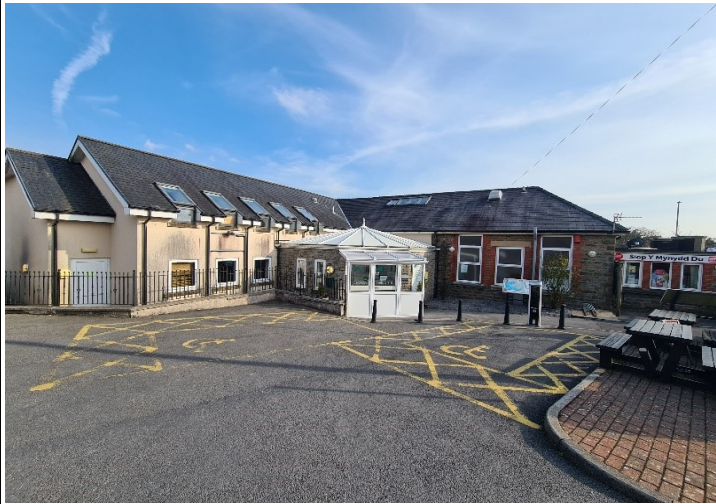
| Windows | 2.4 | New white PVC windows installed around the building. | Good and clean. | Good and Safe condition. | None. | |

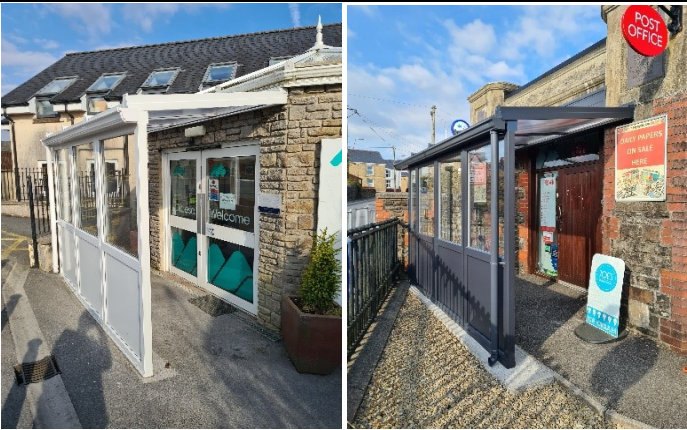
| Doors | 2.5 | <p>The Main entrance has metal automatic doors that are in good condition leading in from the Disabled car Park. The store Entrance has a wooden door.</p> | <p>The Main entrance is in good and working condition.</p> <p>The Store/Post Office entrance door is in tiring condition and is showing some signs of deterioration.</p> | Good and safe condition. | <p>Store / Post Office door needs to be re-painted or re-sealed to protect if from further deterioration with a view to replace within the next 3-5 years.</p> | |
