# CDS Rolls Royce Bushing Bearing Blistering Analysis

Independent Project

5/9/2024  
Bodycote LLC  
David de Vall

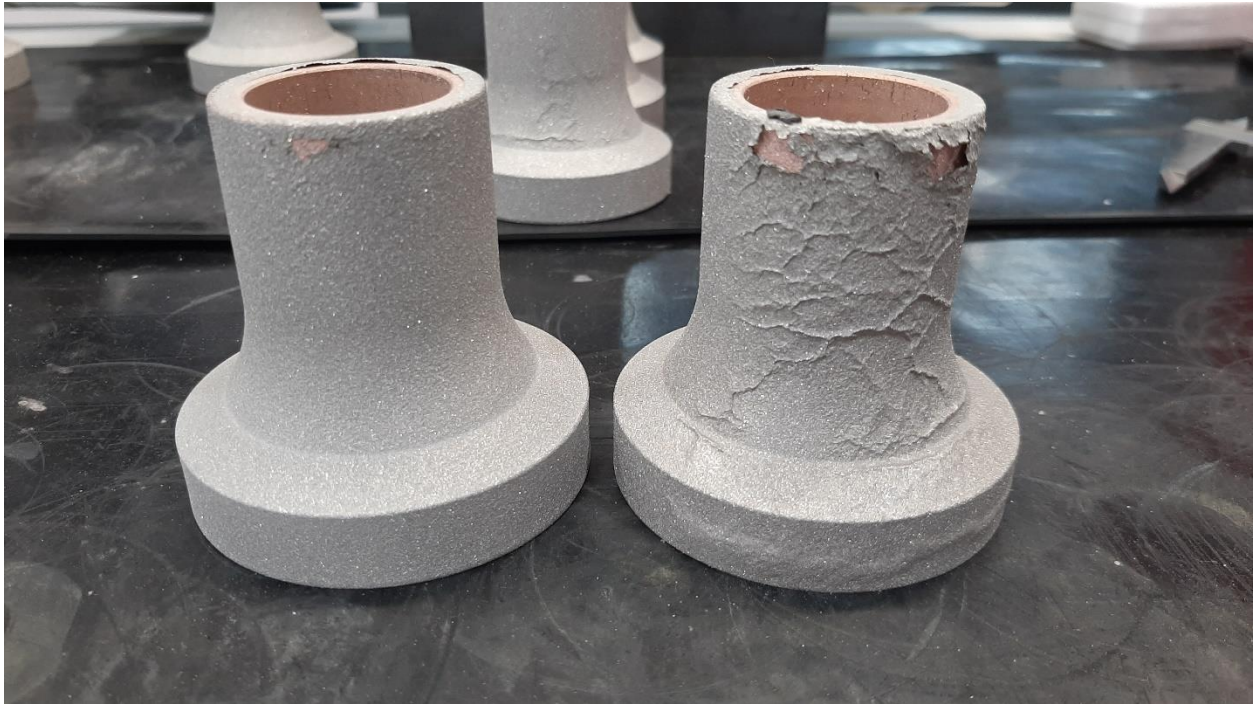
The purpose of this project is to develop a solution to a pervasive problem withing the operations of the CDS-1 booth, which produces bearing blanks for Rolls Royce. During production, the core of the part is grit blasted, which can lead to a phenomenon known as blistering where the surface layer of the part peels away from the main body underneath. This can be minor or catastrophic, but always results in the failure of the part.

*Figure 1: Two blistered components.*

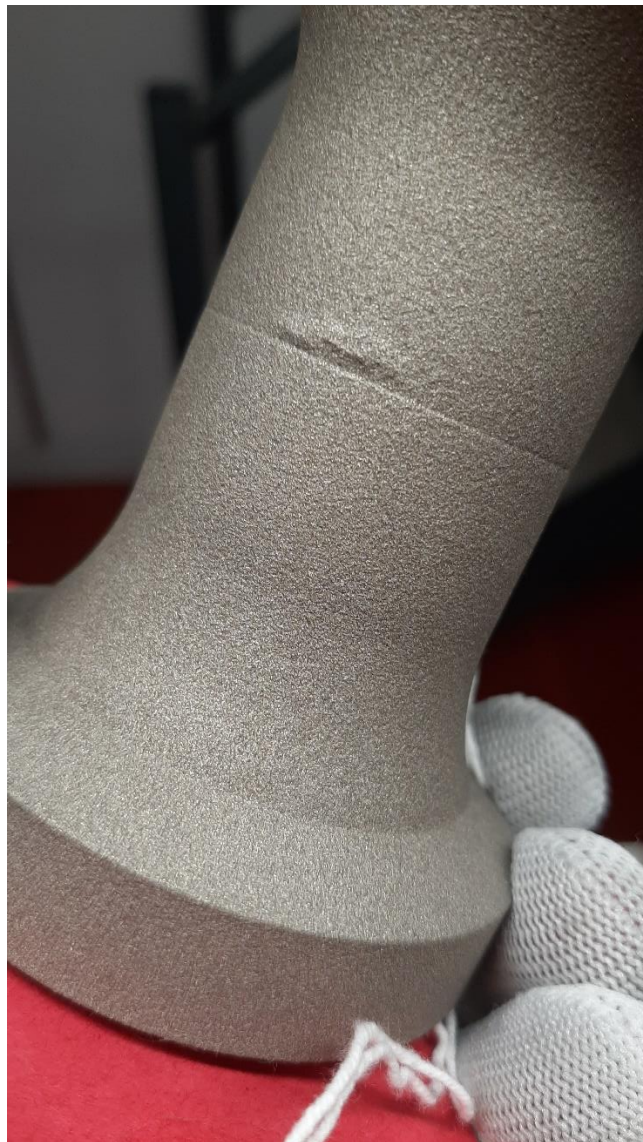
It is believed that blistering is the primary failure mode for CDS-1 parts and should be the primary area of study to mitigate failures. However, it has become clear that not only are failures too commonly occurring, but also that the detection method for failures is somewhat insufficient; parts have escaped detection until after they have been bond coated in some cases.

*Figure 2: A blistered part that has been bond coated.*

This indicates that improvement to the detection method following the blasting process could also use improvement, and this will also be investigated.

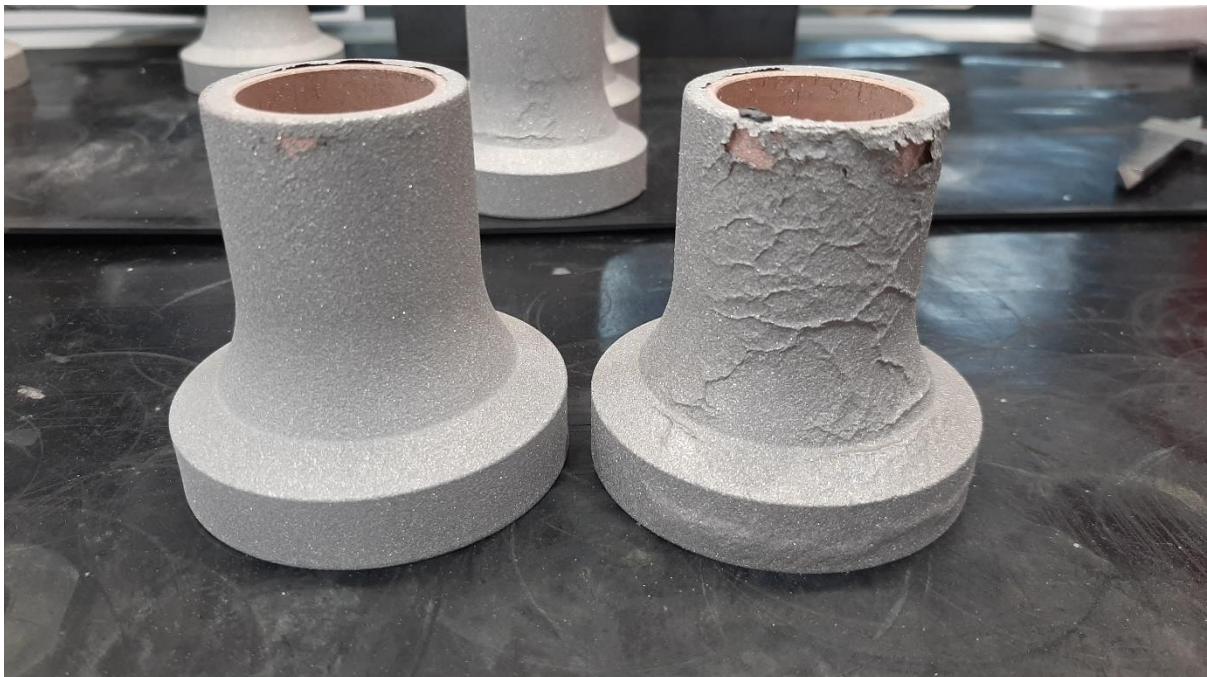
Blistering is a failure mode of thin metal coatings in which the coating bubbles or ruptures away from the core part underneath. This failure can occur during the coating process or during later mechanical or thermal working. This results from localised adhesion failure (Corrosionpedia, 2019). The quantity of blistering failures occurring on Rolls Royce CDS parts seems excessive; it is not uncommon for one or more parts per 24-part batch to blister during grit blasting, which is drastically outside of ideal six sigma parameters.

*Figure 3: Two CDS parts exhibiting blistering failures.*

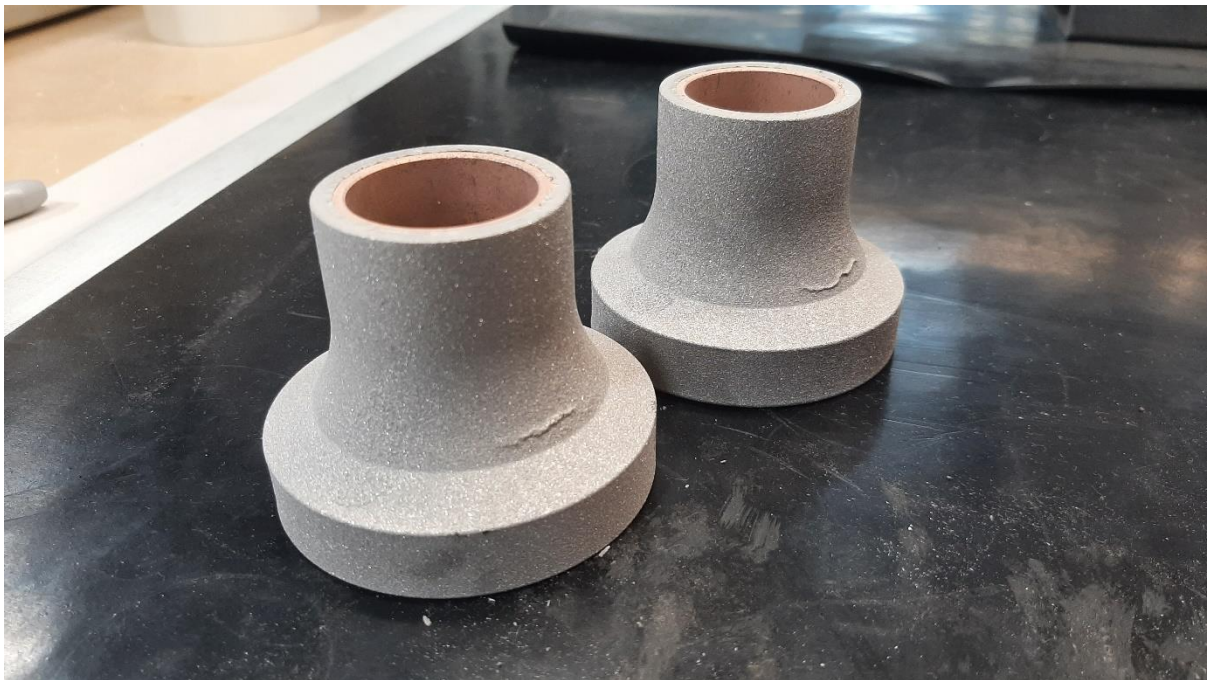
- A lip blister is one that is limited to the narrow end of the part and does not spread more than 10mm away from it. A shoulder blister is one that affects the main body of the part past this 10mm limit, including any lip blister.
- A minor blister is one in which the surface of the nickel coating remains intact, and simply peels away from the base materials. A major blister is one in which the surface of the nickel coating tears, exposing the base material.

*Figure 4: Minor Shoulder Blisters*

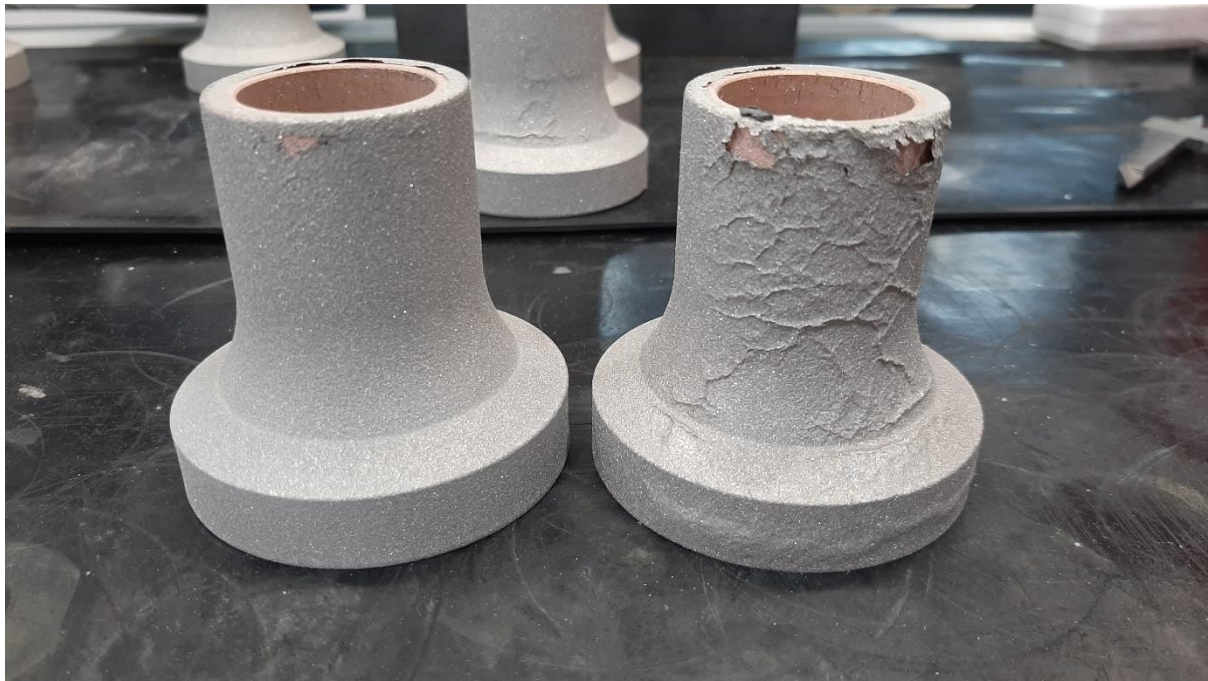
Figure 5: Major Lip and Major Shoulder Blisters

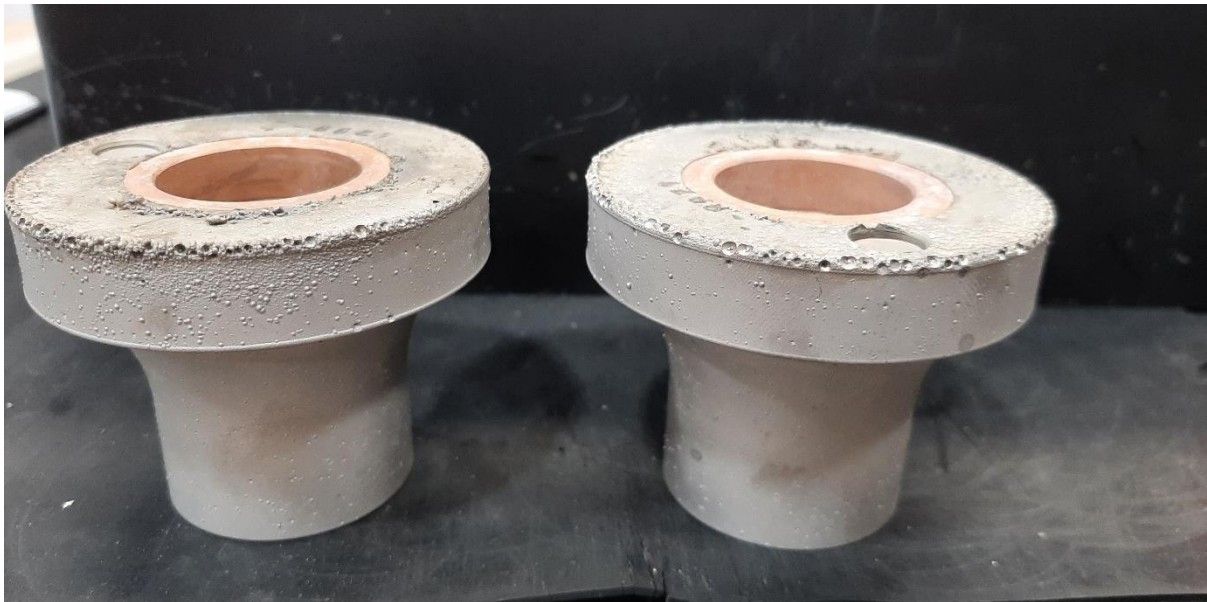
However, it has also been noticed that there has been a considerable increase in pitting in the surface coating of CDS parts; this is a failure mode characterised by holes or pock marks in the surface of varying size. These pits are almost always circular and are more prevalent on the shoulder of the part than on the lip. Thankfully, as the nickel layer exists primarily to assist with the bonding of thermally sprayed aluminium to the lead-bronze core, the surface finish of the layer is not at risk; the pitting is only a direct failure of the part if it causes a through hole and the lead-bronze substrate is visible through the nickel layer. This is much less frequent, although has increased; actual study of the increased failure rate is ongoing.

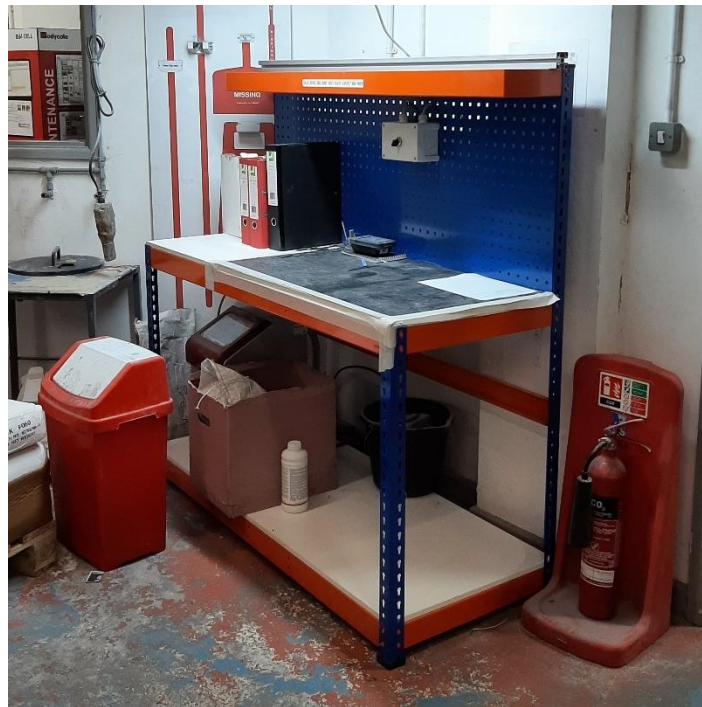
*Figure 10: The new inspection table.*

To combat the low detection rate for blistering, the decision was made to install a part analysis workbench inside the blasting room. This bench is fitted with a light that provides 1400 lux, which is much more than the 1000 lux required for proper part analysis. This allows for the blasting operator to check parts for minor blisters as well as the CDS-1 operator, if both are different. With two pairs of eyes instead of one, it stands to reason that the rate of detection failures for blistered parts will be halved.

To coincide with this installation, support technician Mark James had been trained in the visual inspection of CDS-1 parts for minor Blistering.
