Fracture/Fatigue Failures of Products and Components In-Service

University of Wales Trinity Saint David  
BEng Bachelor of Engineering Program, Ordnance, Munitions and  
Explosives (Safety)

This report presents a materials failure analysis of an in-service Boeing 737 next generation main landing gear wheel hub, a safety critical aluminium alloy component (typically AA7075-T6), that failed due to high-cycle fatigue. The investigation identifies fatigue crack initiation at the bearing bore shoulder radius, a region of high geometric stress concentration, followed by progressive crack growth (characterised by beach marks and multiple axial/circumferential cracks), and final ductile overload fracture, evidenced by a rough, fibrous surface with micro void coalescence.

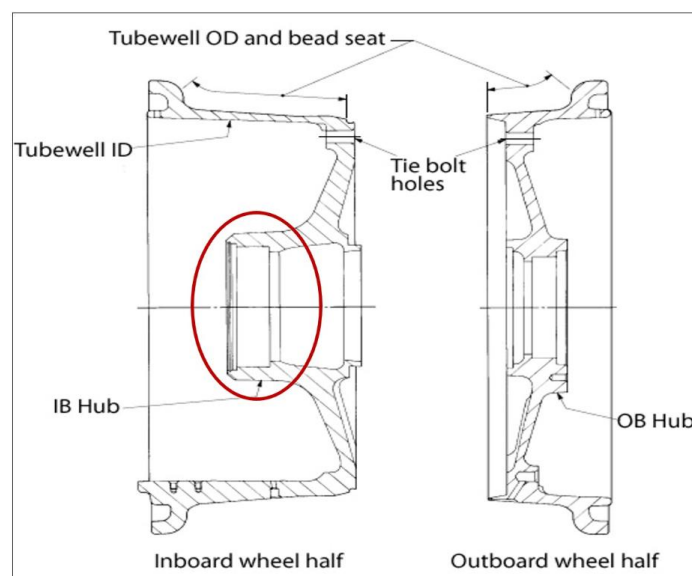
**Figure 13 Schematic Diagram of Wheel Hub with the Failure Location Circled [13]**

The failure of the Boeing 737 NG main landing gear (MLG) wheel hub is assessed to have occurred as a result of high-cycle fatigue leading to final overload fracture. The component examined was the inboard half of the wheel hub, seen in Figure 13, a highly stressed, safety-critical structural element responsible for transmitting landing, braking, and taxi loads from the wheel assembly into the landing gear structure.

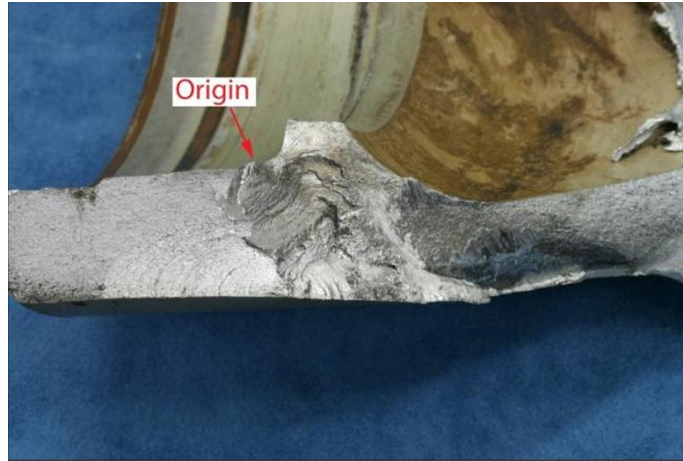
**Figure 15 Fatigue Fracture Surface Showing Beach Marks and Crack Origin [13]**

Fractographic examination of the failed hub, Seen in Figure 15, revealed features characteristic of fatigue failure, included:

- Crack initiation at a localised geometric discontinuity
- Stable crack growth over an extended period
- Final catastrophic overload once critical crack size was reached

Distinct beach marks were observed on the fracture surface in Figure 15, indicating intermittent crack growth corresponding to variations in operational loading. These macroscopic fatigue markings provide strong evidence that the crack propagated incrementally over many service cycles before ultimate failure.

The dull grey, fibrous fracture surface corresponds to ductile overstress failure. Its morphology indicates a sudden overload event, with no evidence of the smooth, progressive crack growth typically associated with fatigue.

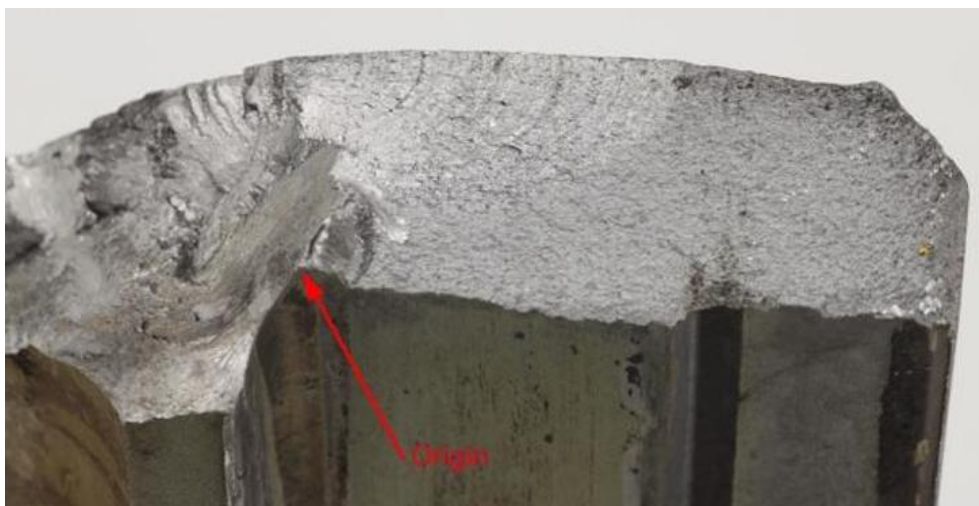
**Figure 16 Crack Initiation at Bearing Bore Corner Radius**

Crack initiation is assessed to have occurred at the bearing bore corner radius, a region known to experience elevated local stresses due to both geometry and loading conditions [7]. This area, seen in Figure 16, represents a transition between the cylindrical bearing seat and the hub wall, where relatively small fillet radii can produce significant stress concentration effects.

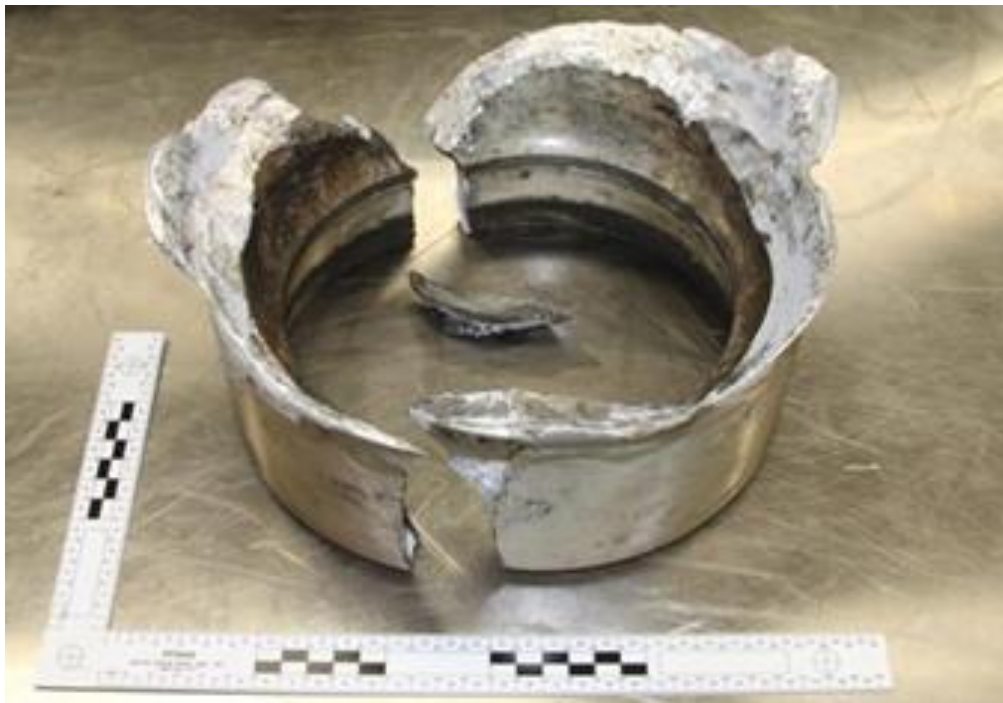
**Figure 17 Fractured Hub Section [13]**

Figure 17 shows the fatigue cracks grew in two main directions:

- **Axial cracks** - running along the length of the hub (parallel to the axle).
- **Circumferential cracks** - running around the hub (like rings around the bore).

These multiple directions show the complex stresses acting on the bearing bore area, radial pressure pushing outward and torsional/shear forces twisting the hub. The cracks eventually linked up, leading to the final fracture and hub separation.

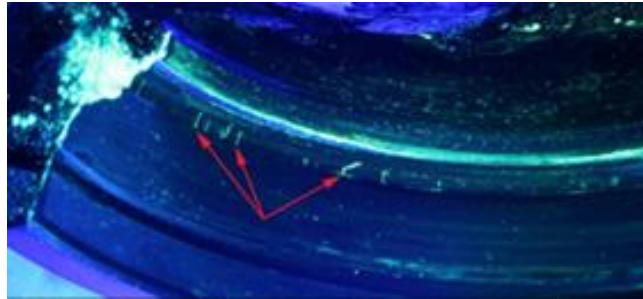
**Figure 18 Radial Cracks Found by FPI [13]**

To check for other cracks, the remaining parts of the inboard hub were inspected using fluorescent penetrant inspection (FPI), seen in Figure 18 and Ultrasonic testing (UT). This technique revealed multiple radial and circumferential cracks in the bearing bore radius area [13]

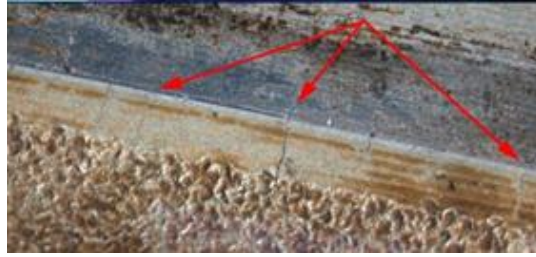
**Figure 22 Radial/Axial Cracks Adjacent to the Shot-Peened Area (High Magnification) [13]**

Surface condition also plays a critical role. Shot peening introduces a layer of beneficial compressive residual stress that suppresses crack initiation, but in this case the bearing-bore radius was not treated. As a result, this transition region lacked the protective compressive layer and remained vulnerable to fatigue under service loading. The presence of multiple radial and circumferential cracks around the bore is consistent with a highly stressed, un-peened region subjected to complex cyclic loading [13].

High-magnification examination in Figure 22, confirmed these cracks were mostly radial and positioned right next to the shot-peened region. This shows the area outside the peened zone was highly stressed and unprotected, allowing extra cracks to start.
