# Retrofit Coordination and Management

HND / BSC CONSTRUCTION MANAGEMENT

By Aaron Griffiths (2223674) | **ACBA5026** | 10/01/25

14 Norgans Terrace, Pembroke is a terraced house built in “1906 which is the last map in which the house was last seen on” - (Maps.nls.uk. (2025). *Map Finder - with Marker Pin - Map Images - National Library of Scotland*. [online] Available at:

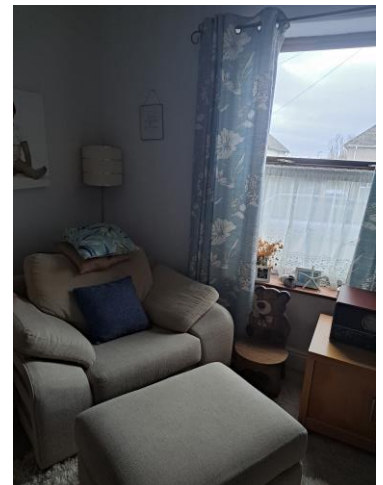
The building is constructed from stone and has a plaster finish in the internal envelope of the building. At the front of the property the bottom half of the building has an exposed stone finish, and the top half has a render finished applied. The render finish completes the whole rear end of the property. All walls in the property have no defect and are in good condition from a visual inspection. The external walls are approx. 600mm thick and internal walls are approx. 100mm thick. Looking at the external walls I can't visualize any cracks or defects which would produce damp in the building

The external doors to the front and rear of the property are old-fashioned timber doors which are not very well sealed and very drafty. However, the condition of the doors is good.

The condition of the paint on the building is in poor condition and needs to be repainted. This is the same with the condition of the waste pipes and soil pipes which need to be painted to protect the pipes from harsh weather conditions.

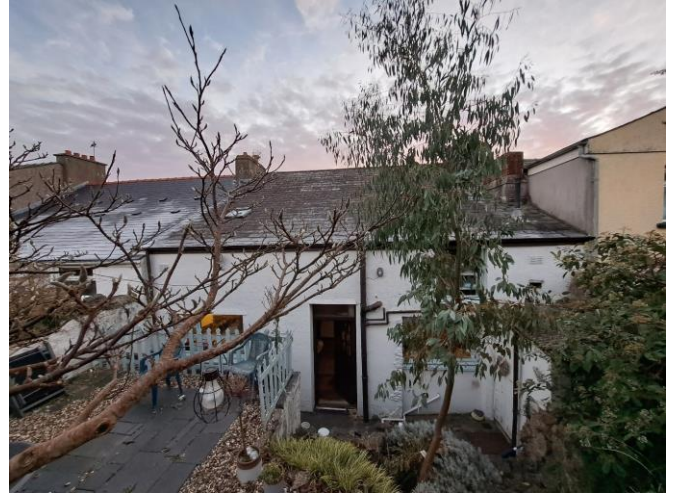
Regarding the roof, it is made from slates from visual inspection. The property has wooden fascia and soffits. The guttering and downpipes are all made from PVC and are all in good condition.

There is an opening in the roof space for a chimney which the brick works it's not in good condition and would need to be repointed. The lead in which the chimney connects to the roof section is in poor condition as well and needs to be replaced and renewed. Another opening on the roof is a valex window. This window is in poor condition and the seal around the window needs to be resealed as when I was on the property could feel a draft coming through.

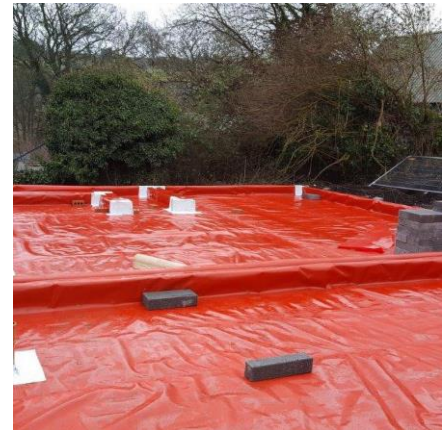
*Fig 5 - Jones, S. (2022). Radon Barrier Membrane - Powerbase Radon Barrier Sheeting. [online] Industrial Textiles & Plastics Ltd. Available at: <https://itpltd.com/powerbase-radon-barrier/>.*

Due to the property being in a high radon area. Radon protection is key to being installed on the property. Which I would like to imply is that a radon protection barrier to be

installed on the ground floor of the property. This would insist on filling in the void at the front of the property and digging up the floor at the rear. This would allow you to install the radon membrane to the floor, I would also recommend that the membrane is secured to the wall at skirting level to ensure the radon below is encapsulated and not penetrated by any air gaps. This membrane will have to be airtight using airtight tape and to ensure the detail is accurate and fit securely with no air bubbles.
