Henry Whittington

NSEDA Assignment K

University of Wales Trinity Saint David, School of Applied  
Computing  
Ordnance, Munitions and Explosives

BEng  
Academic Year: 2025-2026

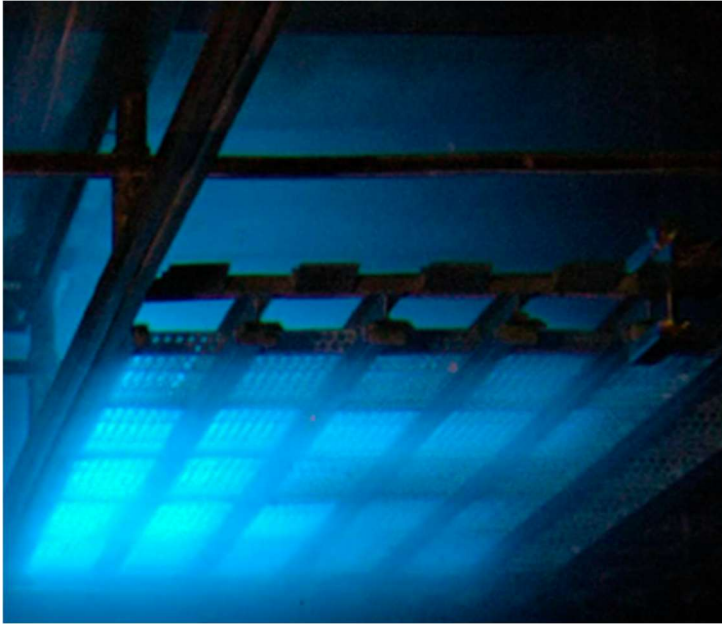
The irradiator comprises a 5 m deep water shielding pool in which the source rack is stored when not in use. During operation, the rack is raised into the irradiation chamber by a motor-driven hoist mechanism.

When the source rack is fully parked, the pool water provides the principal biological shielding.

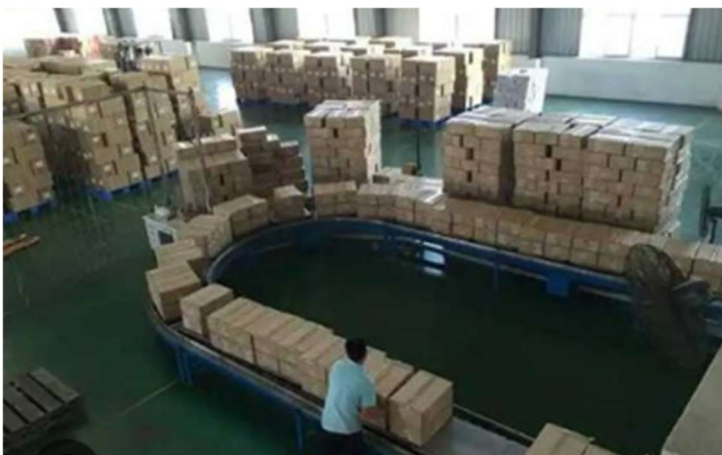
Lead filled steel baffles are used to limit direct radiation shine paths.

Product carriers are transferred through the irradiation chamber by an automated conveyor. Maintenance access is prohibited unless the source rack is confirmed to be fully lowered into the pool and the plant is in a safe state.

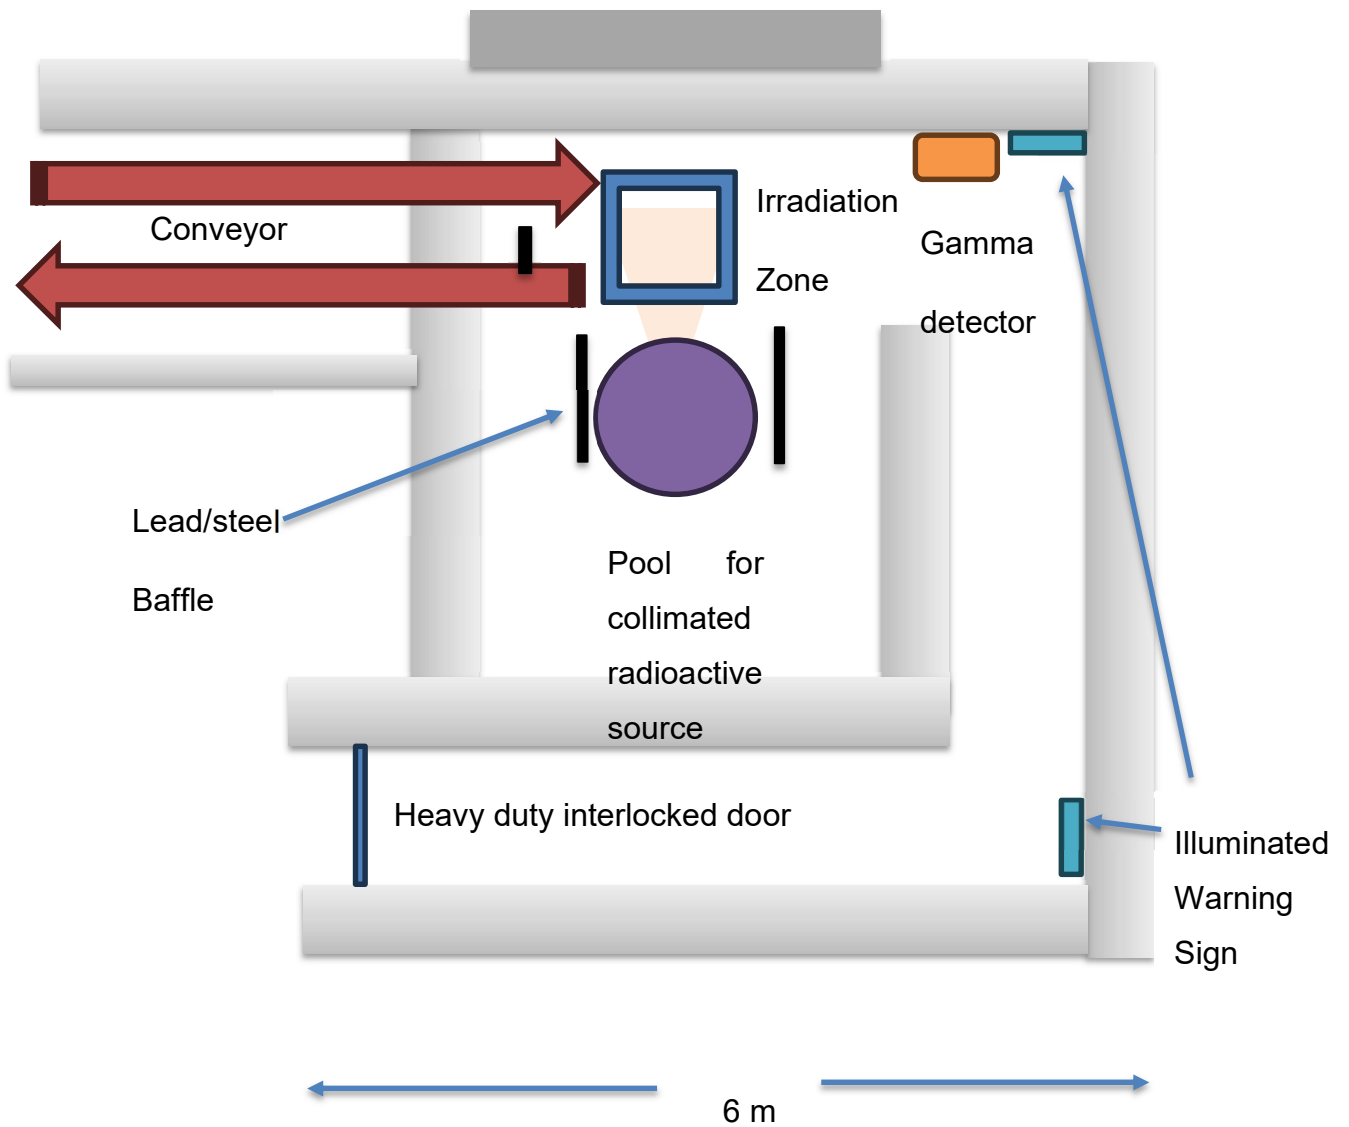
Plan View- not to scale

Plans show that the irradiation area is physically demarcated by a maze and a door, with warning signs positioned at two points within the maze. The author therefore considers that the site is *compliant* with IRR17 para. 9.

Walls are 1.5 m thick barytes concrete
