## PHASE I

### DESK TOP STUDY & SITE WALKOVER

AGBRIGG LANDFILL SITE

REAR OF BRIARY CLOSE  
AGBRIGG  
WAKEFIELD

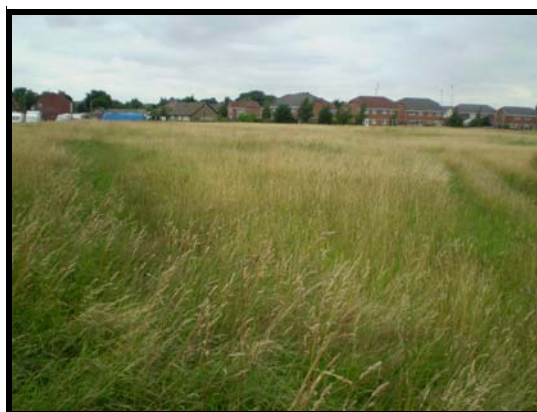
Photograph 1

A preliminary site inspection of the site was undertaken on the 4<sup>th</sup> July 2008 with a further inspection on the 12<sup>th</sup> December 2008 by Environmental Health. The following photographs were taken during the site walkover which confirmed that the land is used for private agricultural hay fields (Photograph 1) and caravan storage (Photograph 2).

- The site is generally flat (Photograph 1)
- There are four monitoring standpipes at the boundary fence of Briary Close (Photograph 3 and Appendix 2 for locations)

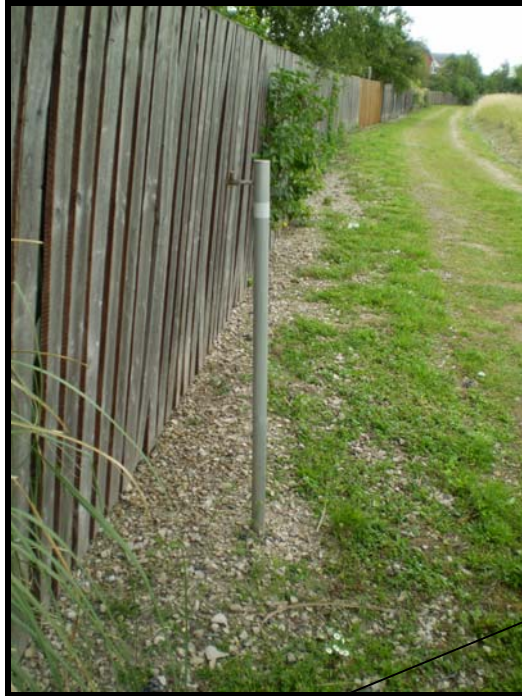
Photograph 3 - Gas Monitoring  
Standpipe at Briary Close

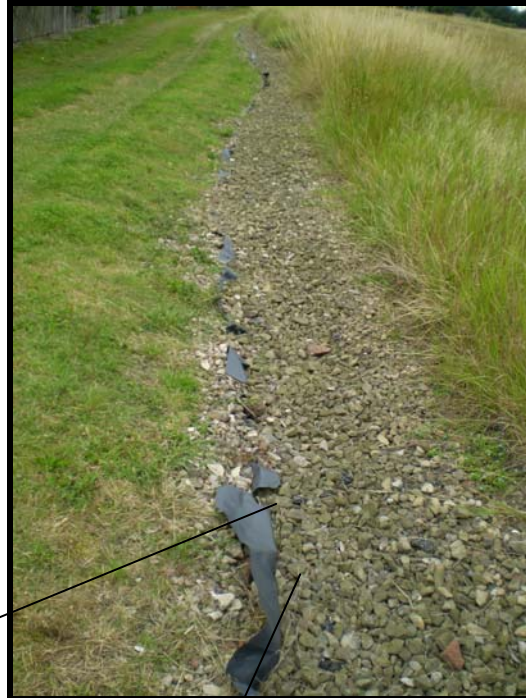
- A 0.5m venting trench is visible between the track and landfill site with a black membrane evident. There didn't appear to be any sand blinding next to the membrane to protect it from puncture by the aggregate. Various punctures were noted in the membrane. (Photograph 4 & 5 and Appendix 2 for the location)

Photograph 4 - Venting Trench

- Migration of LFG through permeable alluvium strata towards residential properties on Station Street, Newland Street, Newland Court and Church View which are believed to have cellars. Chemical odour reported to Environmental Health on the 11<sup>th</sup> November 2000 in this vicinity.
- The condition and effectiveness of the venting trench is unknown as no maintenance regime has been adhered to.

1. Funding should be sought for the following:
  - Installation of landfill gas monitoring boreholes in the southern part of the site i.e. paddock and caravan storage area where dwellings with cellars exist.
  - Monitoring of landfill gas within the boreholes in line with current guidance.
  - Inspection of the landfill gas venting trench to the east of Briary Close to determine its condition and recommend any need for maintenance as deemed necessary.
  - Sampling of the leachate within the leachate chamber
  - Completion of a landfill gas & leachate risk assessment utilising these monitoring results with any recommendations for remedial action.
2. The site should be reassessed after the above works have been completed.

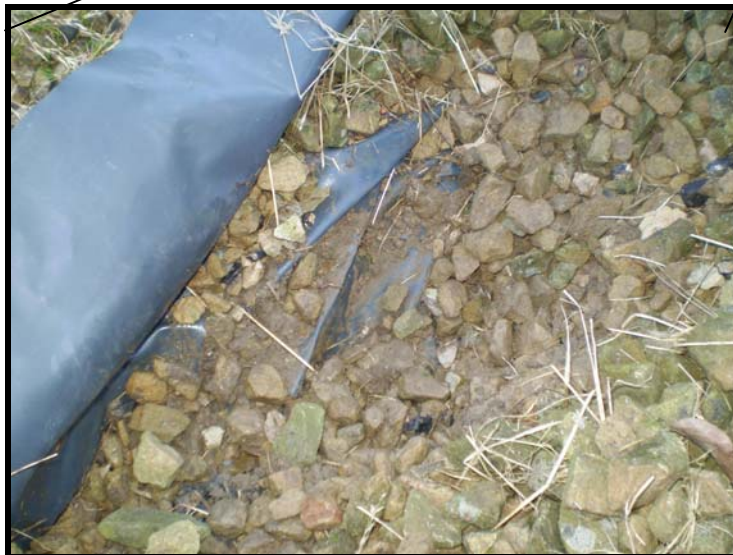
Photograph 5 – Showing  
Membrane and Excavated  
Aggregate Demonstrating  
No Visible Sand Blinding  
Next to Membrane

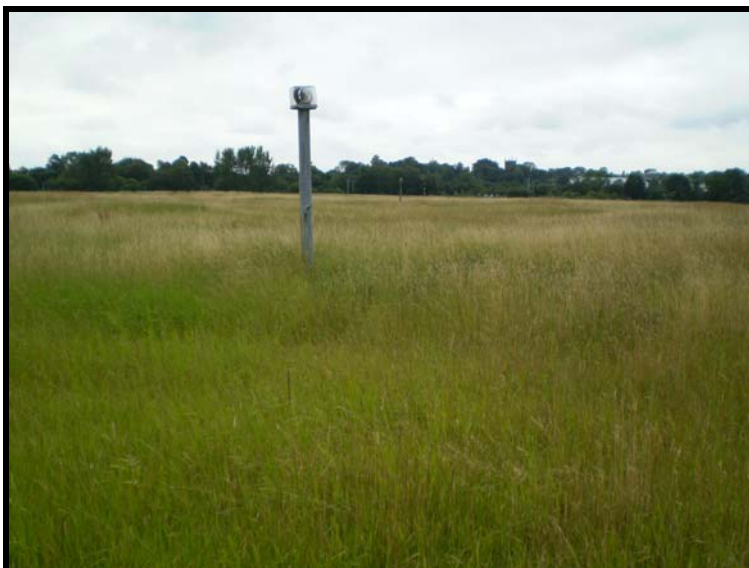
Photograph 7 - On Site Vent Stacks

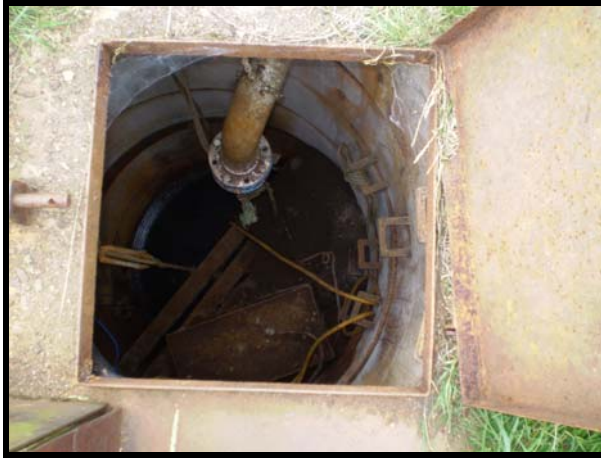
Photographs 8 – Leachate Chamber and Pumps

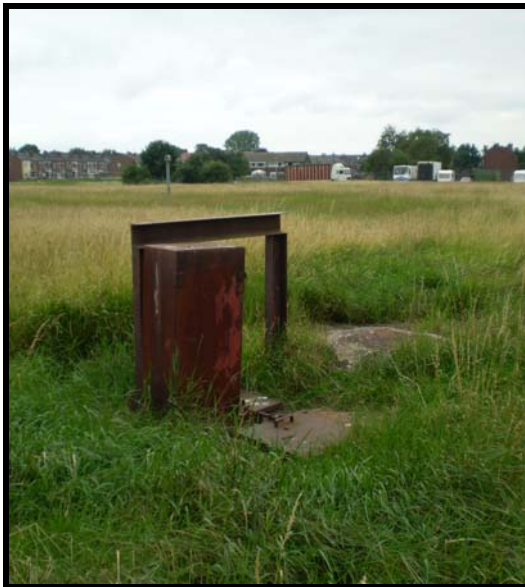
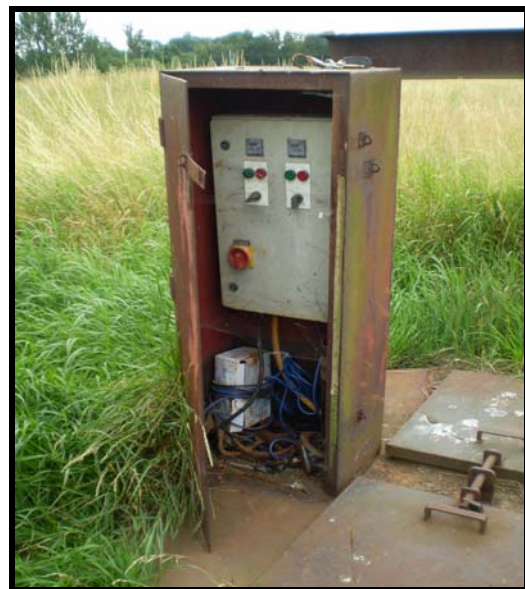
Photographs 9 & 10 – Leachate Pumping Control Cabinet

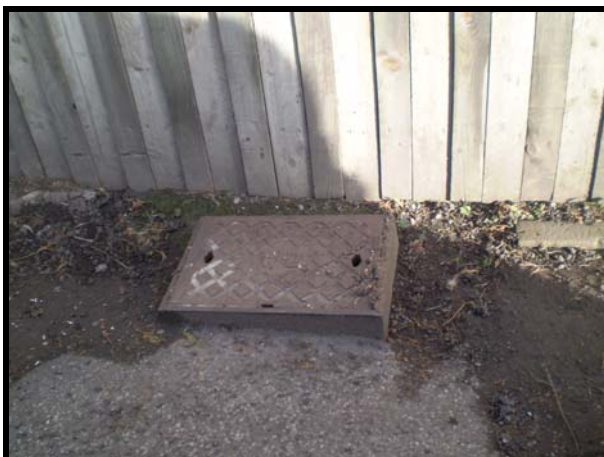
Photograph 11 – Foul Sewer Connection Manhole

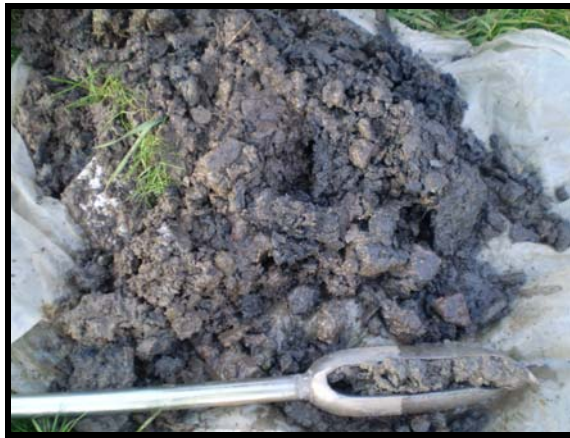
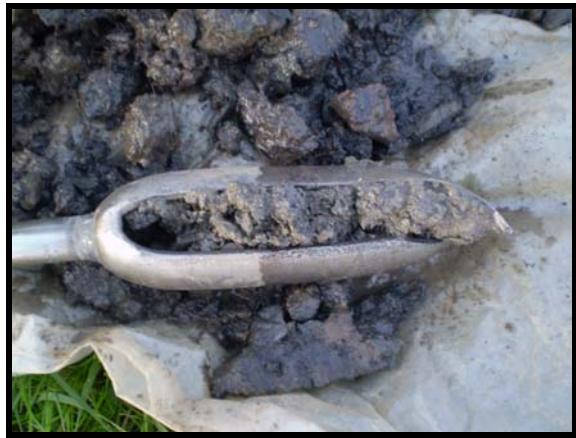
Photographs 12 & 13 - Trail Pit 1

- The site tends to be waterlogged during the winter months.
- Two trail pits (refer to Plan in Appendix 2 and Photographs 12, 13, 14 and 15) were dug to confirm the depth and nature of the on-site cap. The pits revealed a loose layer of topsoil of about 300mm depth overlying made ground of ash, clay, bricks and red shale. Groundwater was encountered at trail pit 1 at 300mm.
