# **School of Engineering Project Dissertation M6X00417**

Safe and Compliant Process Unit Operation

George Bagley P148139  
BEng Mechanical Manufacturing Engineering

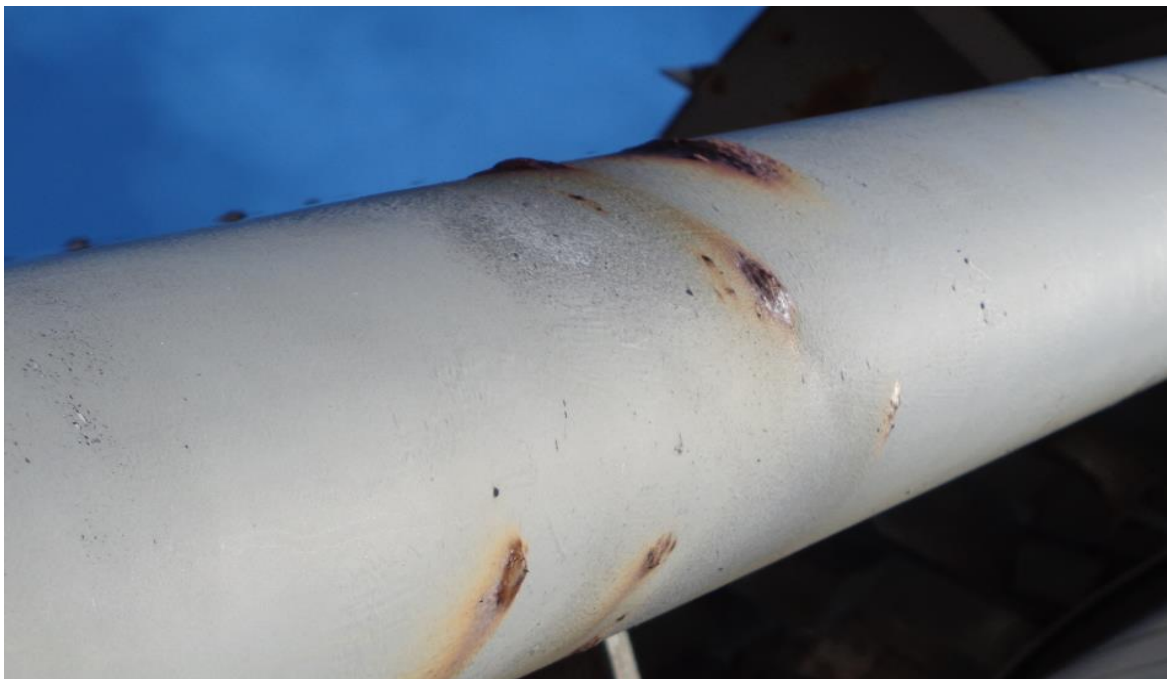
The IAN states that there are a further 12 locations that have not been inspected due to excessive pustular corrosion and scale found. The current inspection method to take piping thickness readings are ultrasonic thickness measurement (USTM). This form of non-destructive testing (NDT) involves a hand held device that measures soundwaves by the time it takes for the soundwave signal to bounce back indicating the material thickness, this is very effective on good material but inconclusive for heavy corrosion. Not knowing these remaining thicknesses due to heavy scabbing on the line presents a potential similar hazard to that of location 12. It would not be best practice to remove the scabbing while the line is pressured up in case a leak were to develop from the process of mechanical descaling. The scabbing shown in (**figure 4**) can however be inspected with an alternative means of NDT.

*Figure 4 showing scabbing to 01-WP-3017-8"*

Radiography can be used to assess RWT. This is not the routine approach to scheduled pipe inspection due to the resource required to carry out the work. This work is also classed as a

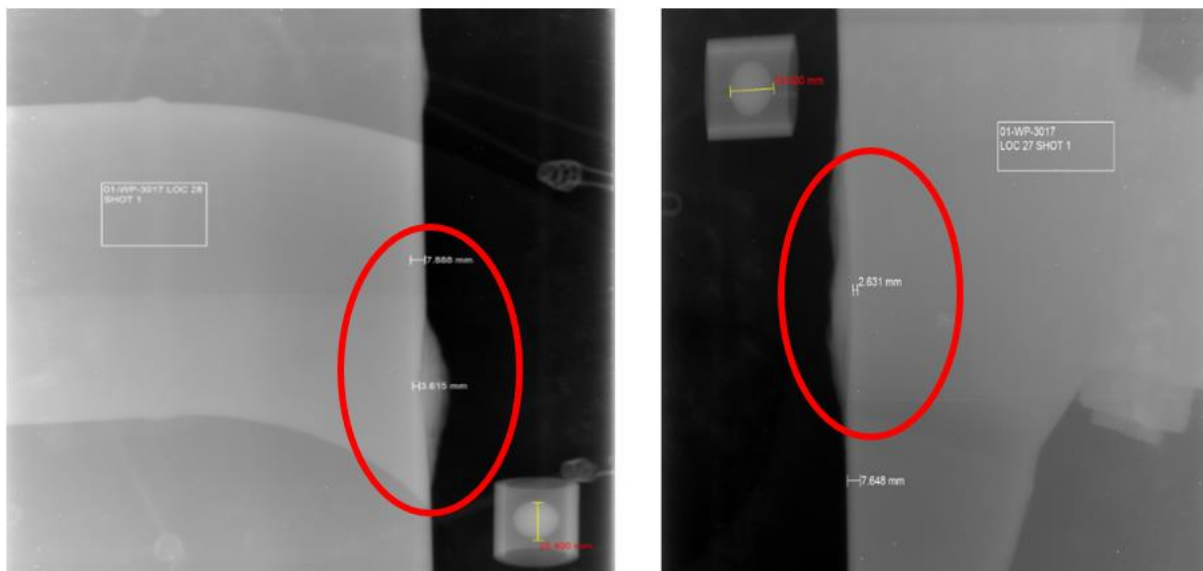
Results of USTM are usually null and void measuring heavy external corrosion and radiography unless corrosion is removed is un-avoidable. Therefore in this case the area inspection engineer is requested to and completes this work with the in-house NDT contractor. **(Figure 5)** shows two rad shots taken of blisters found at locations 27 and 28 these show remaining wall thickness above  $T_{min}$  and in location 28 above PMPT. From the radiography taken it is shown that location 33 has the least RWT of 2.2mm, the thickest was found to be virtually nominal thickness of approximately 8mm. From this information it has become apparent that the unknown areas of the line pose no greater risk than that of location 12.

Figure 5 Radiography carried out at locations 27/28 showing remaining wall under pipe blisters

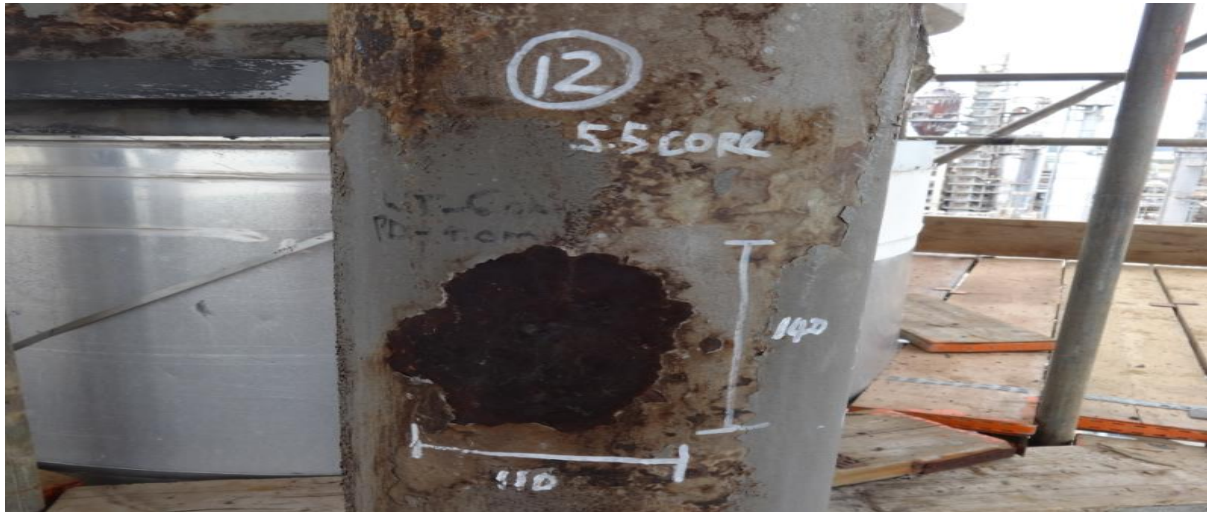
With the present hazard taken into consideration, action is immediately required to mitigate this risk. The IAN has confirmed this line is below PMPT and 3mm min RWT. Work needs to be done to understand all of the facts presented in IAN 0X6976 shown in **appendix D**. The first action to be taken, using the Pembroke risk matrix (**table 2**) to understand what the current level of risk is in order to categorise the priority of this IAN being progressed quicker than others. From the authors experience the consequence of failure of a line in this service is high due to it containing dangerous levels of H<sub>2</sub>S. Before progressing to calculating the hazard of the thinned sections of line some analysis is to take place to establish the minimum required thickness for pressure containment T<sub>min</sub>.

Figure 6 Corroded section of 01-WP-3017-8" at location 12 with 0.5mm remaining wall thickness

As discussed in section 11.1, **Topic one** requires immediate action. The decision of fitting a mechanical enclosure (repair clamp) to mitigate location 12 of the IAN is to be actioned as an urgent priority due to the risk of operating with a line below  $T_{min}$ . At the time, from the author's point of view the process of installing a temporary repair was not clearly defined. To aid the author and with guidance from the engineering team a flow diagram was constructed using MS Visio of which can be seen in (**table 5**). This shows the workflow process that has to take place in order to install the mechanical clamp.

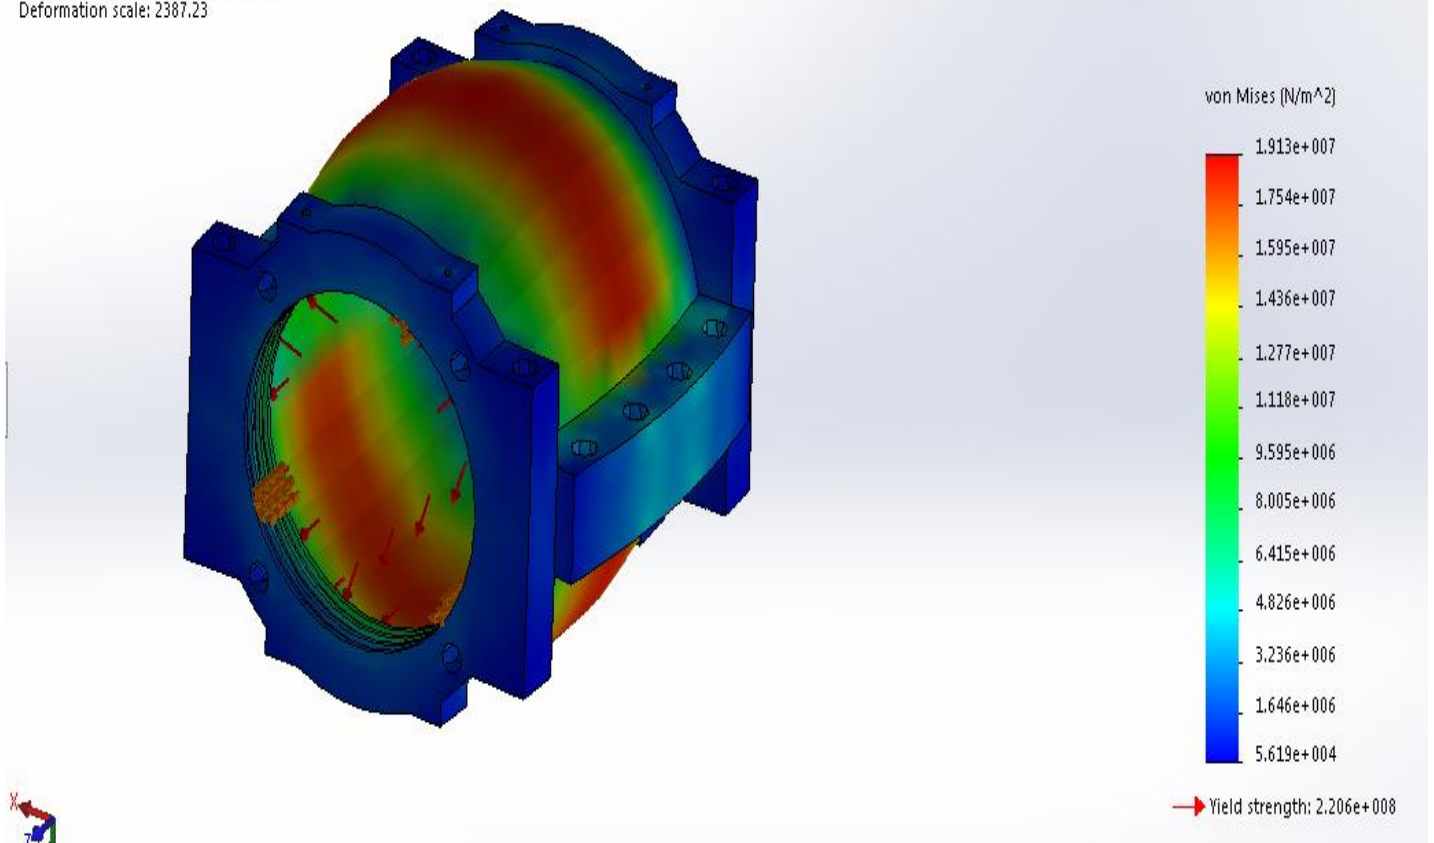
Figure 9 Solid works static study used to validate clamp design calculations

The FEA shown above is set up by fixing the endplate sealing faces to the pipe and applying internal pressure of 1.37MPa to the internal cylinder.

From these standard calculations taken from sections of ASME VIII, the proposed Team-Furmanite clamp is deemed acceptable and fit for purpose as a temporary repair. To further support these findings a solid works model has been constructed using the CAD drawing and FEA has been completed to back up the calculations. As seen in the FEA study (**figure 9**) the maximum Von-Mises stress observed shows  $19.13\text{N/mm}^2$ , this appears acceptable although well below  $137.9\text{N/mm}^2$  that is specified as maximum allowable stress as per ASME B31.3 table A-1 **appendix F (a)**. The actual thickness is far above the minimum thickness so the clamp will not appear to be overly stressed. It should also be noted that the operating temperature of  $149^\circ\text{C}$  has not been accounted for in this static study, neither has any of the forces acting on the clamp from the bolting. The justification for the FEA for this report is to just assess whether or not higher stresses than previously calculated are present which in this case they are not. An SAP work order (5055707) has been entered to progress this clamp which can be seen in **appendix K (a)**.

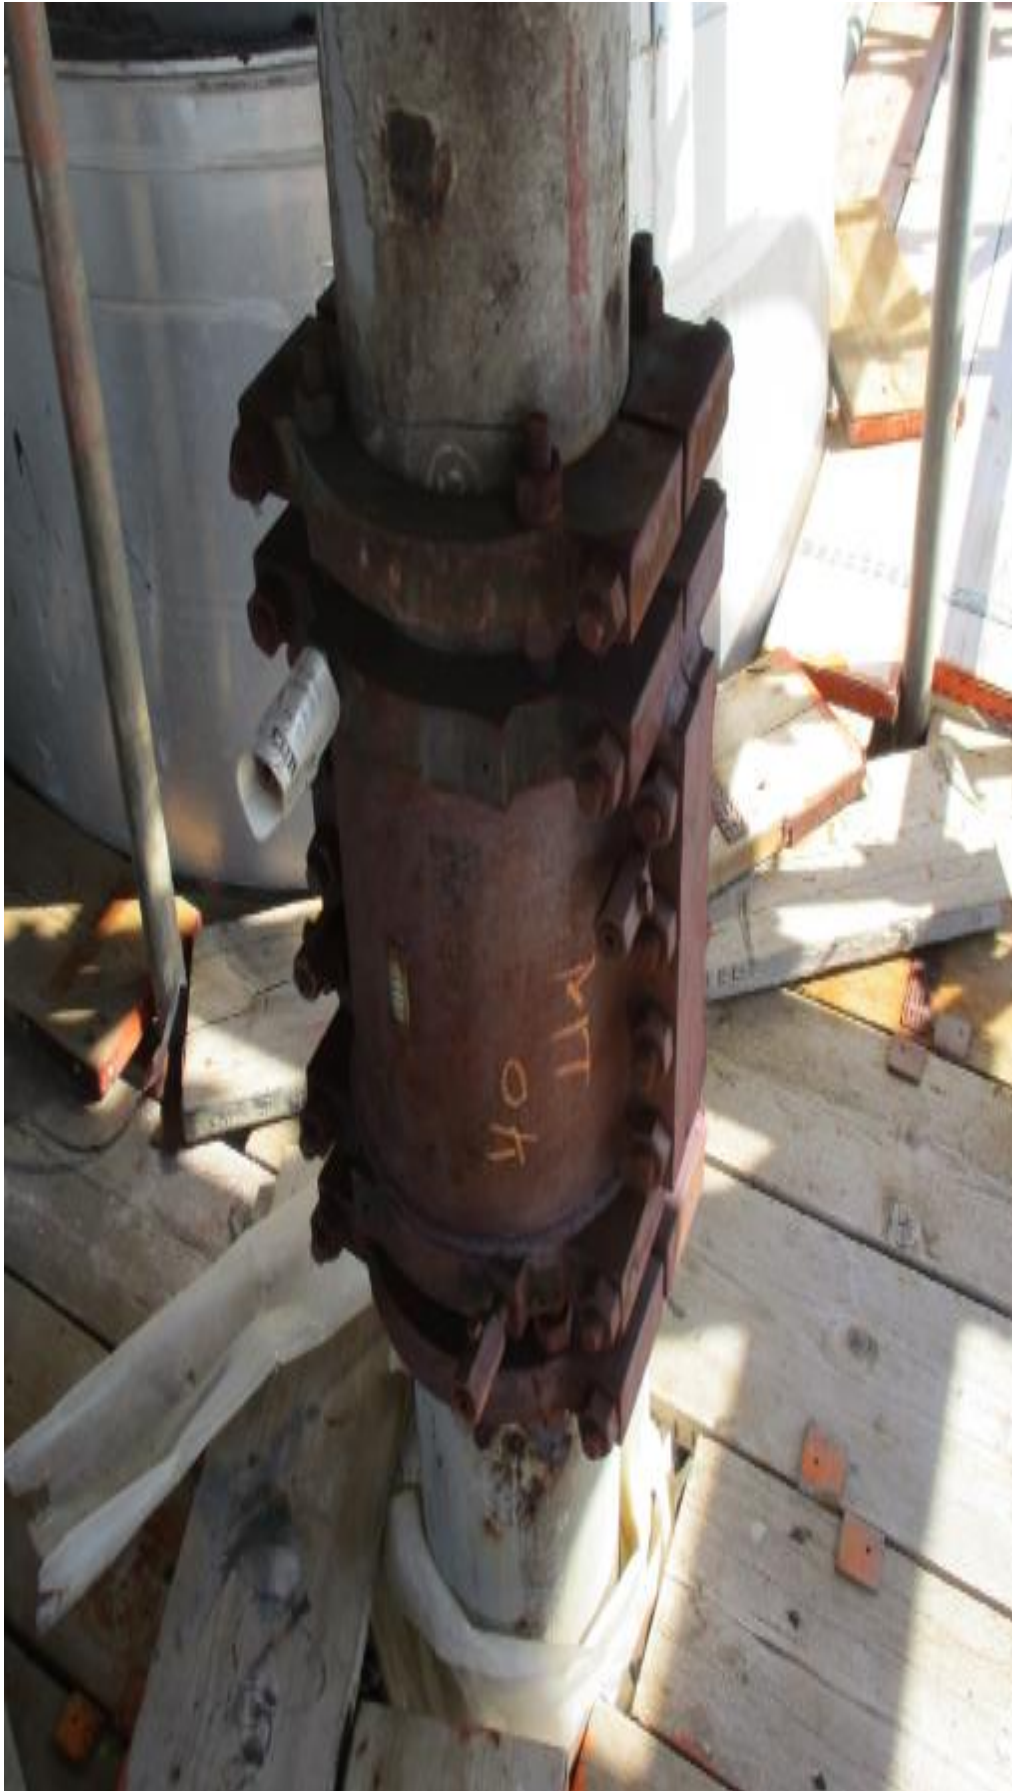
Figure 11 Clamp installed at location 12 of IAN (Clamp No. T26131)

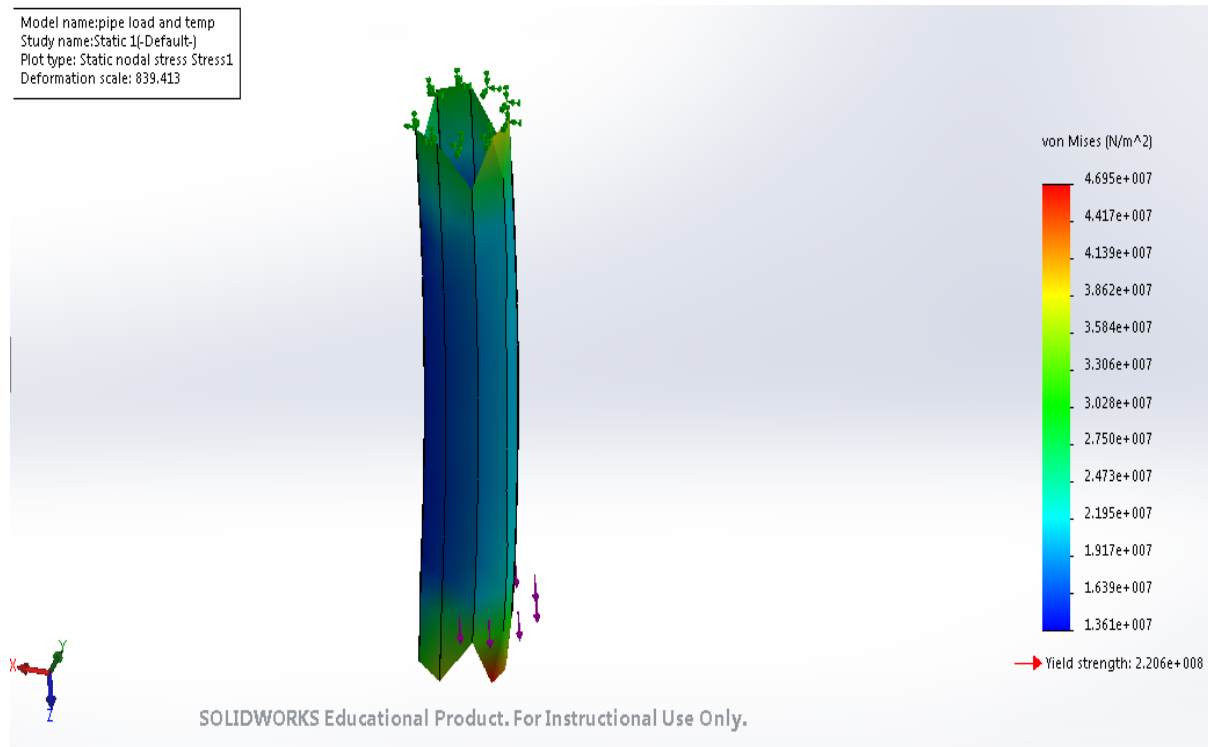
Figure 14 Validation of calculations using solidworks simulation

In this study the line has been modelled by creating a 32m section with a uniform thickness of 1.5mm the same as IAN locations 23 and 11. For the simulation, the model has been fixed at the top with a load of 23kN applied throughout acting downwards. The FEA delivers some very similar numbers to that of the basic calculations.  $46950000 \text{ N/m}^2$  which converts to  $46.95 \text{ N/mm}^2$ . Due to some rounding errors and the fact solid works assumes material properties, this FEA study helps to validate the information calculated for the problem. What is of particular interest in this model is that, if further conditions are applied to the problem, the material shows signs of failure. If design pressure and temperature as stated on the IAN are applied to the same model the material is close to its yield strength and a considerable amount beyond the max allowable stress as stated in API 579. This will later be considered when making recommendations.

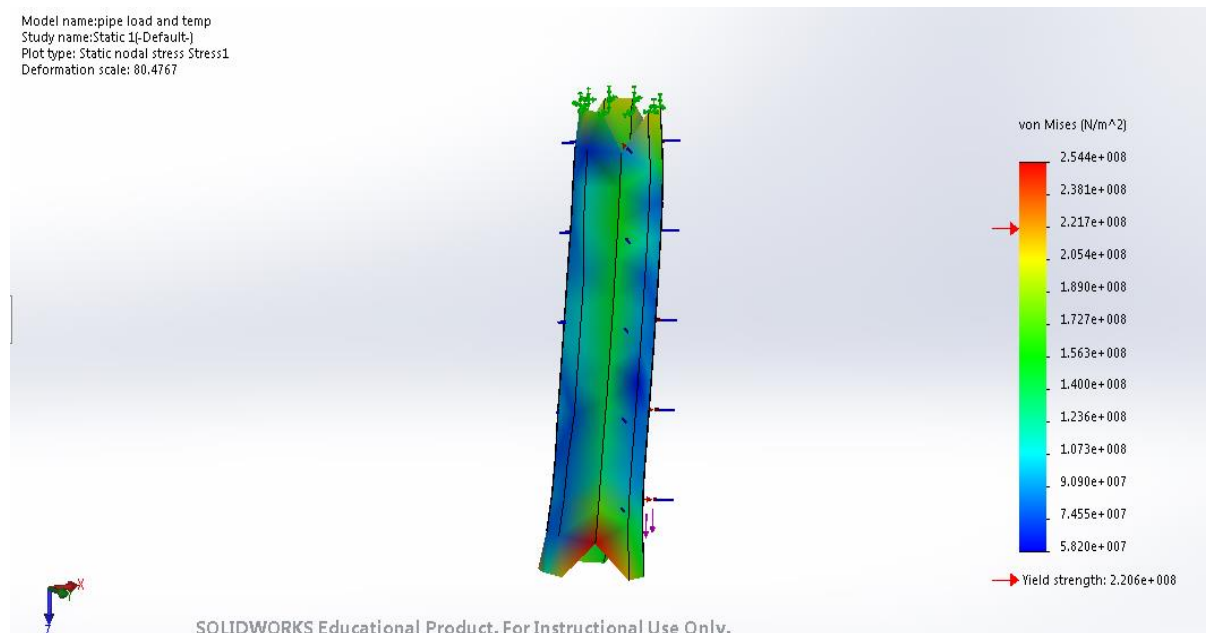
Figure 15 FEA study with design pressure and temperature applied
