Building Conservation Asset and Facilities Management

| Llanelly House – Llanelli..... | 6 |
| Former Water Works – Broadside Court, Denny..... | 16 |

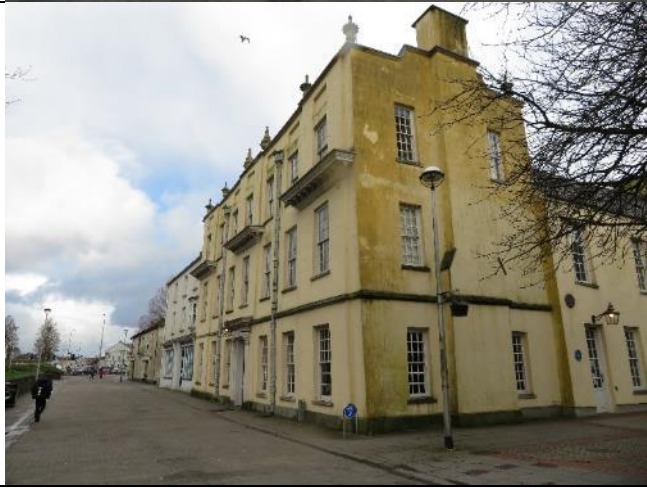
| | <p>West Gable –<br/>Vaughan St.<br/>Lime render<br/>assumed due to the<br/>pattern of moisture<br/>as the wall dries out<br/>following rain.</p> <p>Lime render would<br/>be more appropriate<br/>to allow thermal<br/>movement and<br/>evaporation to take<br/>place.</p> | <p>Render could be<br/>a mixture of lime<br/>and cement due<br/>to its differing<br/>presentation on<br/>different<br/>elevations.</p> <p>(Photograph by<br/>Heritage and<br/>Design Ltd, 2020)</p> |

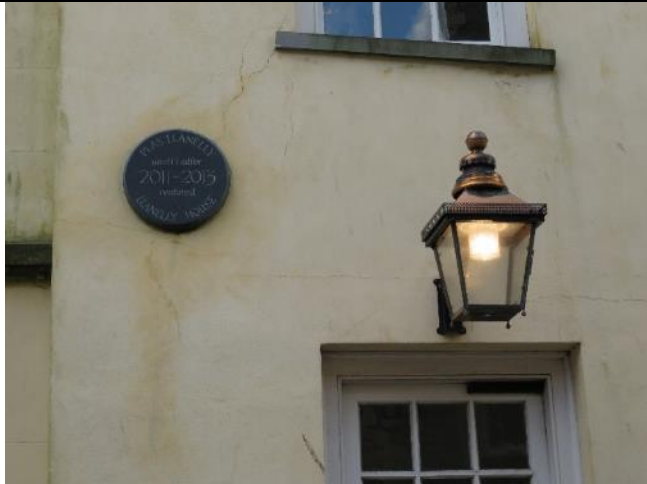
| | <p>West gable</p> | <p>Pattern of cracking would indicate render is cementitious (impermeable &amp; inflexible) over original stone/lime (permeable &amp; flexible) movement in building materials beneath create cracking of cement render.</p> <p>(Photograph by Heritage and Design Ltd, 2020)</p> |

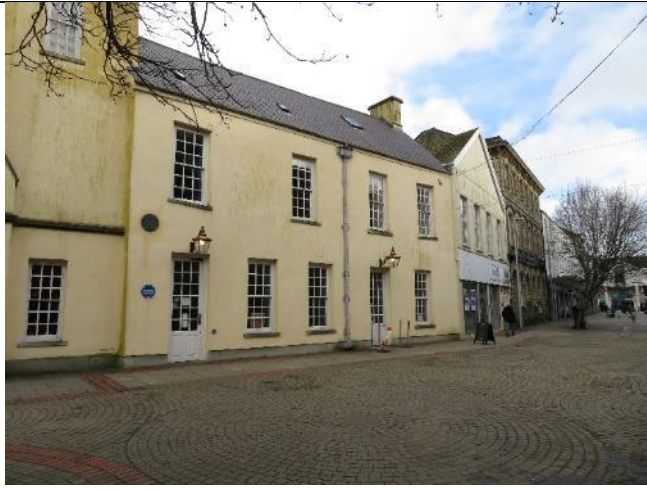
| | <p>Llanelly House – Gable west facing.</p> | <p>Building extends down Vaughan St showing no signs of saturation. Does not mean building is not saturated just no visible symptoms. This section of the building indicates a cementitious render.</p> <p>(Photograph by Heritage and Design Ltd, 2020)</p> |

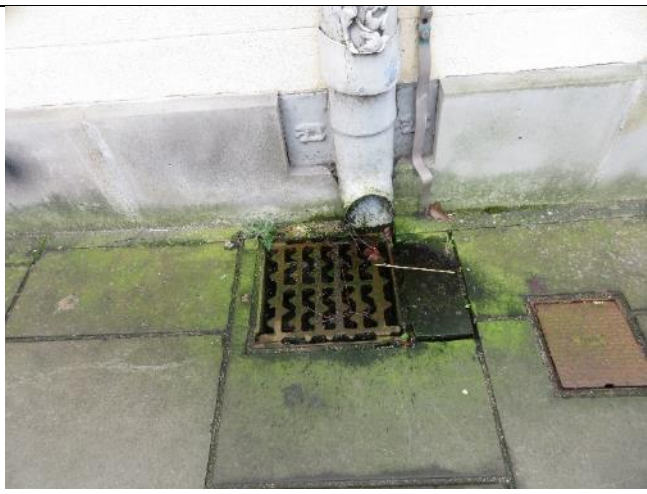
| | <p>Decorative lead downpipe onto pedestrian paved area.</p> <p>Recommendation would be to fit a lead shoe to direct the water into the gully or rotate bottom section of pipe to achieve same outcome.</p> | <p>Downpipe is off centre allowing rainwater to miss gully when discharging. Green staining indicates gully becomes blocked resulting in water causing localised flooding and saturating ground.</p> <p>(Photograph by Heritage and Design Ltd, 2020)</p> |

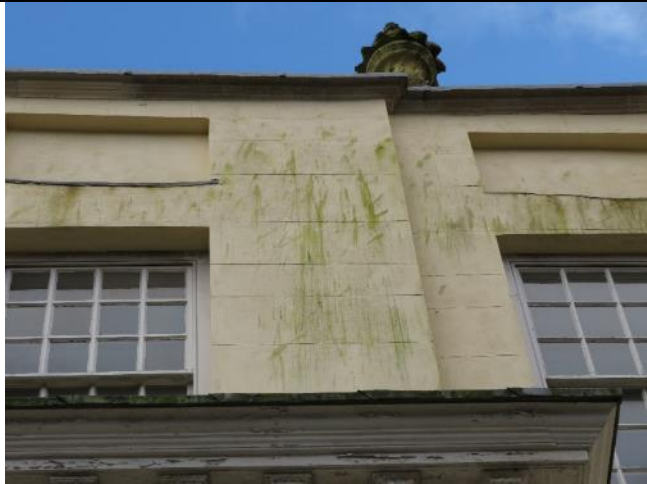
| | <p>Front elevation.</p> | <p>Staining suggests paint is not porous.</p> <p>(Photograph by Heritage and Design Ltd, 2020)</p> |

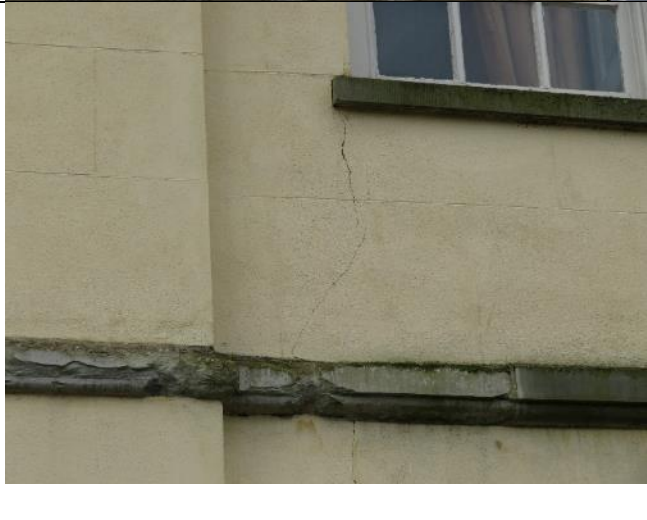
| | <p>Cracking to render between cill and string course suggests render being cementitious. The cement is inflexible against the flexible materials beneath.</p> | <p>Stone string course deteriorating due to moisture evaporation restricted to stone due to decades of impermeable render. Moss growth along string course indicates saturation.</p> <p>(Photograph by Heritage and Design Ltd, 2020)</p> |

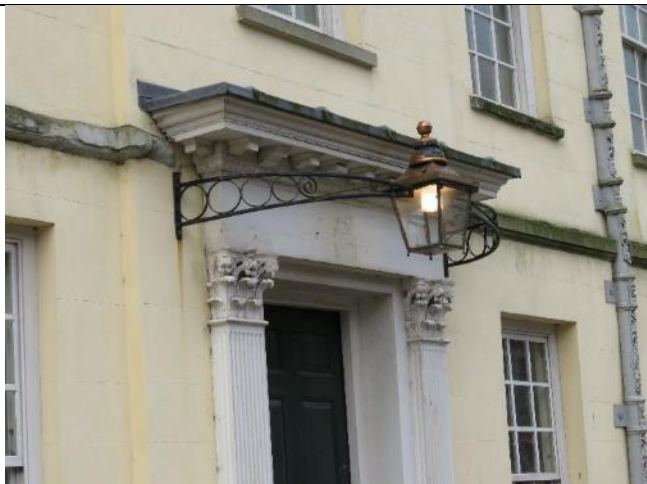
| | <p>Entrance elevation</p> | <p>Door lintel over-cloaked with lead, good choice of materials for weathering and longevity.</p> <p>Metal light bracket above door shows staining from ferrous fixings.</p> <p>(Photograph by Heritage and Design Ltd, 2020)</p> |

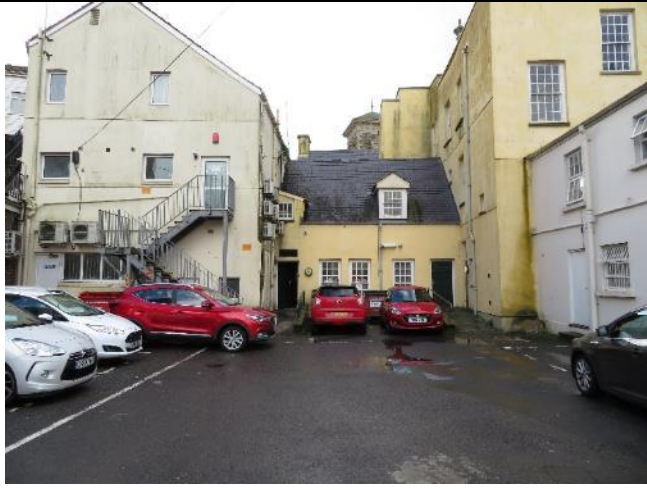
| | <p>Rear elevation at car park.</p> <p>(Photograph by Heritage and Design Ltd, 2020)</p> | <p>Staining at right hand corner where building abuts neighbouring property on Bridge St, shows long term leak from gutter. Install hopper and downpipe to discharge water away from building or additional downpipe – subject to LBC</p> |

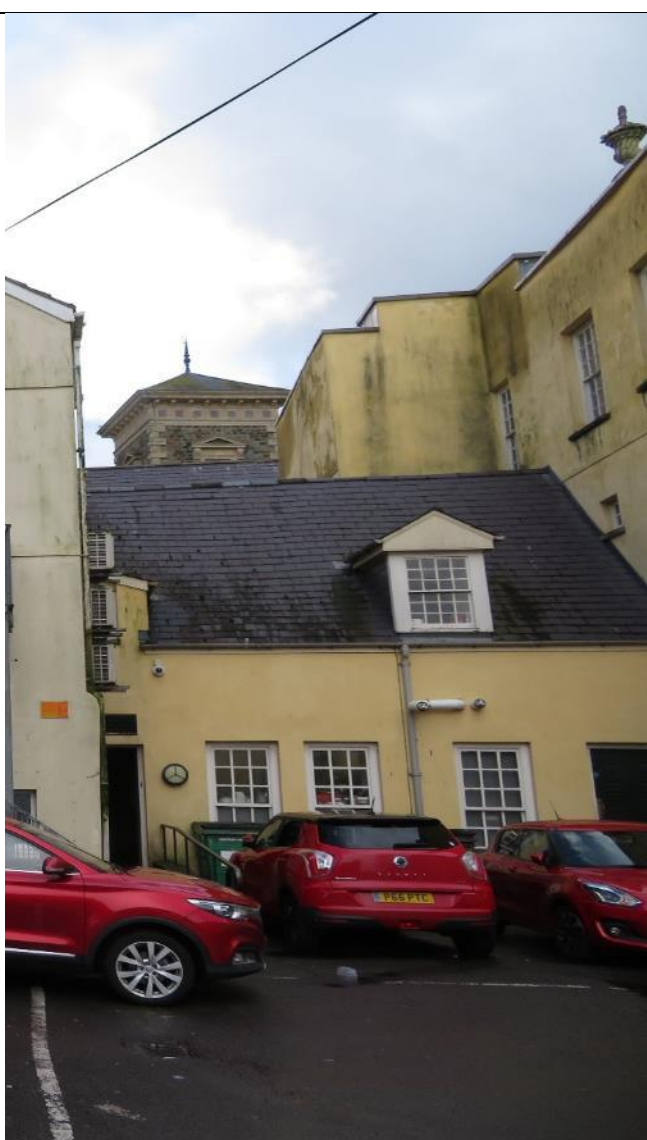
| | <p>As above</p> | <p>Heavy staining on render at high level throughout rear elevation. Large areas of staining from the minimal drip detail at the parapet coping allows rainwater to discharge across the render.</p> <p>Recommendation would be to extend the drip detail.</p> <p>(Photograph by Heritage and Design Ltd, 2020)</p> |

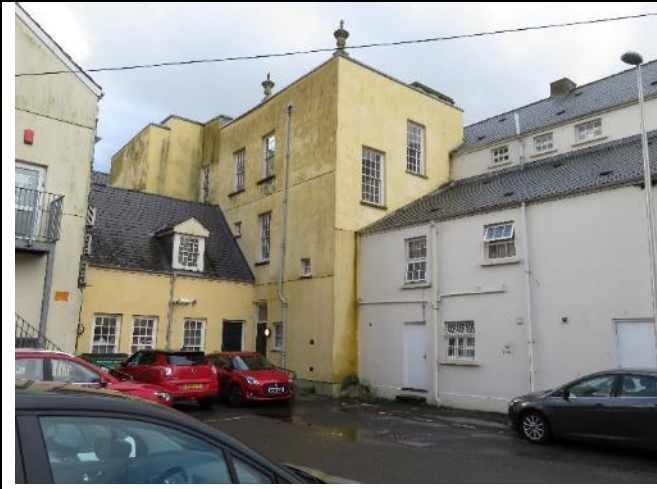
| | <p>As above.</p> <p>(Photograph by Heritage and Design Ltd, 2020)</p> | <p>Mottling across rear elevation suggests either saturation or lime render. Possibly areas of heat loss due to the building fabric being wet.</p> <p>Recommendation to inspect with thermal imaging camera to determine pattern of heat loss</p> |

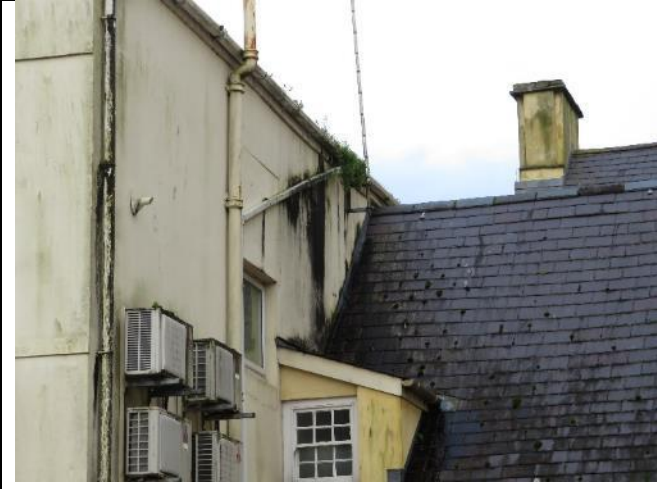
| | <p>Rear elevation at junction of building attached to the south.</p> <p>(Photograph by Heritage and Design Ltd, 2020)</p> | <p>Poor maintenance of neighbouring property blocked and overflowing gutters resulting in heavy staining and debris deposits on main roof and dormer roof.</p> <p>Recommendation: Inform owner of adjacent building to remedy. Clear debris from roof.</p> |

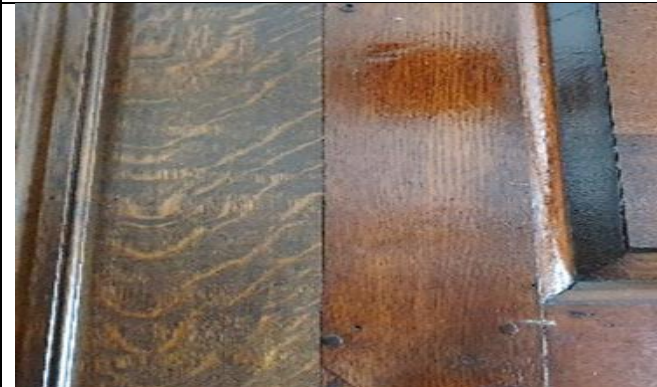
| | <p>Reinstatement of missing timber panelling</p> | <p>Clearly shows different type of timber is used but the repair has not been in an effort to disguise but is well-finished.</p> <p>(Photograph by Heritage and Design Ltd, 2020)</p> |

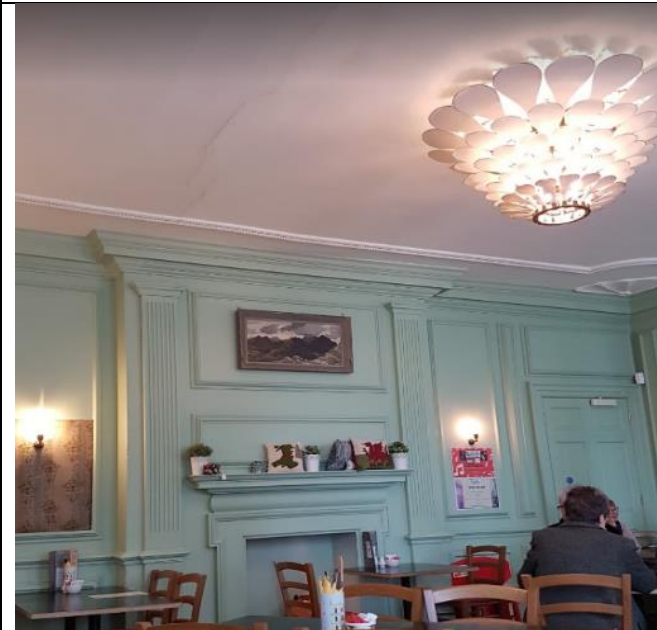
| | <p>Café on ground floor</p> | <p>Ceiling cracking at lath and plaster but remains intact. Should be monitored and repaired as necessary to prevent failure.</p> <p>(Photograph by Heritage and Design Ltd, 2020)</p> |

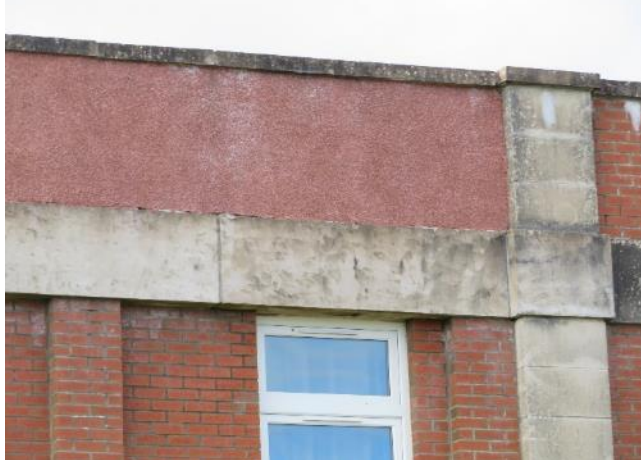
| | <p>Parapet wall with concrete cope. Facing stone over concrete columns and floor slab, single skin brick infill.</p> | <p>Facing stone is heavily stained and salt staining is noticeable to both brick and stonework. Normally as a result of contaminated sand. Rendered section of brickwork likely result of water ingress.</p> <p>(Photograph by Heritage and Design Ltd, 2020)</p> |

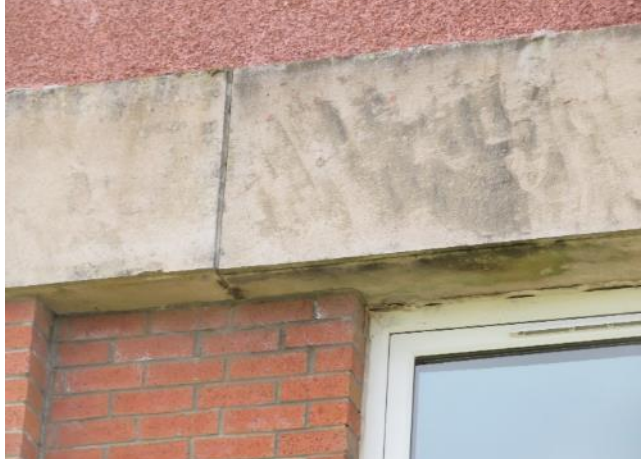
| | <p>Window detail at townhouse accommodation</p> | <p>Silicone sealant appears to have been used around window frames.</p> <p>Recommendation: Remove failed sealant and re-seal frames using good quality mastic.</p> <p>(Photograph by Heritage and Design Ltd, 2020)</p> |

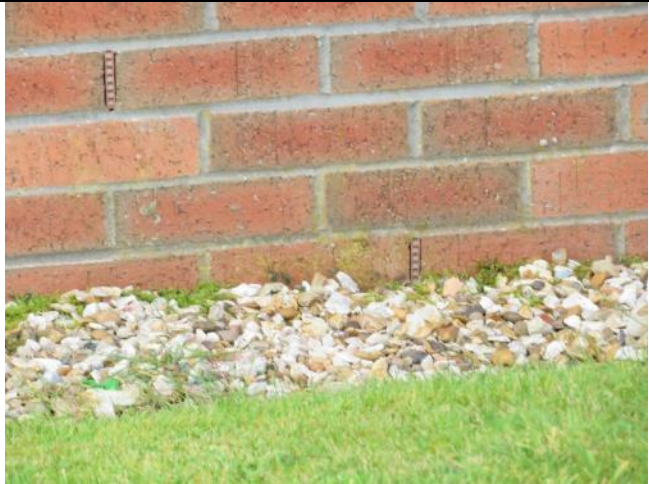
| | <p>Weep vents</p> | <p>Installed apparently randomly so likely to answer defects.</p> <p>(Photograph by Heritage and Design Ltd, 2020)</p> |

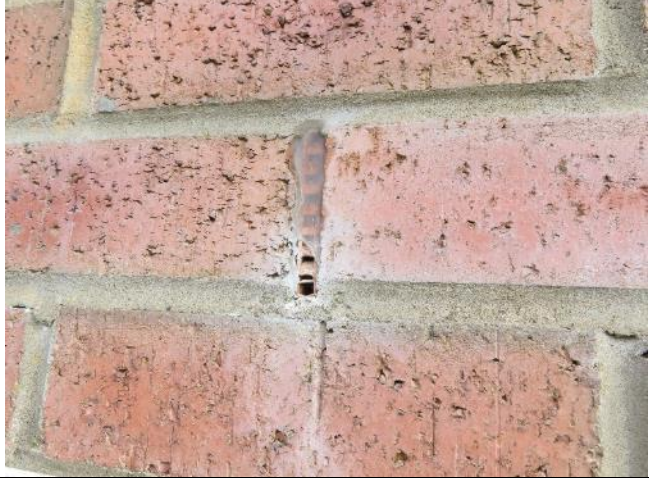
| | <p>As above</p> | <p>Trickle vent part sealed so assumed blamed for water ingress/dampness which is unlikely to be the case.</p> <p>(Photograph by Heritage and Design Ltd, 2020)</p> |

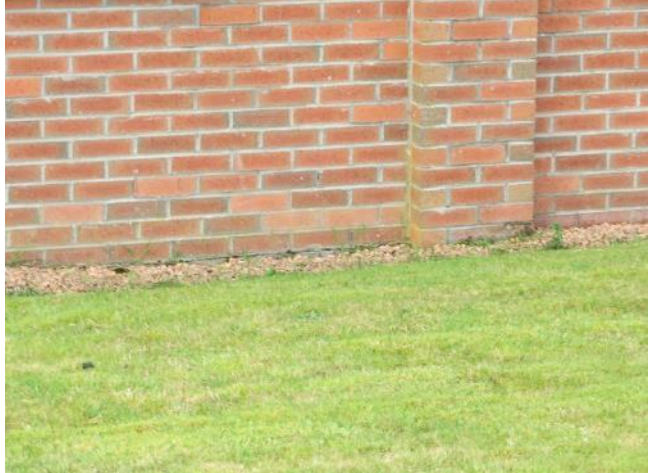
| | <p>Ground levels throughout the site are high and grass is laid close to the external walls.</p> | <p>DPC is bridged.</p> <p>Recommendations:<br/>Reduce ground levels throughout to at least 150mm below DPC.</p> <p>(Photograph by Heritage and Design Ltd, 2020)</p> |

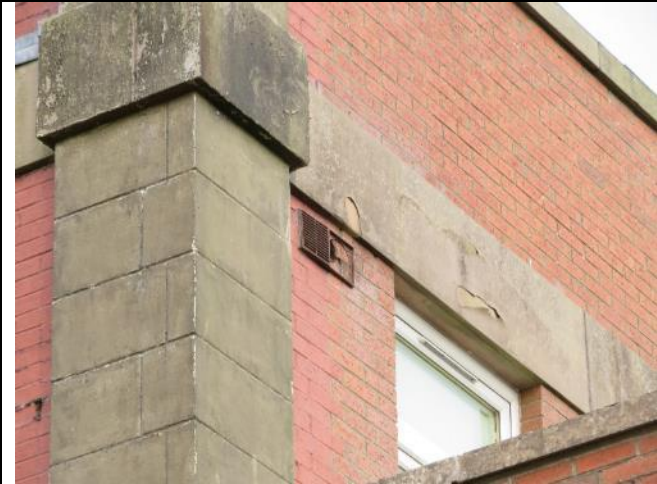
| | <p>Decorative stone margin at main block.</p> | <p>Coating applied, possibly Linostone, as a water proofing material.</p> <p>Recommendations:<br/>Carefully remove coating.</p> <p>(Photograph by Heritage and Design Ltd, 2020)</p> |

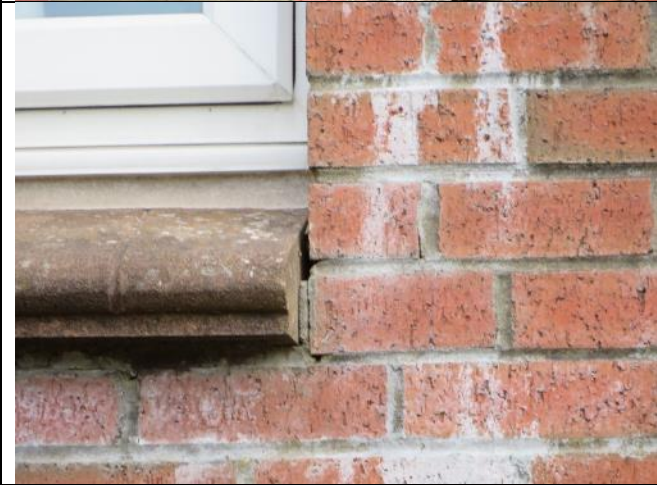
| | <p>Window cill detail</p> <p>(Photograph by Heritage and Design Ltd, 2020)</p> | <p>Efflorescence causing staining to brickwork. Void at cill will allow windblown water ingress. Cill should have extended into brickwork.</p> <p>Recommendation:<br/>Pack joint using cement mortar. Allow for mastic at junction.</p> |

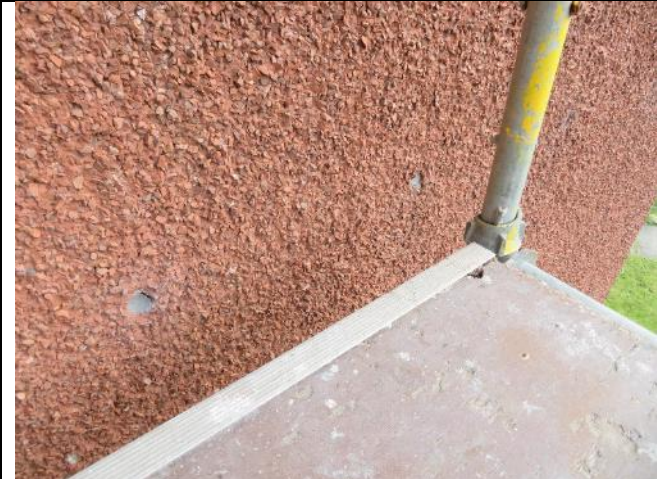
| | <p>Roughcast applied in sections around parapet.</p> | <p>Drill holes too regular for scaffolding fixings. Likely chemical dampproof injection at base of parapet in place of well-designed parapet. Another inappropriate contractor given carte-blanche for repairs.</p> <p>(Photograph by Heritage and Design Ltd, 2020)</p> |

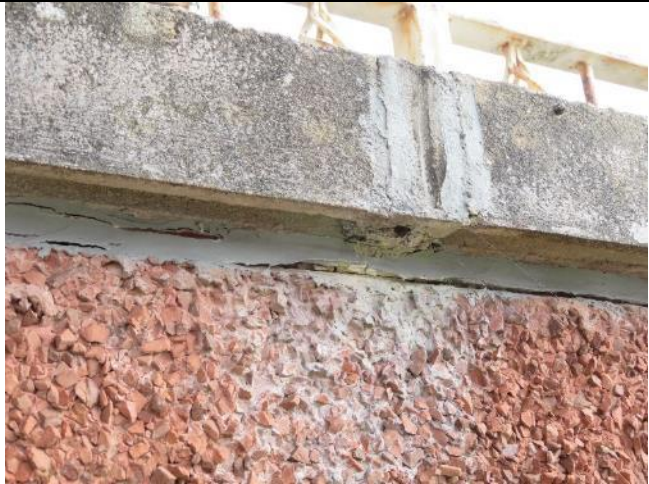
| | <p>Failed sealant, shrinkage, untidy work with staining run off onto painted render.</p> <p>(Photograph by Heritage and Design Ltd, 2020)</p> | <p>Extremely poor work using inappropriate materials. Unsupervised.</p> <p>Recommendation: Removed failed sealant, clean and prepare surface apply mortar to cope junctions and repair render.</p> |

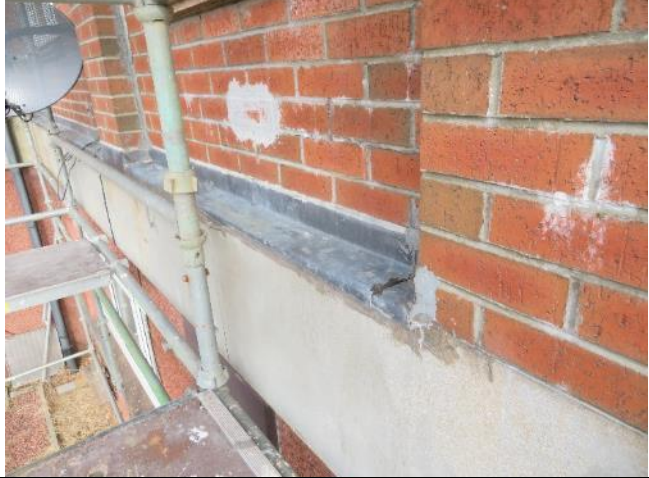
| | <p>Leadwork above stone margin.</p> | <p>Good choice of material to prevent water ingress at junction.</p> <p>(Photograph by Heritage and Design Ltd, 2020)</p> |

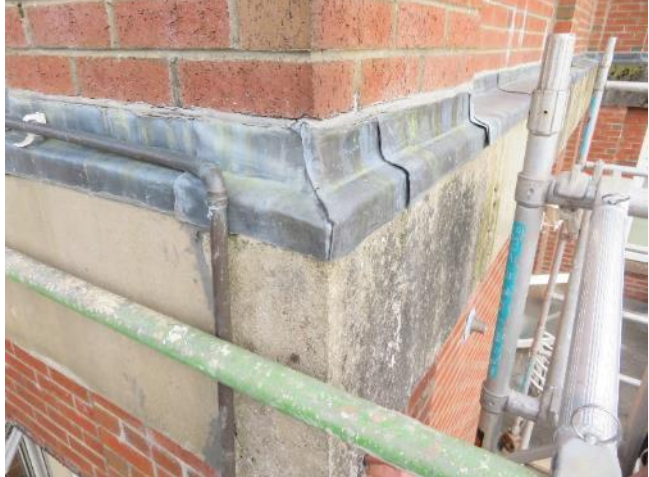
| | <p>As above</p> | <p>Poor workmanship and detailing negating the usefulness and quality materials used.</p> <p>(Photograph by Heritage and Design Ltd, 2020)</p> |

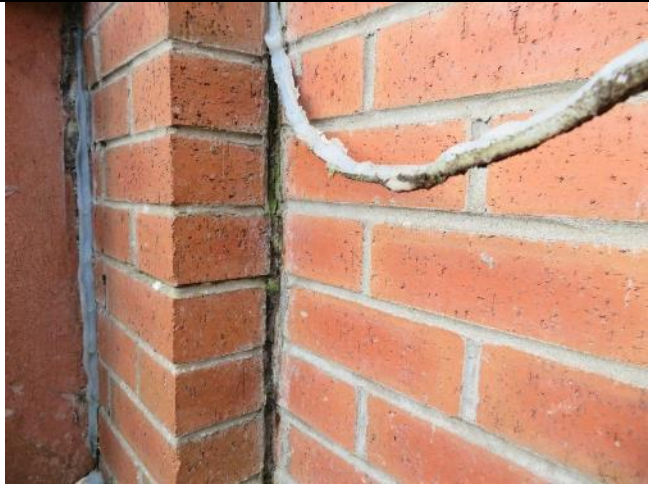
| | <p>Junction of brick butt to infill panel</p> | <p>Silicone sealant used to fill junction in brickwork. Poor choice of materials, poorly applied.</p> <p>Recommendation: Remove, clean and prepare area and apply good quality mastic.</p> <p>(Photograph by Heritage and Design Ltd, 2020)</p> |

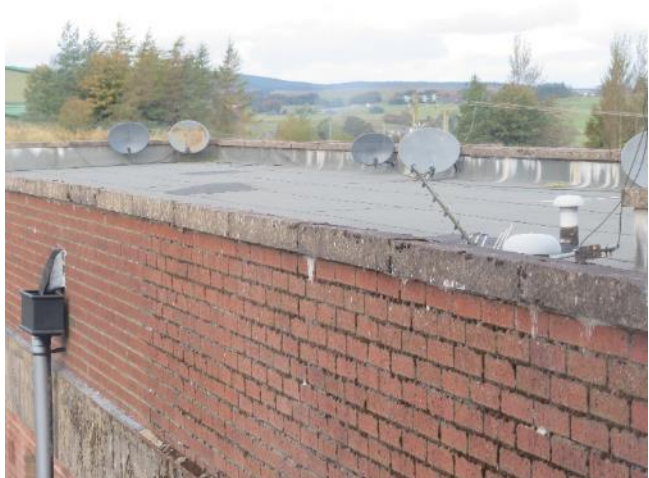
| | <p>Flat roof beyond parapet</p> <p>(Photograph by Heritage and Design Ltd, 2020)</p> | <p>Green mineral felt. Repairs and failures noted. Application poor at detailing at junction of parapet wall.</p> <p>Recommendation: Assess overall condition and consider full replacement where necessary. Consider single ply membrane - EDPM</p> |

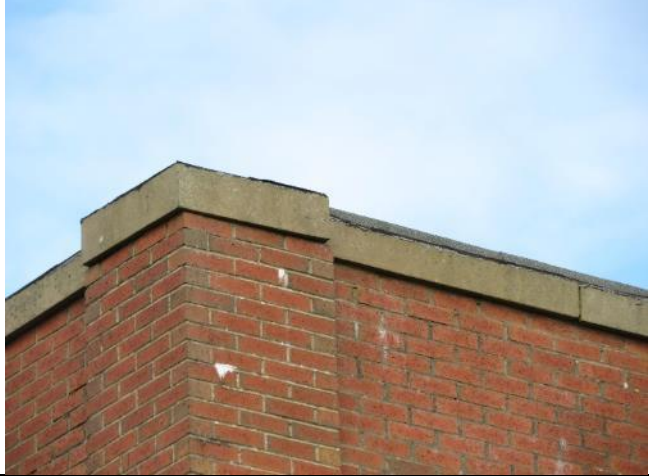
| | <p>Parapet detailing at edge</p> | <p>Mineral felt used to over cloak coping stone, poor detail and finish, short of cope and not providing drip detail.</p> <p>(Photograph by Heritage and Design Ltd, 2020)</p> |

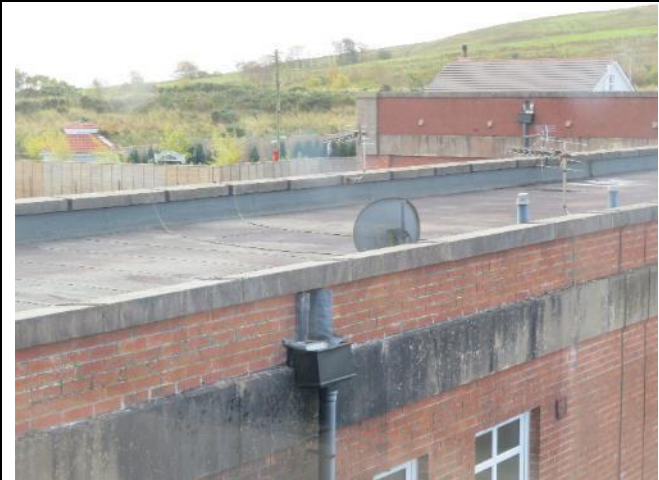
| | <p>Drainage from flat roof</p> | <p>Lead shoe above hopper good choice of material for longevity. Poor workmanship and detailing.</p> <p>Recommendation:<br/>Consider changing detail.</p> <p>(Photograph by Heritage and Design Ltd, 2020)</p> |

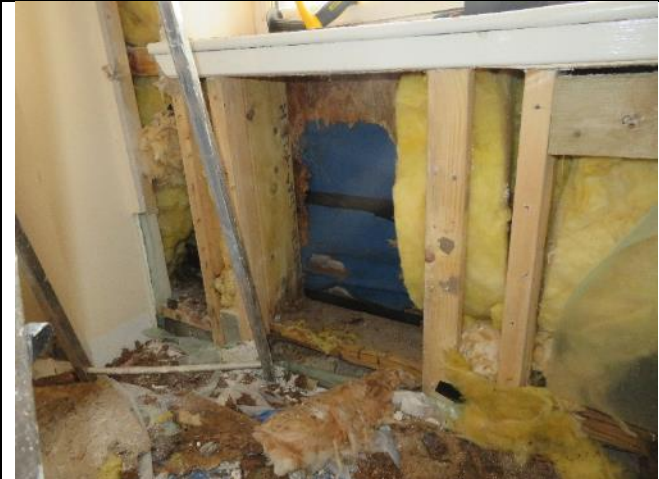
| | <p>Within timber insulated inner frame in common area at window cill.</p> <p>(Photograph by Heritage and Design Ltd, 2020)</p> | <p>Plasterboard finish removed to investigate water penetration. OSB saturated and deteriorated, loose mineral wool insulation (MWI) wet from water ingress resting against softwood timbers also wet.</p> <p>Recommendations:<br/>Carry out external repairs correctly</p> |

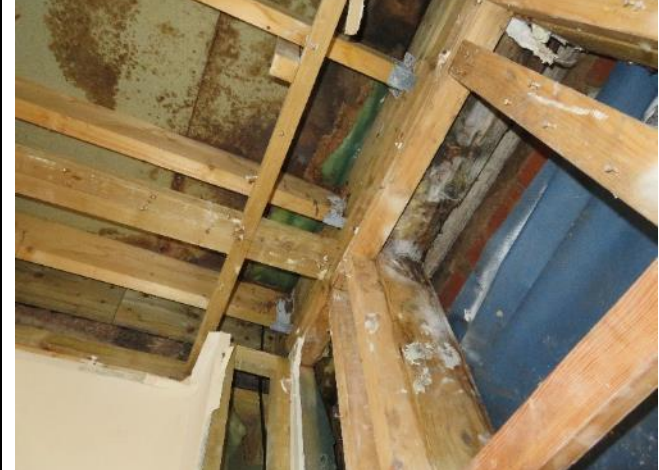
| | <p>Underside of concrete floor slab</p> | <p>Corrosion staining.</p> <p>Recommendations:<br/>Inspect integrity of reinforcement.</p> <p>(Photograph by Heritage and Design Ltd, 2020)</p> |

- The structural integrity of the concrete floor slabs needs further investigation by a structural engineer and an allowance made for repairs where necessary however, repairs of this nature will be disruptive and costly.

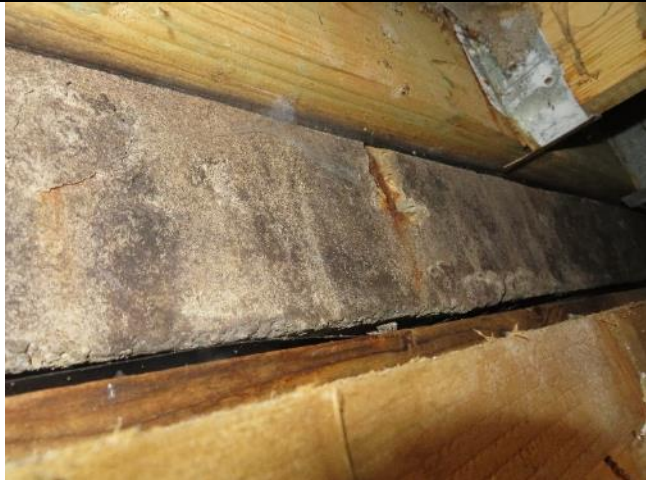
| | <p>As above</p> | <p>Concrete floor slab, corrosion and failure of reinforcement, concrete cover minimal.</p> <p>(Photograph by Heritage and Design Ltd, 2020)</p> |

Of particular concern today is the alkali silica reaction in the concrete and the corrosion of the reinforcing steel, both of which are caused by the alkalinity of Portland cement concrete and moisture.

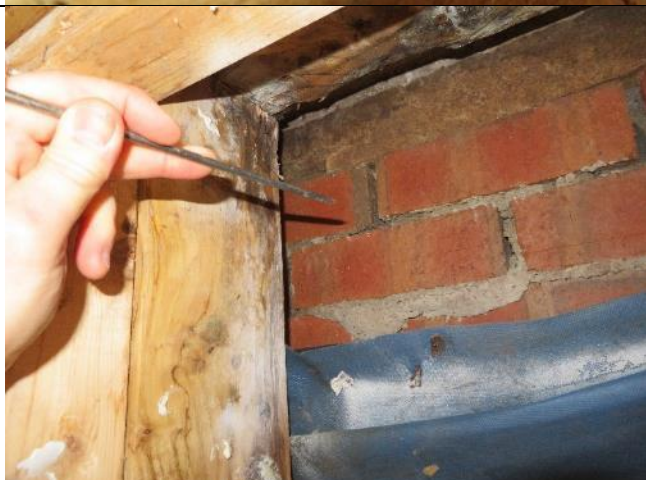
| | <p>Brickwork at outer leaf.</p> <p>(Photograph by Heritage and Design Ltd, 2020)</p> | <p>Staining and wet rot to softwood timber inner leaf and voided brick joints.</p> <p>Recommendations:<br/>Carry out external repairs as necessary.</p> <p>Assess timber and replace as necessary.</p> |

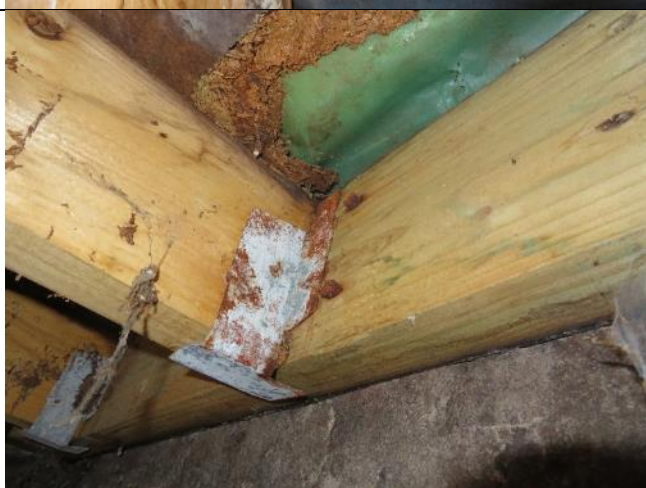
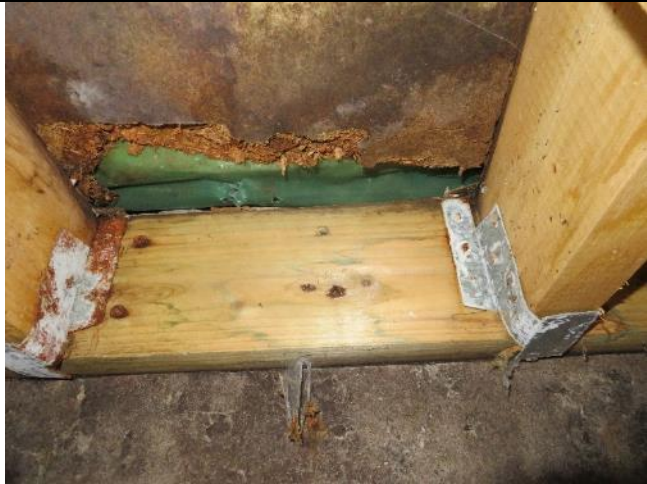
| | <p>Timber connection detail.</p> <p>(Photograph by Heritage and Design Ltd, 2020)</p> | <p>Nail plate showing corrosion from water ingress. OSB flooring of floor above saturated. Plastic membrane above OSB.</p> <p>Recommendations:<br/>Complete external repairs.<br/>Replace decayed material as necessary</p> |

| | <p>As above</p> | <p>As above</p> <p>(Photograph by Heritage and Design Ltd, 2020)</p> |

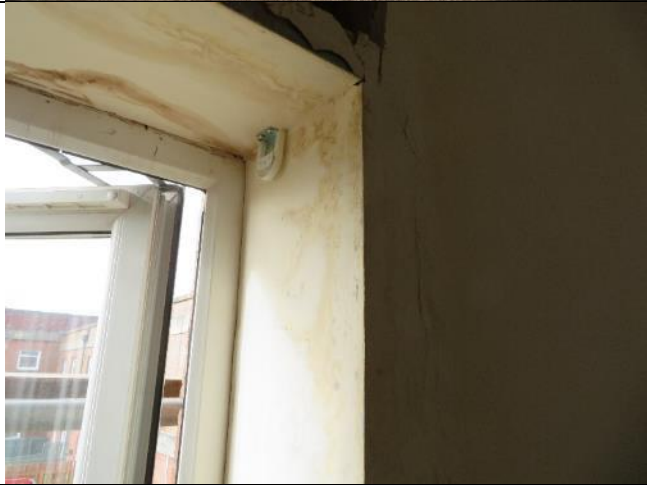
| | <p>Window reveals</p> <p>(Photograph by Heritage and Design Ltd, 2020)</p> | <p>Staining to soffit indicated water ingress from above. Metal corner bead corroding.</p> <p>Recommendation: Complete external repairs. Remove plasterboard to aid drying process and to allow for repairs. Ensure completely dry before reinstating finishes.</p> |

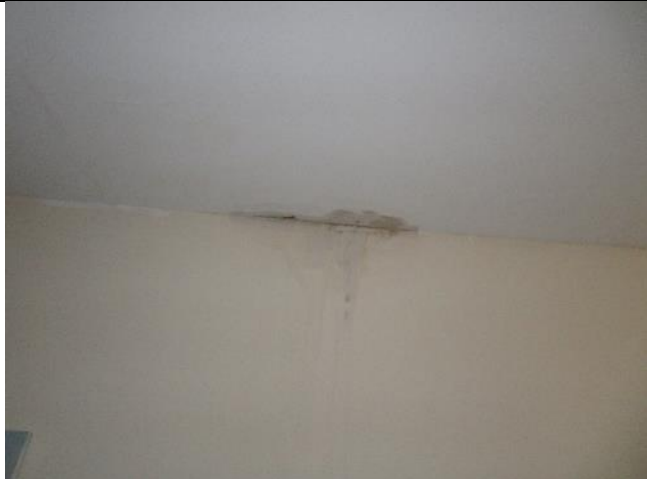
| | <p>External wall</p> | <p>Stain shows bridging from water ingress.</p> <p>Recommendations: Complete external repairs as necessary.</p> <p>(Photograph by Heritage and Design Ltd, 2020)</p> |
