| <b>Hybrid Civil Inspection Report</b> | | Sheet: <b>1 OF 24</b> | |
| Report Reference Tracker No: 12001120348<br>M3 Notification: 15399813<br>SAP PM O/No: 27714331<br>SAP Maintenance Plan No: 54163 | | Date of Inspection – February 04 <sup>th</sup> 2021 | |
| Inspection Location – <b>THE ABBEY GENERAL OFFICE BLOCK<br/>(FLOC 3001-320-0500-0001)</b> | | | |

## CIVIL INSPECTION FOR ABBEY GENERAL OFFICE BUILDING

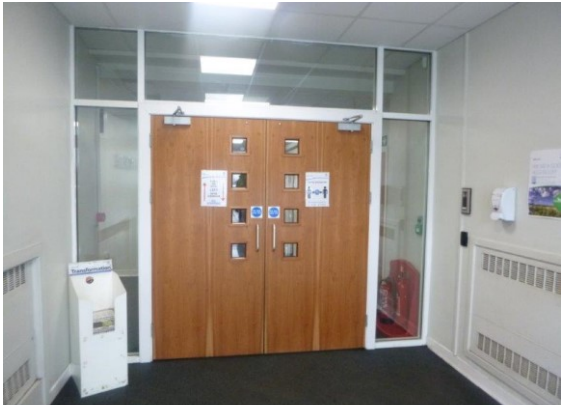
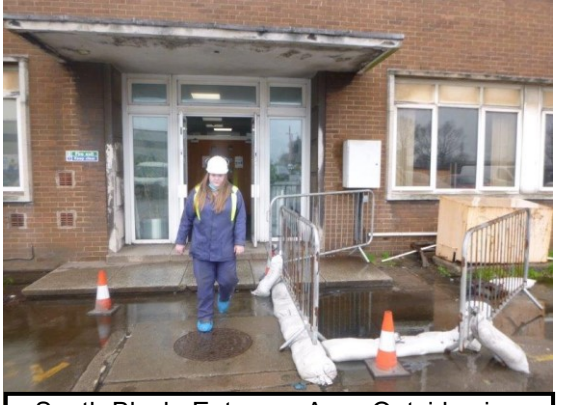
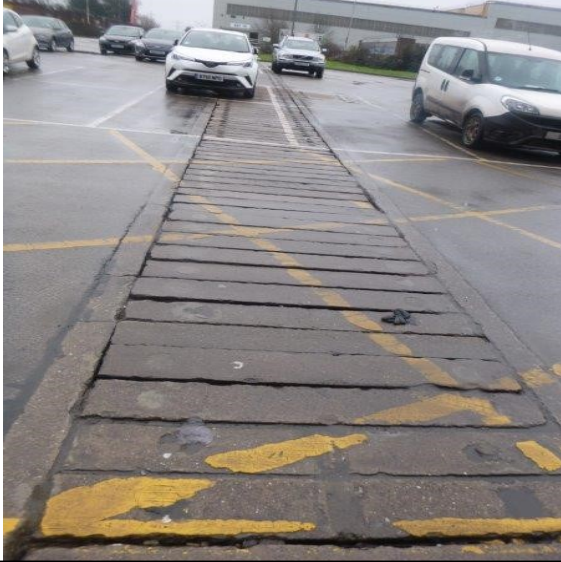
| Item No | Observations/ Defects Found | Action Required/ Comments | Priority RAM Matrix Rating P1, P2, P4 or M3 notification with (Photograph evidence if required) |
|---|---|---|---|
| | <p>➤ RC blocks over steam pipe trench at south side parking area appears to be in fair condition.</p> | | <p>South Block: Entrance Area-Inside view</p> <p>South Block: Entrance Area-Outside view</p> <p>South Entrance Parking Area-Repair works done</p> |

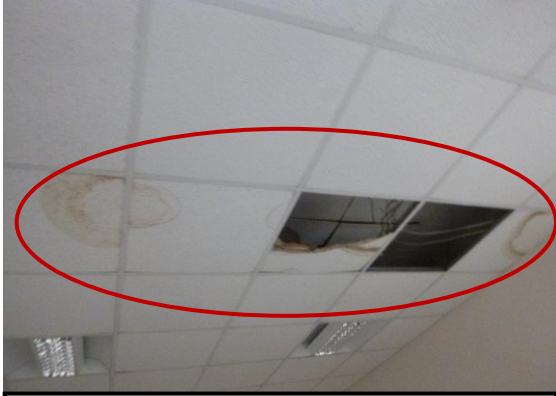
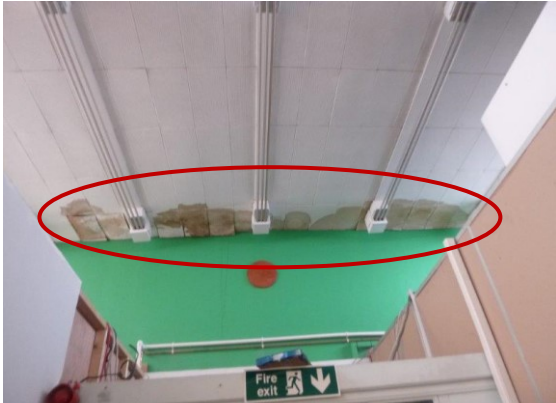
| Item No | Observations/ Defects Found | Action Required/ Comments | Priority RAM Matrix Rating P1, P2, P4 or M3 notification with (Photograph evidence if required) |
|---|---|---|---|
| 18 | <p>➤ Repair work is completed for roof leak near Design office-south &amp; north side entrance at third floor.</p> <p>➤ There is plan to replace damaged ceiling tiles in the area. New ceiling tiles have been received.</p> <p>Emerging works team working on the same to arrange the ladder to get access.</p> | Monitor until next inspection. | <p><b>Priority RAM Matrix Rating M3</b></p> <p>Design office Entrance-South side: Roof leak repaired</p> <p>Design office Entrance-South side: Roof leak repaired</p> |

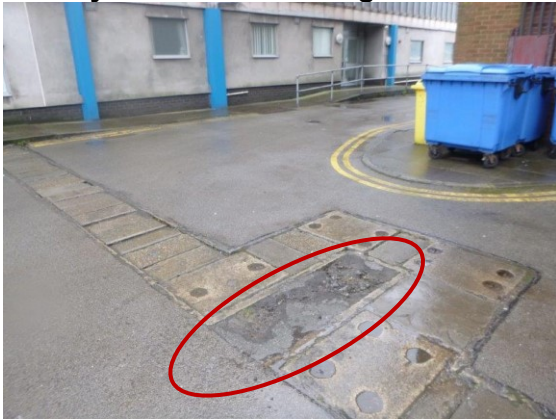
| Item No | Observations/ Defects Found | Action Required/ Comments | Priority RAM Matrix Rating P1, P2, P4 or M3 notification with (Photograph evidence if required) |
|---|---|---|---|
| 11 | <p>➤ One number of duct cover is found to be damaged at the south-east corner of south block near car park area.</p> | Replace the damaged duct cover. | <p><b>Priority RAM Matrix Rating M3</b></p> |

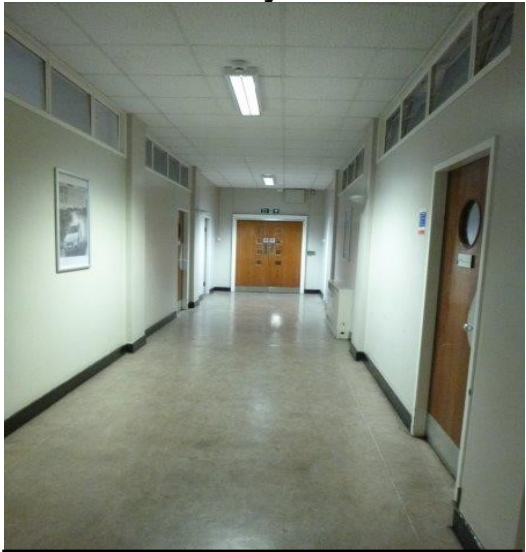
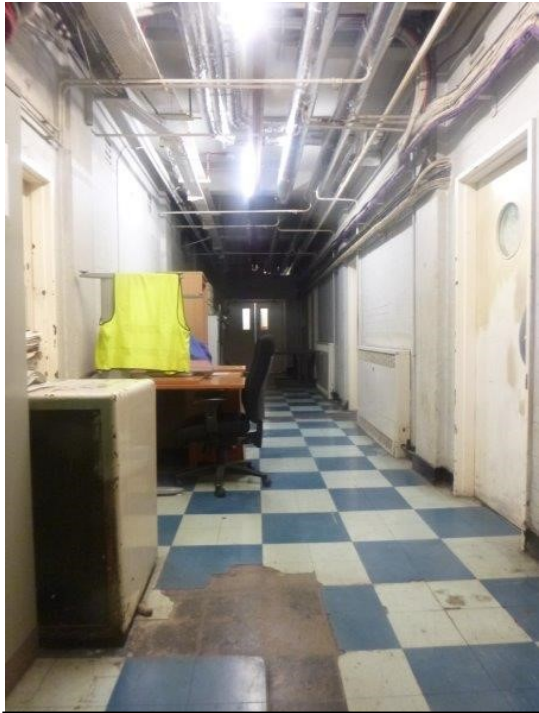
| Item No | Observations/ Defects Found | Action Required/ Comments | Priority RAM Matrix Rating P1, P2, P4 or M3 notification with (Photograph evidence if required) |
|---|---|---|---|
| 6,9,14,18 | Floor corridors appear to be in fair condition except undulations at few places mainly on first & second floor. This does not appear to be a matter of concern at present. Also there is not much deterioration in condition compared to previous inspection. | Information Only | <p><b>For Information Only</b></p> <p>North Block Ground Floor-Corridor</p> <p>South Block Ground Floor-Corridor<br/>-In front of Store Room</p> |

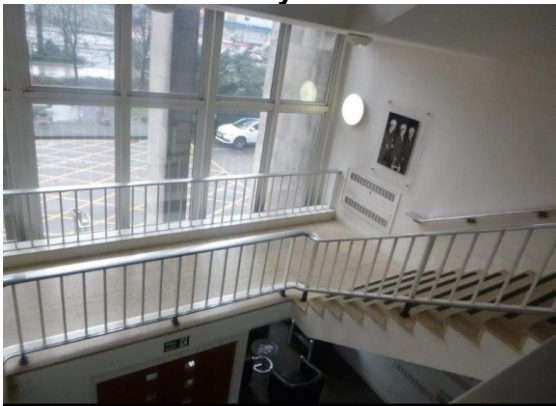
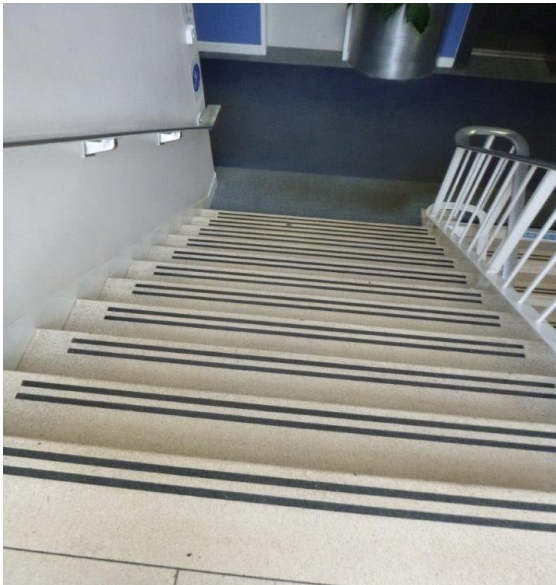
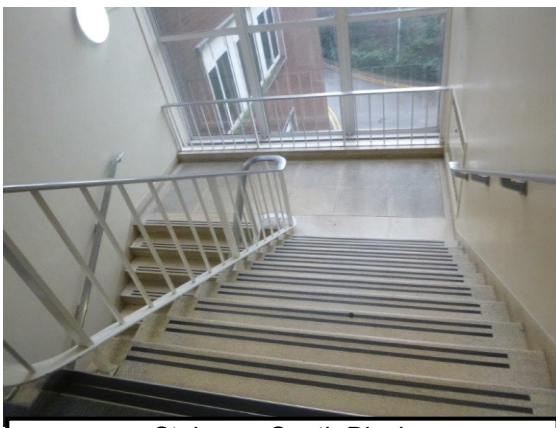
| Item No | Observations/ Defects Found | Action Required/ Comments | Priority RAM Matrix Rating P1, P2, P4 or M3 notification with (Photograph evidence if required) |
|---|---|---|---|
| 10 | <p><u>Central Block Stairway:</u><br/>The concrete stairway appears to be in fair condition. No cause of concern has been identified based on this inspection.</p> <p><u>North Block Stairway:</u><br/>The concrete stairway appears to be in fair condition.</p> <p><u>South Block Stairway:</u><br/>The concrete stairway appears to be in fair condition except one visible crack on first landing. No major change in crack width compared to previous inspection.</p> | For Information Only | <p><b>For Information Only</b></p> <p>Stairway: Central Block</p> <p>Stairway: North Block</p> <p>Stairway: South Block</p> |

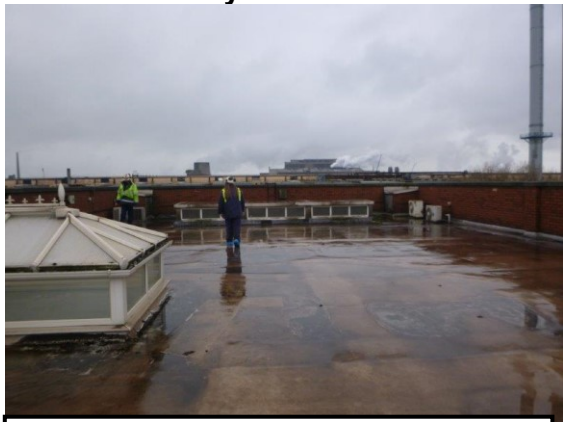
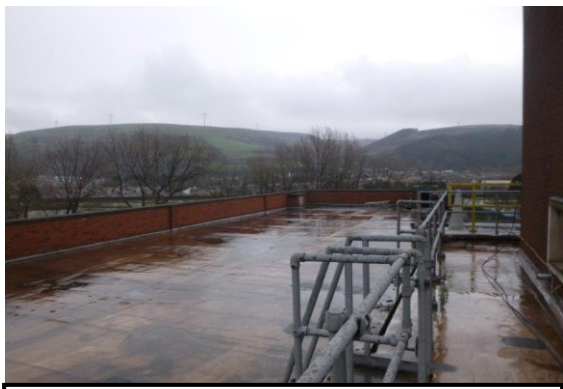
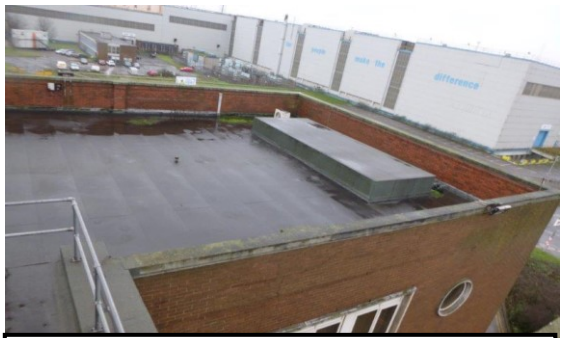
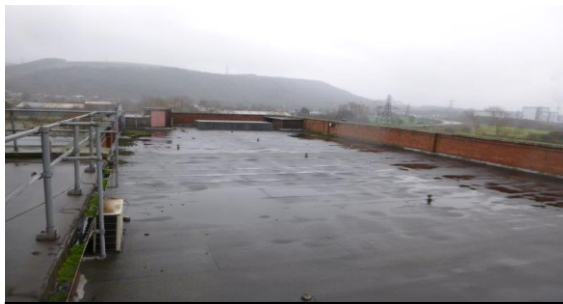
| Item No | Observations/ Defects Found | Action Required/ Comments | Priority RAM Matrix Rating P1, P2, P4 or M3 notification with (Photograph evidence if required) |
|---|---|---|---|
| 7 | <p><u>North Block Roof:</u></p> <ul style="list-style-type: none"> <li>➤Roof area appears to be in fair condition.</li> <li>➤No leakage is reported.</li> <li>➤Moss growth is visible at different locations.</li> <li>➤Standing water is visible within a small area at north-west and north east corner.</li> </ul> <p><u>South Block Roof:</u></p> <ul style="list-style-type: none"> <li>➤Roof appears to be in fair condition.</li> <li>➤Moss growth is visible at different locations.</li> </ul> <p><u>Central Block Roof:</u></p> <ul style="list-style-type: none"> <li>➤Roof appears to be in fair condition.</li> </ul> | Information Only | <p>Information Only</p> <p>Roof: North Block (West side view)</p> <p>Roof: North Block (East side view)</p> <p>Roof: South Block (West side view)</p> <p>Roof: South Block (East side view)</p> |

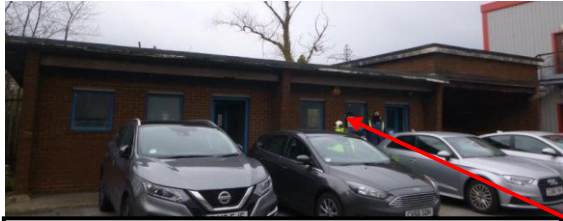
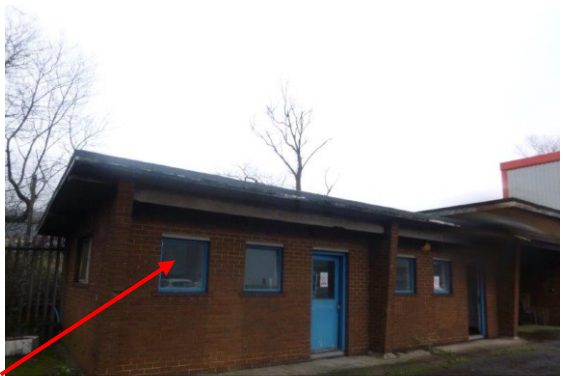
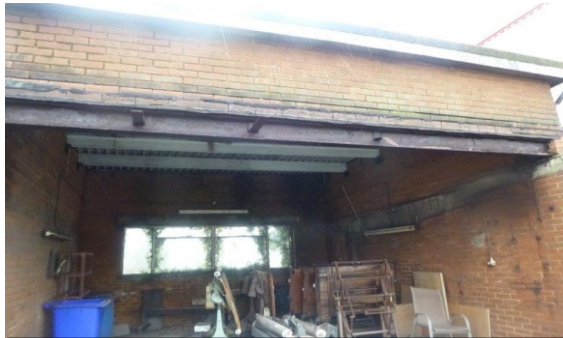
| Item No | Observations/ Defects Found | Action Required/ Comments | Priority RAM Matrix Rating P1, P2, P4 or M3 notification with (Photograph evidence if required) |
|---|---|---|---|
| 2,7,8<br>9 | <p>At present the Chauffer's garage area and office are unoccupied.</p> <p>There are what appears to be asbestos tiles forming the soffit to the beam forming the garage opening. The area is a little run down in appearance at this time.</p> <p>No change has been observed compared to previous inspection.</p> | <p>➤ The AGO Asbestos coordinator to advise prior to any works scheduled to be carried out in this area.</p> | <p><b>Information Only</b></p> <p>The Chauffer's Garage</p> <p>The Chauffer's Garage</p> <p>The Chauffer's Garage</p> |

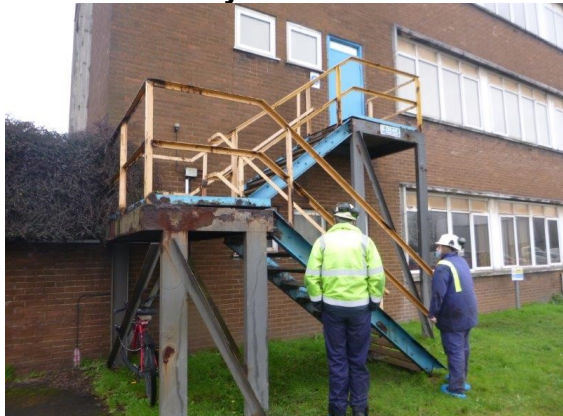
| Item No | Observations/ Defects Found | Action Required/ Comments | Priority RAM Matrix Rating P1, P2, P4 or M3 notification with (Photograph evidence if required) |
|---|---|---|---|
| 10 | <p>The Structural Steel access Stairway at the south Elevation appears to be in fair condition. Minor corrosion of steel members is visible. This needs to be painted.</p> | <p>An order was raised by emerging works team to paint the steel stair.</p> | <p><b>Information Only</b></p> <p>Steel stair at South elevation of the building</p> |

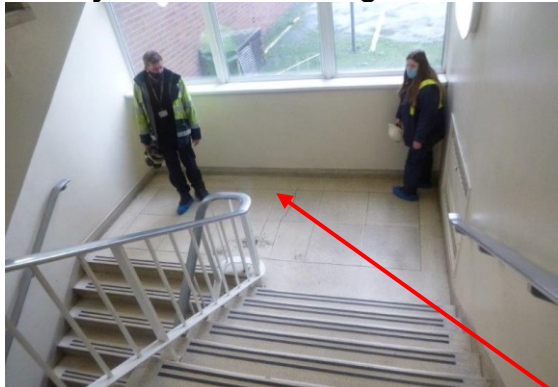
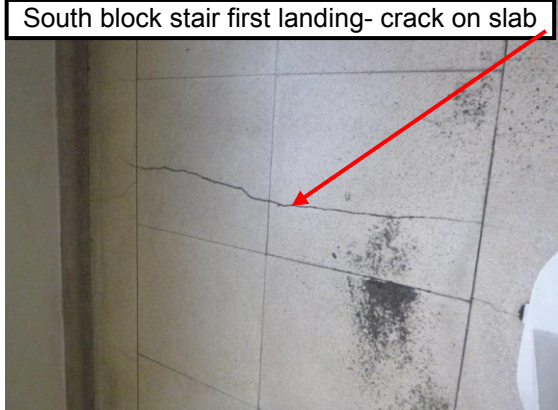
| Item No | Observations/ Defects Found | Action Required/ Comments | Priority RAM Matrix Rating P1, P2, P4 or M3 notification with (Photograph evidence if required) |
|---|---|---|---|
| 10 | <p>There is a visible crack on the first landing of south block stair.</p> <p>No substantial progress of crack/increase in crack width has been noticed by visual inspection during this time compared to previous inspection.</p> | <p>➤ No action is suggested based on this inspection.</p> <p>➤ Same is suggested to be monitored.</p> | <p><b>Priority RAM Matrix Rating M3</b></p> <p>South block stair first landing- crack on slab</p> <p>South block stair first landing- crack on slab</p> |

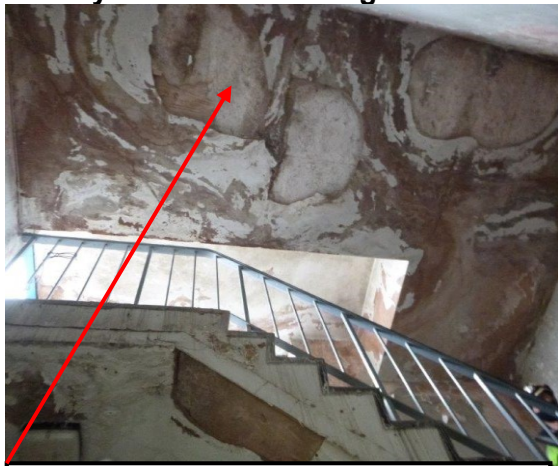
| Item No | Observations/ Defects Found | Action Required/ Comments | Priority RAM Matrix Rating P1, P2, P4 or M3 notification with (Photograph evidence if required) |
|---|---|---|---|
| 7 | <p>Spalling of ceiling plaster and crack on floor finish is visible near roof entrance area of North Block.</p> | <p>Loose plaster is suggested to be taken off to make the area safe. Damages identified within this area are suggested to be monitored during next inspection.</p> | <p><b>Priority RAM Matrix Rating M3</b></p> <p>North Block roof Entrance: Spalling of ceiling plaster</p> |

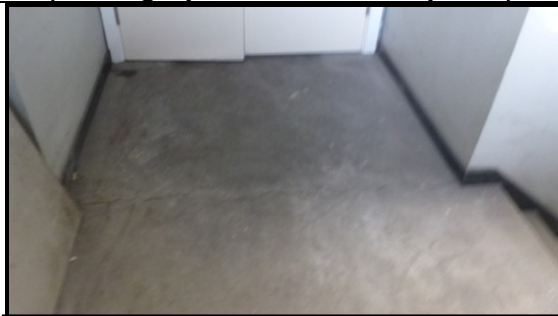
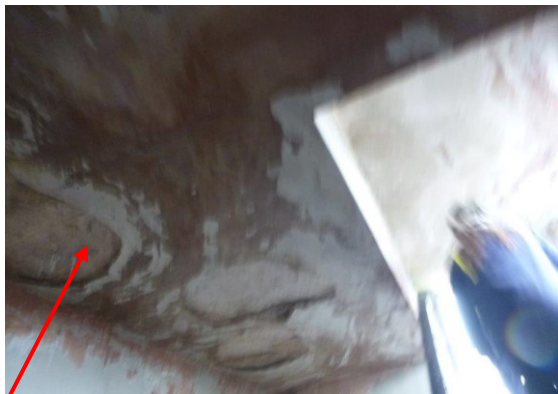
| Item No | Observations/ Defects Found | Action Required/ Comments | Priority RAM Matrix Rating P1, P2, P4 or M3 notification with (Photograph evidence if required) |
|---|---|---|---|
| | | | <p>North Block roof Entrance Area: Crack of floor</p> <p>South Block roof Entrance: Spalling of ceiling plaster</p> |

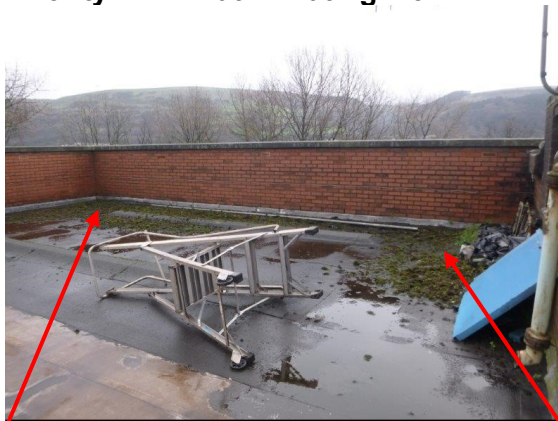
| Item No | Observations/ Defects Found | Action Required/ Comments | Priority RAM Matrix Rating P1, P2, P4 or M3 notification with (Photograph evidence if required) |
|---|---|---|---|
| 21 | <p>Moss and vegetation growth is visible in following areas:</p> <ul style="list-style-type: none"> <li>➤ On South and North block roof areas</li> <li>➤ Central roof-North end: Vegetation growth inside drain near downpipe.</li> <li>➤ Vegetation growth on North block south face wall</li> </ul> <p>This will be monitored during next inspection.</p> | Clean moss and vegetation growth over the structure as identified. | <p><b>Priority RAM Matrix Rating M3</b></p> <p>North Block roof-East side: Moss growth</p> |

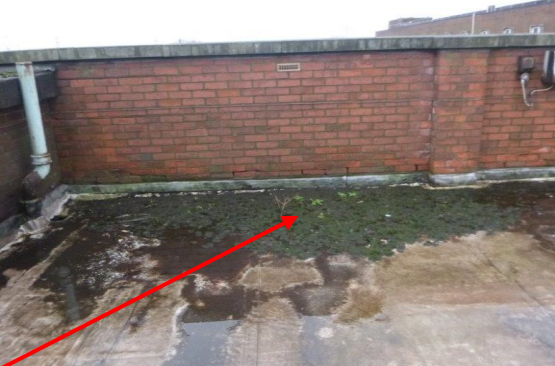
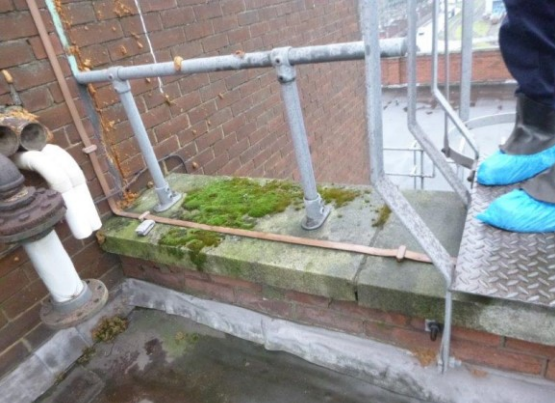
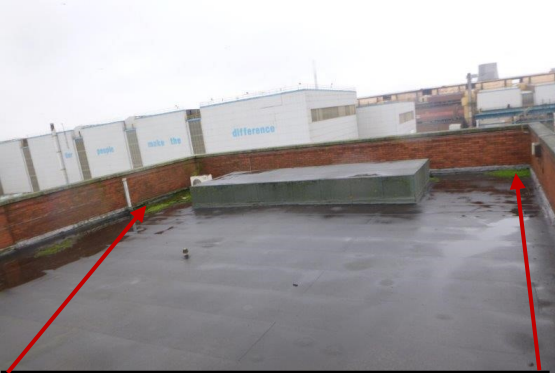
| Item No | Observations/ Defects Found | Action Required/ Comments | Priority RAM Matrix Rating P1, P2, P4 or M3 notification with (Photograph evidence if required) |
|---|---|---|---|
| | | | <p data-bbox="842 745 1399 779">North Block roof-East side: Moss growth</p> <p data-bbox="842 1209 1399 1243">Moss growth on North block roof</p> <p data-bbox="842 1664 1399 1697">Moss growth on South block roof-West end</p> |

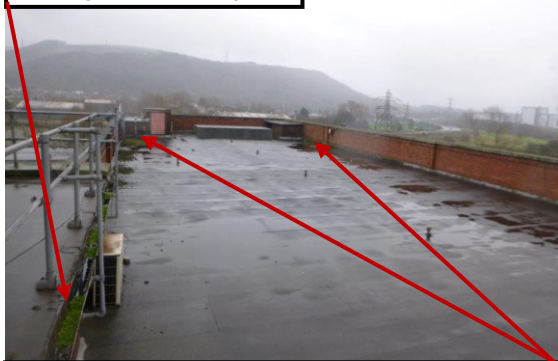
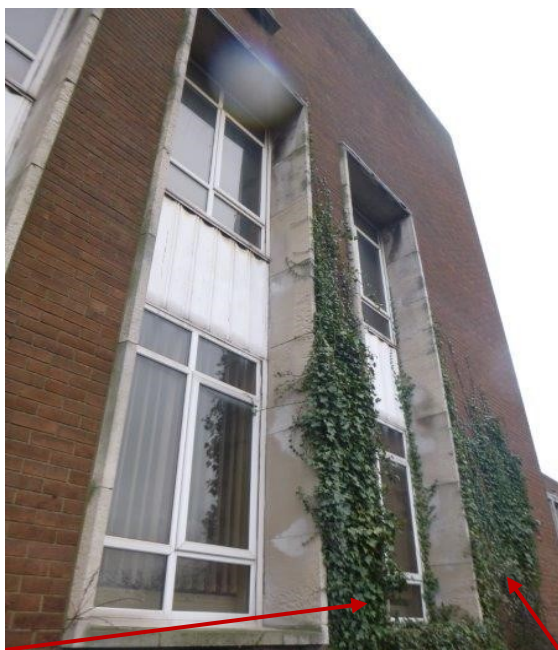
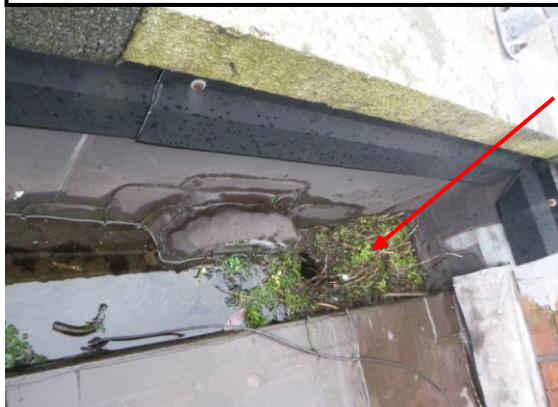
| Item No | Observations/ Defects Found | Action Required/ Comments | Priority RAM Matrix Rating P1, P2, P4 or M3 notification with (Photograph evidence if required) |
|---|---|---|---|
| | <p>➤Minor moss and vegetation growth is visible within the drain area. But, no blockage is visible in drainage system.</p> | | <div data-bbox="837 315 1396 748"> <p>Moss growth inside gutter</p> <p>Moss growth on South block roof</p> </div> <div data-bbox="837 752 1396 1480"> <p>Vegetation growth inside drain near north end down pipe</p> </div> <div data-bbox="837 1485 1396 1973"> <p>Vegetation growth inside drain near downpipe</p> <p>Roof: Central-North end</p> </div> |

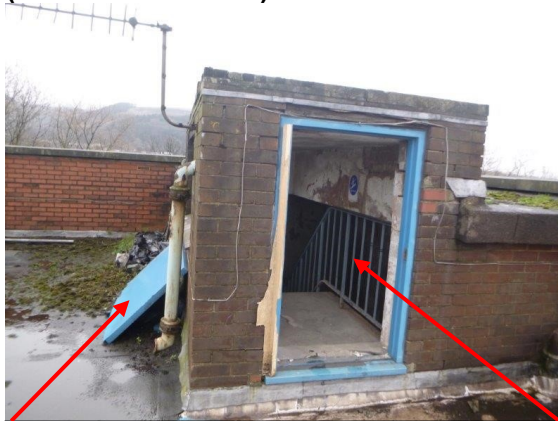
| Item No | Observations/ Defects Found | Action Required/ Comments | Priority RAM Matrix Rating P1, P2, P4 or M3 notification with (Photograph evidence if required) |
|---|---|---|---|
| 14 | <p>➤ North block roof access door panel is found to be missing.</p> <p><b>New Notification No: 15399424</b></p> <p><b>P4 No:</b></p> | <p>➤ Reinstall the missing door panel.</p> | <p><b>Priority RAM Matrix Rating P4 (Within 11 months)</b></p> <p>Missing door panel</p> |

1: North Block roof access door panel missing (Within 11 months)-**Notification No. 15399424-New**
