# Detachment of the Ball from the Stem on a Micro-Sized Stylus

By Carissa George

University of Wales Trinity Saint Davids

Beng (Hons) Mechanical & Manufacturing Engineering

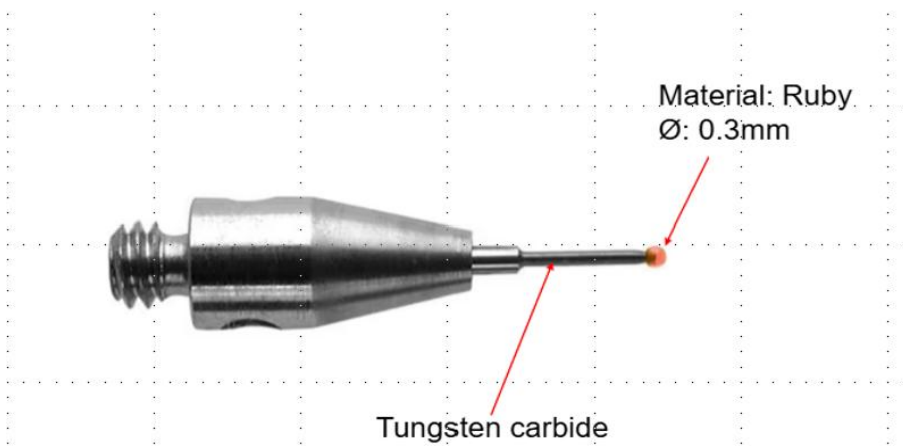
Figure 1: Micro-size (1mm) Stylus product.

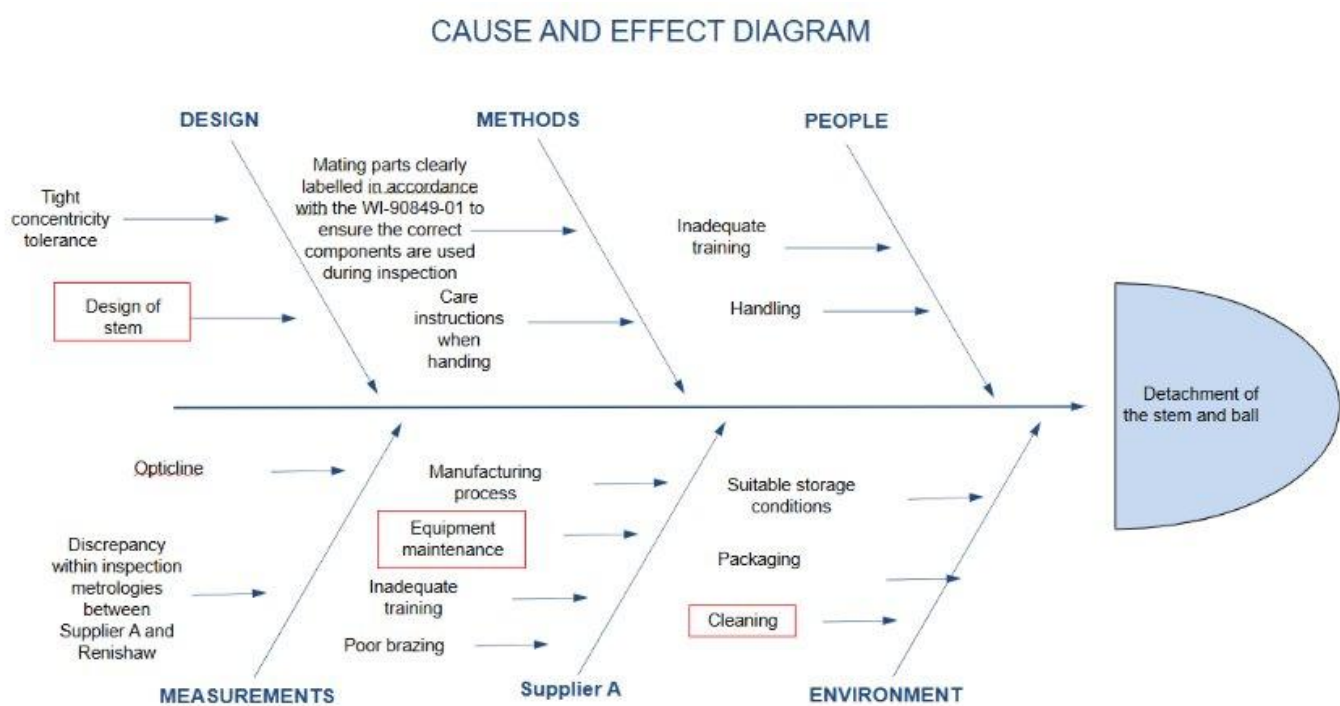
Figure 29: Ishikawa diagram (Ishikawa diagram)

Design of stem: Stem was not optimised for Design For Manufacture (DFM) resulting in inconsistent bonding.

Equipment maintenance: lack of maintenance led to poor conditions of fixtures.

Cleaning: was investigated but showed no impact on concentricity

1. Lack of a maintenance schedule causing fixture wear and misalignment.
2. Design of Stem not suitable (highlighted in Figure 29)

- Introduced a 6-month maintenance schedule to inspect fixtures for wear.
- Remade fixtures which reduced failure rate to 5% from 30%. (Estimat4ed cost reduction of £6,206.03 (95%))
- Re-designed stem by introducing a 'V' shaped seating feature, reducing failure rate from 5% to 0%. (Estimated reduced cost of £6,206.03 to £0)
