## 1.0 Assignment 4: Critical Reflection of Roles and Responsibilities

- 1.0.1 In 2019, MSDS Marine were commissioned by the National Museum of the Royal Navy (NMRN) to produce a Conservation Management Plan (CMP) for three Coastal Forces vessels that the museum had recently acquired; Motor Torpedo Boat (MTB) 331, MTB 71, and Rescue Motor Launch (RML) 497. The Coastal Forces division of the Royal Navy was established during World War I and was re-instated during World War II. The division was principally developed for the protection of the coast of Britain and comprised around 2,000 craft that were mainly crewed by wartime sailors and volunteers. These vessels were responsible for a great variety of tasks including minesweeping, larger vessel support, submarine chasing, and torpedo launching. The Coastal Forces vessels collectively fought over 1,000 actions during both World War I and II.

## 4.0 Appendix 3: RML 497 CMP

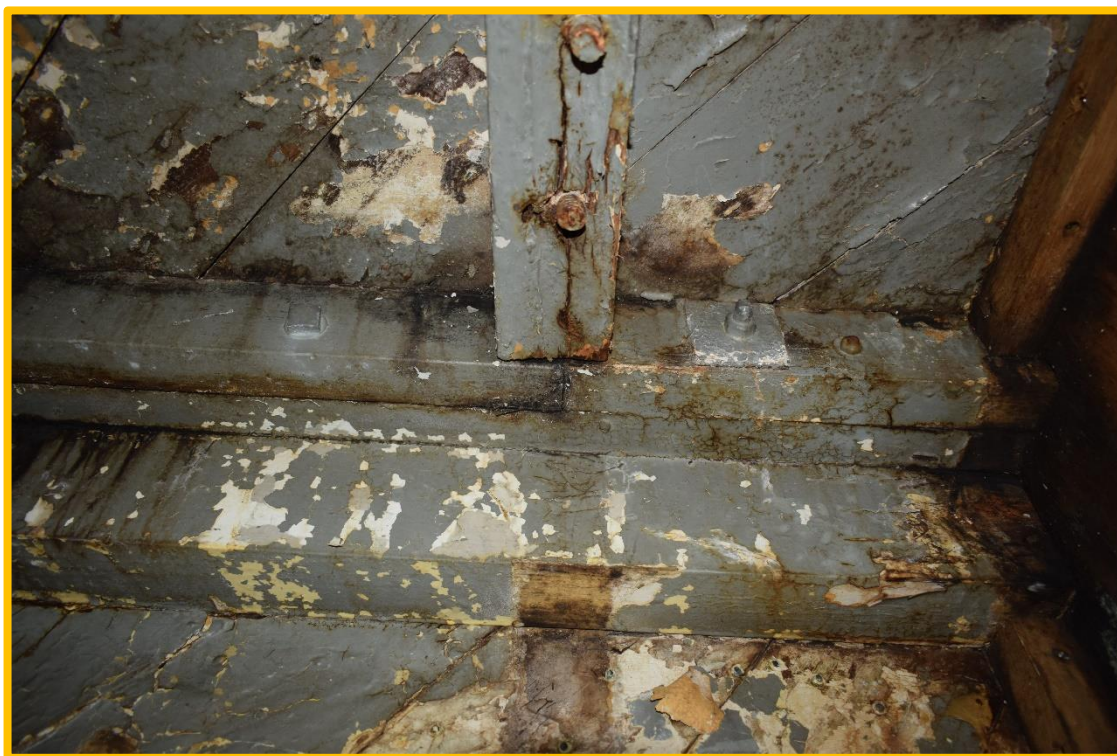
*Figure 7 Beam shelf between frames 9-10 on starboard side, with dry rot*

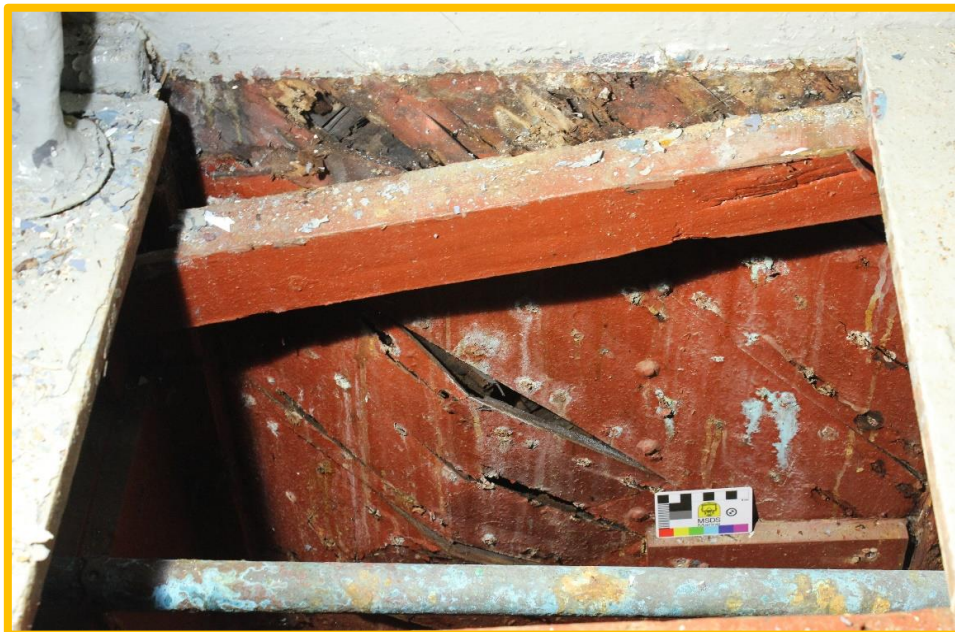
*Figure 10: Buckled section of bulkhead 4, forward face, port side.*

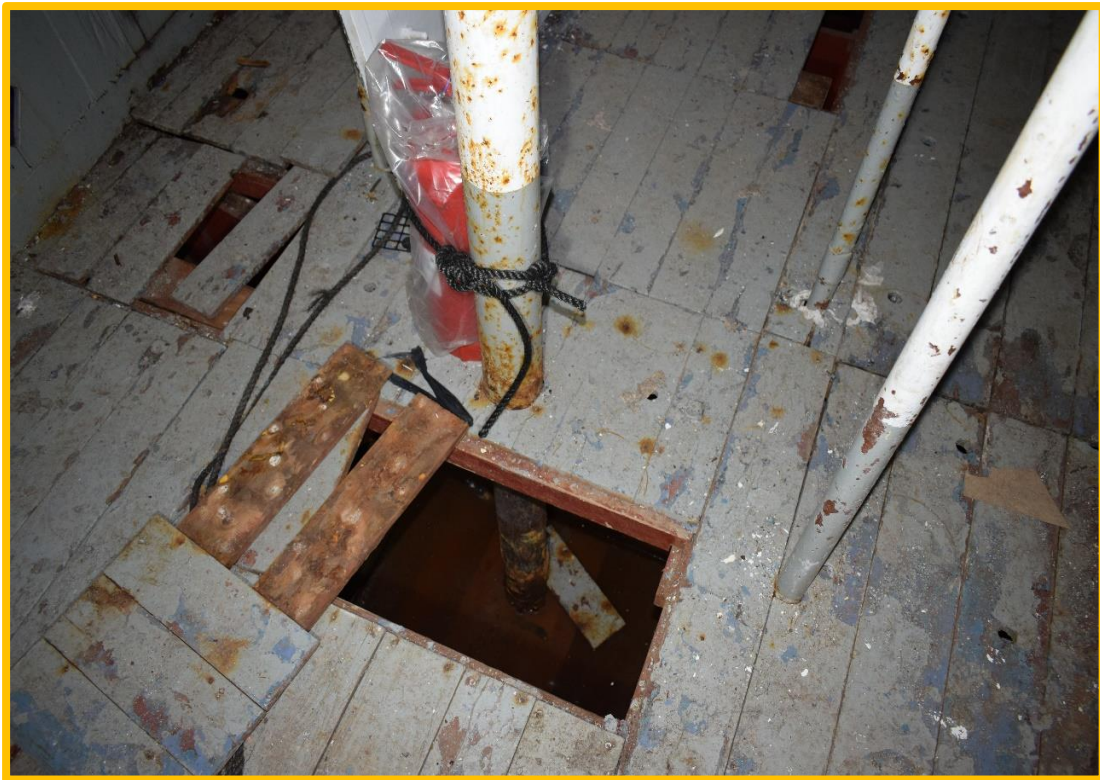
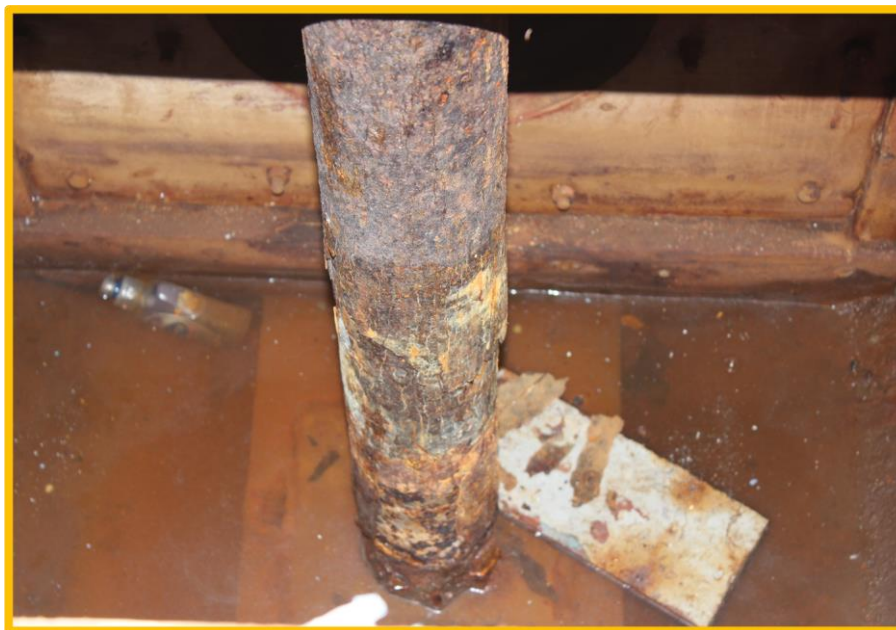
*Figure 11: Base of large metal support with close up of support in bilge water below decks*

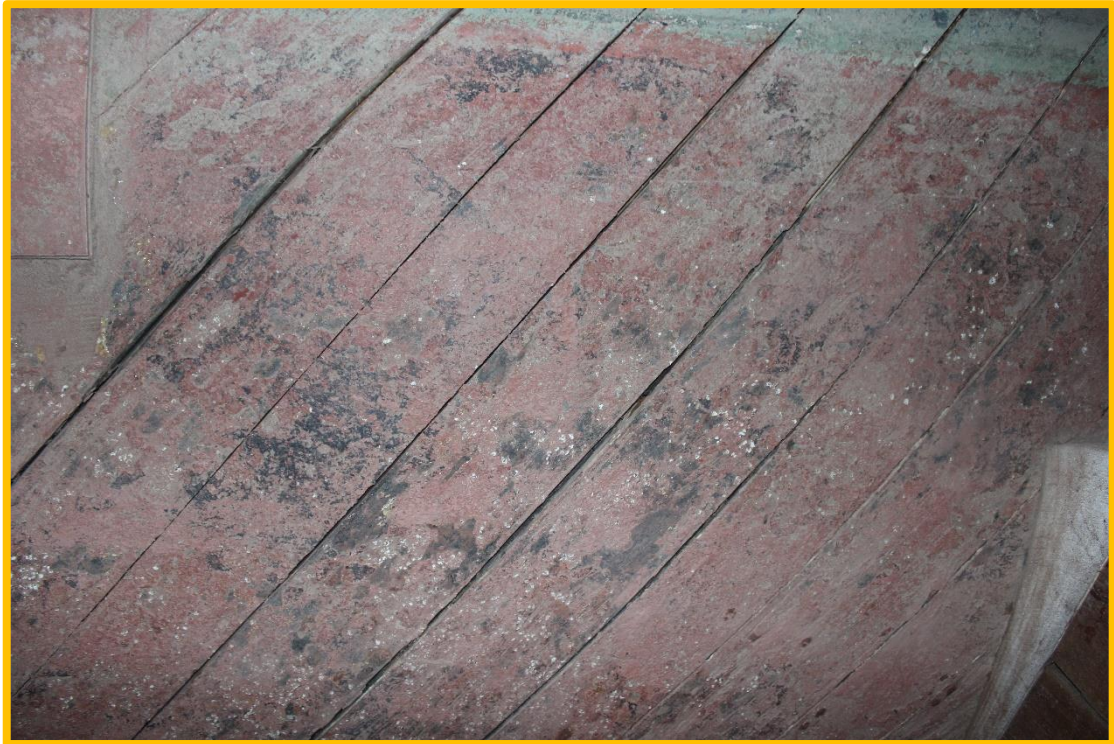
*Figure 12: Plank shrinkage on external hull on starboard side close to stern*

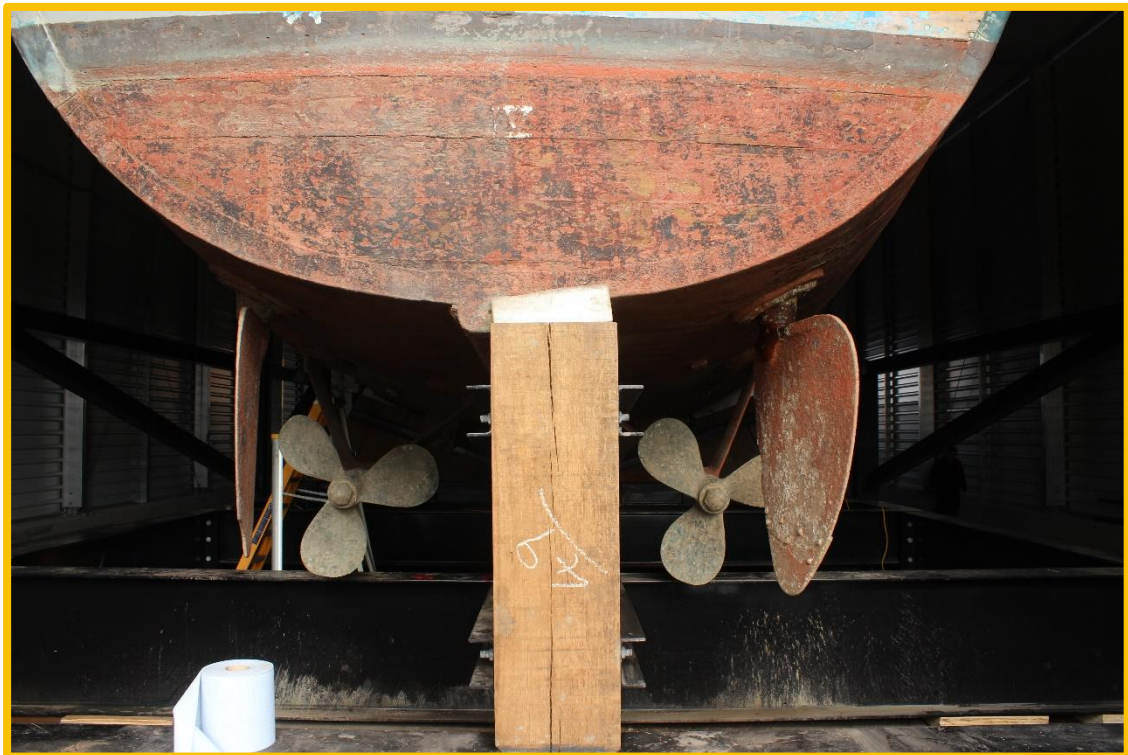
*Figure 13: Keel sitting off-centre on the cradle, and cracking in cradle timber*

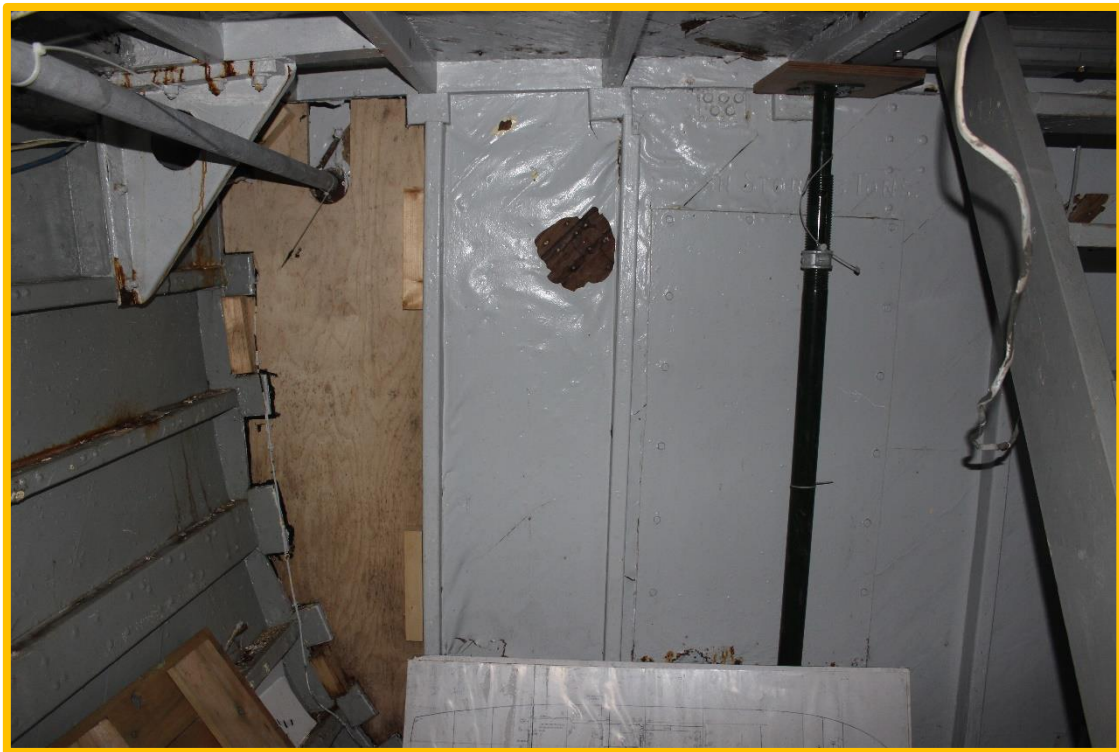
Figure 26: Bulkhead at frame 22, with brown rot

- The aft compartment is badly affected by rot with all timbers at risk of loss through active deterioration;

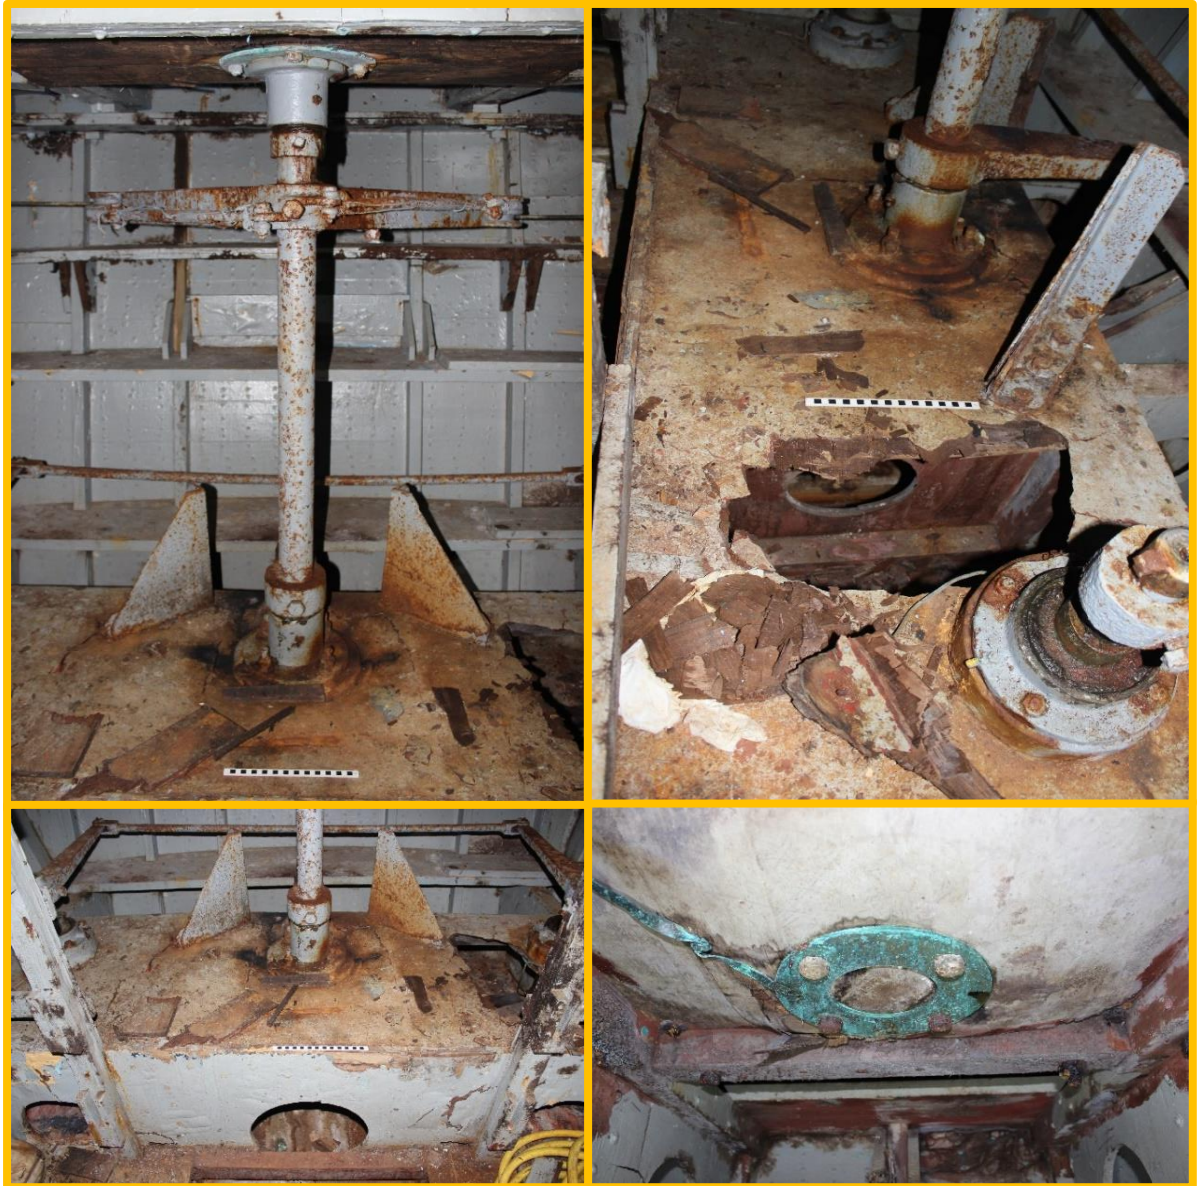
*Figure 28 Top to bottom, left to right: Steering quadrant on plywood box; hole on the port side of the plywood box; plywood box sagging beneath weight of the steering gear; underside of plywood box showing lack of support*

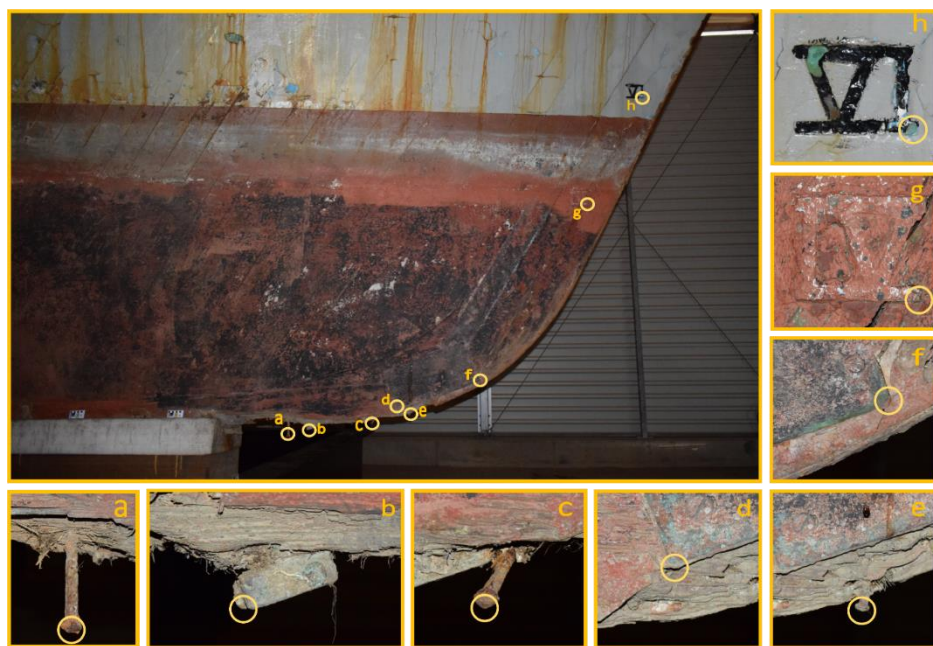
13.1.4 Measurements were taken at the time of the surveys conducted for this CMP to establish monitoring points for the bow of the vessel (Figure 39), and a photogrammetry survey of this area, and the stern, was completed (Figure 39 and Figure 40). Repeat measurements can be taken with reference to the positions and details given below, and repeat photogrammetry surveys or collection of laser scan data would provide additional means of monitoring this critical area.

Figure 39: Monitoring points established to record the bow
