# Coastal regeneration at Llanelli, South Wales, **UK: lessons not learned.**

International Coastal Symposium (ICS) 2009.

**Mike Phillips<sup>\*</sup>, Victoria Powell<sup>#</sup>  
and Robert Duck<sup>#</sup>**

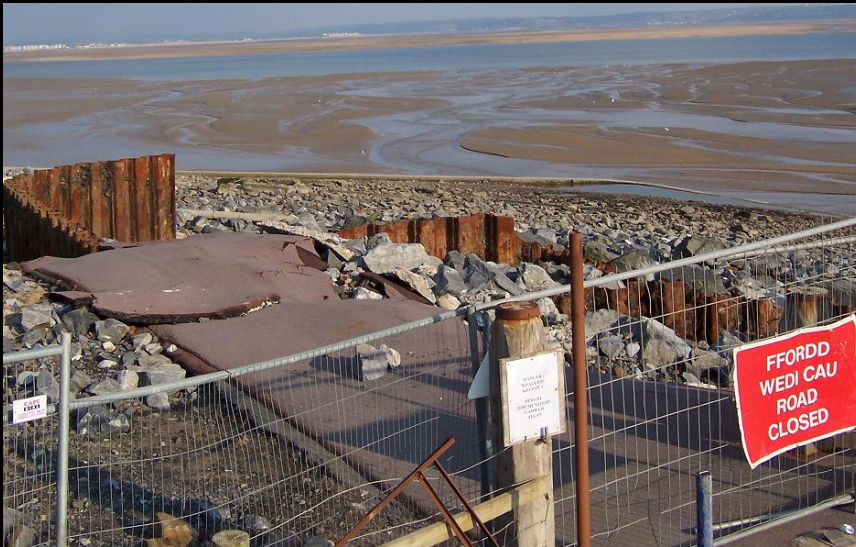
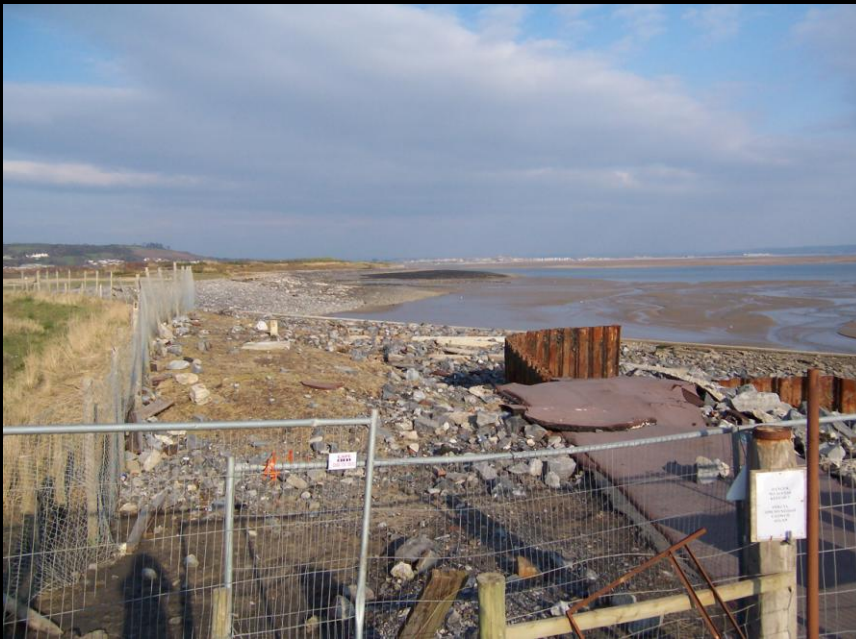
**Burry Port Harbour has been restored during the Millennium Path development. It has a new harbour gate and is now a busy leisure boat facility. There are two beaches either side of the harbour, with the east beach being down stream from the harbour defences. Damage to coastal path started within 3 years of completion (CCC, 2007).**

- **Consequences of March 2007 storm – structural collapse – 150m lost;**
- **If the path is completely lost within seventy-five years then the Lottery funding would have to be repaid;**
- **Not financially feasible – management problem!**

- Use the dredged material from the harbour channel to recharge sediment on East Beach or Llanelli Beach;
- Apply for grant to install originally planned flushing lock gates;
- Maintain seawall and rock armour in front of the harbour, East Beach and towards the Earth Sculpture.

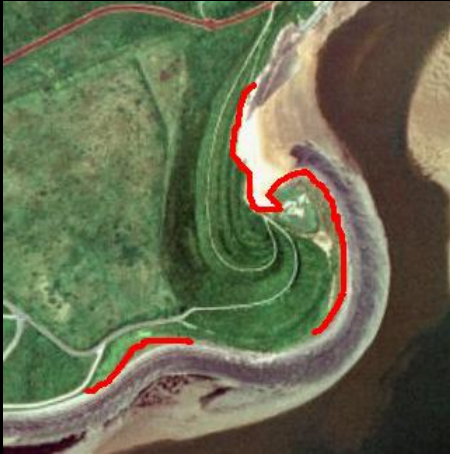
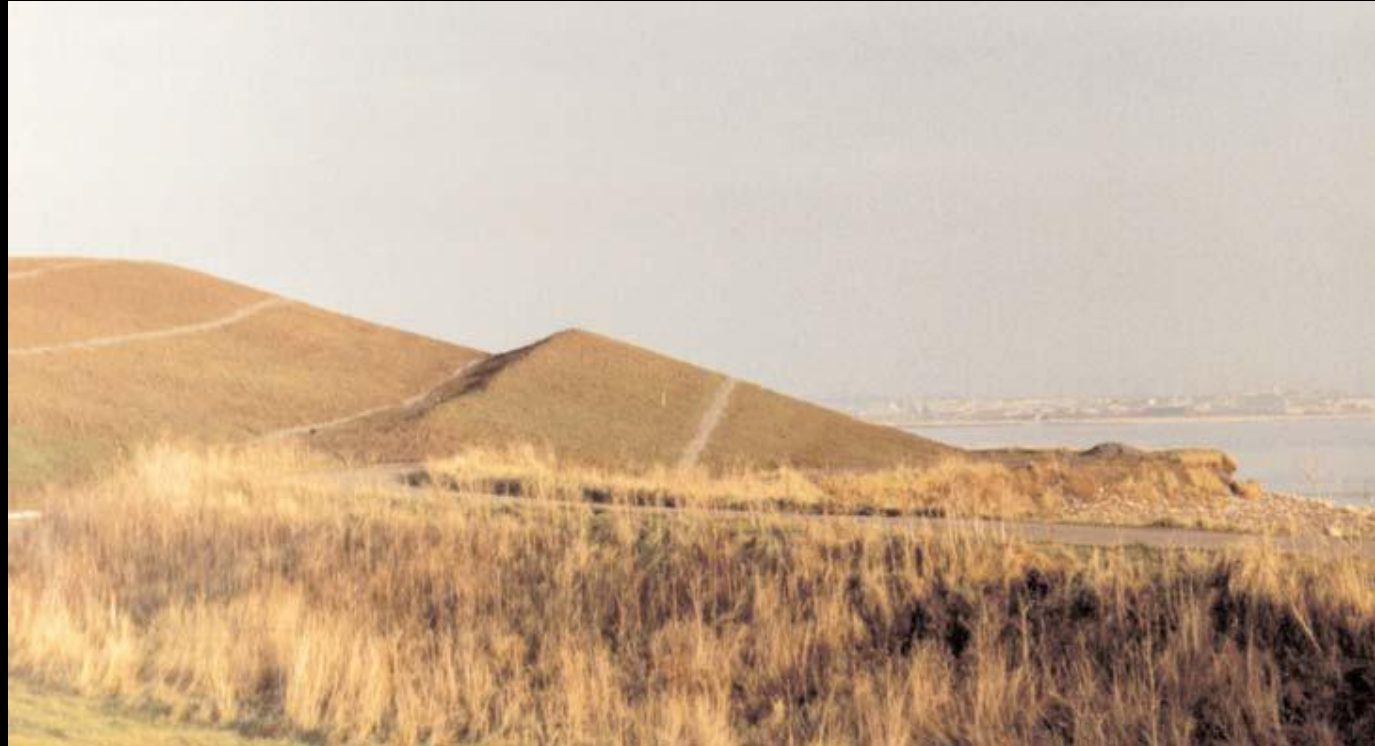
- Significant erosion of the earth sculpture (direct and refracted wave attack) - 10m retreat (CCC, 2007);
- Fence posts strewn across the beach;
- PFA leaching onto constructed beach;
- Current management via gabions and small quantities of rock armour.

- Low-lying coastal path is inappropriately located;
- Erosion caused by storms, and over a tidal cycle by westward flowing river currents and eastward sea currents;
- Allow the site to degrade naturally with minor protection points,
- Investigate the impact of a submerged breakwater

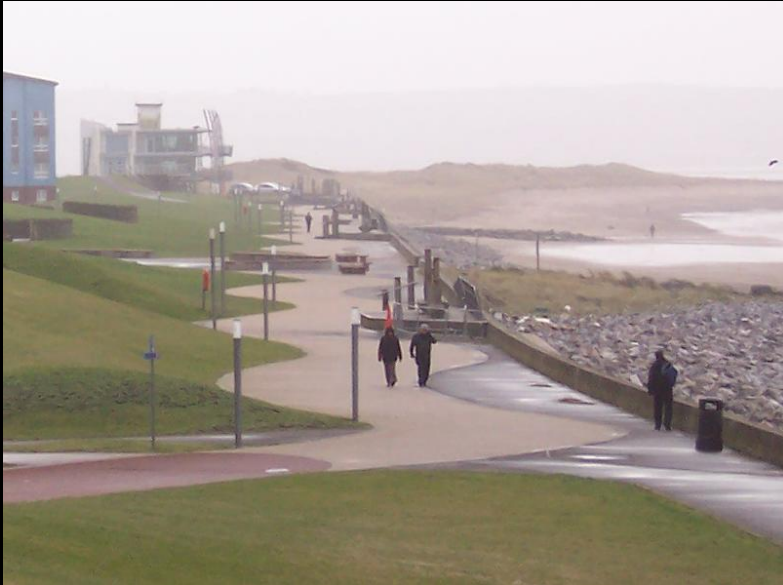
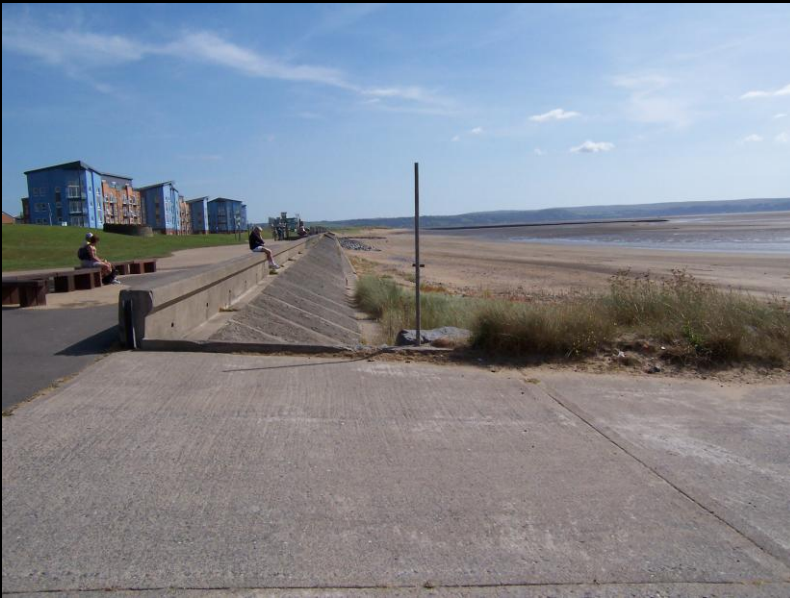
- **Beach depletion adjacent to dune system;**
- **Hard engineering structures do not fully protect shoreline;**
- **Rock armour and beach nourishment supplement hard defences but greater volumes needed;**
- **In 2001 coastal defences protected £5M assets but risk/costs are significantly increasing with new development.**

- Improved seawall maintenance along the coastal frontage;
- Increase rock armour at seawall toe;
- Investigate submerged breakwater in front of the railway,
- Beach nourishment with dredged sand from Burry Port;
- Enhance dunes to the east and investigate breakwater removal;
- Assess cross-shore water movement;
- Investigate contributions from sale of development land.

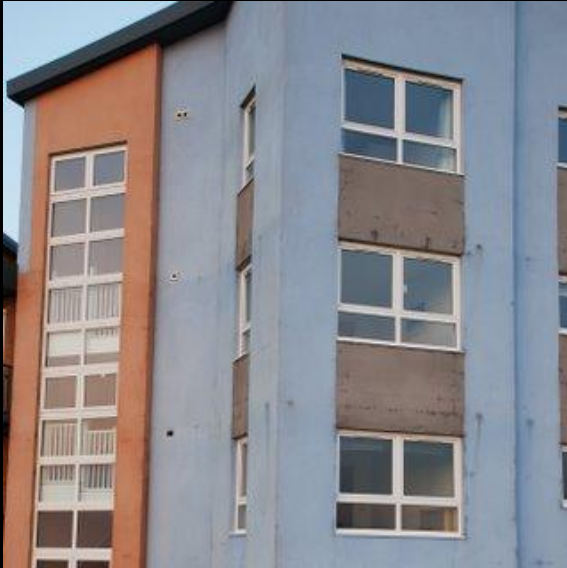
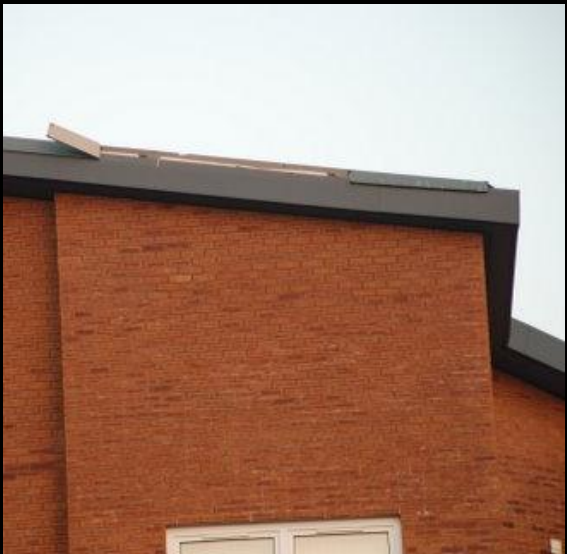
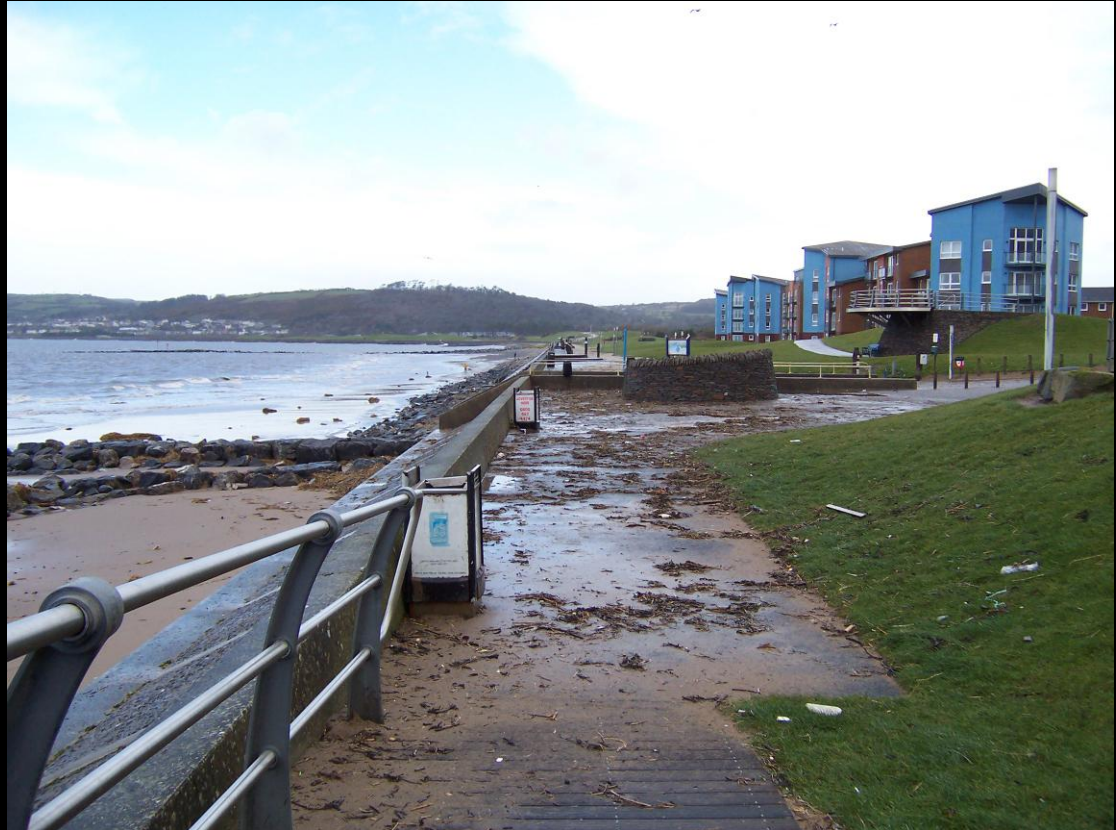
### Consequences of March 2008 storm:

- Overtopping damaging seawall and promenade;
- Property damage.
