***Risk Management and Root Cause Analysis  
regarding a Manufacturing Defect in the  
Automotive Manufacturing Sector***

**Engineering Applications and Study Skills  
(ACMA 4039)**

Benjamin Cole

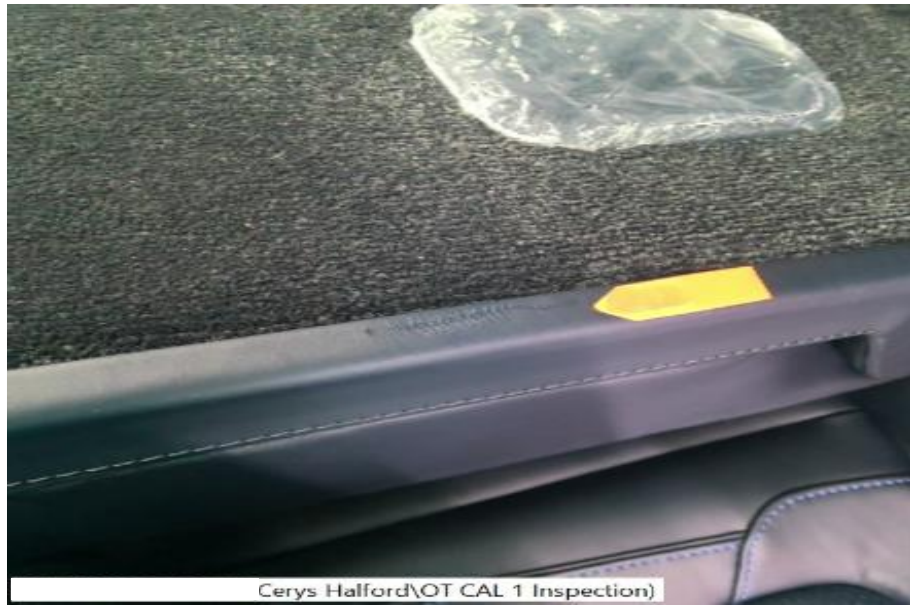
Within the last 30 days exclusively, the concentration of scuffs in this area has reached 9 in the 104 vehicles inspected during this time. That is 9% of vehicles produced in this time frame with this exact damage. It has been established that the average rework time for a scuff of this caliber is 40 minutes, equating to £150 in both labor and material. Therefore, a total of 360 minutes and £1,350 in costs just for these 9 established scuffs within 30 days. This issue is going to be rectified as soon as possible.

*Figure 3 - Flags Image of Squab Damage (Cerys Halford, 2025)*

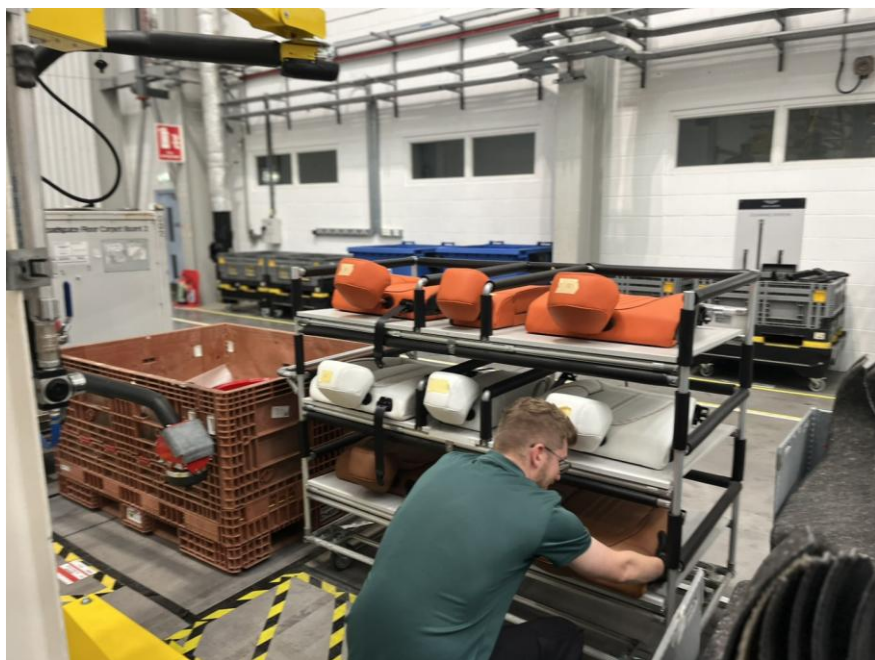
However, whilst investigating the issue, another issue was raised by technicians. The issue is that they are having trouble with the trolley that these parts are loaded on to. The technicians informed that bending over to obtain the part and lift it out of the trolley is causing repetitive strain on their backs due to the parts weighing approximately 20kg each, and being a difficult shape to carry.

*Figure 4 - Example of lifting part from Trolley (Author, 2025)*

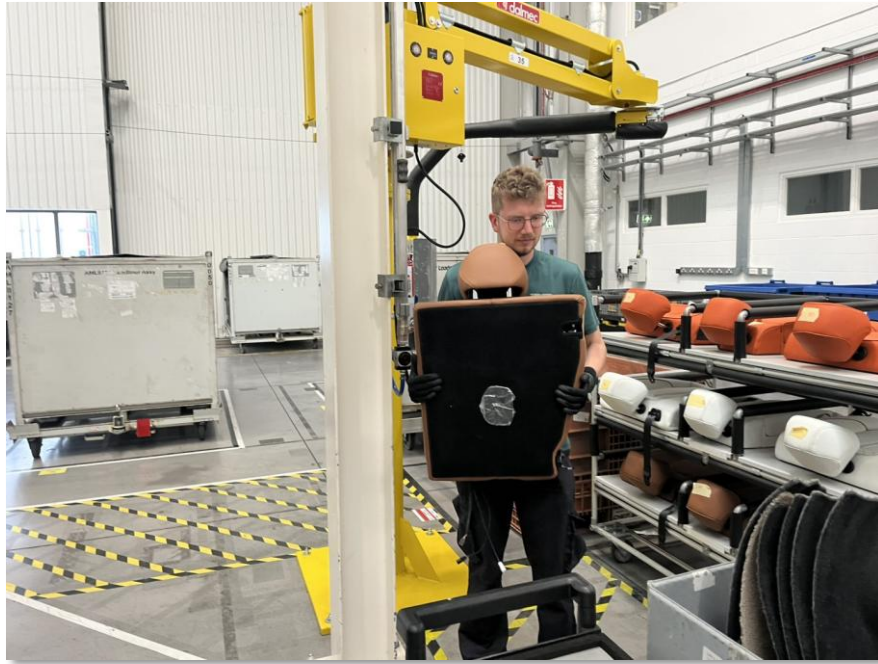
*Figure 5 - Example of lifting part from Trolley (Author, 2025)*

The Health and Safety Executive state “Ergonomics can also reduce the potential for ill health at work, such as aches, pains and damage to the back. Consider the layout of equipment – Place those used most often where they are easy to reach without the need to stretch.” (Health and Safety Executive, 2013). This emphasizes the need for improvement on this station, where technicians are having difficulty regarding safely lifting and carrying the parts.
