# Rotating Equipment Operating Outside Intended Design Life and Usage Parameters

UNIVERSITY OF WALES

BEng Mechanical & Manufacturing  
Engineering

2017

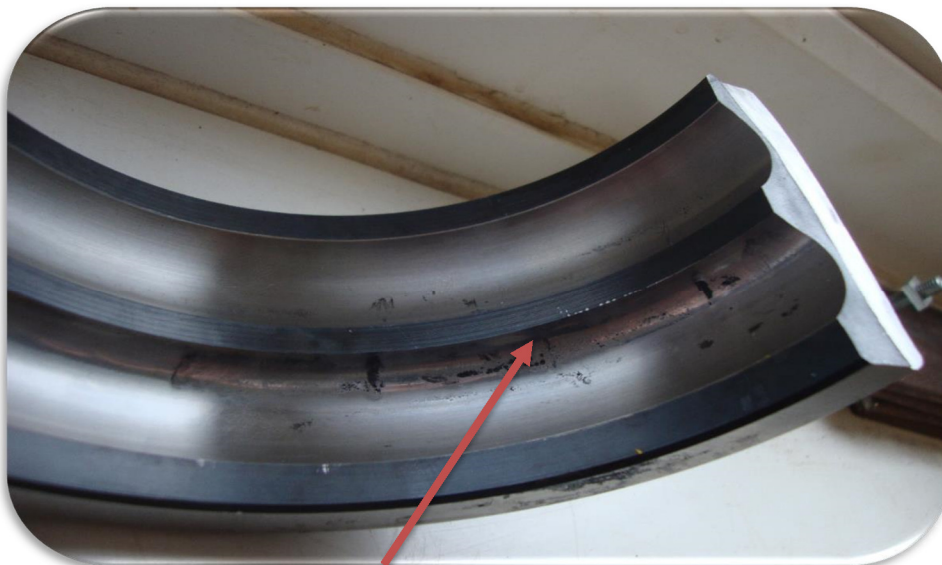
#### 1.2.6 - Figure 9 – Outer Race Visible Defect

The drive end bearing of the unit in question was removed and cut open and cleaned, upon close visual inspection, signs of outer bearing race condition breakdown were found:

Visible outer race condition breakdown.

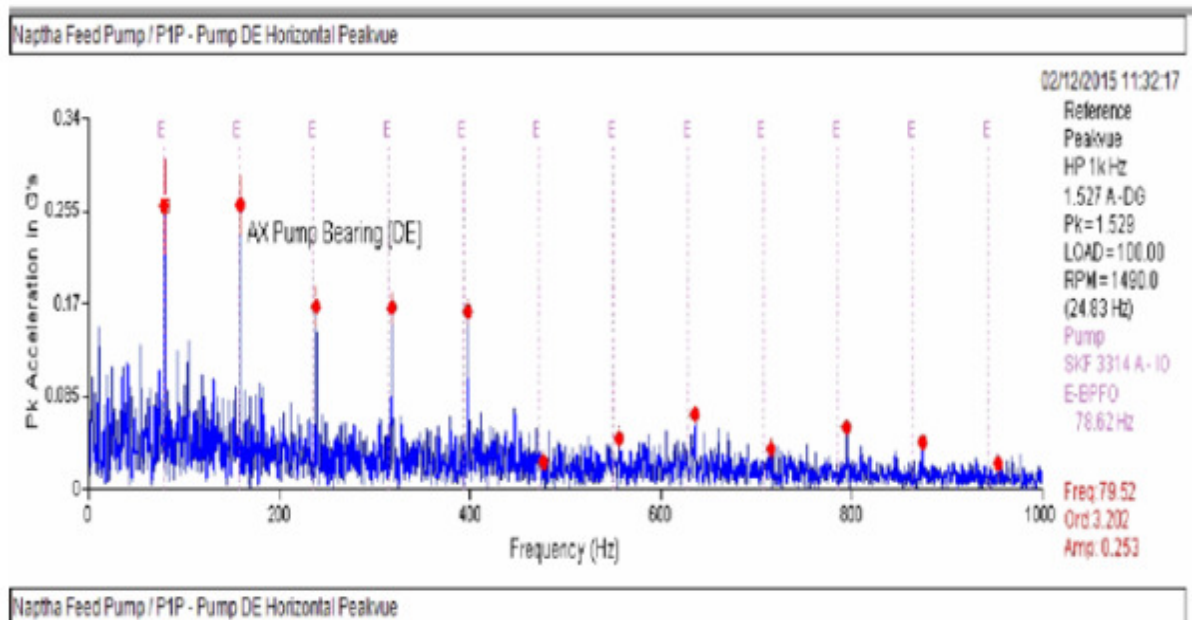
1.2.8 - Figure 11 – Vibration Survey Extract - Harmonics

Figure 11 analysis showed evidence of high levels of harmonics present, harmonics have proven to be associated with outer bearing race defects, (Electromotores, 2003) elaborates: “If the frequency and harmonics (multiples) of it are present are on the vibration spectra, you most probably have an outer race bearing defect....a spall on the raceway, electrical fluting, false brinelling acquired during bearing storage or equipment transfer”.

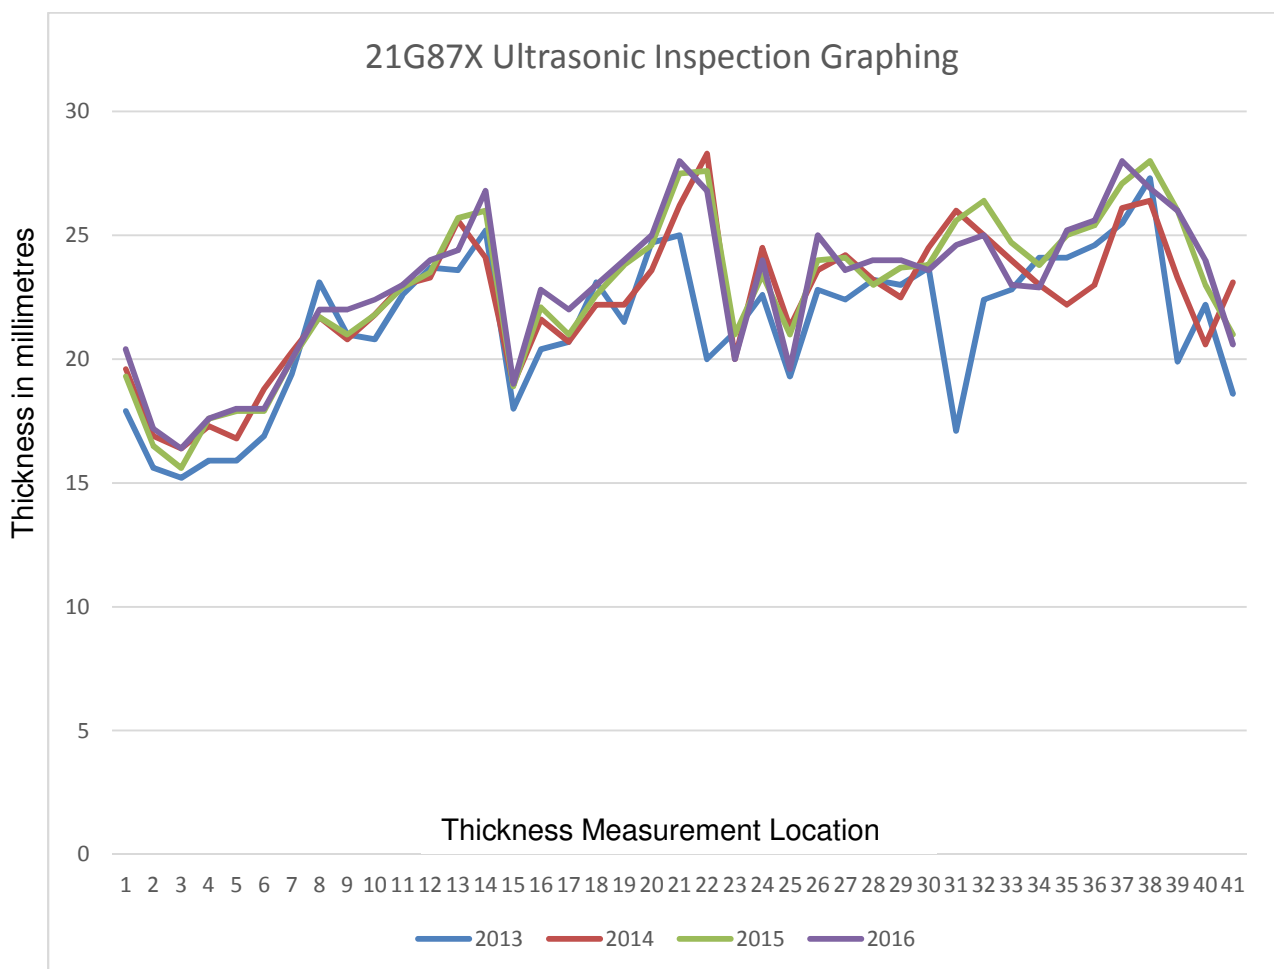
#### 1.2.14 - Figure 14 – Graph 1 - Pump Set UT Graphing

As can be seen in figure 14, although there appear to be discrepancies as high as five or six millimetres in some cases, there are no thickness measurement locations that show a general downward thickness trend.

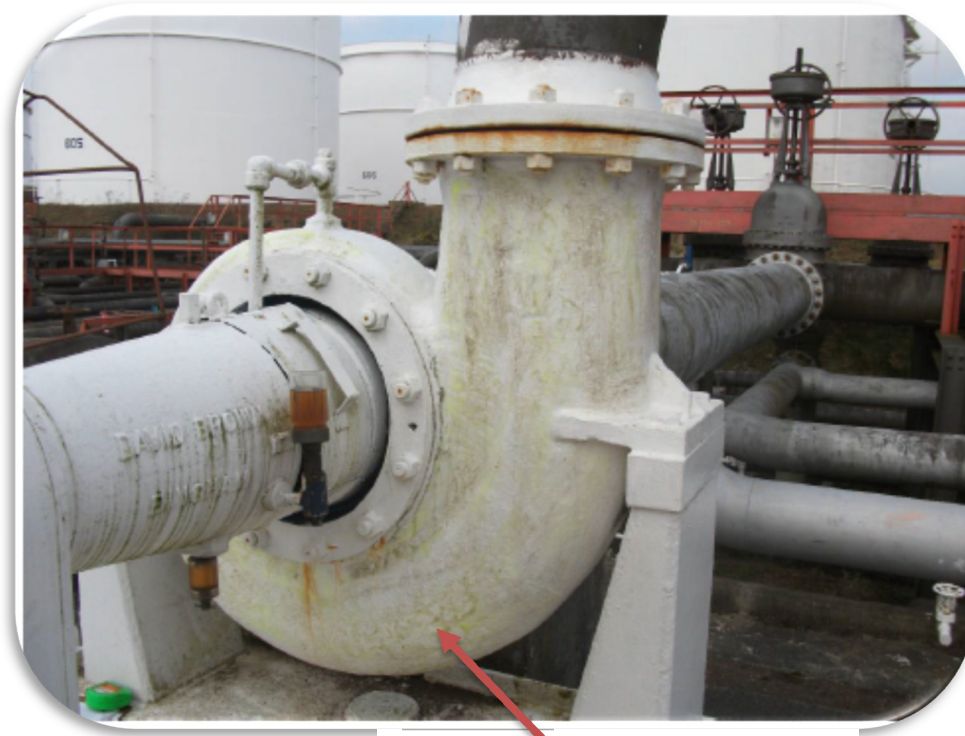
#### 1.3.1 – Figure 15 – Volute Casing Defect Location

A material flaw was highlighted in a pump casing, the nominal thickness of the volute casing being twenty millimetres, with one area measured at six point six millimetres.

Point measured at 6.6mm thickness

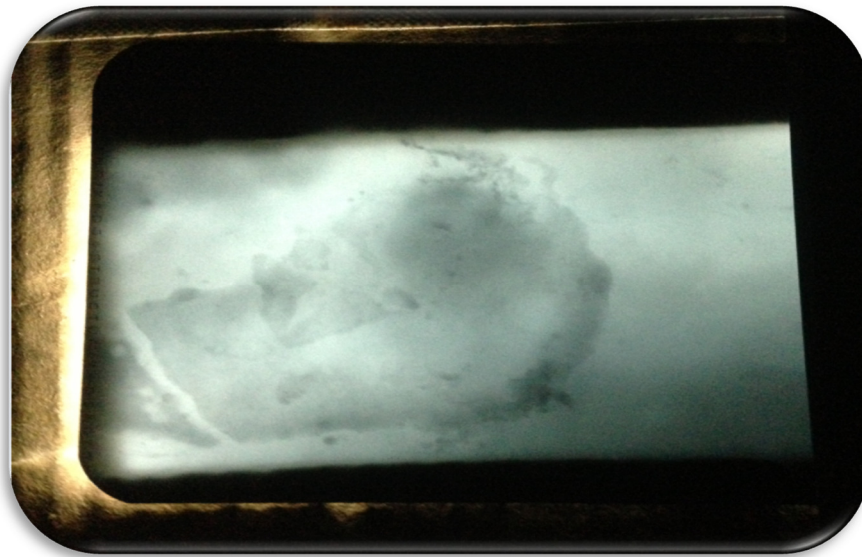
#### 1.3.4 - Fig 16 - X-Ray Image of Casing Wall

Following an X-ray of the area in question, a report was provided by IRISNDT, a local specialist company, which highlighted that the area in question was of similar thickness to the rest of the volute casing. (IRISNDT, 2013) “The area in question shows a similar thickness to the adjacent area this can be seen due to density of radiograph being similar, the area adjacent is approx.17-20mm thickness”.

Figure 16 provided evidence that the area in question was in fact of similar thickness to the rest of the pump casing, and therefore the reason for the results of the ultrasonic inspection should be further investigated.

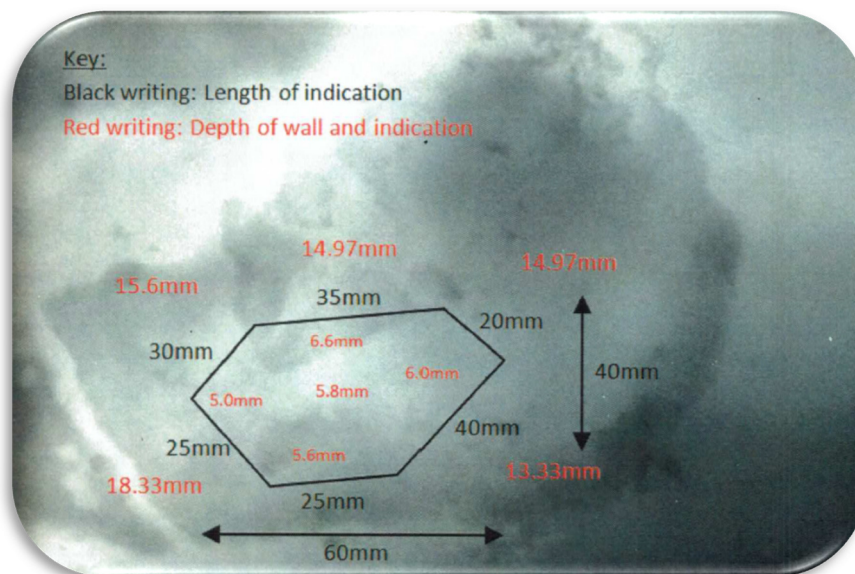
#### 1.3.6 - Fig 17 – Shear Wave Inspection Interpretation of X-ray

As can be seen in figure 17, only a small area was affected, extract of report can be found as Appendix 2.

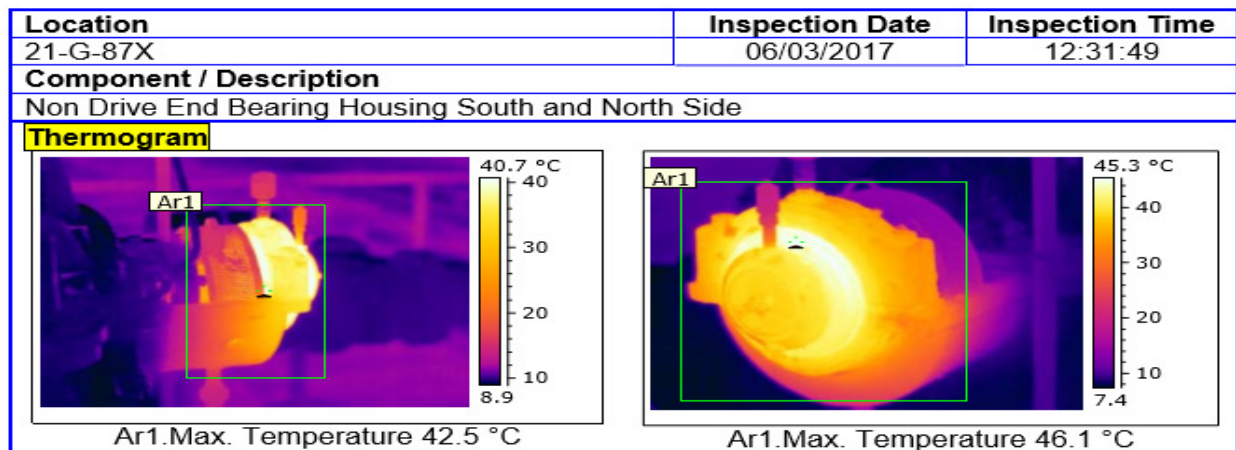
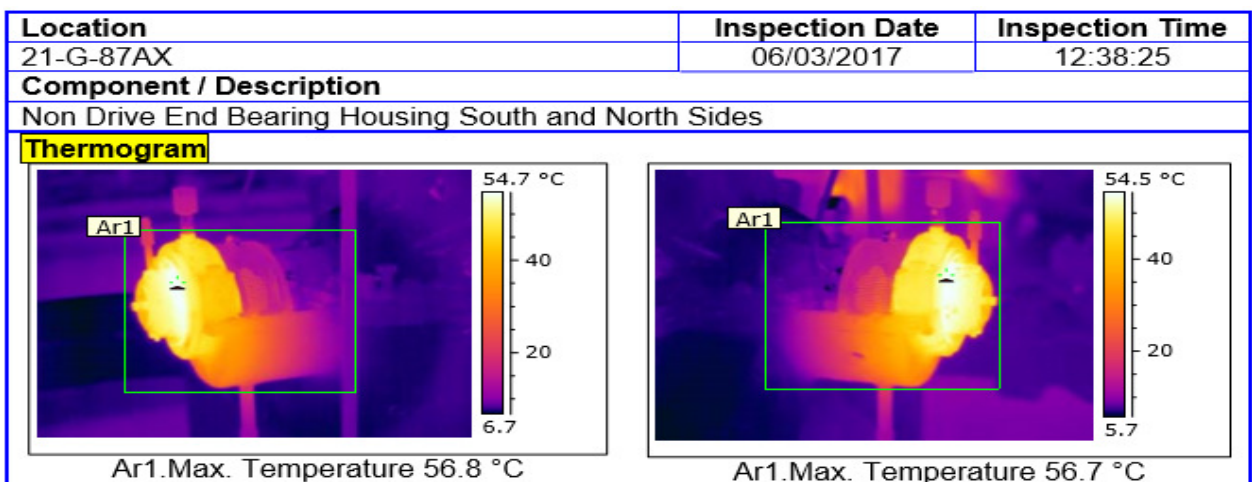
The thermography showed that although there was a small difference in temperature in comparison to the neighbouring unit, approximately 10°C. The difference was attributed to the unit not having yet undergone refurbishment and hence it was possible that the grease may have lost some of its lubricating properties.

Recent vibration data listed the machine as healthy, additionally (Whitcher, 2017) stated “No items of concern were identified...the bearing housing temperature is not excessively high”.

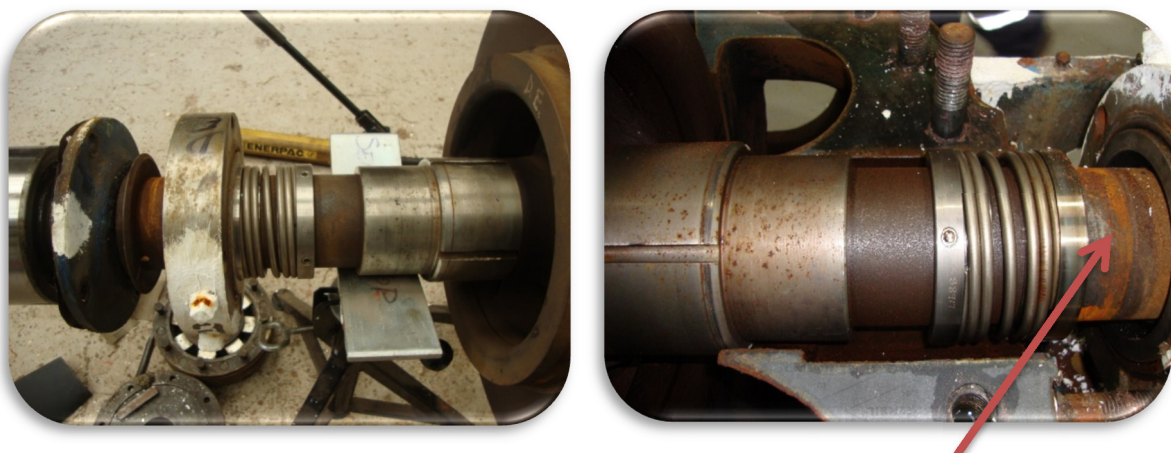
#### 2.1.2 - Figure 20 – Seal Running Area

Closer view of corroded shaft

This interference had prevented the rotary seal ring, (RSR), from moving up the shaft to meet the stationary seal ring, (SSR), as the faces wore over time which was allowing seal seepage.
