## **BUILDING CONDITION & RETROFITTING SURVEY REPORT**

**Property Address:** 113 Priory Road  
Milford Haven  
Pembrokeshire  
United Kingdom  
SA75 1TU

**Date:** 20<sup>th</sup> December 2025

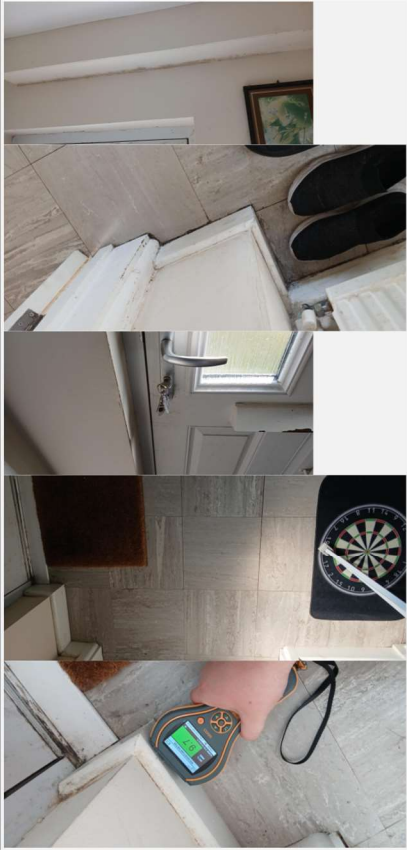
| | Inspection | Photos |
|---|---|---|
| <b>Notes:</b> | <p>The primary UPVC/composite door on W4 provides the main access from the front to the home.</p> <p><b>Wall 1:</b><br/>Timber door with timber surround provides access to the boiler room/cloaks facility.<br/>Constructed with brick or block, finished with plaster. No immediate signs of mould or damp penetration was seen at the time of the inspection. Surface-mounted electrics and thermostats reading 10C.</p> <p><b>Wall 2:</b><br/>Timber door with timber surround provides access to the kitchen.<br/>Timber staircase leading to the first floor.</p> <p><b>Wall 3:</b><br/>Brick or block construction with a plaster finish. Timber door with timber surround provides access to the main lounge.</p> <p><b>Wall 4:</b><br/>Composite door provides access to the front elevation.<br/>Brick or block construction with a plaster finish. Signs of mould above the door on timber boxing.</p> <p>Radiator not properly sealed, with some damp below the radiator.<br/>Floor covering is a thermoplastic floor tile.<br/>Ceiling is plaster finished and in good order.</p> | |

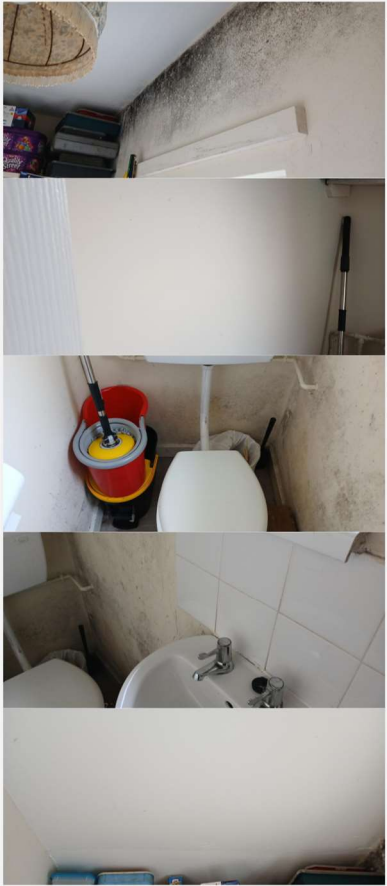
| Downstairs Toilet | |
|---|---|
| | <p><b>Wall 1 (Left-facing wall adjacent to the WC):</b><br/>Evidence of mould growth was observed on the lower right section of this wall, extending up to approximately 800 mm above floor level.</p> <p><b>Wall 2 (Low-level WC wall with plastic cistern):</b><br/>Signs of dampness were noted beneath the cistern area, though the extent was limited.</p> <p><b>Wall 3 (External wall with uPVC window and porcelain sink):</b><br/>Mould growth was present up to the height of the window sill, approximately 1.2 metres above floor level. Additionally, significant mould was observed descending from the ceiling perimeter, particularly concentrated above the window header.</p> <p><b>Flooring:</b><br/>Thermoplastic floor tiles were present. No visible issues or signs of moisture ingress were noted at floor level.</p> <p><b>Ceiling:</b><br/>The ceiling has a plaster finish with surface-mounted electrical fittings. No mould was observed on the ceiling surface.</p> |

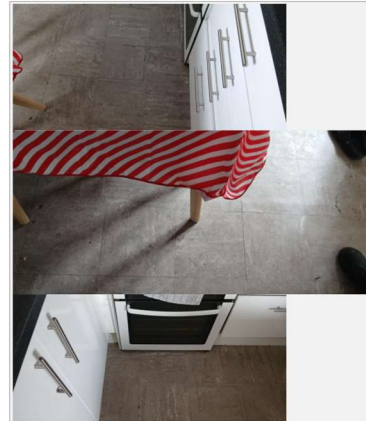
| Kitchen | |

| Kitchen | |
|---|---|
| <b>Notes:</b> | Kitchen units are outdated and in disrepair due to damp at plinth height |
| | Brick or block construction with a plaster finish. Signs of mould above the door on timber boxing. |

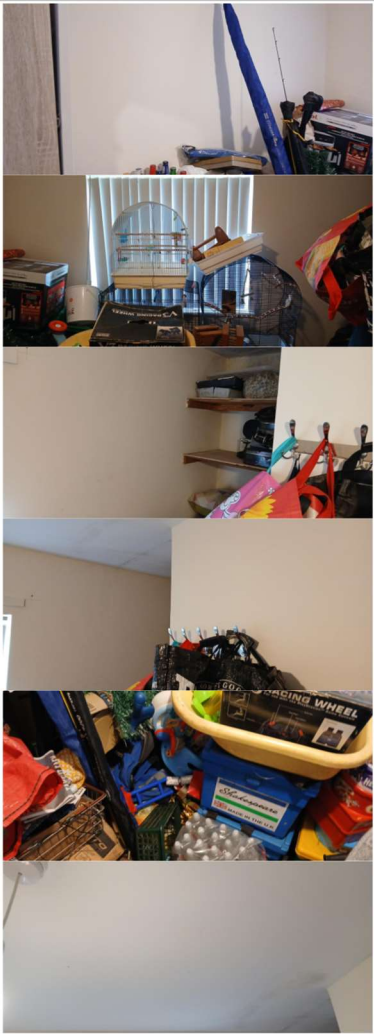
| Parlour Room | |
|---|---|
| <p><b>Notes:</b></p> <p><b>Access Limitations:</b></p> <p>Access to lower wall areas was restricted due to stored items, limiting full inspection.</p> <p><b>Wall 1:</b></p> <p>Brick and block construction with a plaster finish. No visible issues observed.</p> <p><b>Wall 2 (Rear-facing wall):</b></p> <p>Contains a uPVC window; rear view access was restricted.</p> <p>Cracking observed in the plaster at the top left-hand corner (as shown in the photograph).</p> <p>Wall extends beyond a small storage area with no access, but signs of mould were noted on the ceiling in that section.</p> <p>Remainder of the wall is brick or block with plaster finish</p> <p><b>Ceiling:</b></p> <p>Plaster finish with some staining or variation in paint finish. This appears to be cosmetic rather than due to water ingress.</p> <p><b>Heating and Flooring:</b></p> <p>No heating present in the room.</p> <p>Floor is carpeted.</p> | |

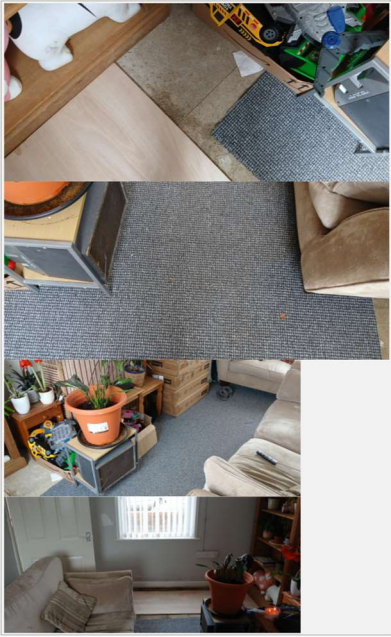
| Living Room | |
|---|---|
| <b>Notes:</b> | <p>Works in place to replace the flooring as needed. See notes above for new insulated detail.</p> <p>Wall 1:<br/>Timber door with timber surround provides access to the kitchen.</p> <p>Wall 2:<br/>Timber door with timber surround provides access to the Entrance hall. Constructed with brick or block, finished with plaster.<br/>Timber staircase leading to the first floor.</p> <p>Wall 3:<br/>Brick or block construction with a plaster finish. Timber door with timber surround provides access to the main lounge.</p> <p>Wall 4:<br/>Composite door provides access to the front elevation.<br/>Brick or block construction with a plaster finish. Signs of mould above the door on timber boxing.</p> <p>Floor covering is weyrco and off cuts of bedroom carpet.</p> <p>Ceiling is plaster finished</p> |

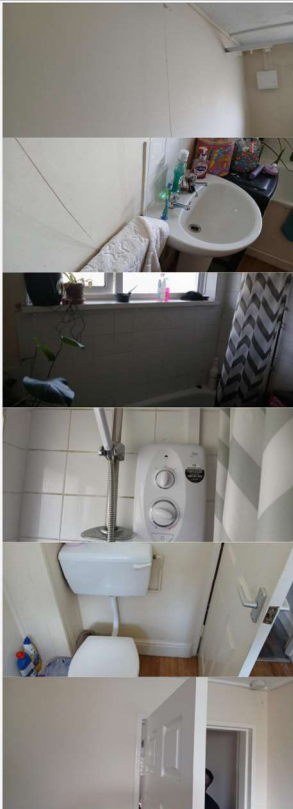
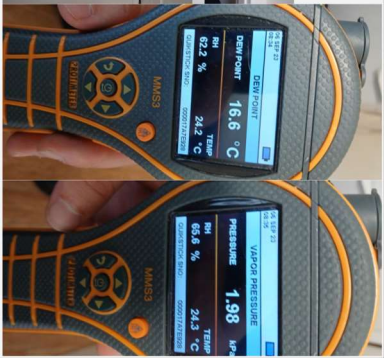
| Notes: | <div><div><div>W1 - Brick and block wall with a plaster finish, PWHB</div><div>W2 - Bath with ceramic tile surround, extraction fan humidity type, UPVC window internal beaded, Trickle vents closed at the time of the inspection.</div><div>W3 - Ceramic tiles over bath with electric shower Over, remaining wall has plaster finish over a brick and block construction, riser to the corner where it meets W3</div><div>Wall 4 - WC with timber door and surround presenting access to the hallway, skirting is an ornate torus style looks like a 4 to 6 inches.</div><div>Ceramic tiles over bath where seen to have blown in sections of the wall.</div><div>Ceiling areas and wall to higher levels above the bath and shower visible mould was seen in sections</div></div><div></div></div> |

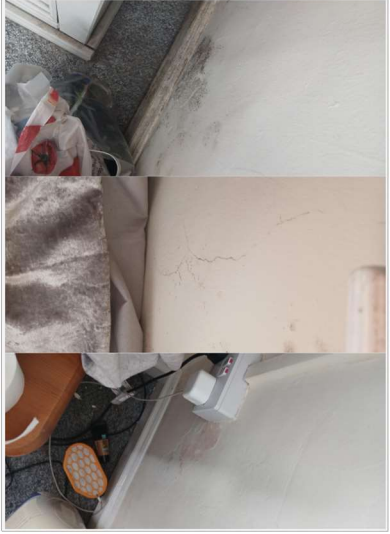
| Bedroom 1 | |
|---|---|
| <b>Notes:</b> | <p>Wall 1 - Brick or Block construction with dado rail Taurus skirting 6 inches, picture rail over and frieze over.</p> <p>Electrics seen was surface mounted, mould seen in the bottom right hand corner where it meets W2.</p> <p>Wall 2 - Formed the same as W1 with UPVC window to the front elevation central flag opening and two casements casement openings, some signs of mould to surfaces, residue only.</p> <p>Wall 3 - Same as W1 and W2, electrics surface mounted and air vent. At the time of the inspection the extraction vent was sealed with tape, residual mould seen in this location</p> <p>Ceiling where it meets W3 &amp; W4 some historic mould seen where the tenant has clean the surface.</p> <p>Wall 4 - same as the rest, radiator, timber and surround presenting access to the room.</p> <p>ceiling texture coatings</p> <p>floor carpeted</p> |

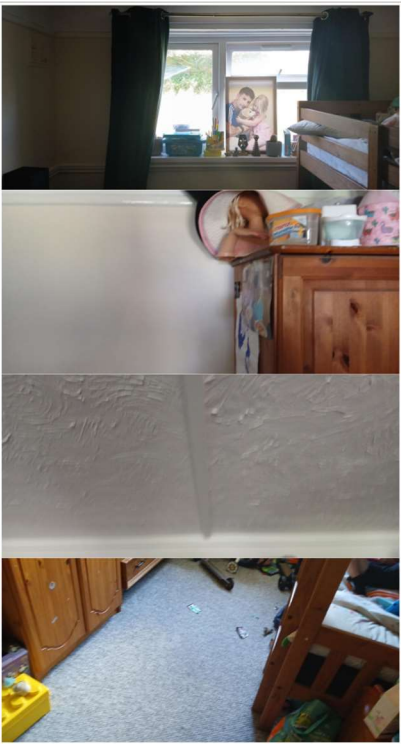
| Bedroom 2 | |
|---|---|
| <b>Notes:</b> | <p>W1 - party wall between bedroom 1 and bedroom 2 is brick and block timber skirt, dado and picture rail to match other rooms.</p> <p>Bedroom 1 wall 2 is the same structure as wall 2 in bedroom 2. I which houses a vent to the far right corner, just below the picture rail.</p> <p>W3 - radiator change in skirting to bull nose from Taurus U PVC window overlooking the rear elevation.</p> <p>W4 - Brick or Block construction with timber door and surround presenting access from the hallway</p> <div data-bbox="962 311 1364 1052"></div> |

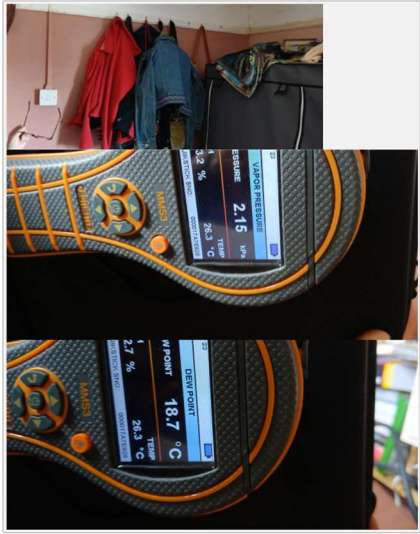
| <b>Bedroom 3</b> | <p><b>Notes:</b></p> <p>W1 - Block timber skirt, dado and picture rail to match other rooms.</p> <p>W2 - Same wall type as Bed 2. Picture rail and skirting in good condition.</p> <p>W3 - radiator change in skirting to bull nose from Taurus U PVC window overlooking the rear elevation.</p> <p>W4 - Brick or Block construction with timber door and surround presenting access from the hallway</p> | |
