University of Wales Trinity Saint David  
School of Engineering

Undertaking a Green Belt Project

ACMA 5005

| <b>Project Name</b> | <i>DBX rear quarter glass damage and defects</i> | <b>Business / Location</b> | St Athan |

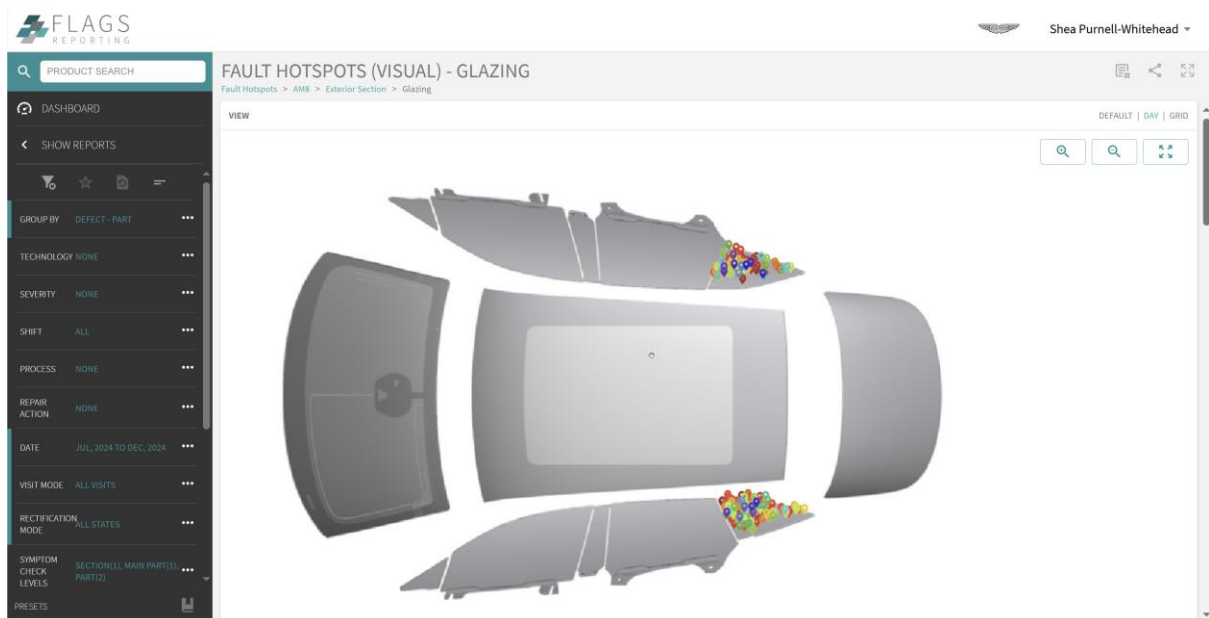
Figure 2-Flags reporting software showing defects showing Quarter glass defects (Purnell-Whitehead, 2025).

Figure 2 shows Aston Martins internal reporting software. Here damage is reported giving an accurate description and location of defects. Figure 3 shows eighty-six instances in a six-month period. The defect leads to a loss in time due to rework. (Moore, 2011) Says that it's a common misconception in manufacturing that time can be "made up" but when time is lost, its lost forever.

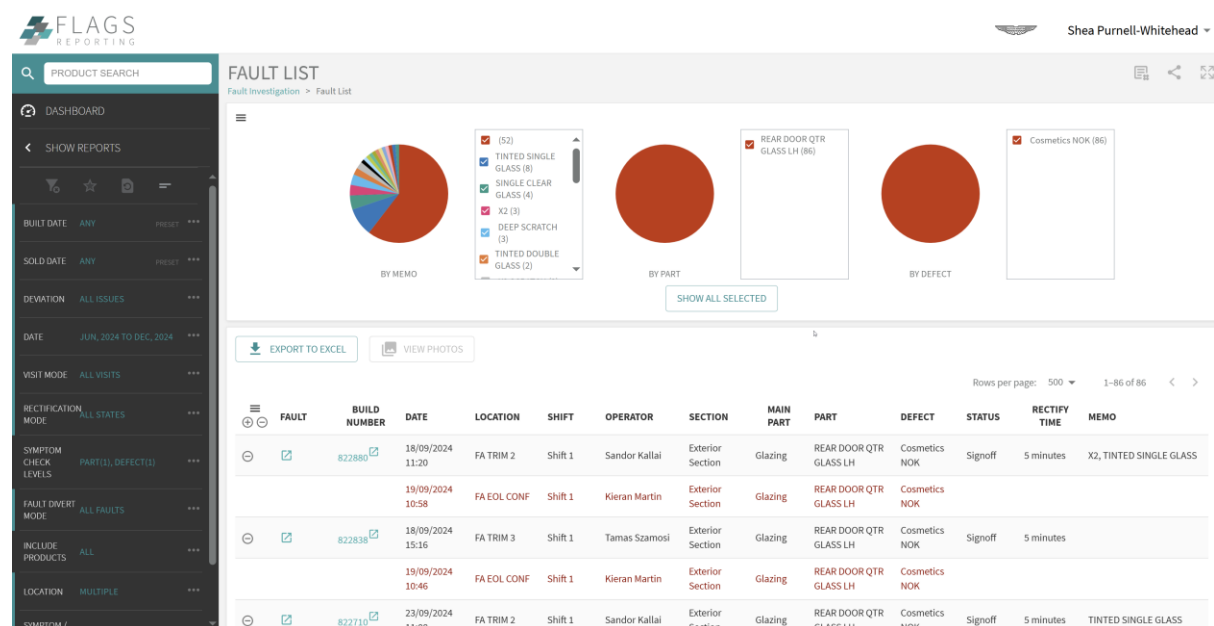
Figure 12: Flags inspection reporting software (Purnell-Whitehead, 2025)

Figure 12 shows that in the six-month period between July 2024 and December 2024 a total of eighty-six defects have been reported across the three-inspection station throughout trim and final. The reporting software also gives the inspector to label the exact location and type of defect that is being reported (Figure 13). The damage reported is in the same proximity of the glass. Repeated damage in the same proximity could be a sign of a process issue.

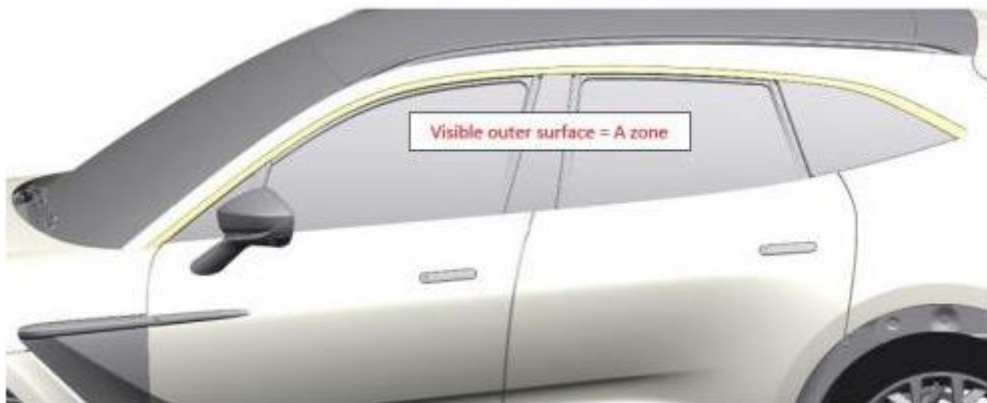
Figure 19:DBX cant rail (Aston Martin, 2025)

**Root Cause Identified:** Lack of Standard Operating Procedure (SOP) for protecting sensitive components like glass during installation.

After applying the 5 why method, it was found on the installation of the cant rail highlighted in yellow in figure 19, the metal component was damaging the glass. Whilst observing the process it was not that this is a one-man operation, and that no protection is applied neither cant rail nor glass leaving both parts exposed to damage.

- Install soft, impact-absorbing materials such as foam pads or leather covers created from offcuts of leather from the trim shop on cant rails and body protection surrounding installation areas. This will prevent direct contact between the glass and sharp edges during installation.
- Application of glass protection after the inspection and confirmation of acceptable condition (figure 25)

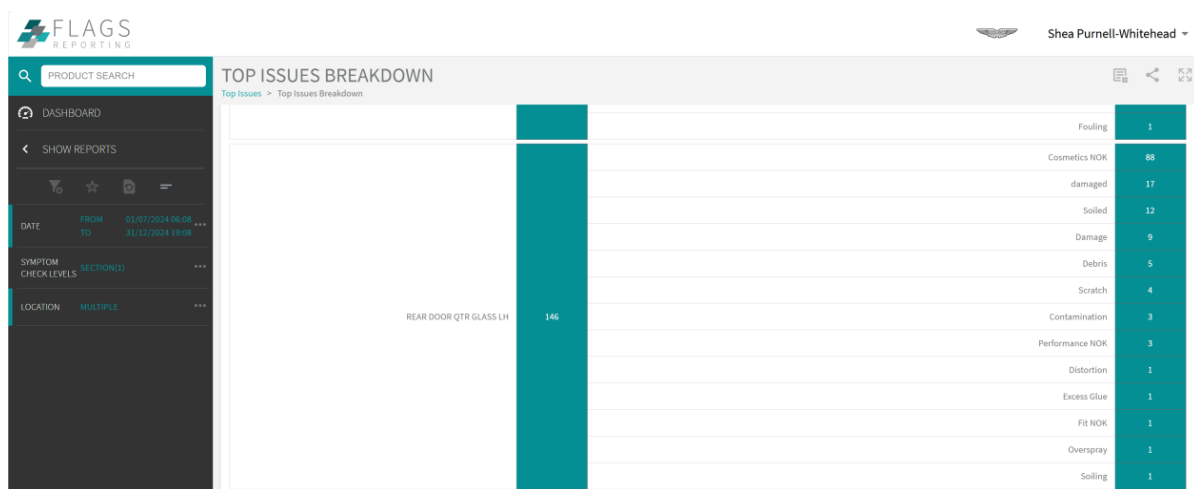
Figure 20:Flags top issue breakdown of defects (Purnell-Whitehead, 2025)

With the aid of the graphical data provided by the flags reporting software a breakdown in defects being called are highlighted. Figure 20 shows the varying defects. Using the graphical analysis, it can be said that there is more than one root cause and not solely a damage. Defects such as bubbles in glass would indicate be a parts supply issue.

A breakdown of defects are as follows:

Scratches are the major problem, so your improvement efforts should focus there first. Pareto to causes can also apply, not just types of damage:

- Poor handling – 45%
- Inadequate storage – 30%
- Supplier defects – 15%
- Installation errors – 10%

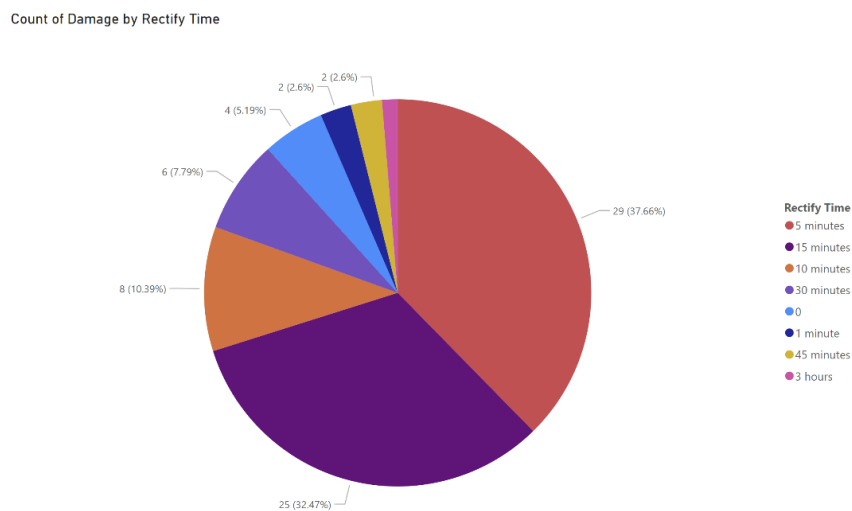
Figure 21:Flags rectification time data (Purnell-Whitehead, 2025)

After the defect is entered into Flags, it is then the responsibility of the rework team who are the customer of the production team, to determine the rectification required. Some minor scratches and imperfections can be repaired with minor polishing which can be carried out in the rework stations online, these vehicles would then not fail the RFT target set. Others that damaged cannot be reworked would require glass replacement. This is an intrusive repair that can lead to secondary defect/damage. After the correct method of repair is carried out the technician clears the flags data and enters the time taken. This is shown in (figure 21).

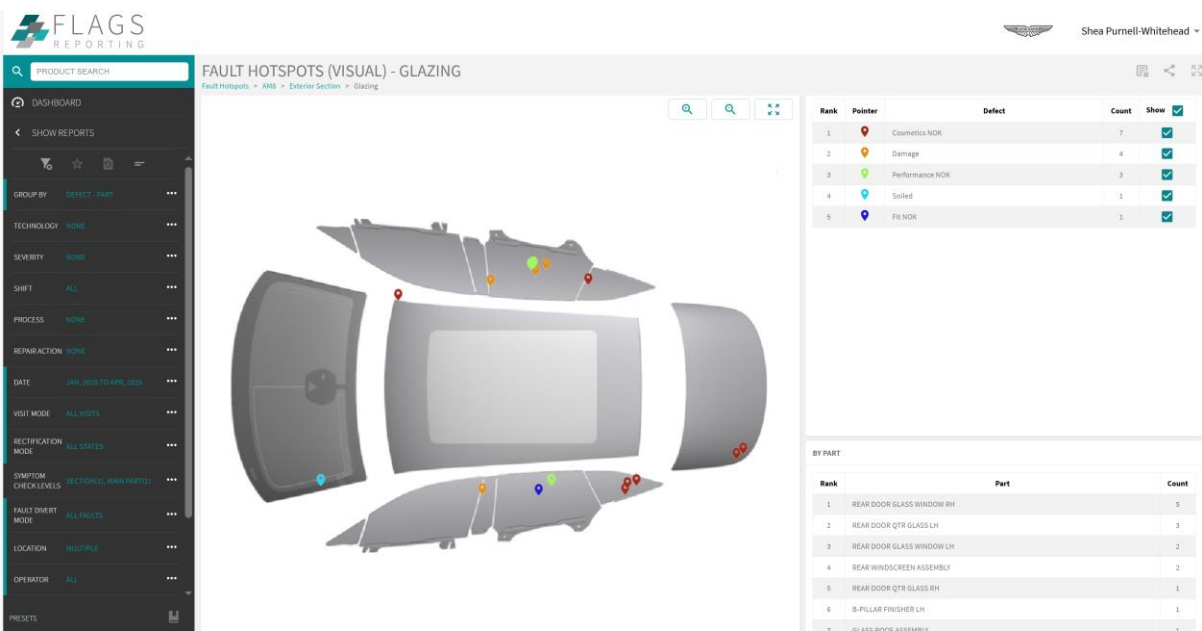
Figure 28:Flags data after improvements (Purnell-Whitehead, 2025).

Before implementing a change, a thirty-car line trial was carried out and monitored before the permanent release. With the addition of the glass protection and covers fitted to the cant rail where the damaged was identified. From January to April 2025 a significant reduction can be seen. In the four-month period a total of four defects were found. Data from the improved period (figure 28) was collected and compared with baseline damage rates. Statistical analysis confirmed that the improvements led to a statistically significant reduction in rear quarter glass damage with a total of four defects found.
