# BUILDING SURVEY REPORT

[13th January 2023]

Woodland Avenue

Building Surveying

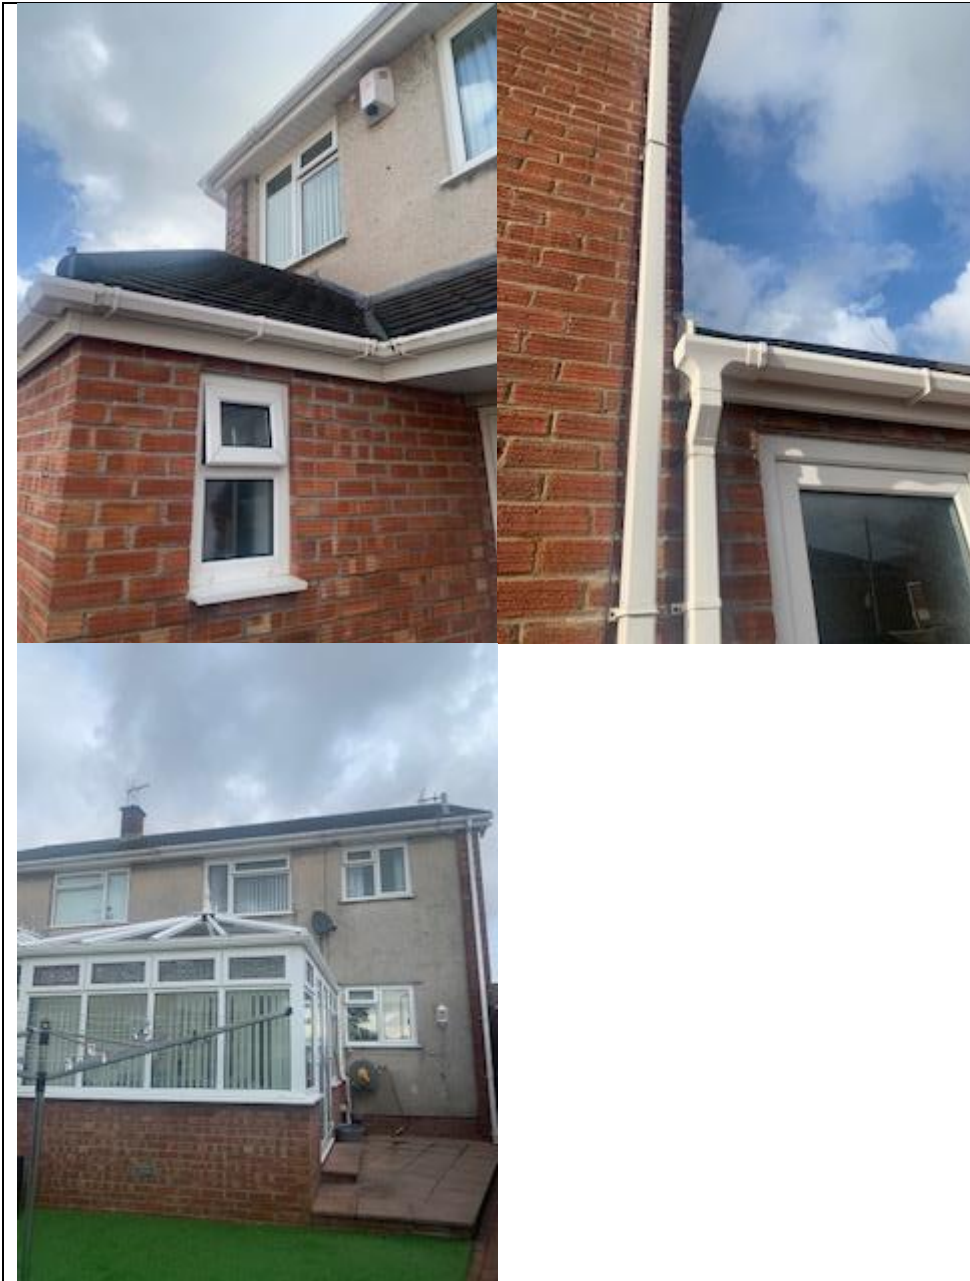
All pipes are of uPVC plastic construction in traditional white colour. Gutters appears to be clear of debris and flowing freely. Assumptions must be made due to unable to access height of this. All pipes and gutter work are in generally good condition.

Be advised that downpipes and gutters require high maintenance and periodic inspections to ensure no damage to the property itself. Inadequate maintenance of these can result in property having damp and timber decays.

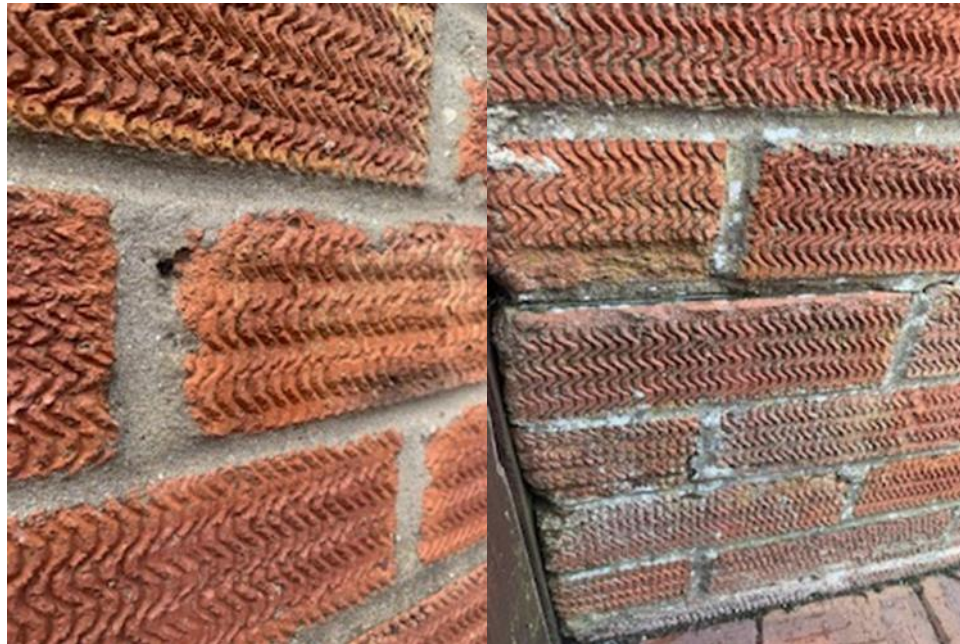
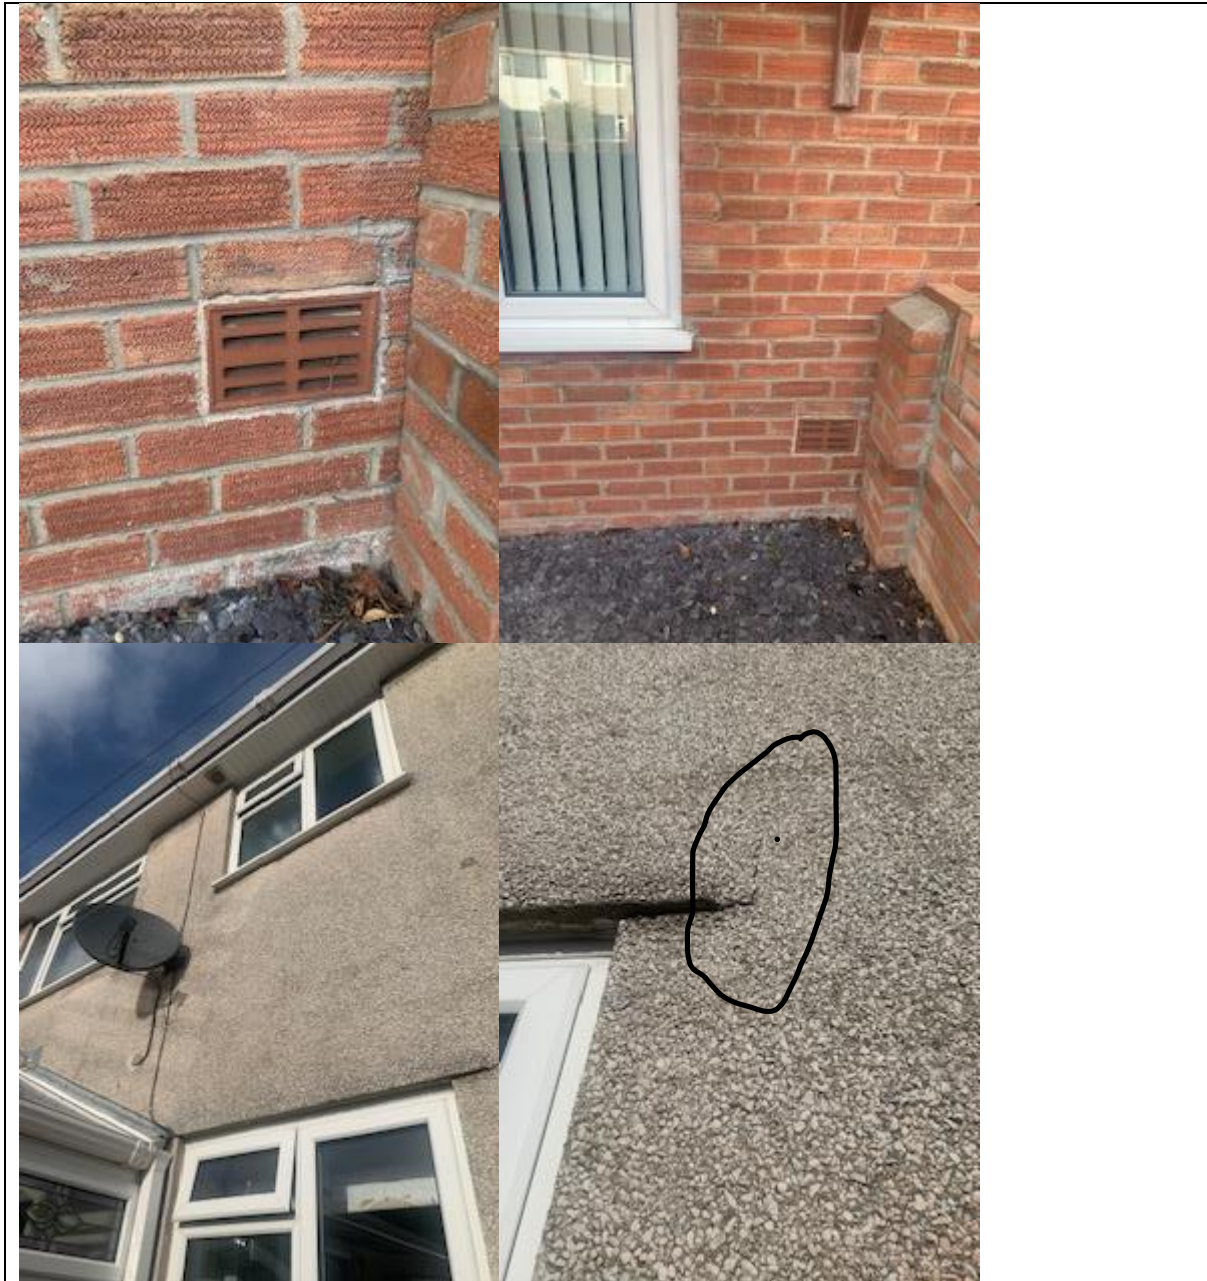
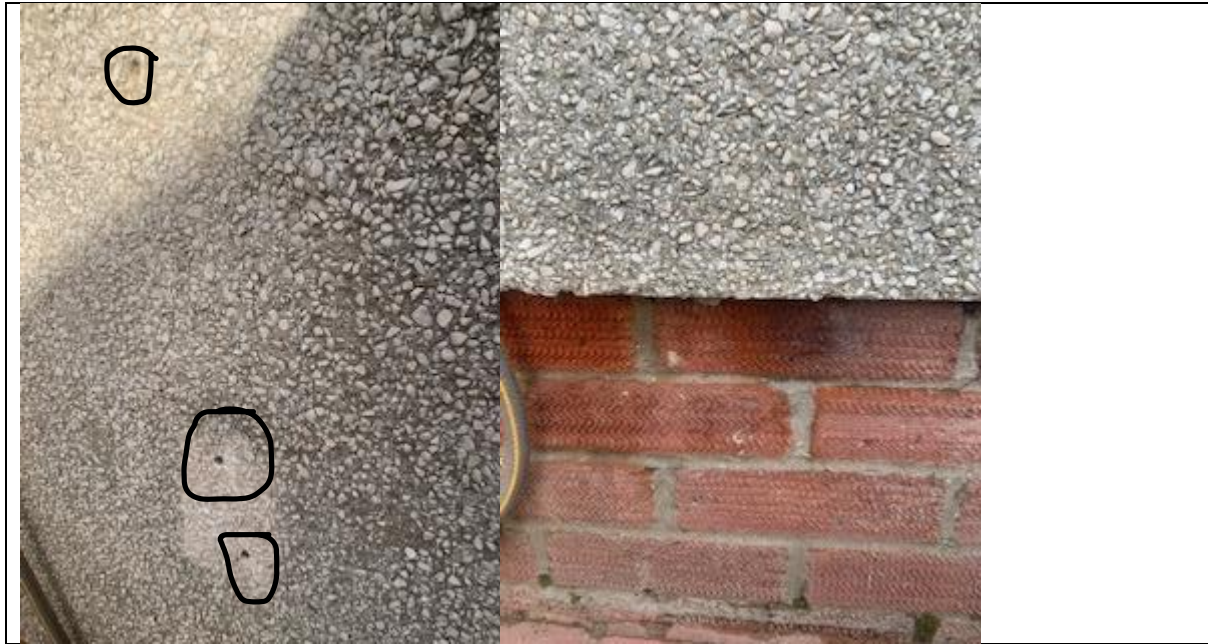
A block cavity wall with and red brick-built external structure on front and side elevations, the rear consists of a limestone chipping pebble dash render.

The side elevation has Damp proof course that can be seen on the property although in areas cement seems to have minor holes in nearby mortar therefore further investigation advised.

The external walls contain built in vents to the front of the house, these are empty and clear of any obstruction to prevent air flow.

The side elevation holds the extractor fan vent, this is clear and free of debris. The rear render seems to have a crack on the opening of the kitchen external window render, further investigation required, this may allow adverse rain to enter and cause damage to the internal walls in the kitchen.

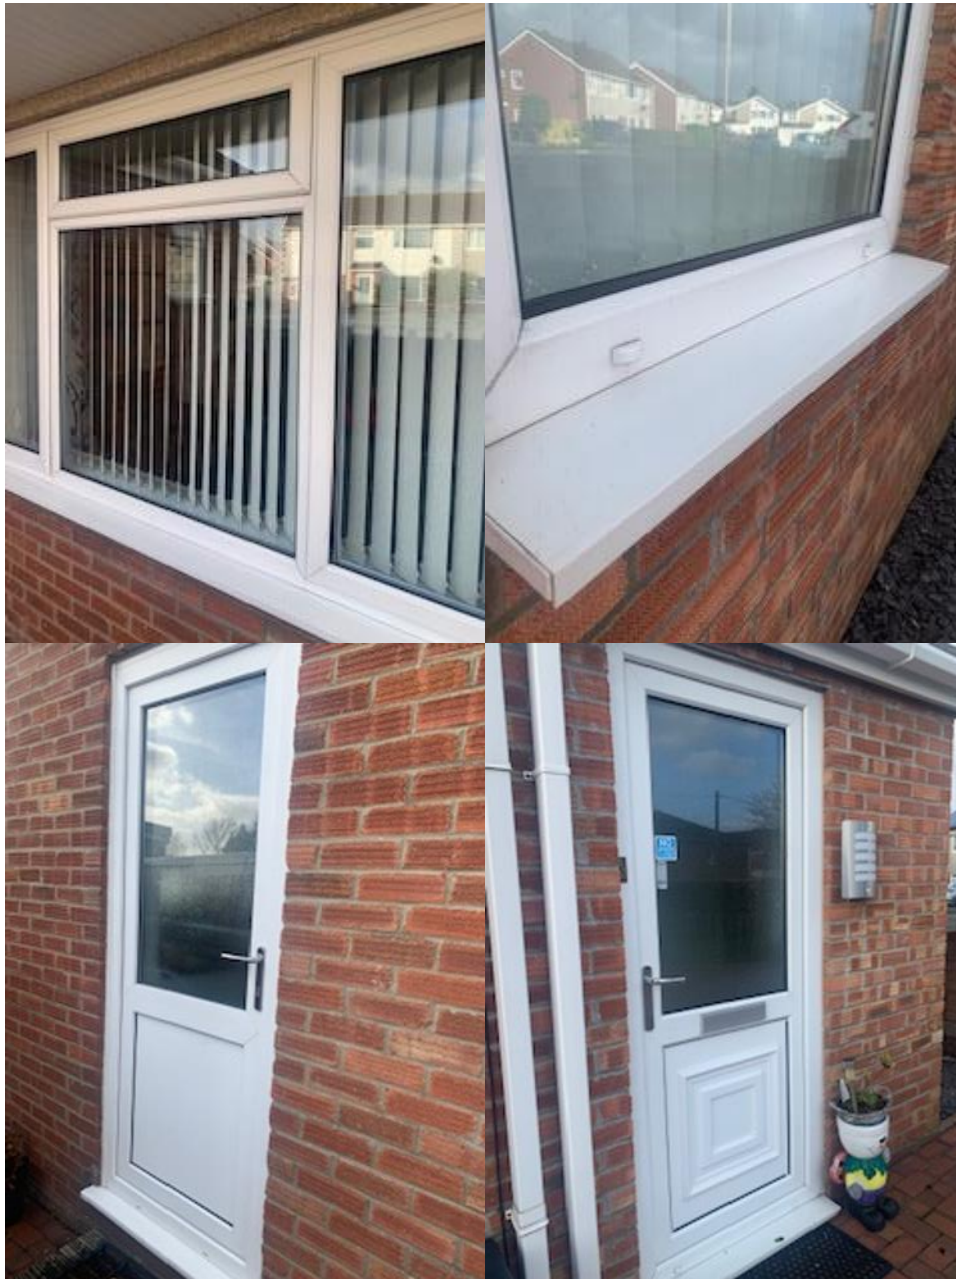
Double glazed windows with plastic sills and both external side doors are of uPVC construction and have been present since 2004 when the conservatory was constructed, all windows in the entire house were replaced.

All windows and doors and seals are in good condition, no issues present currently. The windows and doors were opened and closed as part of the inspection, no issues with movement were noted.

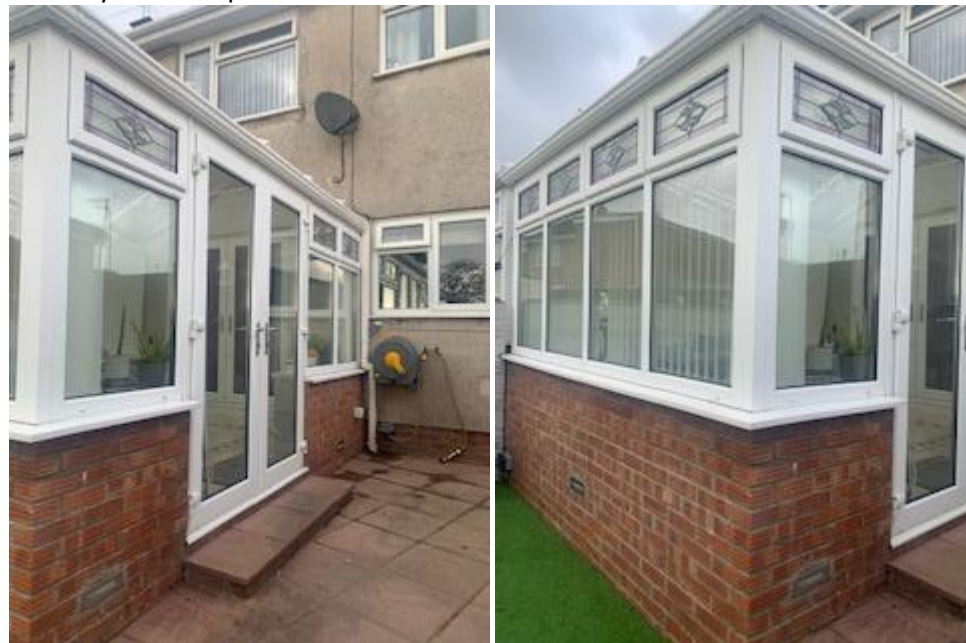
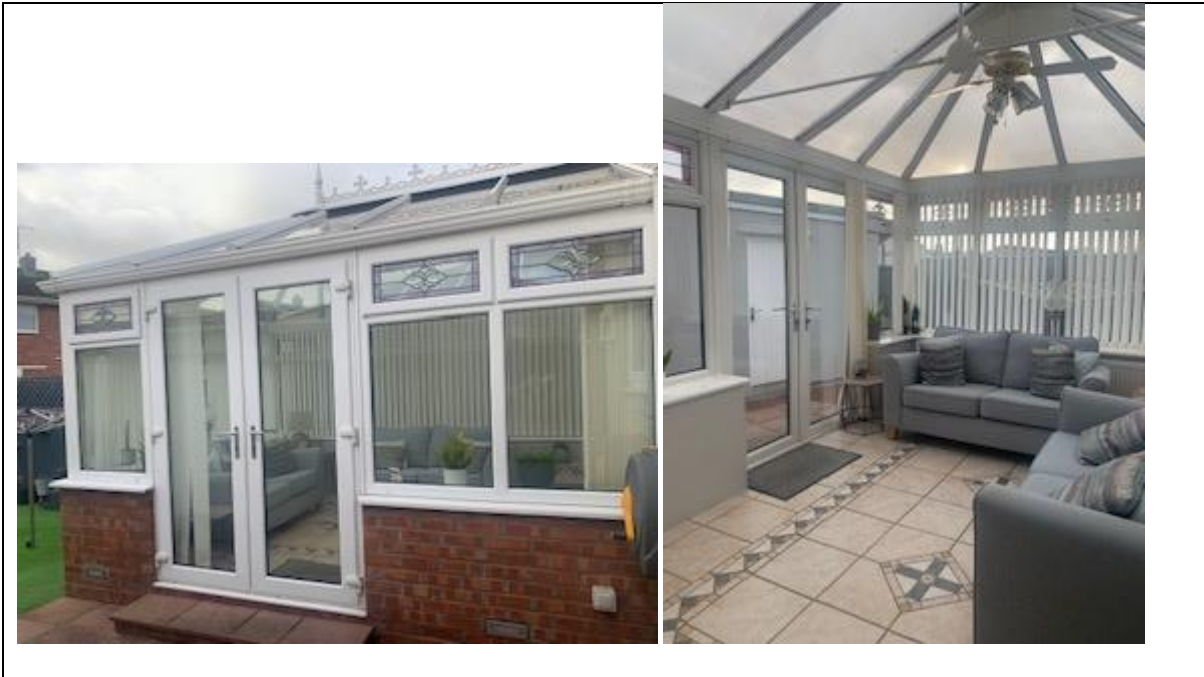
The construction of a conservatory to the rear of the property built in 2004 with red faced brick base formed with 12 double glazed spilt glass panels forming the sides of the conservatory and double-glazed roof formed of 14 glass panels using 2 x patio doors. Internally the conservatory walls are 2.13ft high layered with skimmed plaster and finished with emulsion paint, the conservatory benefits from underfloor heating and 1 large wall hung radiator, underfloor heating was provided to help combat the cold winter temperature and this can help with continued used throughout the whole year. No issues to be found with the conservatory internally and externally. Gutters may need to be cleared, blocked gutters can cause water ingress and large damages internally if not correctly dealt with.

The porch to the front of the house opens up into a hallway leading to an additional side door and downstairs W/C. The porch is completed with skimmed plaster walls painted in a white emulsion and fully fitted carpet.

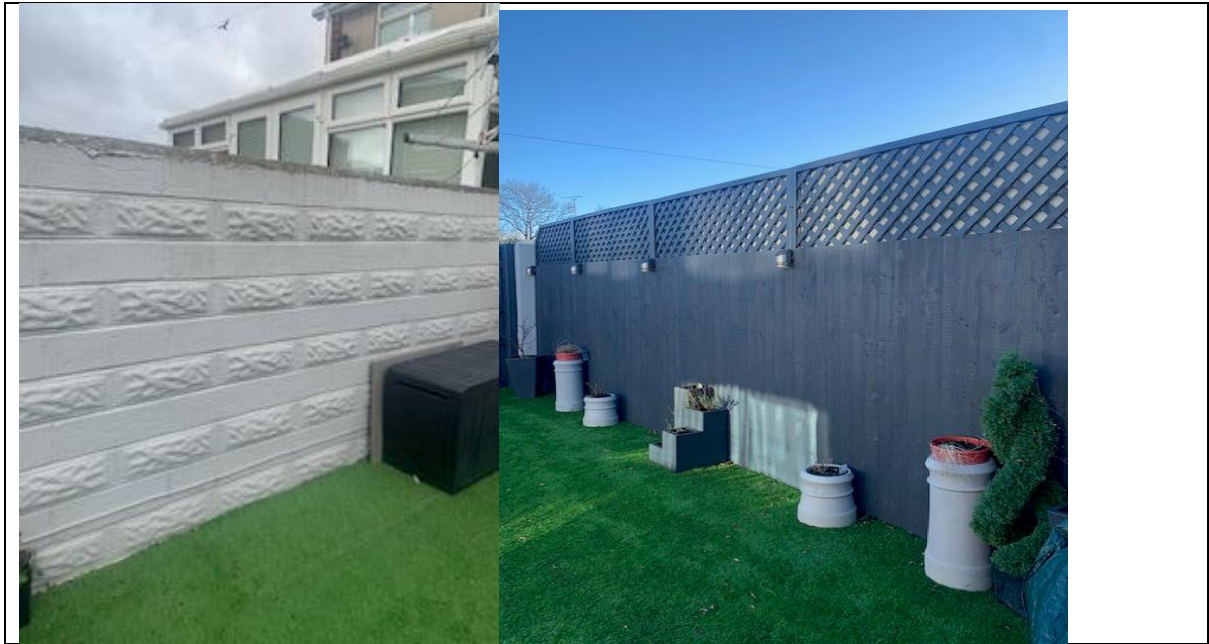
Front garden wall is a stretcher bond wall using red brick. The walls are capped with a 330mm end brick pier. One part of the wall is in front of the artificial grass and the other is in front of slate chippings.

Rear party walls partition both an adjacent property and a rear property. These partition walls are constructed of concrete blocks coating in grey weather resistant paint. The rear party wall contains fence panels which are for decoration purposes only.

All walls are in satisfactory condition, regular wood treatment is advised to protect the rear fences from the weather.

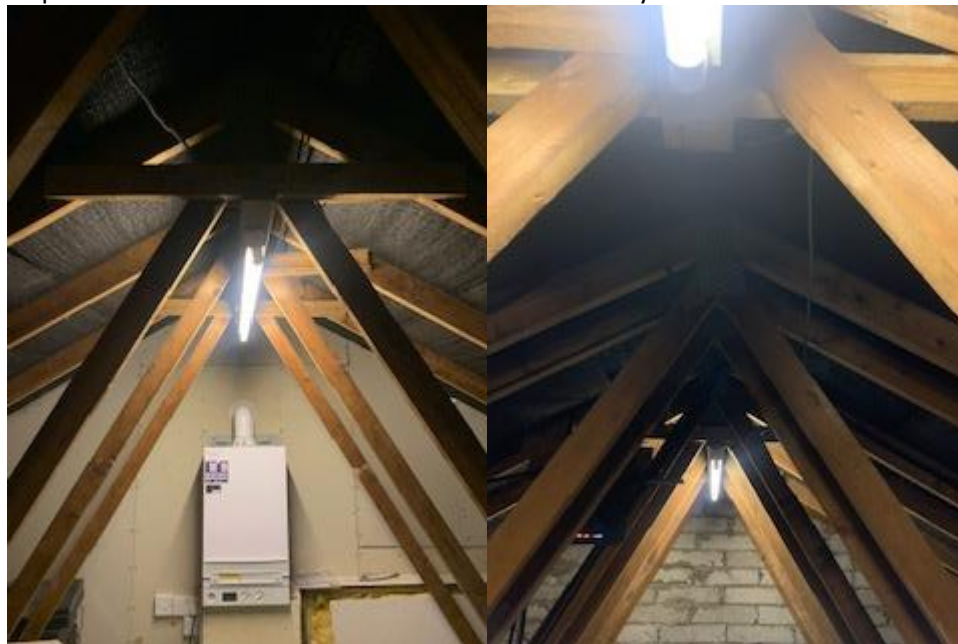
Roof structure consists of a fan type wooden truss with gusset plates. A breathable felt membrane was fitted to aid ventilation accompanied by a ventilation provision.

The attic space is a large span space fitted with carpet and 150mm mineral wool insulation.

The attic currently stores the boiler and has space for additional storage.

Inspection shows the roof structure is in a satisfactory condition.

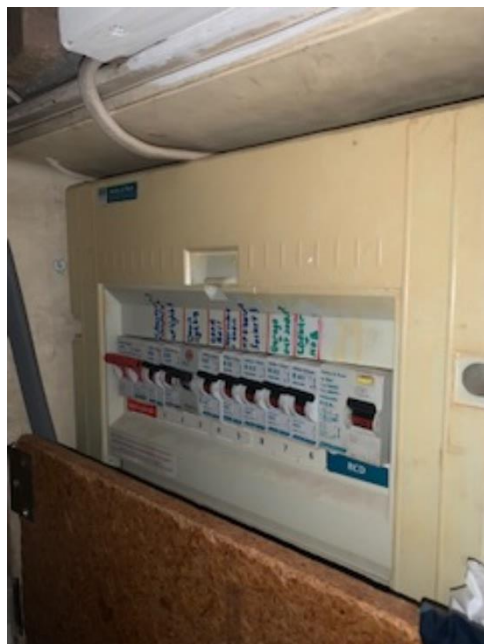
The Electricity meter is situated internally under the kitchen cupboard. The electricity meter can also be seen via a glass artificial brick enabling utility companies to access the meter readings without gaining access to the internal area of the house.

The modern consumer unit can be found in the kitchen under counter pantry,  
The fuse board can also be located here. Trip switch has been fitted with a newly installed RCD.

A competent and qualified person needs to certify the electric throughout the house to ensure no issues present.

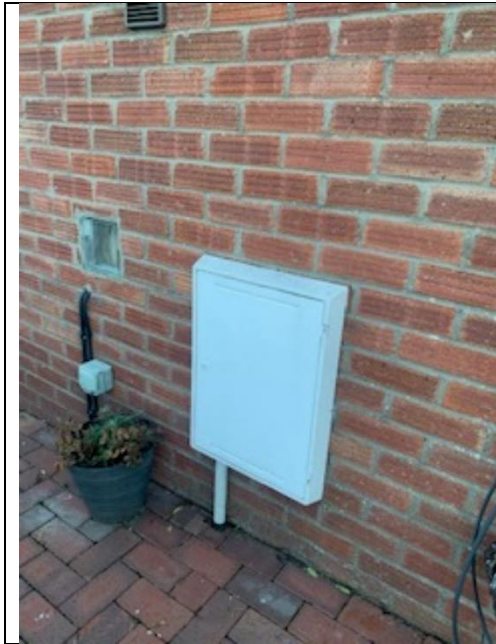
The Gas meter is situated externally to the right of the furthest side door.

A gas certificate has been carried out every 12 months with physical records to show and can be provided by the vendor.

Gas safe registered contract should investigate to ensure safety.

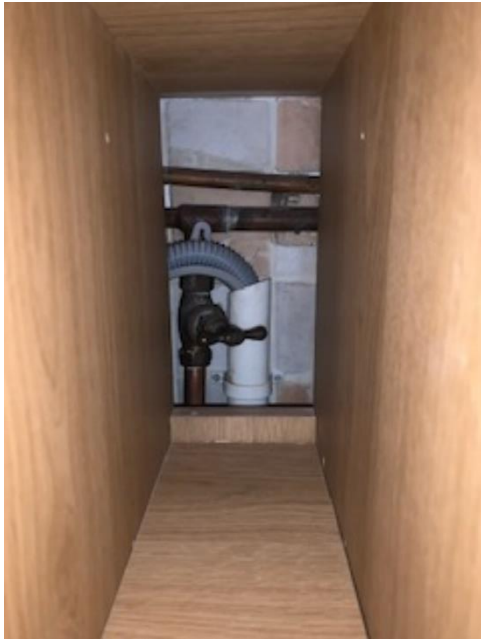
Water mains to the house are in the pavement in front of the house. House is currently on a fixed main without a meter.

No significant water leaks noted.

The water stop tap valve can be located in the kitchen cupboard next to location of washing machine.

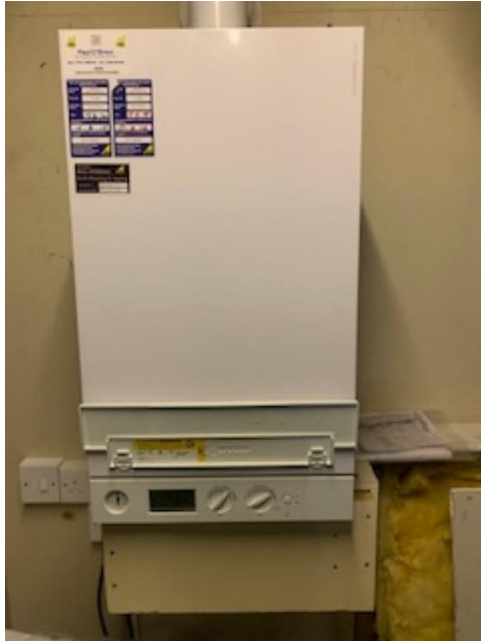
From vendor's information – the boiler which is in the attic was fitted within the last 5 years. The boiler is a combination boiler which supplies hot water to taps, Shower as well as central heating radiators in the house.

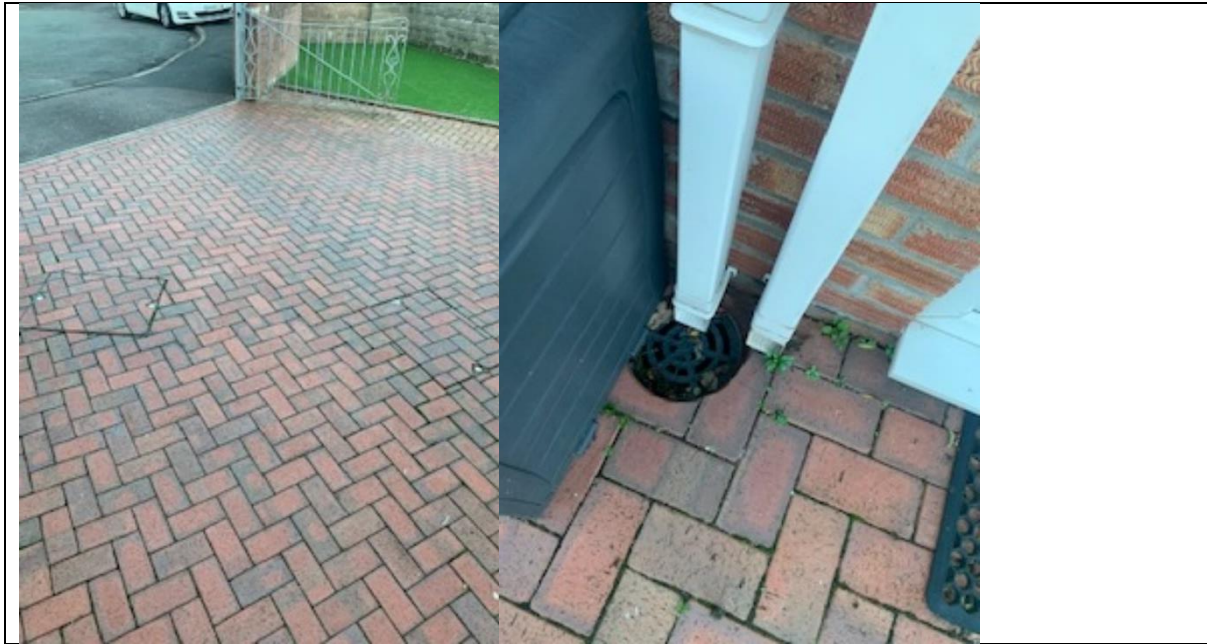
From wastewater and sewerage plans provided by vendor. Sewerage and wastewater drainage is located on the driveway in manhole covered in redbrick to help blend these in.

Manhole in good condition no issues.

It is recommended to have these drains inspected by a specialist drain contractor due to lack of inspection of the physical drains.

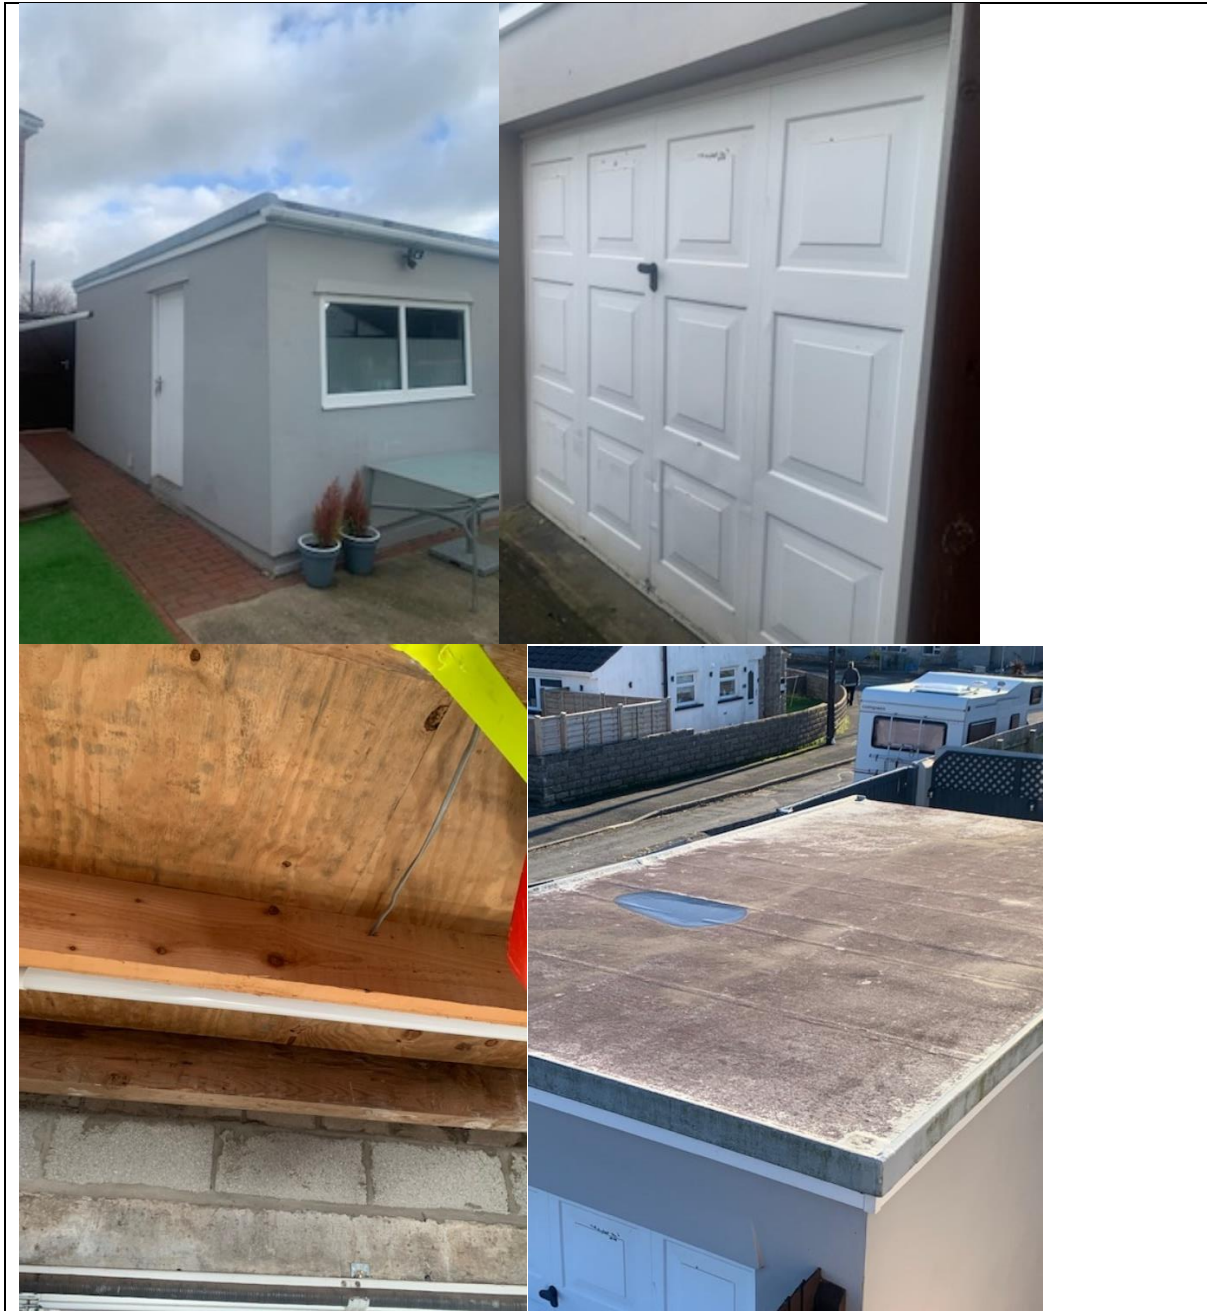
| Detached garage construction with a single skin concrete block with a fiberglass flat roof using wooden beams positioned on a raised solid concrete floor.<br><br>Garage has potential to house one car where as now, it is currently used for storage.<br><br>One metal roller shutter door and a wooden side entrance door. All doors have extensive locking systems to ensure high security.<br><br>On inspection, pooling of water seems to be present on the roof of the garage, further inspection is advised to prevent sagging of the roof which could cause collapse if pooling worsens. |

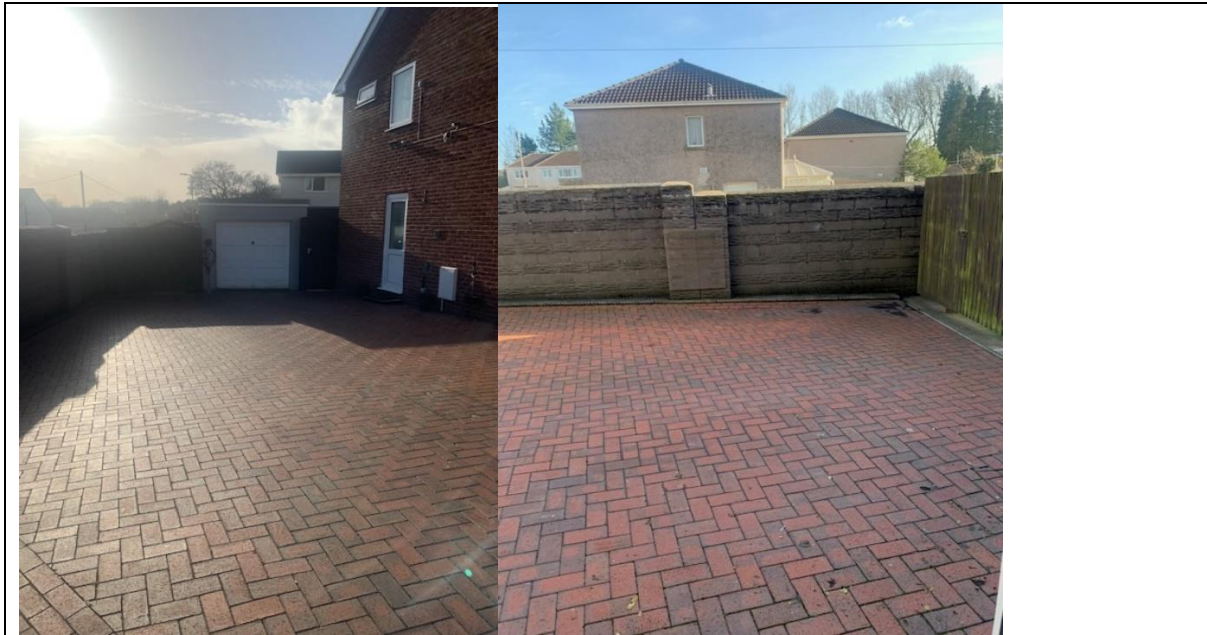
Large brick driveway, surrounded with concrete block walls.

There is a small area located off the side of the garage which is currently used as a bin refuge area.

Driveway has been built at a slope to help with rainwater drainage.

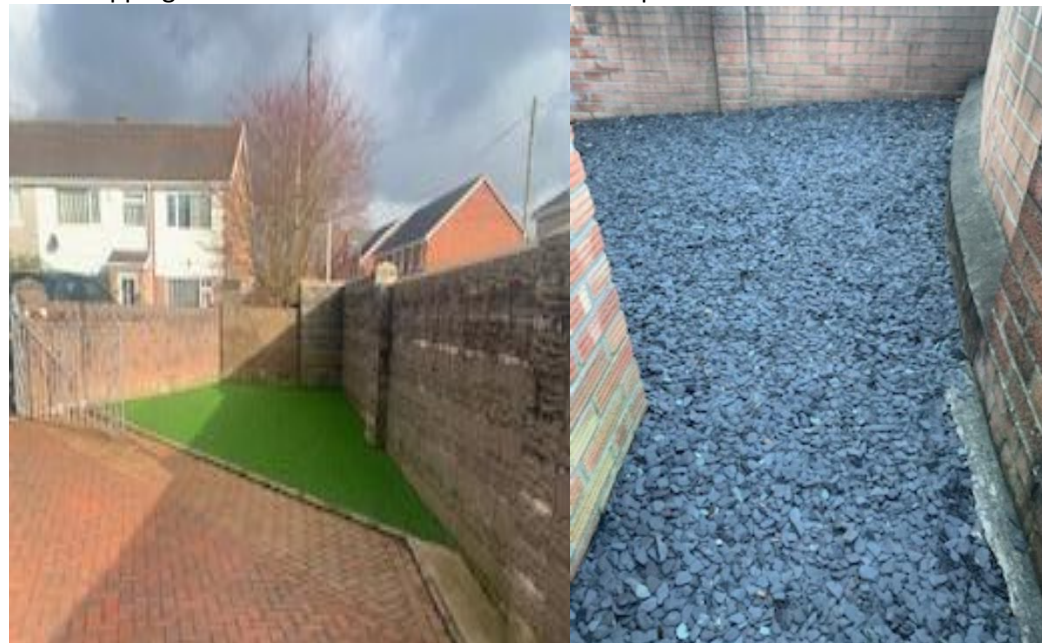
Artificial grassed area surrounded by front walls.  
Slate chipping area located in front of the house and porch.

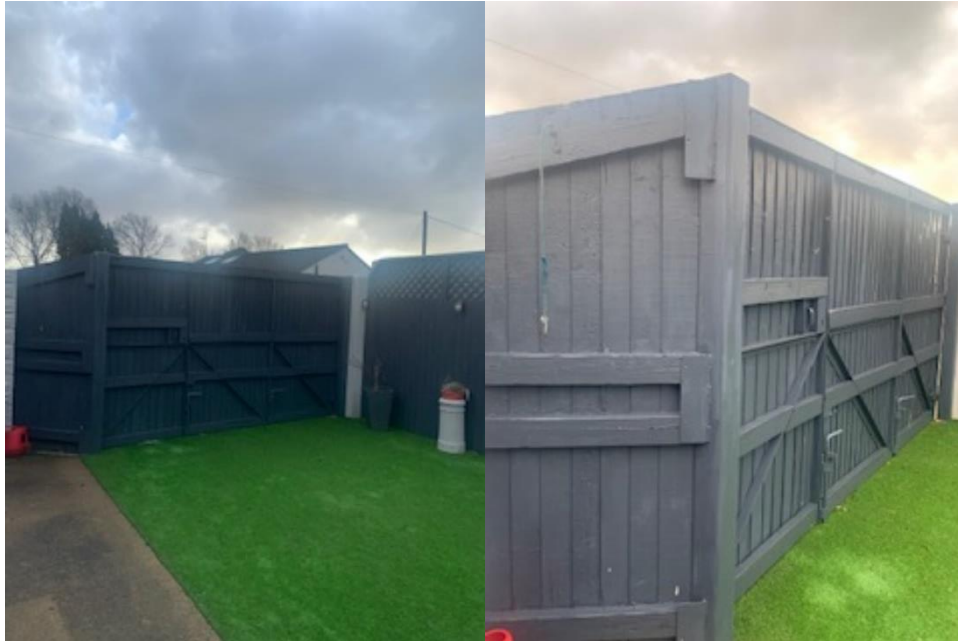
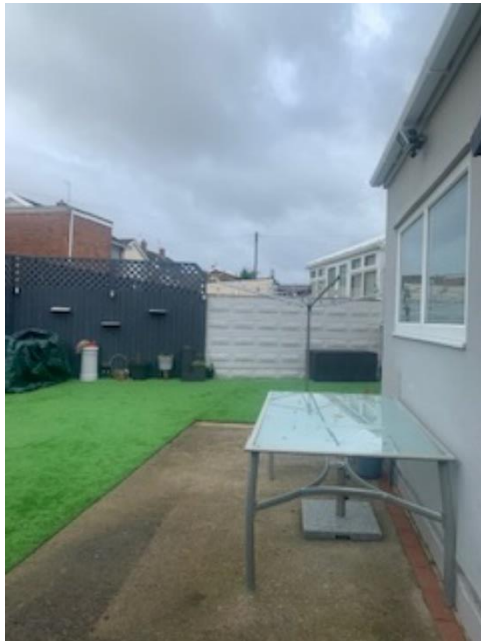
Concrete rear garden layered with artificial grass. Large wooden and metal bi folding gates painted in water resistant wood paint to prevent rotting and damage.
