**ACBA4001: Fundamentals in Construction Technology****Swansea Foreshore Ice-Cream Parlour**

**1.1 Introduction**

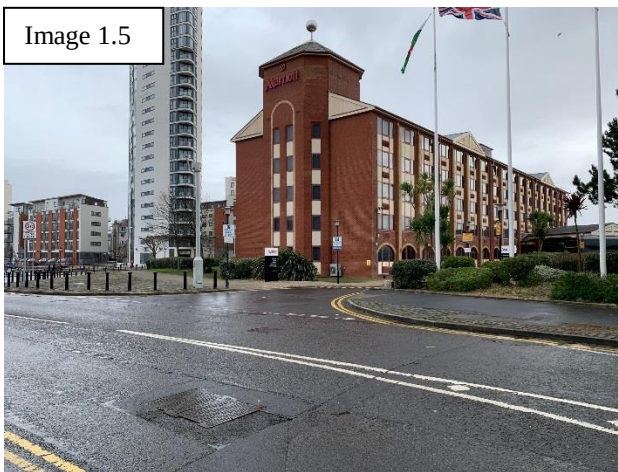
Image 1.5

Image 1.5: Access point from Dunvant Place into Marriott Hotel Carpark

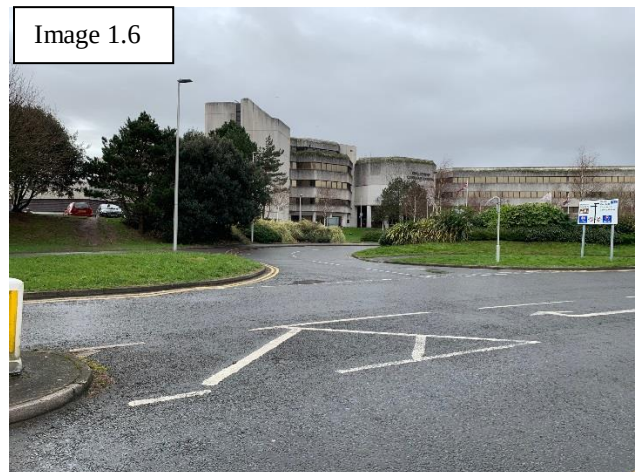
Image 1.6

Image 1.6: Access point from Dunvant Place into Swansea Civic Centre Carpark

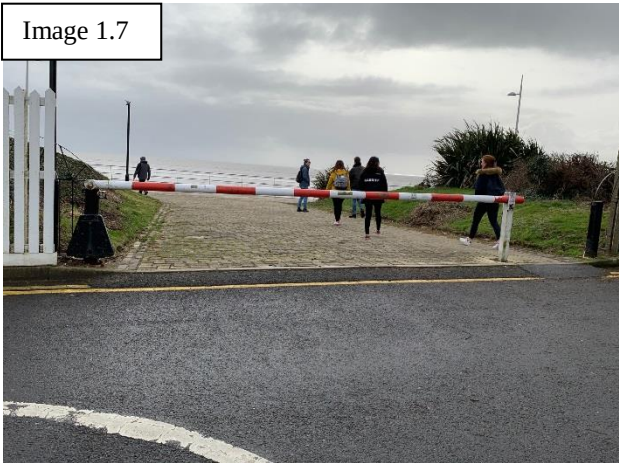
Image 1.7

Image 1.7: Vehicle access point with barrier at back of Marriot Hotel Car Park

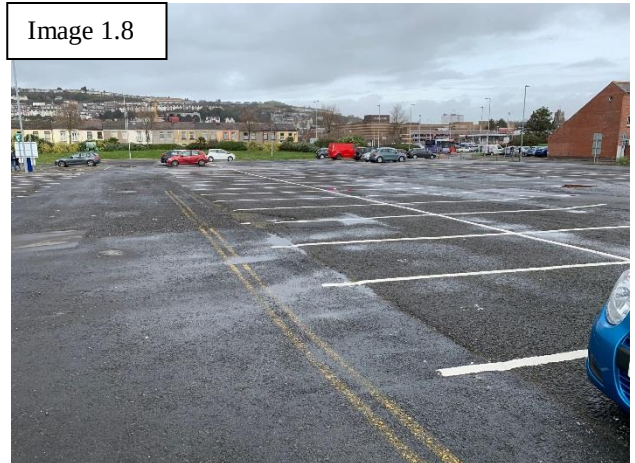
Image 1.8

Image 1.5: Large car park just to north of site

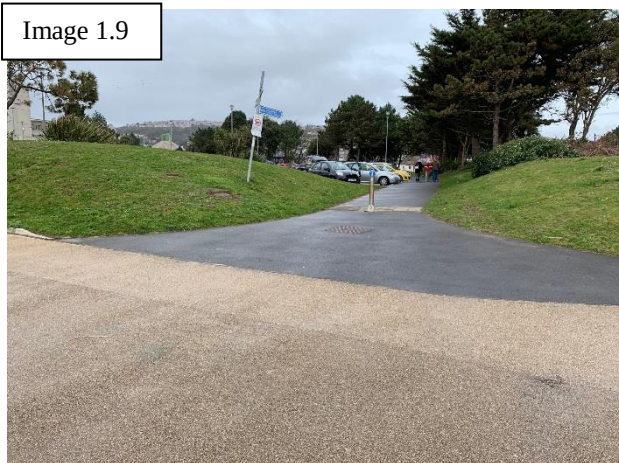
Image 1.9

Image 1.9: Cycle/footway between both car parks

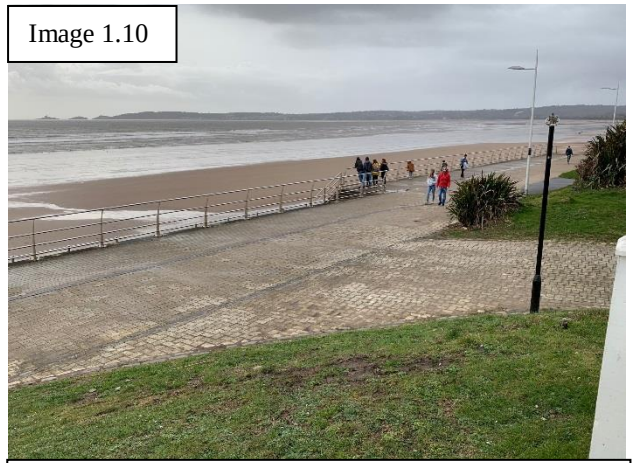
Image 1.10

Image 1.10: Large promenade at southern boundary of site

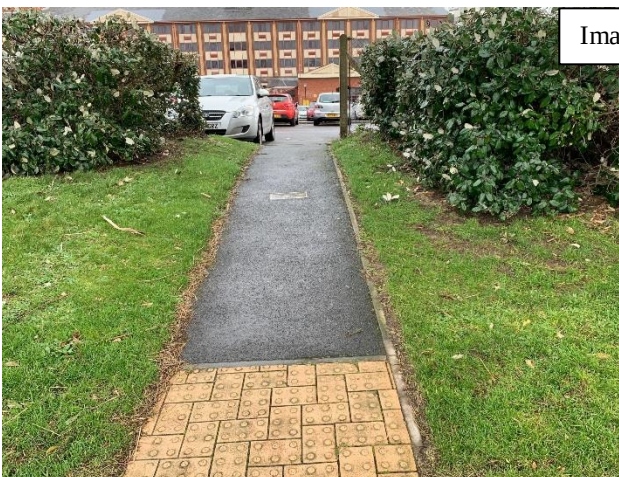
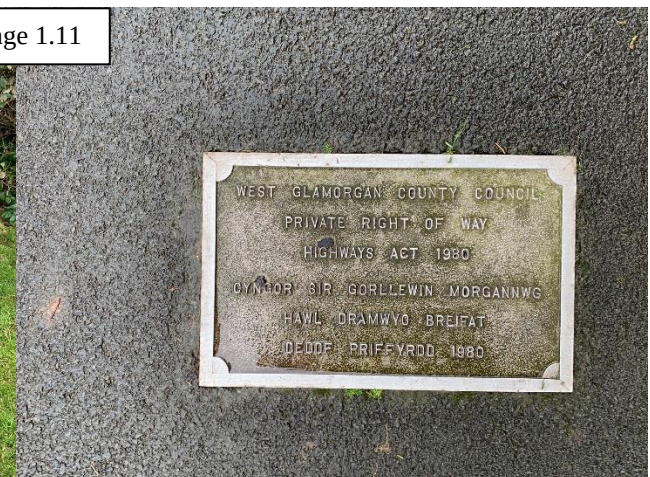
Image 1.11

- Pathway between cycle path and Marriott car park with a plaque put in by West Glamorgan County Council as a 'Private Right of Way' under the Highways Act of 1980. (Image 1.11)

Image 1.11: Private Right of Way footpath implemented by West Glamorgan County Council under the Private right of way Act 1980

There is also public access through a cycle/footpath of which contains a private right of way. If this access point is to be altered we would need to apply for permission through Swansea Council. This right of way can either be diverted if in the best interest of the public or extinguished completely which is a rare and difficult process, the right of way may also be subject to temporary closure and can last up to six months under council authority and may be extended subject to approval by the Welsh Government (Swansea.gov.uk, 2019). Private rights of way can also be removed under the Town and Country Planning Act 1990 which states "A competent authority may by order authorize the stopping up or diversion of any footpath if they are satisfied it is necessary to do so in order to enable development" (Legislation.gov.uk, 1990). Once the specific area for development within the site is chosen it may be best to temporarily close the right of way or provide a temporary diversion as altering this right of way is a long and difficult process so should be taken into high consideration before development begins. Flora and Fauna would need to be accounted for by an outside consultant to determine if there are any species that are protected before work begins.

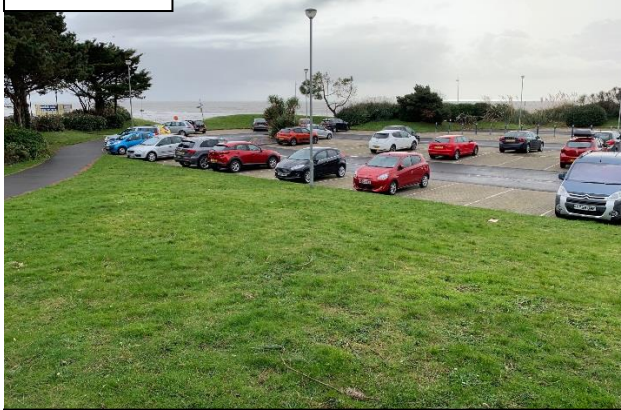
Image 1.12

Image 1.12: Verges and Civic Centre car park with lighting columns within

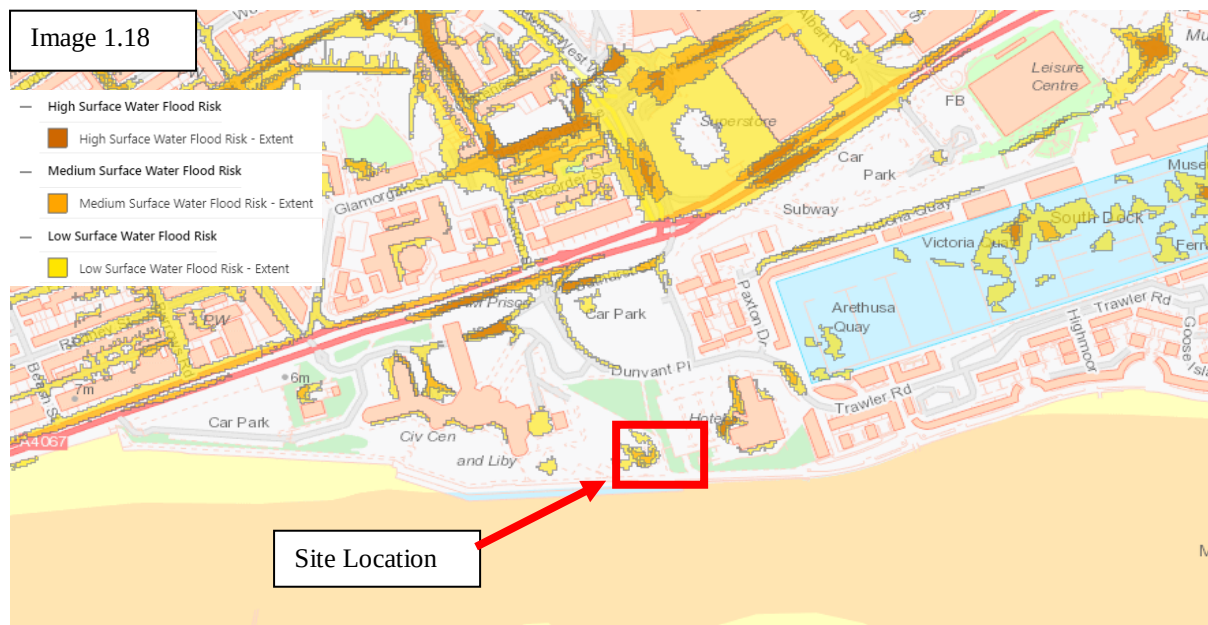
Image 1.18 – Showing risk of flooding surface water (Maps.cyfoethnaturiolcymru.gov.uk, 2019)

The search in Image 1.18 indicates surface water flooding potential implications. The map provided by NRW shows that the west of our site has a medium maximum risk for surface water flooding. This data provided means that we would need to contain and prepare for any flooding using sustainable drainage systems (SuDS) or storm drains to minimize risk of flooding from this area of our site.

After carrying out a search during the desktop study using the NRW flood risk tool it was determined that there are potential surface water flooding risks on the western area of the site as 'medium risk' (Image 1.18). A flood risk assessment will be needed to outline the main hazards and the potential impact our new development will have on the surrounding area. It may also provide details on how to reduce and redirect flooding problems appropriately.
