## SWANSEA FORESHORE ICE CREAM PARLOUR

#### 1. BRIEF

##### 2.1 SITE WALKOVER

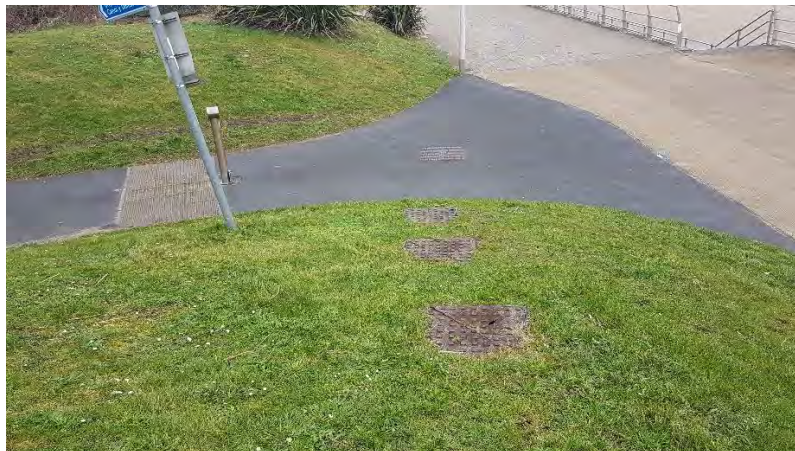
A site walkover was undertaken by Emilie Driscoll on 12 Dec 2018. The weather was overcast but dry. During the walkover, manhole covers were found along the site and some mounds. No other issues were noted. More site photographs in Appendix A.

South entrance to site. Possible drainage or sewerage system? Driscoll, E (2018)

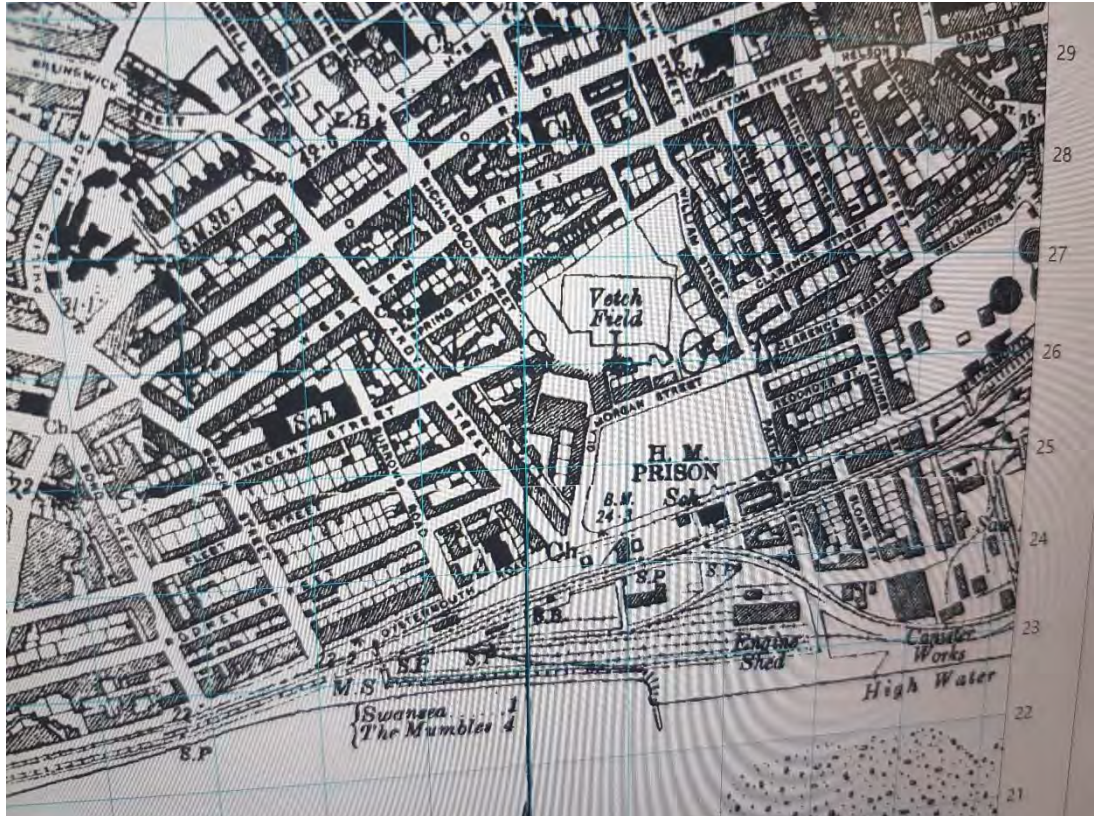
1920 Map

| Date | On Site Observations | Off site observations |
|---|---|---|
| 1920 | No significant changes | There appears to be an Engine shed and railway tracks running through the proposed site as well as Cannister works. To the north there appears to be residential buildings. |

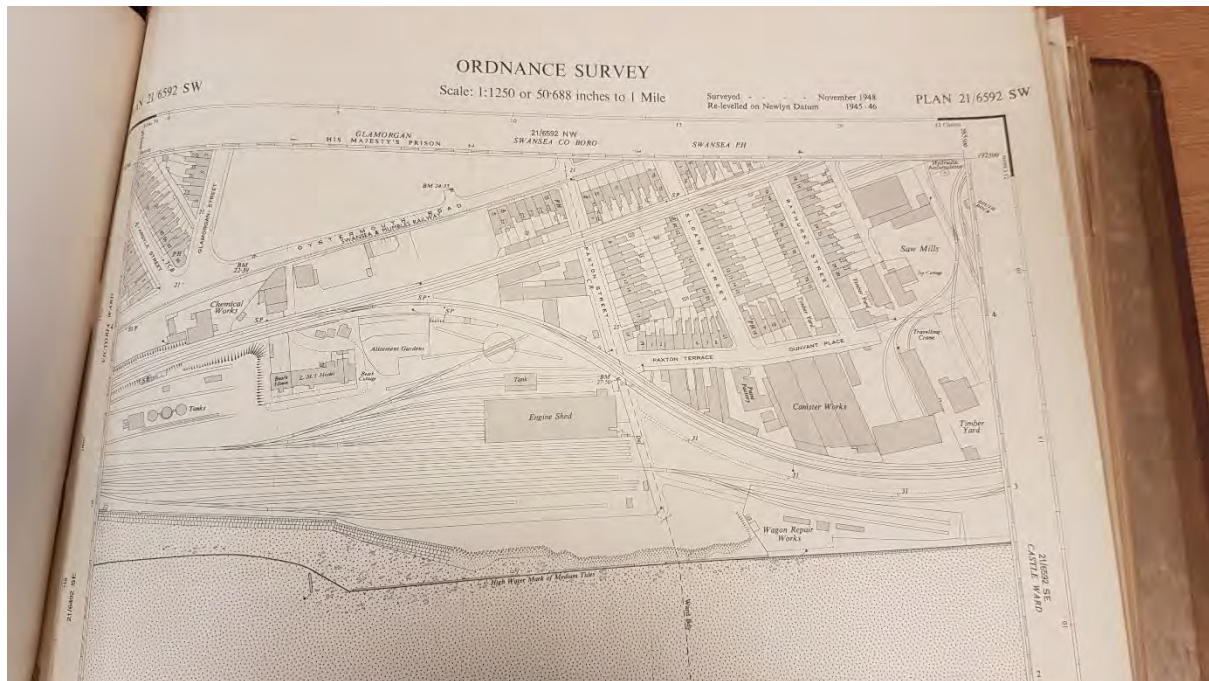
Swansea (1948)

| Date | On Site Observations | Off site observations |
|---|---|---|
| 1948 | There appears to be a paint factory located on the site as well as some warehouses | Wharehouses have been built to the east of the site |
