## **Assignment 1. Fundamentals of Construction Technology**

### **CASE STUDY: SITE INVESTIGATION**

(Preliminary desktop study and report document)

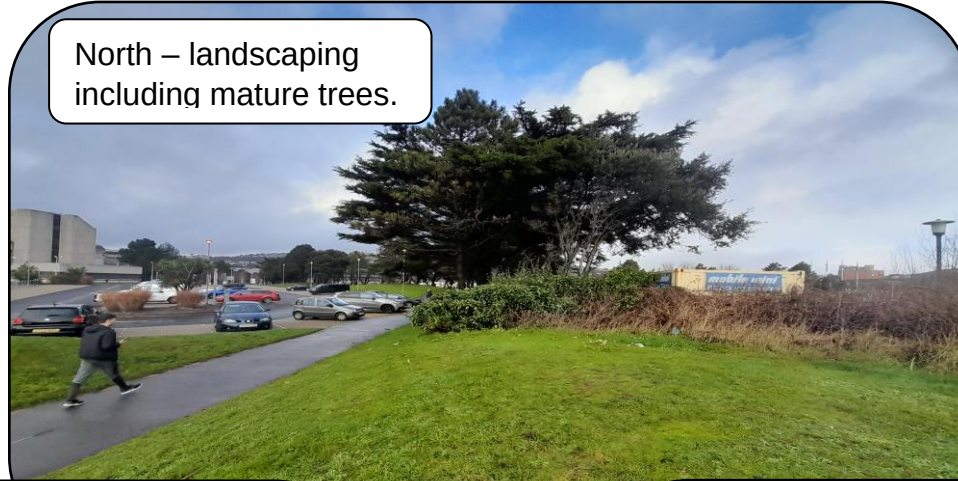
North – landscaping  
including mature trees.

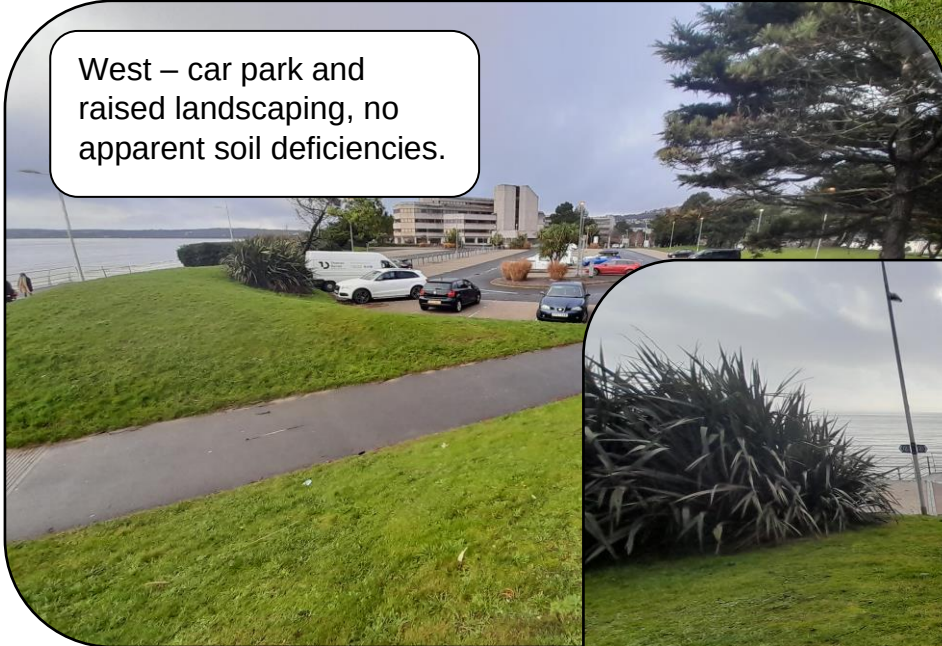
West – car park and  
raised landscaping, no  
apparent soil deficiencies.

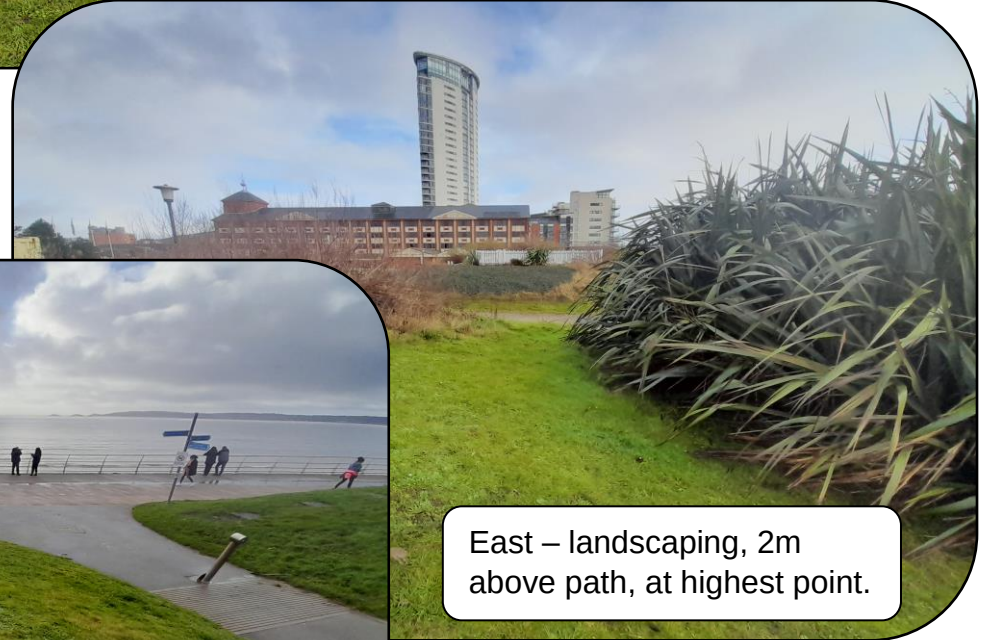
East – landscaping, 2m  
above path, at highest point.

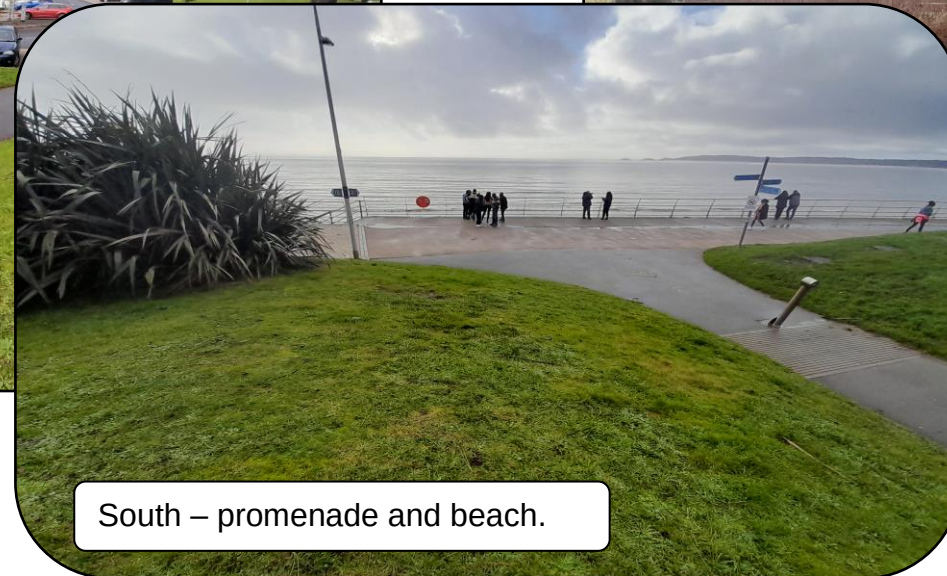
South – promenade and beach.
