### **Ground Investigations (6003-CCL-XX-XX-SU-J-001-Ground)**

## **Feasibility Study (6003-CCL-XX-XX-RP-J-001-Feasibility)**

### Foundation Calculations (6003-CCL-XX-XX-CA-S-001)

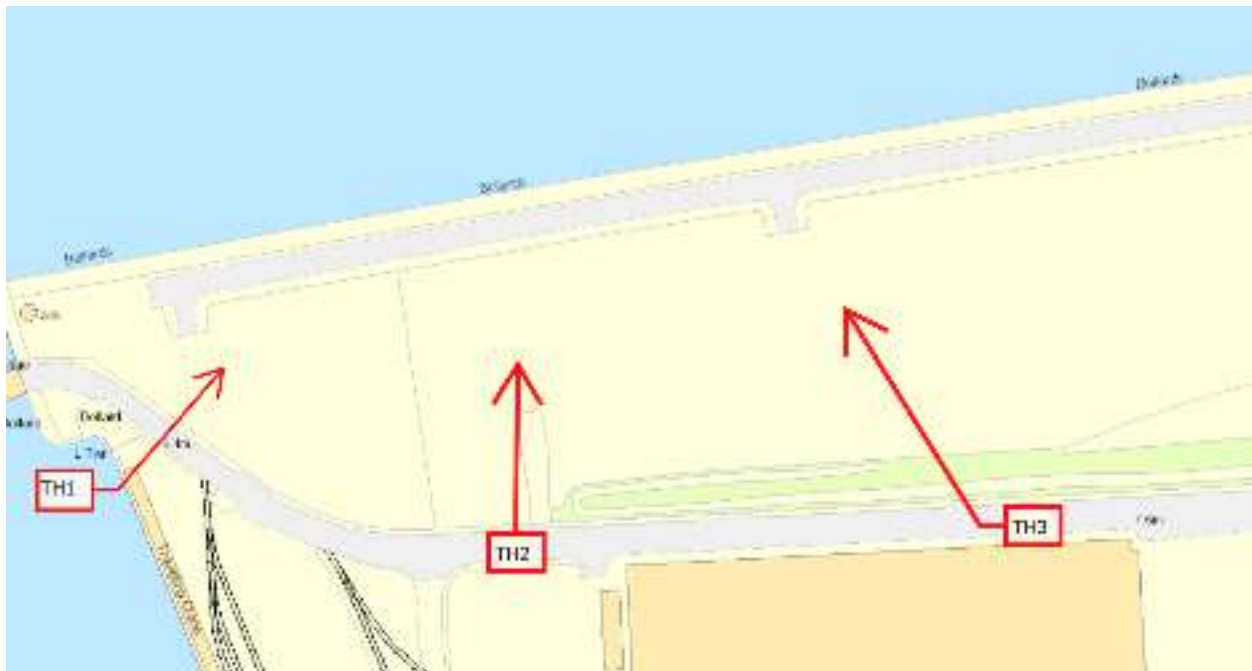
(Site map depicting trial hole locations on site, DCWW, 2021)

Each hole was roughly 2mx2m and 3m in depth.

Trial Hole 1: (X: 266993.96, Y: 192778.19)

Trial Hole 2: (X: 267096.34, Y: 192784.21)

Trial Hole 3: (X: 267198.72, Y: 192801.53)

These three locations were selected as between the 3 TH's they should fairly represent ground conditions across the whole site. The results are presented over the following pages. Risk Assessments and Method Statements for this work can be found in appendices.

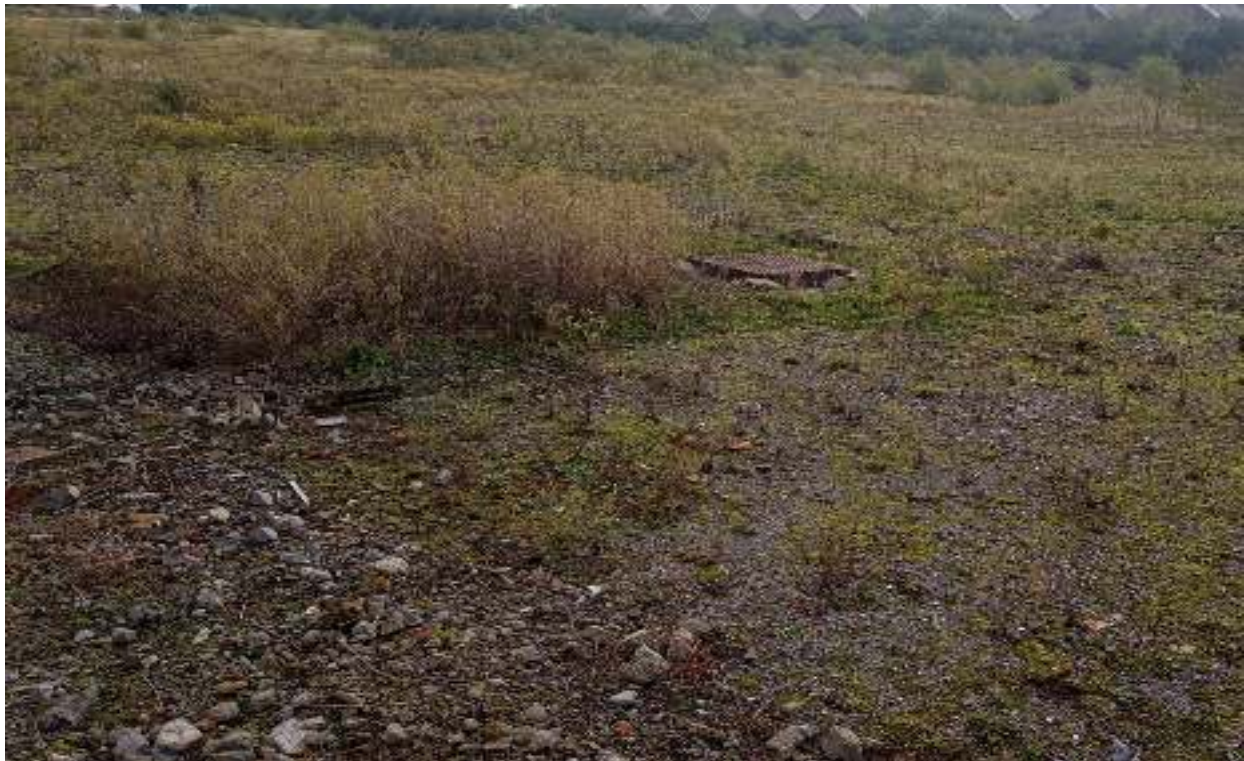
Copperstone Construction's commitment to sustainable construction in an environmentally responsible fashion necessitates an Ecology Survey to be carried out at all sites at an early stage of all projects. The survey of 'Plot F', was undertaken by the in-house Environmental team in September 2021. The Brownfield site previously housing activities characteristic of Swansea's maritime and industrial heritage. At an unknown point in the recent past the site has been somewhat 'prepared' for re-development via clearance and a hardcore / stone surface laid. Since then nature has begun to recolonise the land, although not to that extent that any mature trees are resident:

(View of site during Autumn 2021, Cullen, 2021)

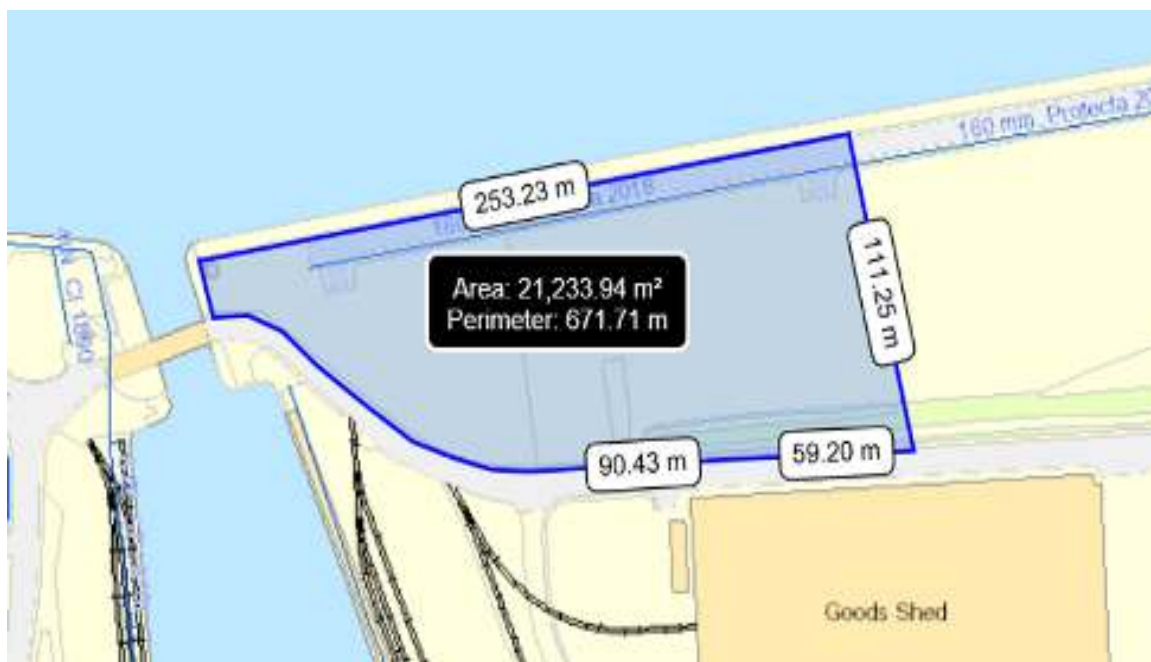
UWTSD has owned the land since 2020 with their land deed and legal boundaries corresponding as per plan below:

(Map of site with perimeter and area measurements of plot, DCWW, 2021)

Within the boundaries depicted above, there are no existing covenants, terms of lease, easements, rights of way, or wayleaves.

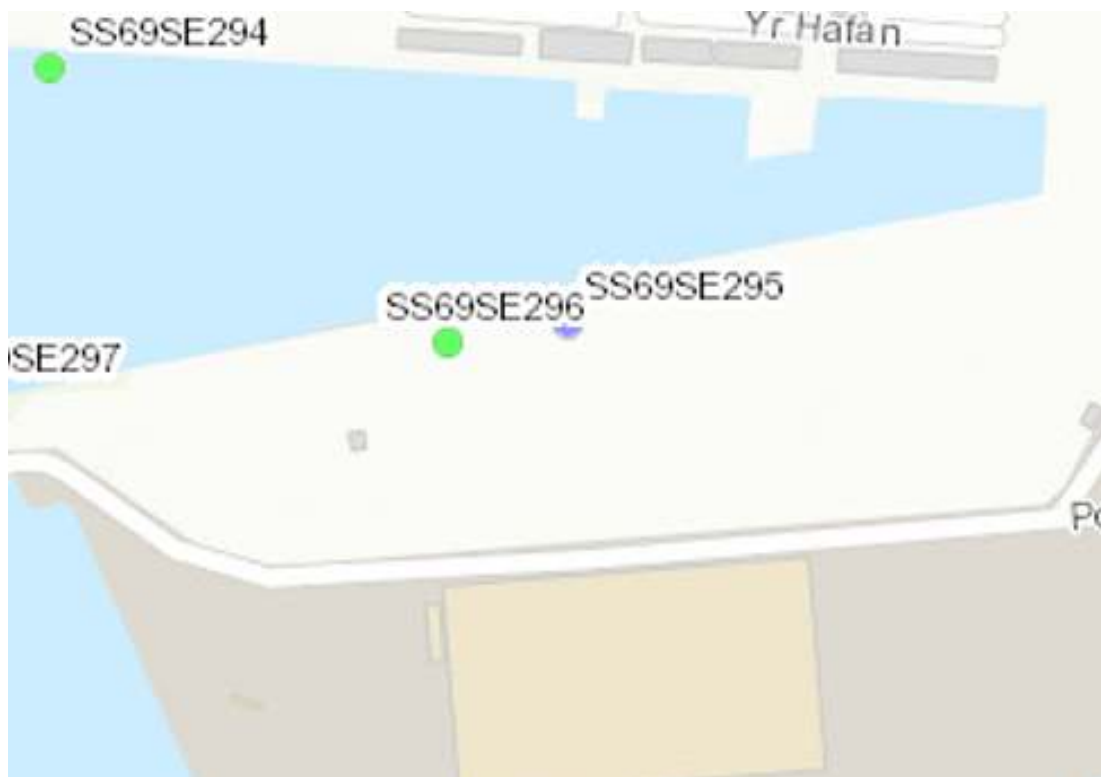
The historic borehole data available in the vicinity of the site is depicted as per below:

(Map depicting the location of boreholes on site, British Geological Survey, 2021)

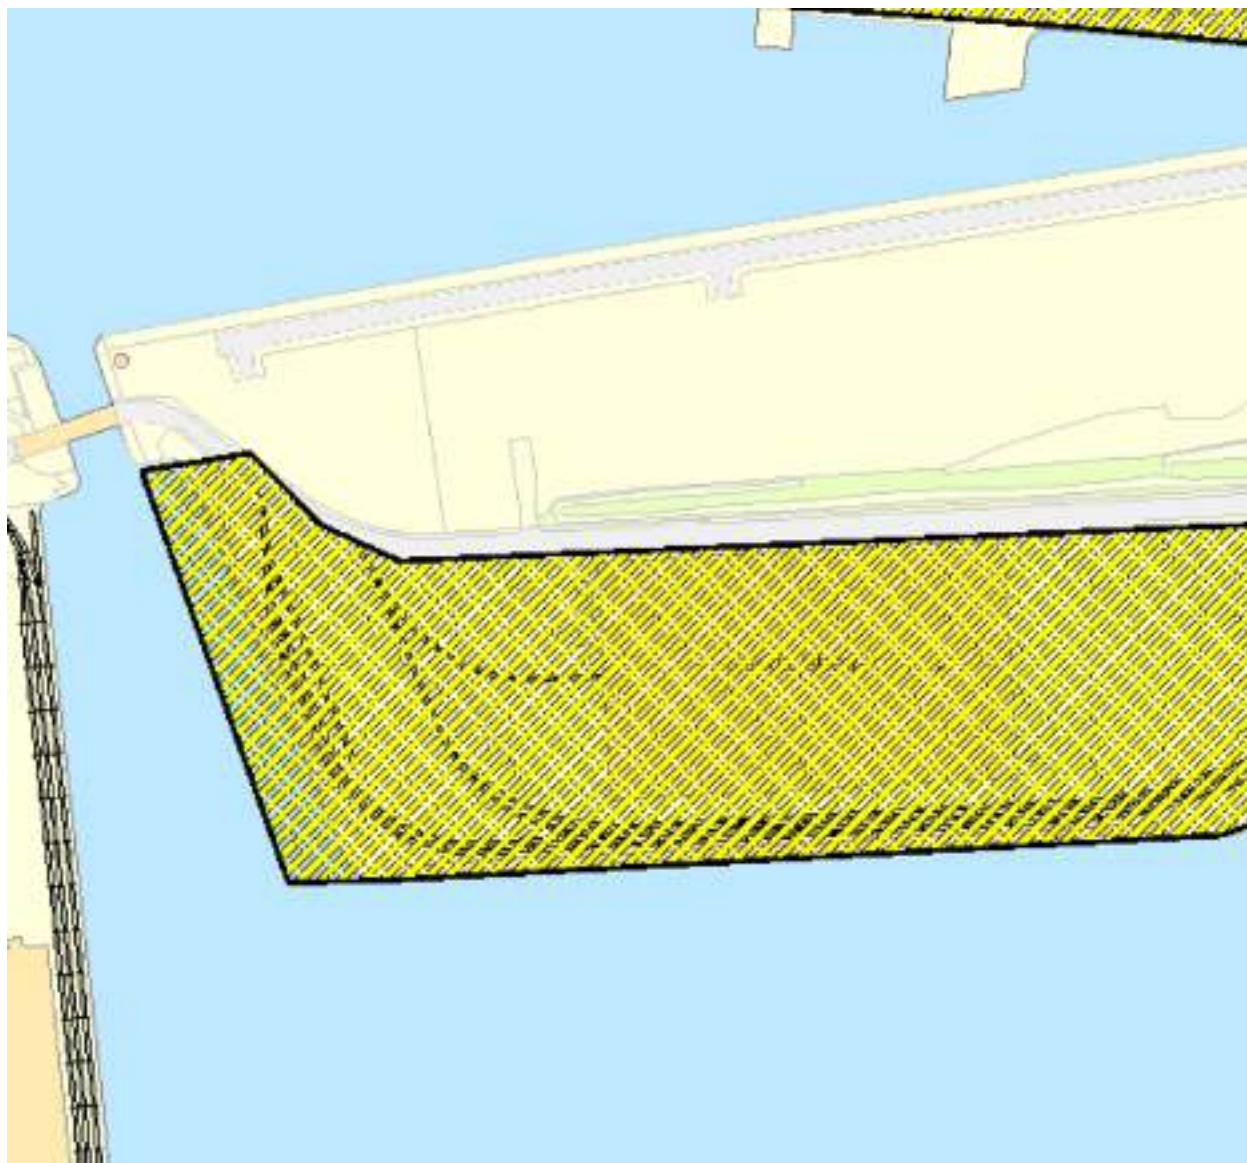
The location, it is thought borders but is not subject to contamination itself as per plan below:

(Map depicting site in relation to areas considered to be 'contaminated', DCWW, 2021)

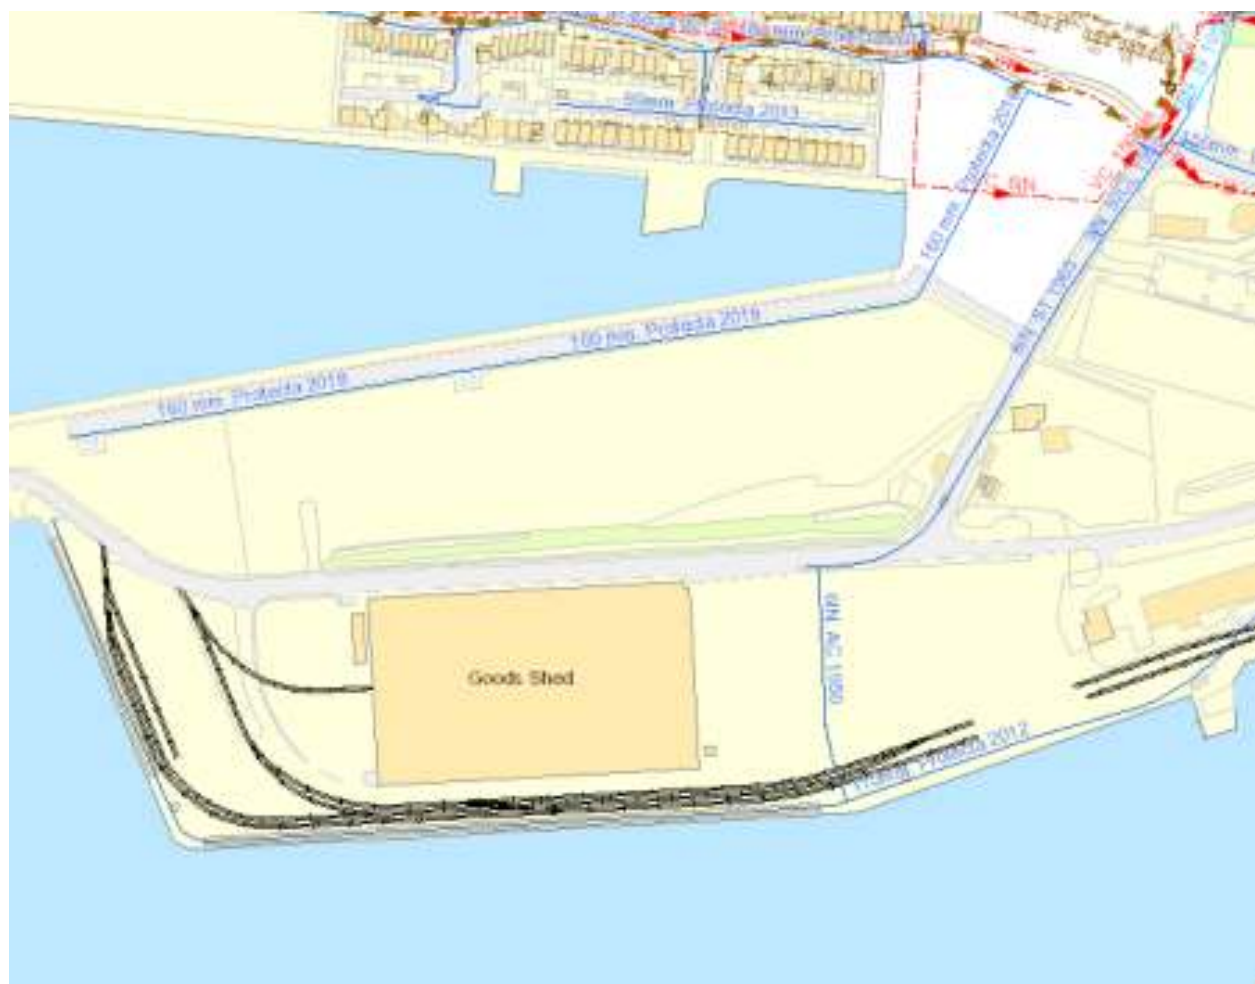
There is no current water, sewerage or drainage provision at site as per plan below:

(Map profiling the water mains and sewerage in the region, DCWW, 2021)

However, 160mm water main runs very near to the site, presumably laid with future development and expansion of the area in mind. Early, informal discussions with Welsh Water (local water / waste utility company) suggest connection onto this main would not present any major issues.

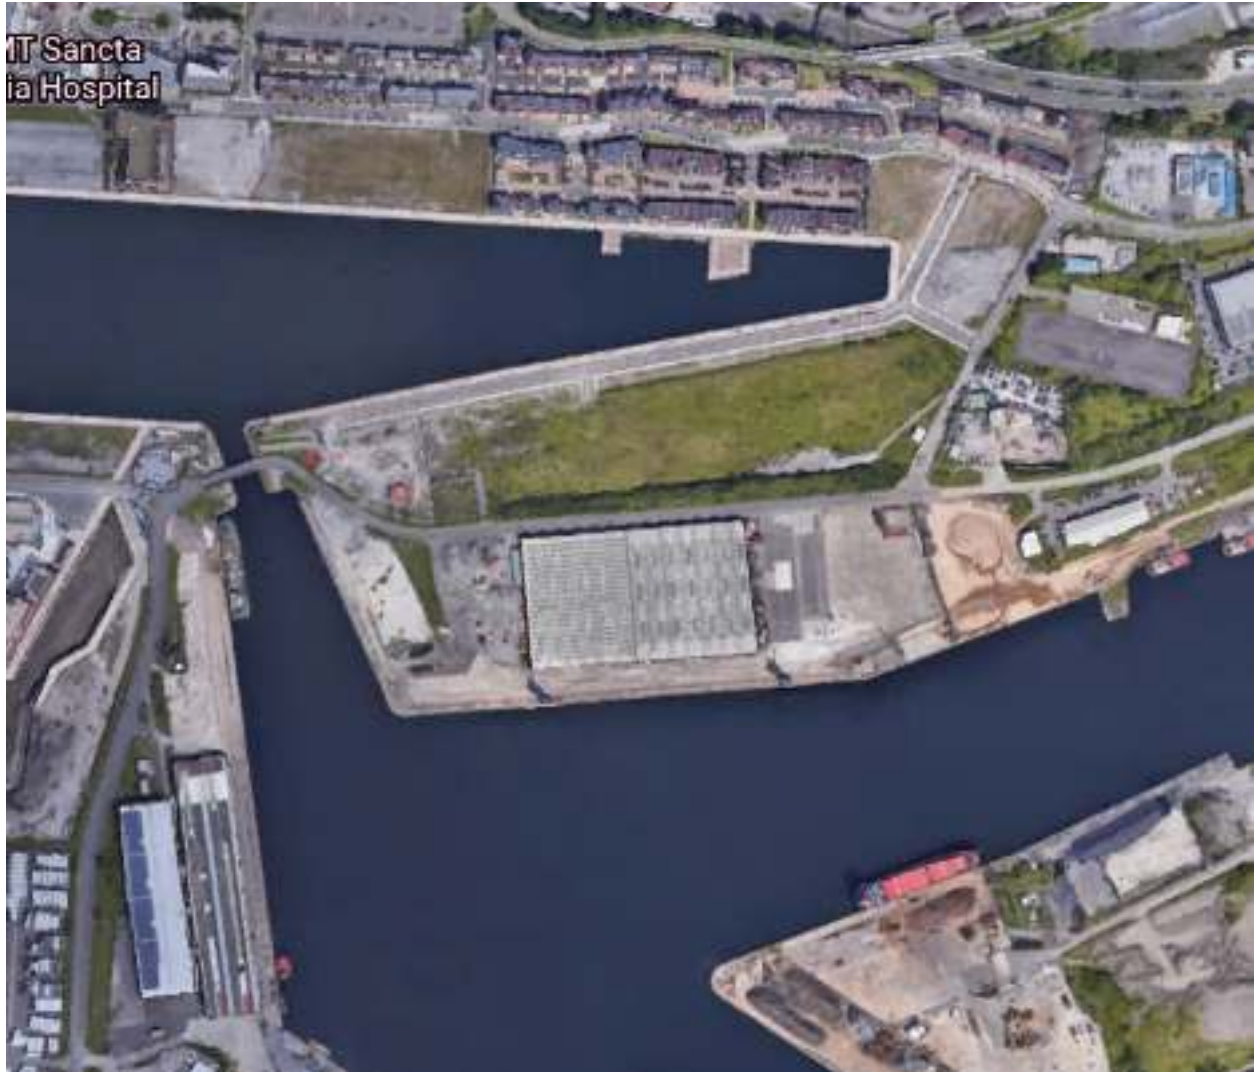
(Aerial photograph of site, Google Earth, 2021)

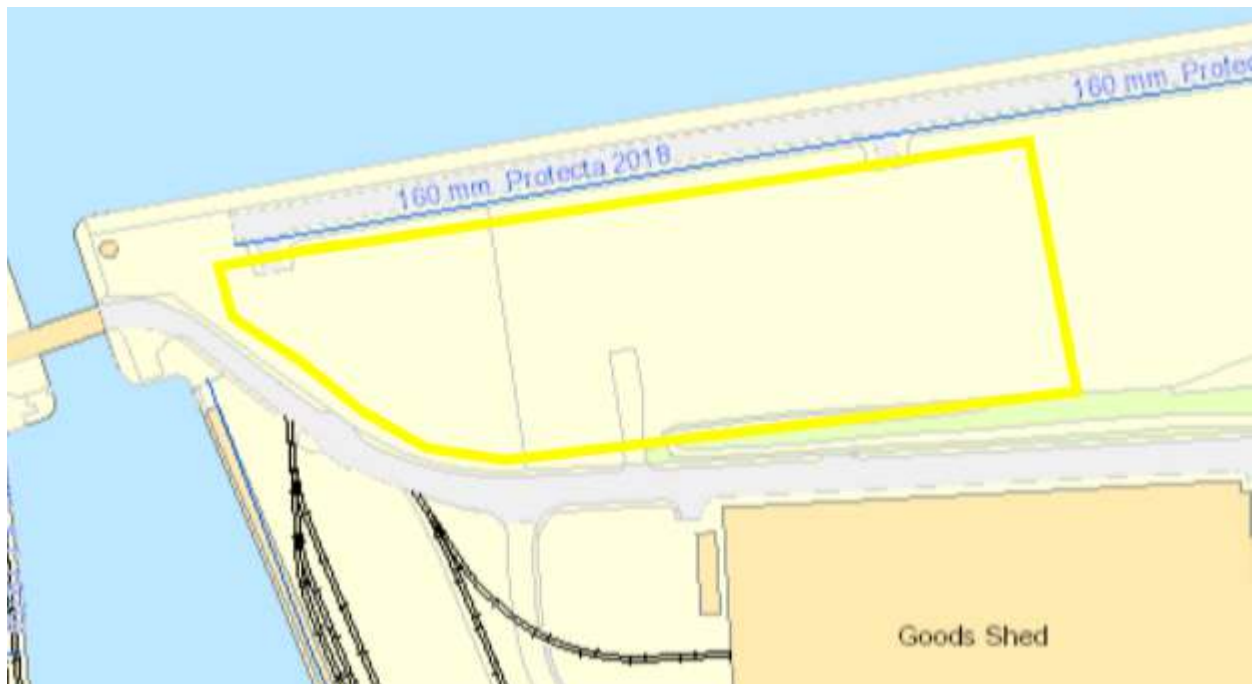
- Excavating to a depth of roughly 5 metres covering roughly 5100 square metres to house the building foundations, basement and a level from which to pile-drive the sheet piles:
