MODULE: GREEN BELT SIX SIGMA  
MODULE CODE: ACMA 5005  
LECTURER: ANDREW THORN  
ASSIGNMENT TITLE: UNDERTAKING A  
GREEN BELT PROJECT

## Executive Summary

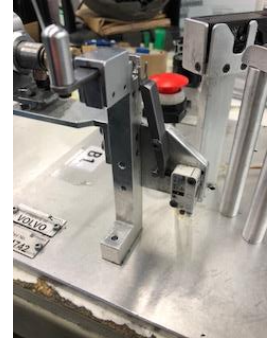
In order to push the capability results down towards the bottom tolerance of zero (has the most resistance to water pressure) it was decided that William himself could move the Pneumatic switch back a fraction so that the release tolerance is pushed closer to the bottom end. This will then fine tune the process and further include the quality of the parts produced by the fixture.

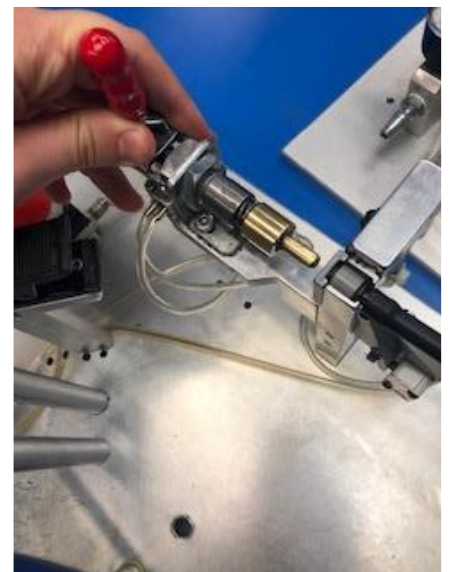
Once manufactured by the tool maker William Davies personally retrofitted the second modification to the tool post and connected it up to the pneumatic system. 3 assemblies were built and the total hose length was firstly measured to ensure that the Poke Yoke hadn't altered the length. He then went onto measure the gap between the connector and cut end of hose to ensure that it was equally as efficient as the first. The result from the initial tests were:

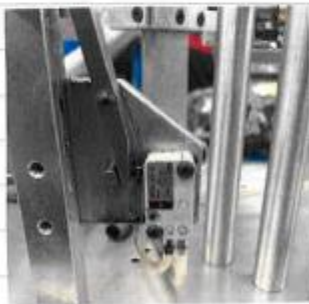
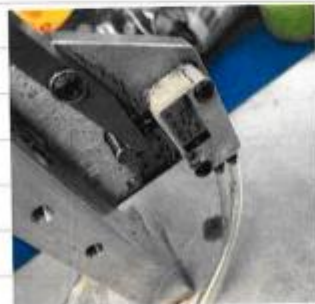
## Required Modification:

1. In order to push the capability results down further towards the bottom tolerance of 0 (which has the most resistance to the water pressure) I decided it was best to move the pneumatic switch back a fraction so that the

release tolerance is pushed closer to the bottom end which will fine tune the process and further improve the quality of the parts.

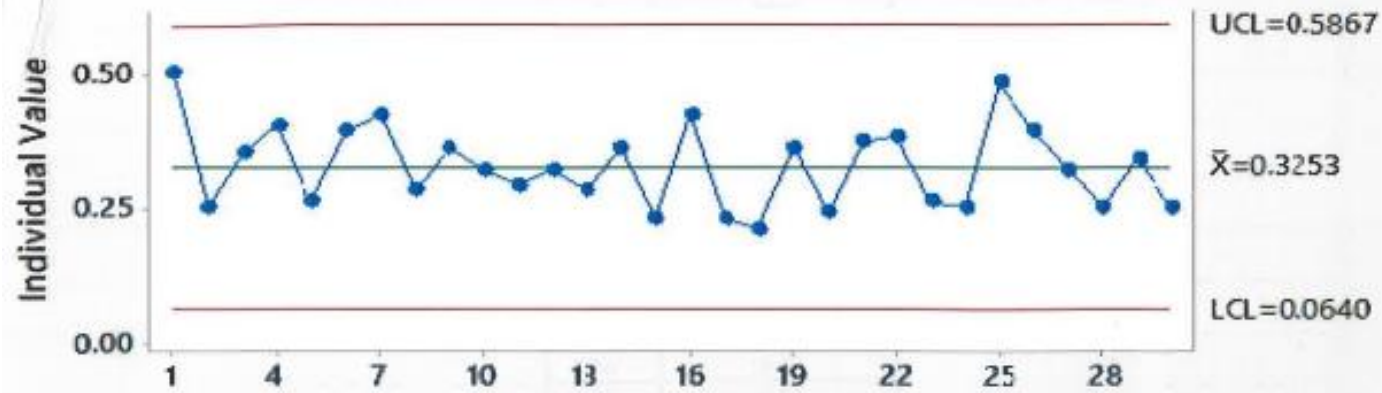
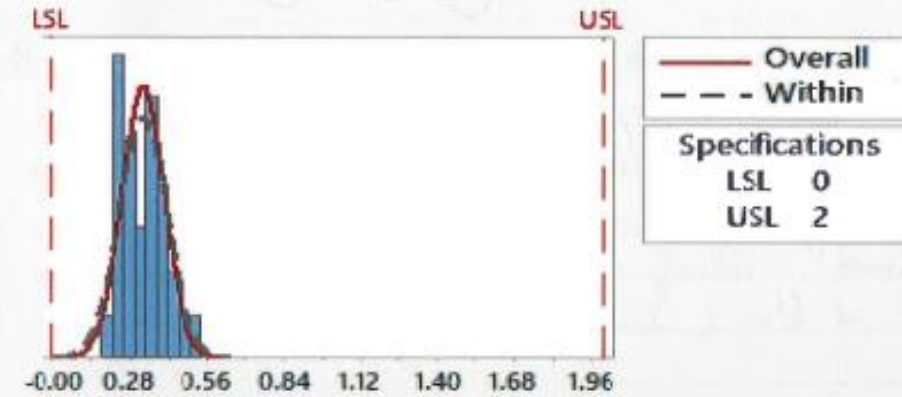
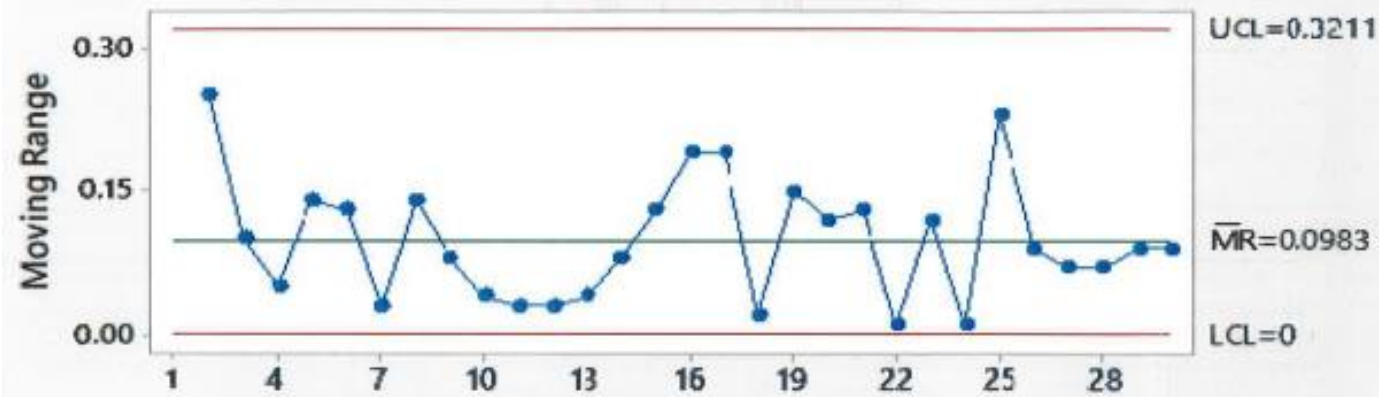
AD: 0.530, P: 0.162

This capability study shows a positive decrease in the defect parts per million. The graph shows that the very minor adjustments that I had made have improved the capability in my opinion due to the fact that all values/measurements have been pushed further towards the bottom specification limit of zero which would be the most reliable part.

This capability study shows a positive decrease in the defect “Part Per Million.” The graph shows that the very minor adjustment made improved the capability in the teams opinion, due to the fact that all values/measurements have been pushed further towards the bottom limit of Zero which would produce the most reliable assembly part. This meant that there were no further adjustments required on the modification.
