# 1909365

**Course:** BSc (Hons) Electrical and Electronic Engineering  
**Module:** SGEE6002 Electronic Production and Test  
**Assignment Title:** Fault Modelling  
**Name:** Matthew Davies  
**University number:** 1909365  
**Date Submitted:** 11/02/2023.  
**Word Count:** 2443

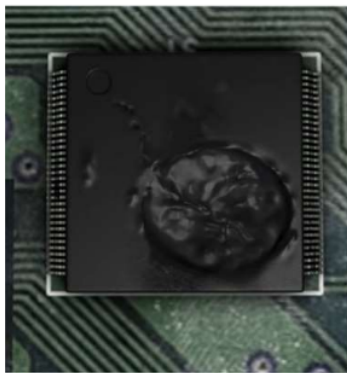
Figure 3 - ESD damage to a PCB (Peterson, 2017)

ESD can cause damage to integrated circuits (IC) if they are not protected sufficiently against the discharges. If the IC cannot withstand the high voltages produced from the ESD, then the discharge will cause severe damage to the components and will likely discharge through the gate oxide, as this is the most susceptible to these kinds of problems. The components will be crossing their operating thresholds regularly and will degrade and break down eventually. An example of this is shown in Figure 3. Due to the smaller nature of ICs in the modern world, there is now a lot smaller surface area for the ESD to discharge through, in turn causing the components to take a higher amount of discharge. (Toms, et al., 2015)

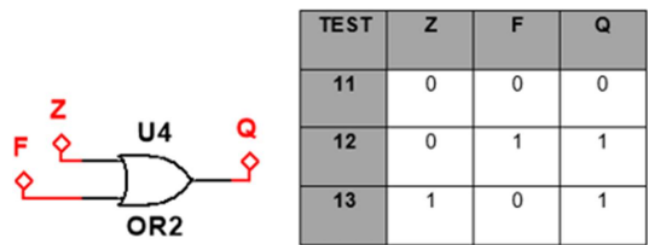
Figure 9 - Reduce test 2 input OR gate.

Figure 9 shows the 2 input OR gate and the testing table.
