**Phillips, M.R.** (2009) Beach consequences of an industrial heritage. In: Williams, A.T. and Micallef, A., *Beach Management: Principles and Practice*. Earthscan, Case Study 12: 353-362.

## **Beach consequences of an industrial heritage: a case study.**

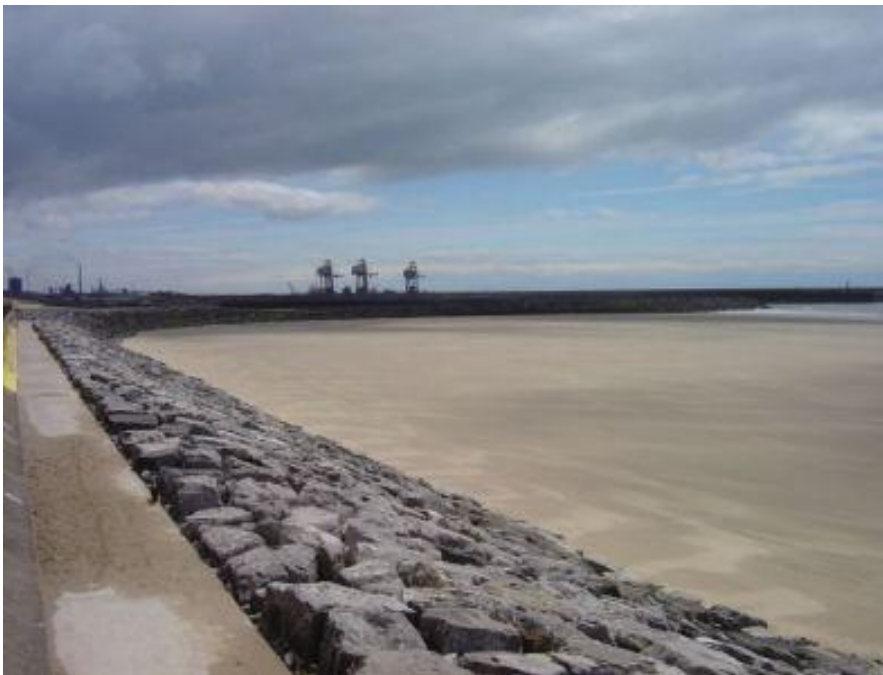
Figure 3: Rock armour fronting promenade seawall

The tidal harbour interferes with accepted northerly net longshore transport (SBCEG, 1999), thereby reducing sediment supply to the beach. If a line joining the extremities of the breakwaters (Figure 1) is projected onto the shoreline, beach consequences differ to the north and south of this location. To the southeast, there is northward sediment movement with little replenishment. This causes beach levels to fall resulting in exposure of sheet piles at the seawall toe and in the past, this has been managed by placing rock armour against the seawall (Figure 3). To the northwest, beach levels increase as sediment supply is restored and the area is subject to wind blown sand (SBCEG, 1999). The Coastal Protection Authority (CPA) periodically removes this (Figure 4) and redeposit's it on the southeast beach section (Figure 1).

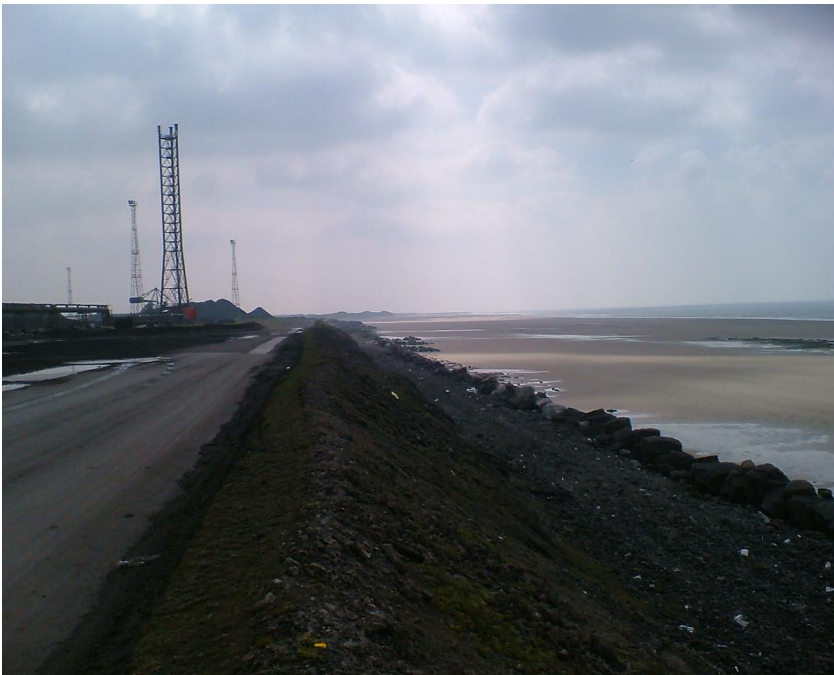
Figure 5: Coastal defence Corus (SBCEG, 1999)

The Corus frontage, southeast of the tidal harbour (Figure 1) is experiencing ongoing erosion and slag has been used for coastal defence, which protects the steelworks and infrastructure such as access roads (Figure 5). However, the slag tip revetments themselves were susceptible to erosion and consequently, are further reinforced at certain locations with stone armour revetments (Figure 6). This coastal sector was highlighted as

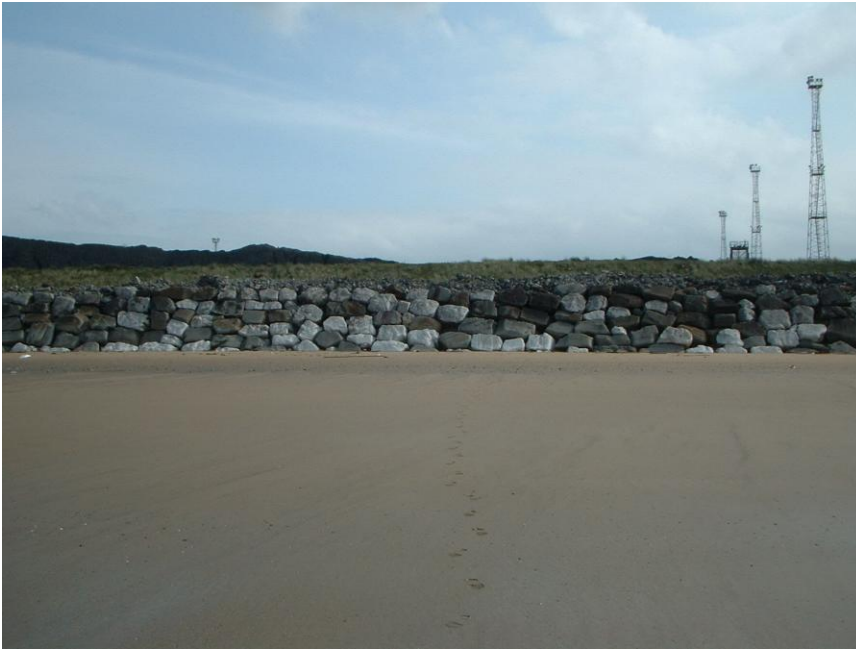
Figure 6: Slag and rock armour revetment (SBCEG, 1999)
