# Preliminary Coastal Vulnerability Assessment for KwaZulu-Natal, South Africa

<sup>1</sup>Oceanographic Research Institute, <sup>2</sup>eThekweni Municipality, <sup>3</sup>School of Geological Sciences, University of KwaZulu-Natal, <sup>4</sup>Sustainable Development Projects, <sup>5</sup>Environmental Mapping & Surveying, <sup>6</sup>Department of Agriculture, Environmental Affairs & Rural Development

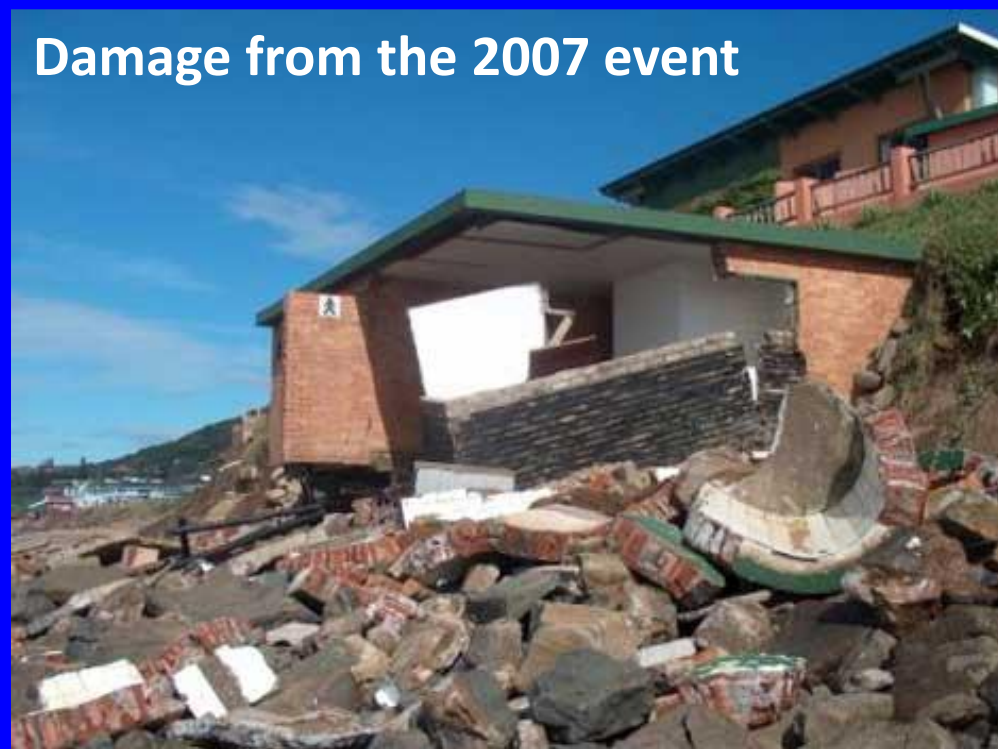
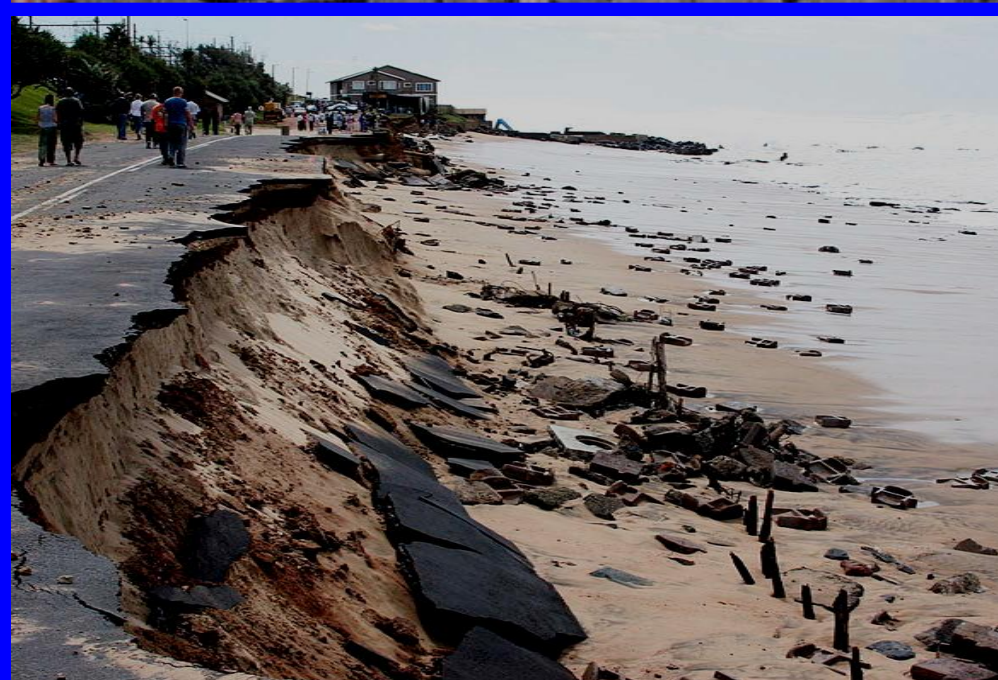
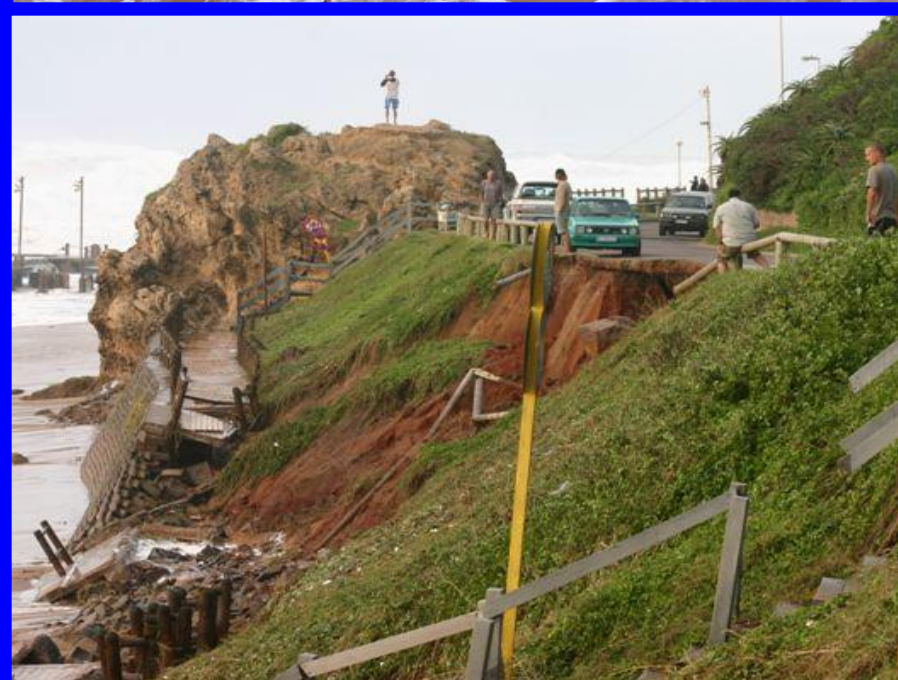
- During 2006 and 2007 a number of large swell events occurred on the KwaZulu-Natal Coast
- Notability an event in 2007 resulted in significant damage to properties and infrastructure
  - An extreme wave event coincided with an equinox
  - Resulted in a maximum swell height of 14m

Damage from the 2007 event

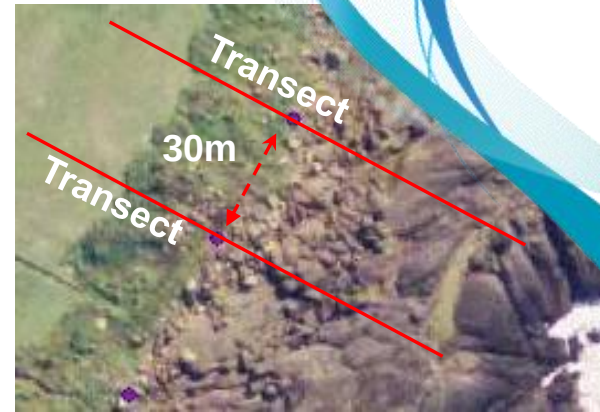
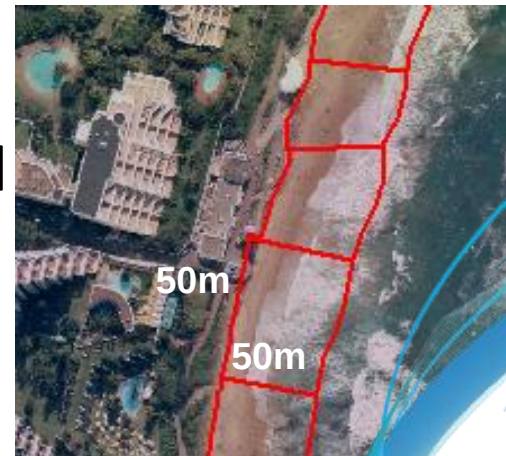
- Physical coastal parameters were extracted as point data from the aerial photographs at 30m intervals
- Data was converted into a more regular grid of 50 by 50m cells along the LAZ
- Sites of known erosion were captured as a separate dataset
  - Results of which were used to inform vulnerability thresholds

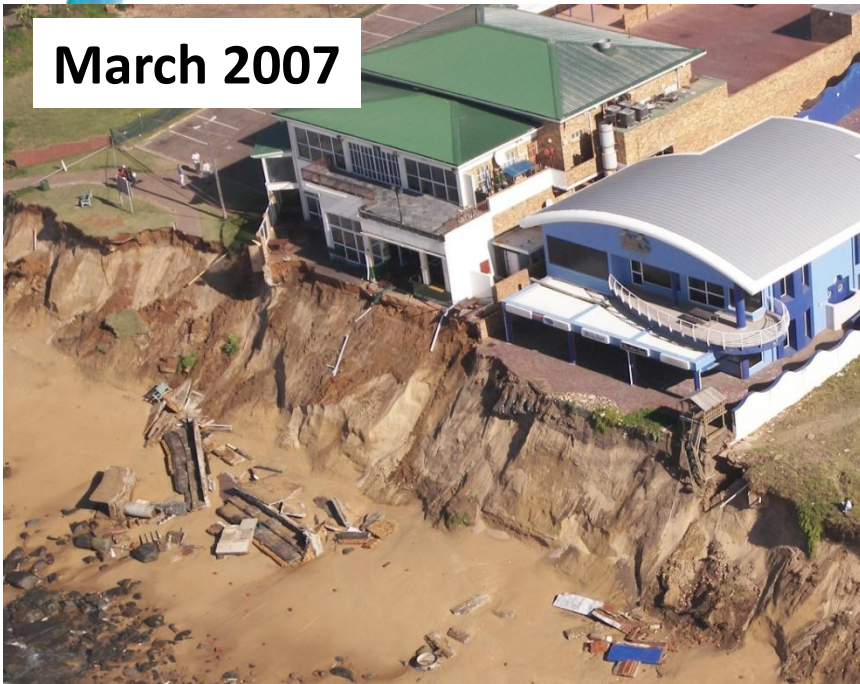
**March 2007**

- Example of re-vegetation post 2007 storm event
