# ANALYSIS OF BUILT ASSETS – A CASE STUDY APPROACH – ACBA6006

*BUILDING CONSERVATION ASSET & FACILITIES MANAGEMENT*

St David's University College  
College Street  
Lampeter  
SA48 7ED

Grade: II\* Date Listed: 21 September 1964 Cadw Building ID: 10431

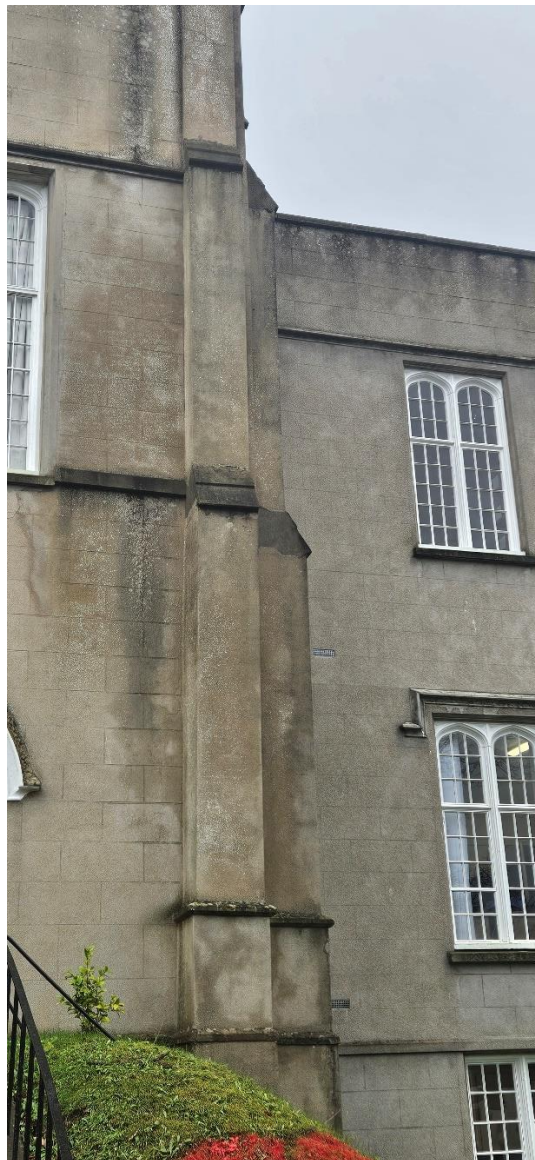
Table 2 external works and façade repairs to envelope of building

| PROPOSED WORK | <p><b>4.1.2 Façade Repairs</b></p> <p>Carry out major repair works to the entire façade of the majorly degraded façade of the building.</p> <p>An external wall insulation system is proposed “warmshell external wall insulation” which is a system that can wrap around timber or masonry ensuring. Once completed a new lime render is to be applied across the entire building to match all previous rendering design. Samples will need to be taken of the current lime render to match the new render to be applied. Testing will need to be carried out to get the exact match. Existing ornate stonework will need to be removed and repaired by using cast stone repair methods, chosen for versatility, bespoke design moulds which enables restoration of stonework to be exact shape and style it is also a cost effective method. This will then be returned to the building once the EWI is completed.</p> |
| HARMFULL IMPACT | Loss in some historic value, by removing all old lime render and |

| | replacing with EWI and new lime render. | |

Ensuring that the significant old college building has a long-term survival, the building that is over 200 years old requires major repair work to the façade of the entire building. It is extremely important to bring the façade up to standard and have a long-lasting maintenance program in place to ensure it does not degrade to such disrepair in the future.

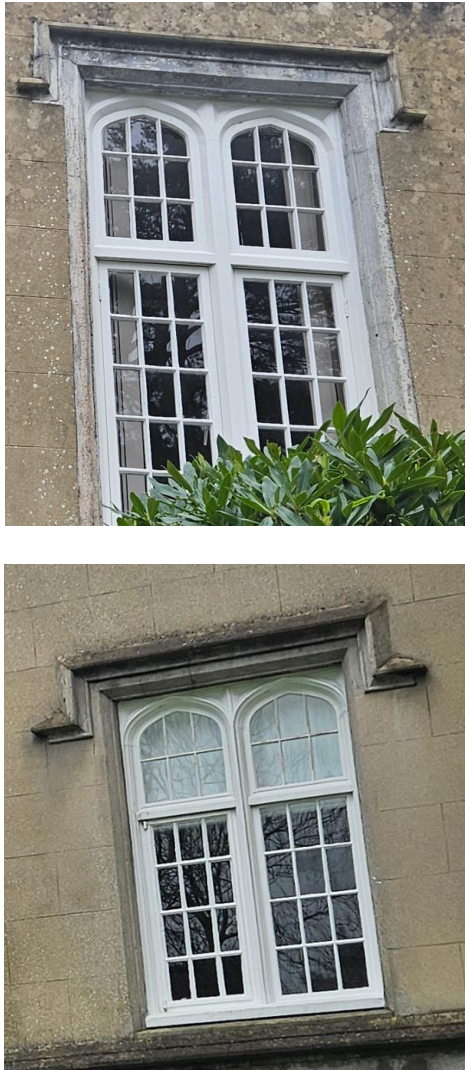
Table 3 window replacement and repair work

| <p><b>4.2 Works to windows, window reveals, and sills</b></p> <p>The windows, reveals and sills of all the windows are in bad condition. Replacement and repair work to take place. This needs to be carefully selected and only essential work to be carried out.</p> | | |
| PROPOSED WORK | <p><b>4.2.2 Window replacement &amp; repairs</b></p> <p>Replace windows where possible with double glazed to match current window style using conservation or period bespoke double glazed window units where possible. Where this is not possible secondary glazing will be applied this can only be applied once all windows, reveals, and seals have been repaired.</p> <p>Chisel away and repair stonework on window reveals, and sills replace and ensure watertight. This needs to be done and matched to the new EWI and new rendering.</p> | |

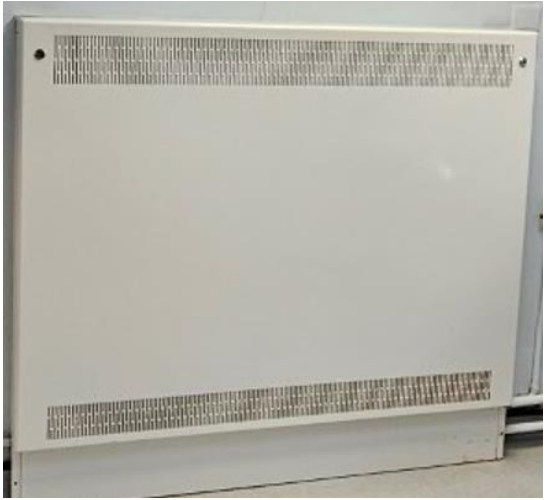
| <h3>4.3 Heating upgrades</h3> <p>Essential new heating upgrades and system is to be installed, along with the new thermal values of the building fabric and windows.</p> | | |
| <b>PROPOSED WORK</b> | <p><i>4.3.2 New heating system</i></p> <p>A completely new heating system consisting of a mix of electric radiators (it may be possible to convert any existing radiators that have historical value) and under floor heating is proposed this needs to be designed in such a way that it does not cause any damage to any historic flooring within the building, and this will work in conjunction with the new thermal values of the envelope of the building ensuring it is energy efficient and can meet new energy efficiency standards and ratings. A Very good to excellent rating on BREEAM would be required. Ground source heat pump system is proposed, due to the amount of space on the site, this will be viable.</p> | |

| <b>PROPOSED SOLUTION</b> | A full survey of the heating system and radiators as well as all the pipework for the heating system needs to be carried out. U-values of the building will need to be calculated for the proposed works and a new ground source heating system will be fitted to the required specification to ensure the building will keep moisture out and the internals dry and comfortable for all. Checking for any flooring that has had direct contact to the ground needs to take place, this is to ensure any damp or suspected damp is dealt with prior to installation of under floor heating. | |

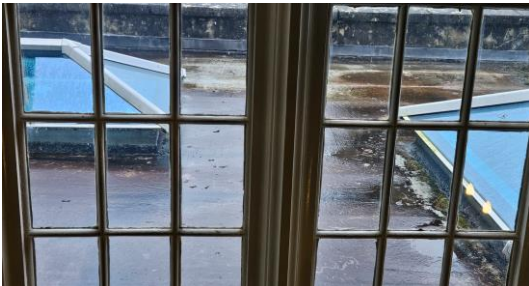
| <h4>4.4 Roof repair work and chimney</h4> <p>Essential roof repair work needs to take place, as well as chimney repair work on the chimneys that have not had upgrades and repairs.</p> | | |
| <b>PROPOSED WORK</b> | <h5>4.4.2 Roof and chimney repair</h5> <p>Installation of all new membranes wherever necessary on all flat roofs, as well as repair works to other pitched roof with slate tiles. Carefully check all slate tiles and replace where necessary. Removal of all guttering and cleaning and repair work to gutters and pipping. All leadwork and flashing replacement where necessary. All copings and parapets to be removed and set aside for repair works to take place, these will need to be repaired and brought back to standard before replacing. All roof</p> | |

| | ends rafters and timber trusses need to be checked and replaced where necessary. Chimney's will need to be made watertight and all lead flashings need to be replaced, hack off render where necessary and repair allow for rebuilding of chimney to match other upgraded chimney's with blue brick to match. | |

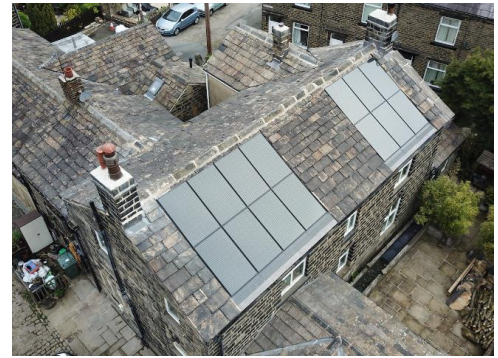
To maintain the building and ensure it meets sustainability, and carbon net zero it would be essential to add solar panels to assist with the energy usage and storage of the old college building.

| PROPOSED WORK | <i>4.5.2 Solar panels</i><br>It is proposed to install solar panels across the building on all south facing roof pitches as well as any flat roofs. |
