As a group we were instructed to survey the Trinity Gardens area at UWTSD, to produce an accurate A3 drawing showing the layout of key features. We were tasked to establish the positions of site elements such as kerb lines, boundaries, street furniture, manholes, lamp post, drains and represent these clearly. Using GNSS (Global Navigation Satellite System) equipment, which allows precise positioning and elevation data to be obtained through satellite signals referenced to a global coordinate system satellite, geometry and correction techniques such as RTK, to achieve accuracies in the range of 10–20 mm under suitable conditions.

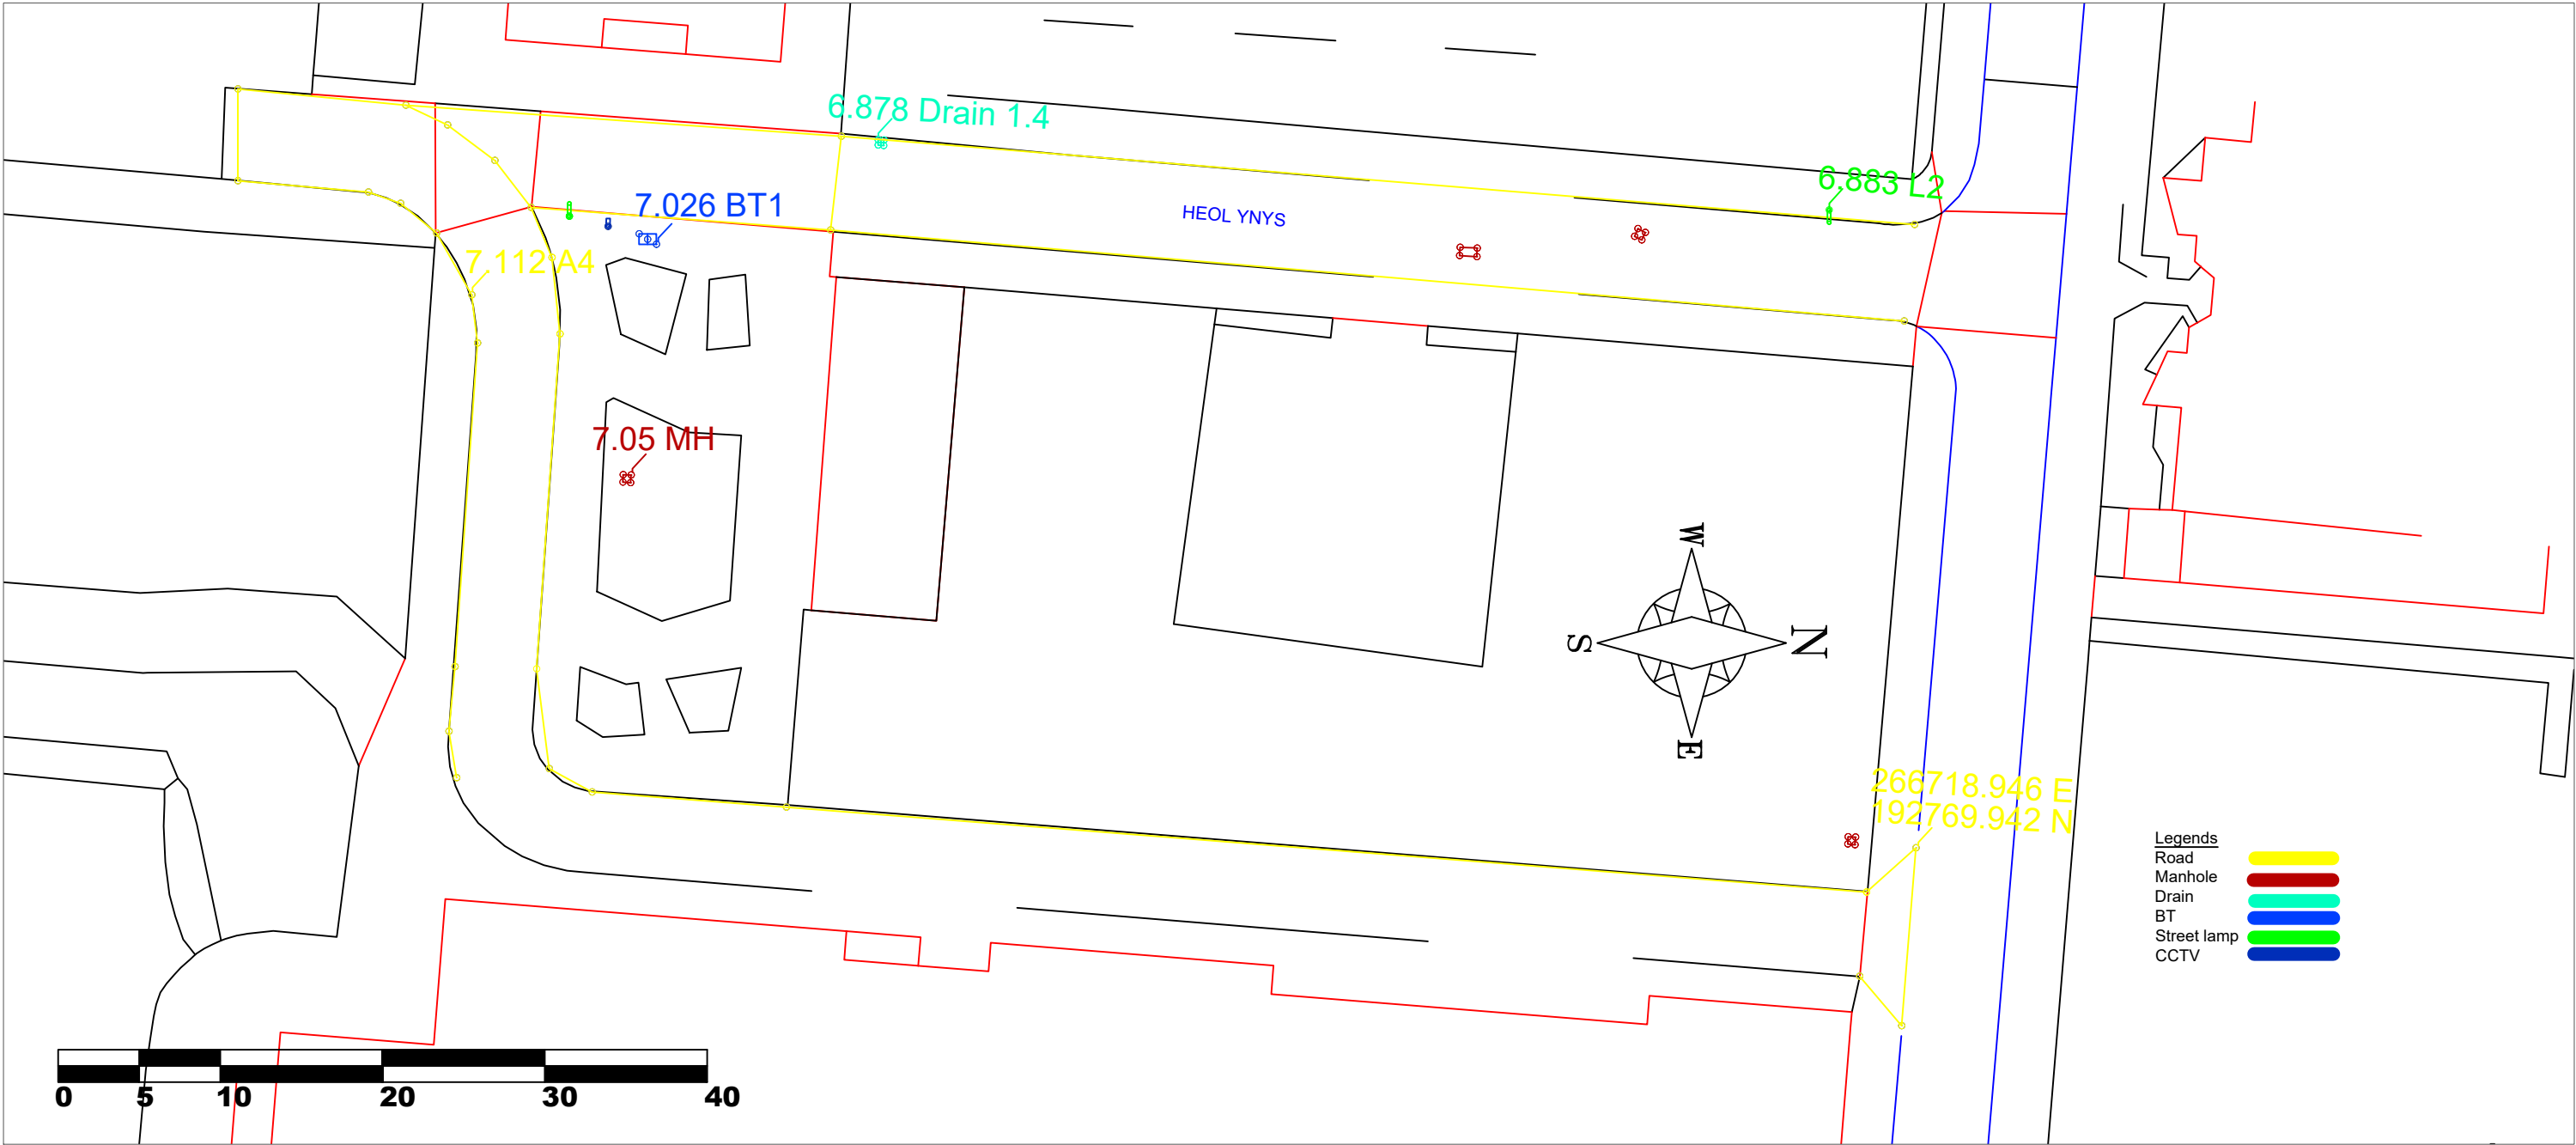
To overcome these limitations, survey data was supplemented using information collected by other student groups. This allowed for a more complete dataset and ensured that key features could still be represented within the final drawing. Despite the challenges, the survey demonstrates an understanding of GNSS surveying principles, including the importance of satellite visibility, environmental conditions, and data accuracy. The final output is an A3 AutoCAD drawing that presents the surveyed features in a clear and professional format, including appropriate layers, annotations, scale and title information.
