**Title:** Statistical Analysis to Find Root Cause of Quality Defects in Hot Rolling Operations  
**Module:** Quality and Business Improvement (ACMA4008)

Leighton Williams  
Student ID: 2418806  
(February 2025).

## Abstract

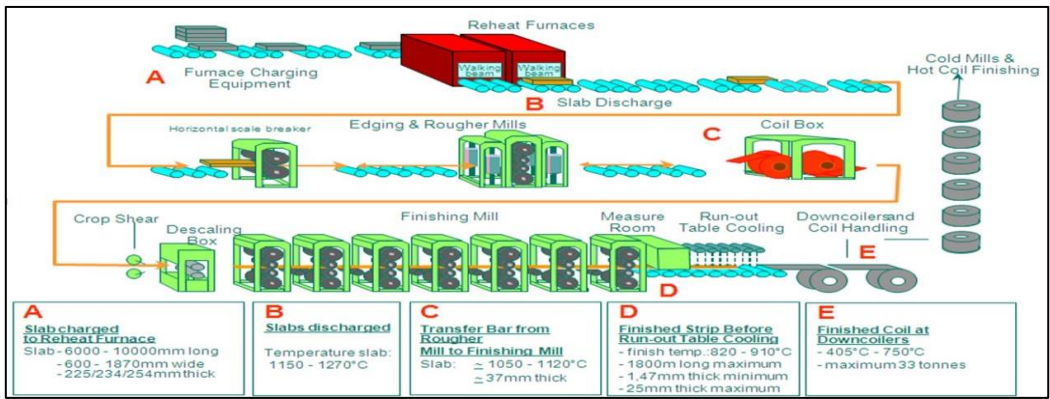
At Port Talbot, Cast Steel Slabs are processed through Hot Rolled Products where they are reheated in a furnace, then processed from a cast steel slab into a hot rolled coil through a series of reduction mills. See below **Fig 1** the process flow for the current configuration of Hot Rolled Products. For additional information on the process at Hot Rolled Products please see '[Appendix 1](#)' ('Port Talbot Hot Strip Mill Process Flow', Leighton Williams, 2024)

Fig 1 - Hot Rolled Products Process

This report is specifically relating to low temperature quality issues found on hot rolled coils exiting the 'Edging & Rougher Mills' from **Fig 1, (from this point on known as 'The Reversing Roughing Mill')**, a part of the process in the operation of processing Cast Steel Slabs, into Hot Rolled Coils.

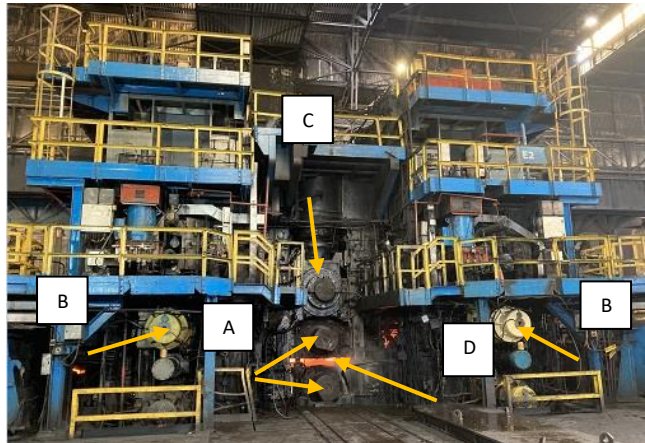
The area of scope for this report is centred around the Reversing Roughing Mill (**Fig 2, Fig 3**). This is a four high reduction mill that will reduce slab thickness down from between 260-215mm to 38-42mm, depending on the end thickness requirements by the customer (Gauge).

Fig 2 – Reversing Rougher at Hot Rolled Products

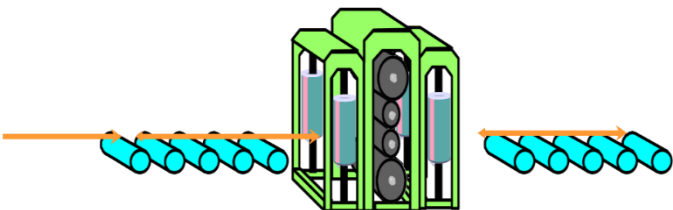
The slab will pass back and forth through the mill either five or seven times, with each 'pass' reducing the thickness (gauge) of the product prior to moving to the next part of the process (**Fig 3**). The width of the end product is achieved here in the roughing mill and is done with 'edger rolls' on both sides of the four high mill.

Fig 3 – Reversing Rougher Process Illustration

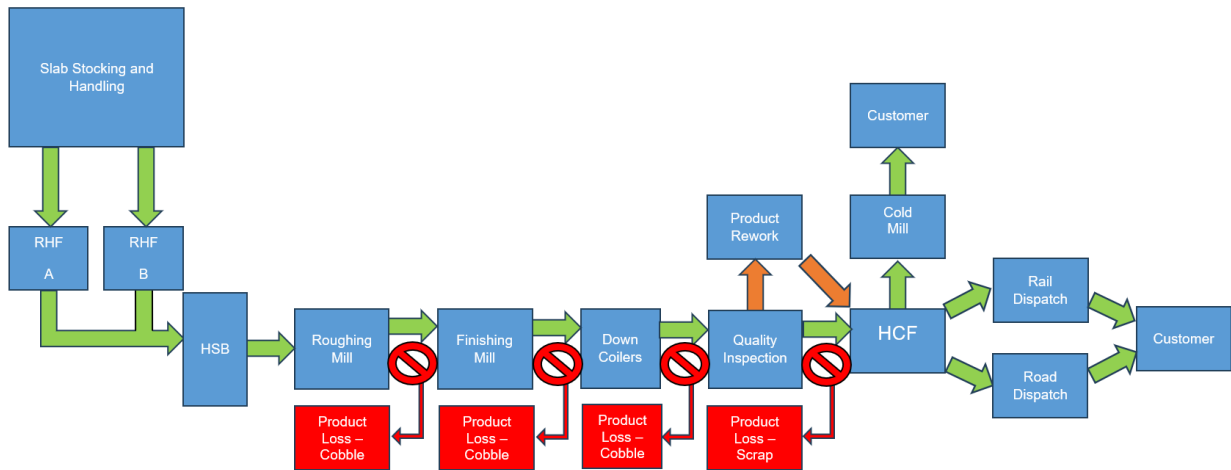
Fig 4 – Process flow for HRP indicating impact of quality and product loss routing.

The increased quality defects change the process flow of Hot Rolled Products and congest the quality inspection area (Fig 4). More significantly, due to the linear formation of the plant product losses stop production and cause lengthy delays in production. As well as equipment damage.

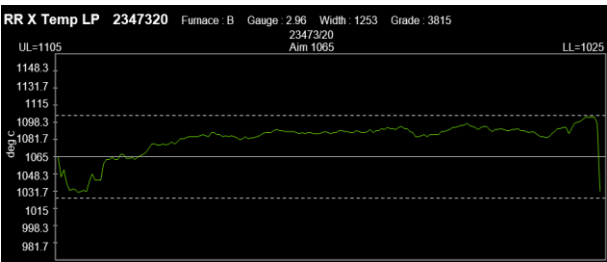
Measured roughing exit temperatures are taken by a non-contact infra-red detection device, and the results are displayed on a graph like illustration on software known locally as ‘The Met-Man’ see below examples (Fig 5, and Fig 6):

Fig 5 – Example of a temperature trace within range

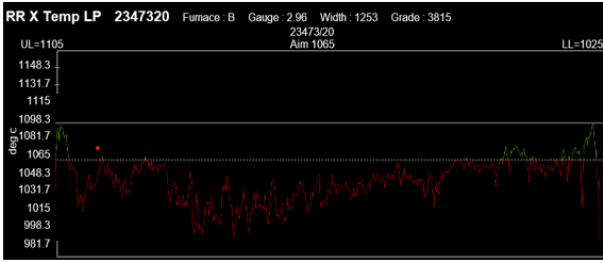
Fig 6 – Example of a temperature trace below target, typically leading to a defective coil.

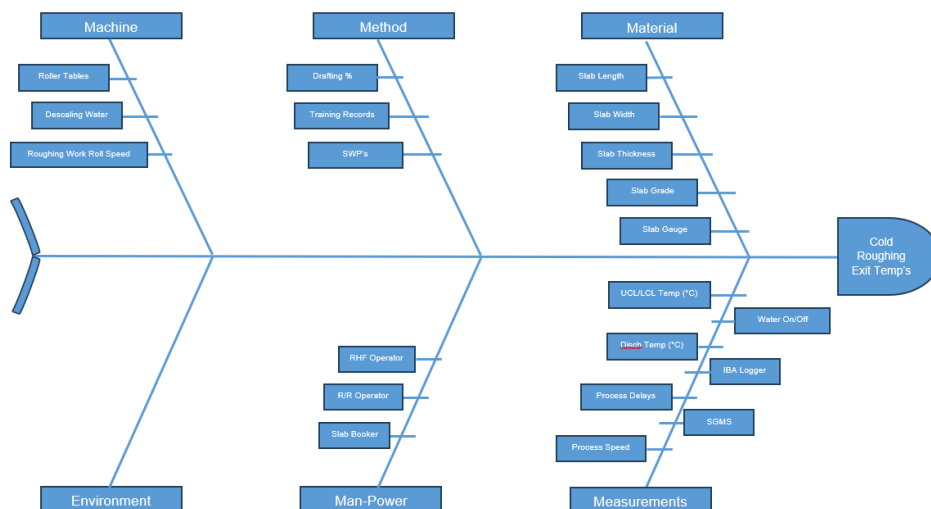
**Fig 7 – Cause and Effect Diagram of Potential Contributing Factors**

Further elaboration on this cause-and-effect approach was undertaken and completed as a full Root Cause Analysis Review and can be accessed via '[Appendix 2](#)' ('RCA', Leighton Williams, 2025). This RCA identified six potential contributing factors to this intermittent problem of cold temperature defects. Due to the considerable number of variables to consider, and the variation range within each variable the only way to proceed was to take a sample of data from the processed material and analyse it statistically. There was a need to collate both quantitative and qualitative data for each slab being processed into a coil. After deciding on the variables to consider the data was collated over a 12-hour period, the sample size was one hundred slabs. The quantitative data was recorded via system/instrument measurements that are taken, logged, and retrieved via an SQL type system. The defect data is more of a descriptive judgement, or qualitative nature. To collect this a check sheet was used and the defect type categorised and graded by an operator both before '[Appendix 3](#)' and after '[Appendix 4](#)' the Improvement Initiative. Both these data collections were combined, organised, and classified before being analysed. This can be seen in '[Appendix 5](#)' – ('Sample Data and Statistical Analysis', Leighton Williams, 2025).

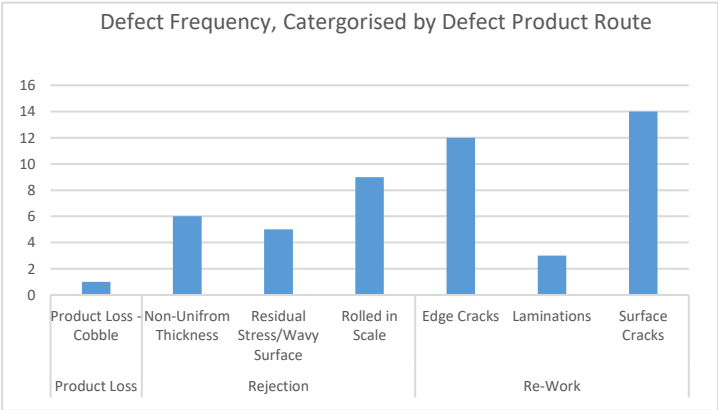
Fig 8 – Defect Type and Frequency

Fig 8 shows there are seven defect type categories also the routing that product would take. There are three routes:

1. **Product Loss** – Product breaks during processing bringing the operation to a halt. This also causes unexpected downtime, and potential equipment damage.
2. **Rejection** – There is no ability to re-work this product to meet customer requirements. They become product losses after inspection.
3. **Re-Work** – These defects are not product losses but incur significant cost to put right and cause congestion in the quality inspection department, and further processing units. This can lead to unexpected down time as a result.

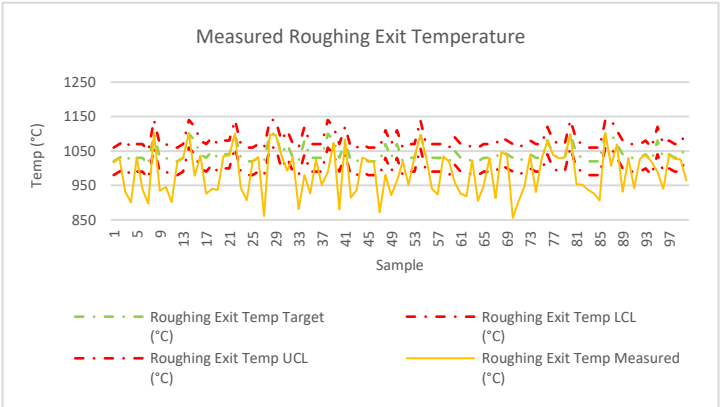
Fig 9 illustrates the measured temperature of material being processed. The target temperature varies from slab to slab, with the UCL and LCL being set at +/-40°C from target. This data sample shows a deviation from LCL of 50%. In this data set that is fifty out of one hundred slabs measured are being processed below the temperature LCL at the roughing mill, these are the slabs that are then classed as defective. To find the main contributing factors, the data collected was analysed comparing this deviation from the LCL of the roughing exit temperature against the variables collated in the data sample.

Fig 9 – Product Measure Temp Vs UCL/Target/LCL

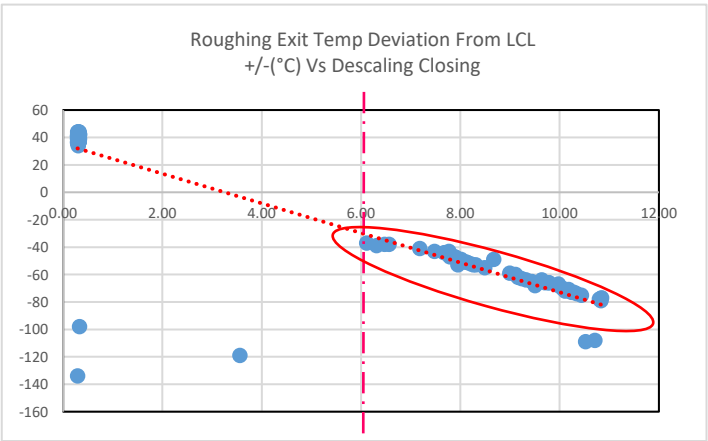
Fig 10 – Scatter Plot of Descaling Valve Closing Delay Against Temp Deviation at the roughing mill

Heat loss in the hot rolling operations is predominantly done through descaling water used to remove the build-up of oxide forming on the surface (Scale). The process is an automatically controlled function at each processing unit. The control of these descaling operations is carefully measured, monitored, and controlled. The valve has a proximity switch built in that can signal when the valve is physically open/closed. By using the measurements, the delay between being asked to open/close and the valve physically being open/closed can be measured. It is within this data that the root cause can be found (Fig 10).

Here the delay in valve operation to the closed position can be seen varying from between 0 and 11 seconds. The valve operation being slower to reach closed position leads to excess unwanted water being dumped on the slab as it is being processed causing unwanted and unexpected heat loss. A direct correlation between the temperature deviation from the LCL at the roughing mill, and excess water being used by a delayed closure of a water valve.

From the analysis of the data, the team was able to isolate and compare data from a range of variables against the temperature deviation from the roughing mill exit. The correlation or lack thereof was easily identified. Using this statistical approach to finding the root cause definitively identified the contributing factor and the engineering teams were then able to take the appropriate action. In this case the descaling water automatic valve worked within parameters when going from the closed position to the open position. But when being operated to return to the closed position there was significant delay in achieving this movement. The resulting excess water being dumped on the steel strip as it was being processed dropped the temperature of the steel product below the acceptable LCL. Also evident is the longer the valve takes to close, the further below the LCL the steel strip went. **Significantly, the valve operation only caused defective coils when it took 6 seconds or longer.**

After finding the root cause of this particular data sets deviation from expected parameters, the engineering teams went on to change the valve in question. A pneumatically actuated poppet valve with solenoid pilot. System pressure requirements are in the region of 200bar. Going forward the valve operation times will be added to production KPI's. After the valve change the first one hundred slabs processed were subject to the same data collection as before. As can be seen in **Fig 11** and **Fig 12** there is no deviation from the LCL of the temperature target at the roughing mill after the valve has been changed.

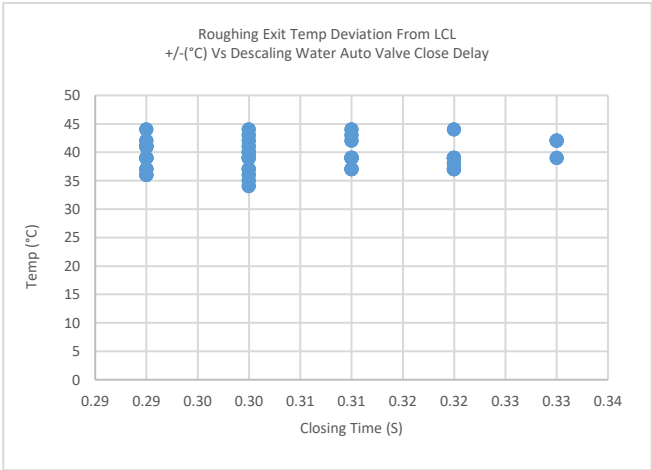
Fig 11 – Descaling Valve Close Delay After Change

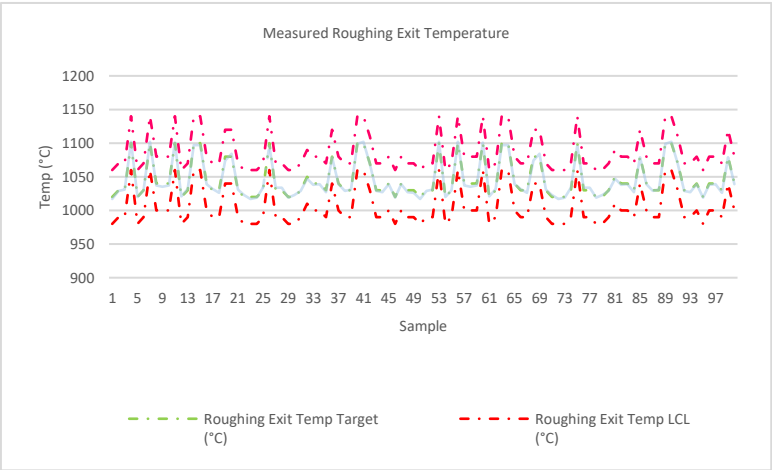
Fig 12 Measured Roughing Exit Temperature/Target/UCL/LCL
