**Programme : MSc – Motorsport**

**Engineering Module : Structural Integrity & Materials Evaluation**

**Assignment Title : Ultrasonic Attenuation Coefficient Determination and  
Probability of Sizing Analysis**

## Ultrasonic Attenuation Coefficient Determination

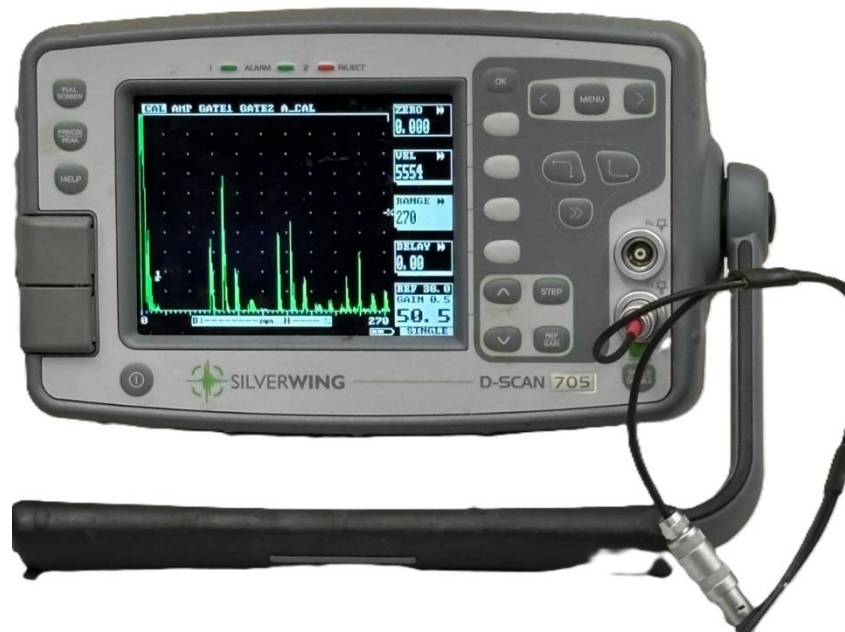
**Fig. 1: ultrasonic Flow detector**

waves and measure the time-of-flight (TOF) and signal amplitudes, was the main component. To enable wave propagation through the samples, a zero-degree ultrasonic probe running at 5 MHz was positioned perpendicularly on the test material surfaces and connected to the defect detector.

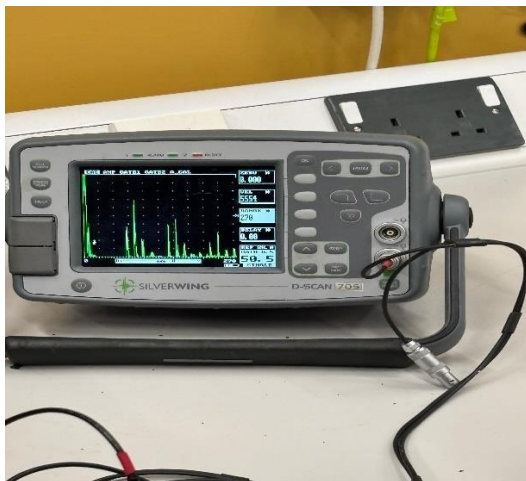
#### GRAPH

The brake disc's thickness, which the ultrasonic wave travelled through, was represented by a graph plotted against the distance. As predicted by the attenuation equation, the data points showed a linear trend. The attenuation coefficient, which measures how much the amplitude of the ultrasonic signal diminishes as it passes through the brake disc material, is shown by the slope of this line. The link between amplitude attenuation and distance travelled is validated by this graphical representation.

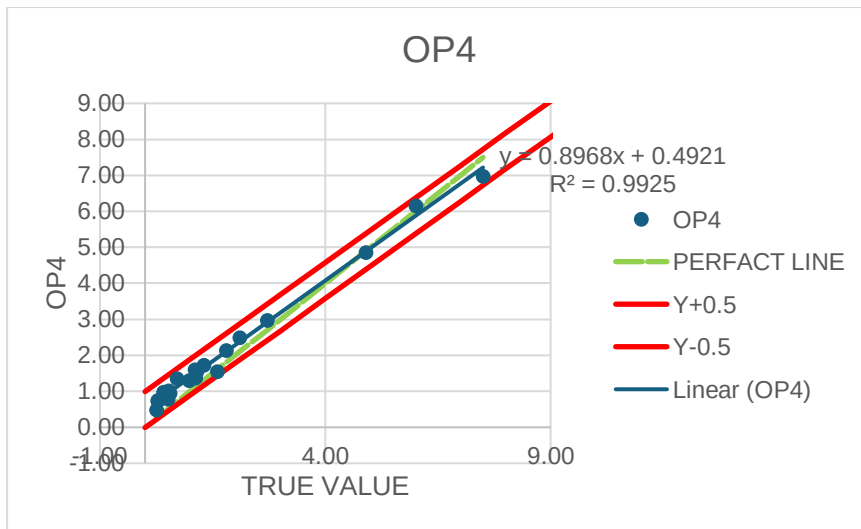
Different levels of measurement accuracy and consistency are highlighted by the regression modelling and error analysis for each of the ten operators. There is a discernible bias in a number of operators, since the measured sizes differ greatly from the actual defect sizes. Smaller standard deviations for readings from operators 4, 6, and 8 show comparatively low variability, suggesting greater consistency among problems. However, Operators 1 and 5 show more variability and larger mean errors, indicating that their technique or calibration needs to be improved. In spite of these discrepancies, the regression equations of the majority of operators show a rather strong linear relationship between

measured and true sizes. These results highlight how crucial it is to standardise the measurement process in order to reduce errors and guarantee uniformity in defect sizing among operators.
