**Programme : MSc – Automotive, Motorsport, Motorcycle Engineering**

**Module : Structural Integrity & Materials Evaluation**

**Assignment Title : Ultrasonic Attenuation Coefficient Determination and Probability of Sizing Analysis**

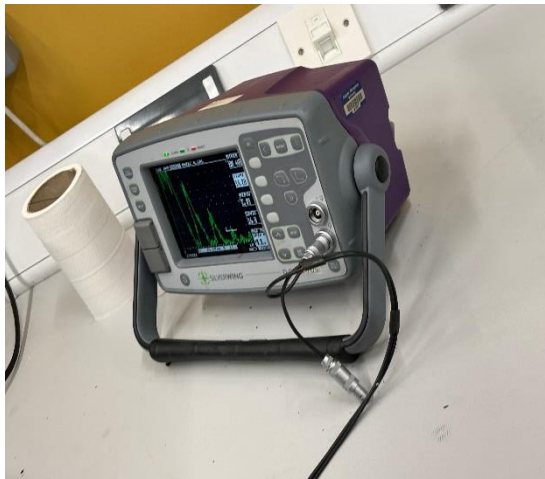
- **Ultrasonic Probe:** 5 MHz zero-degree probe for transmitting and receiving ultrasonic waves.
- **Pulser/Receiver Unit:** Generates high-frequency electrical signals and receives reflected signals from the material.
- **Digital Ultrasonic Flaw Detector:** This visualizes and analyzes ultrasonic signals.

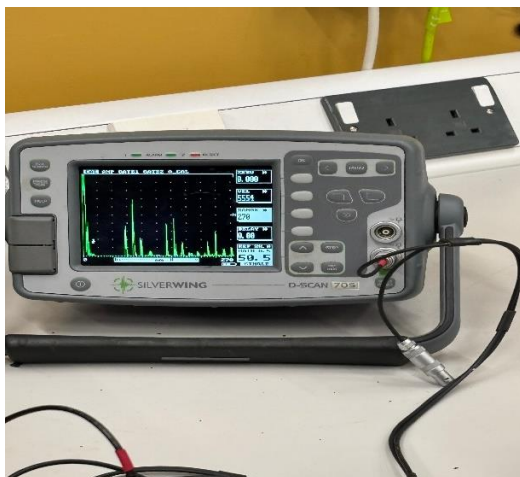
### Graph

Ultrasonic flaw detectors operate by emitting high-frequency sound waves into the material using a transducer. When these waves encounter a discontinuity or flaw, such as a crack or inclusion, they reflect back to the transducer. The detector then analyzes these returning echoes to determine the type, size, and location of the flaw, providing real-time, precise measurements crucial for material evaluation.
