Module name: Structural Integrity & Material Evolution

Assignment: Ultrasonic Attenuation Coefficient Determination and Probability of Sizing Analysis

# Part 1: Ultrasonic Attenuation Coefficient Determination

## Part 2: Through Wall Sizing Accuracy Analysis

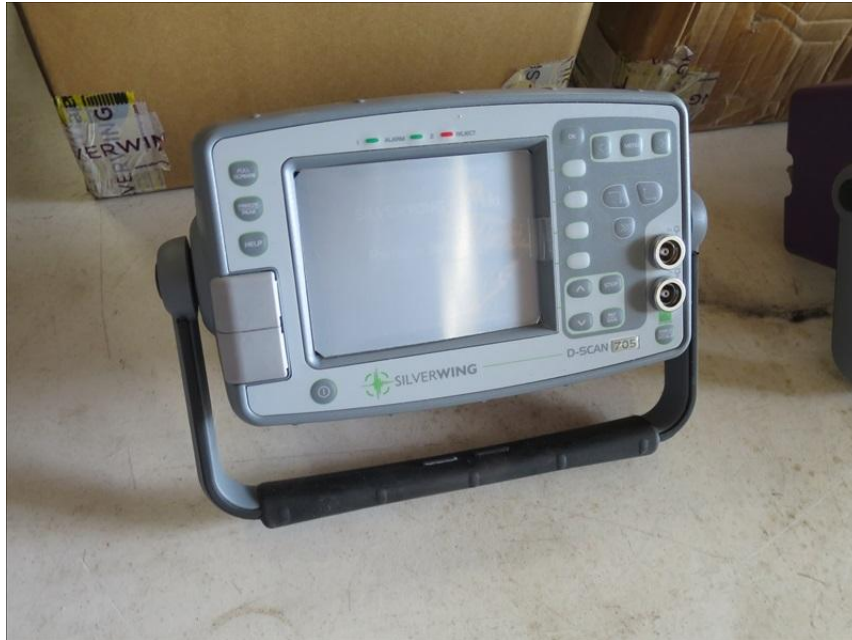
Figure 1.1 Silver wing D scan 705

Ultrasonic flaw detector (e.g., silver wing D scan 705)
