## APPENDIX 1: PROJECT DESIGN

- 1.1.1 The National Trust has invited Oxford Archaeology North to submit proposals for a historic landscape survey and condition assessment of their holdings at Thorneythwaite Farm, Borrowdale, which was purchased in 2016. This is intended to record and evaluate the archaeological and historical features, which will inform the management of the estate, and in particular will serve to inform the compilation of an overall masterplan. It is also required to undertake a condition survey to establish a baseline for future archaeological monitoring. The aim of the survey is to identify the landscape character and significance of the landscape. It will examine the archaeological history and landscape development as part of this process and will present the results of the survey, allowing the National Trust a comprehensive understanding of the overall landscape. The study area is owned by the National Trust and is 1.2 sq km in extent.

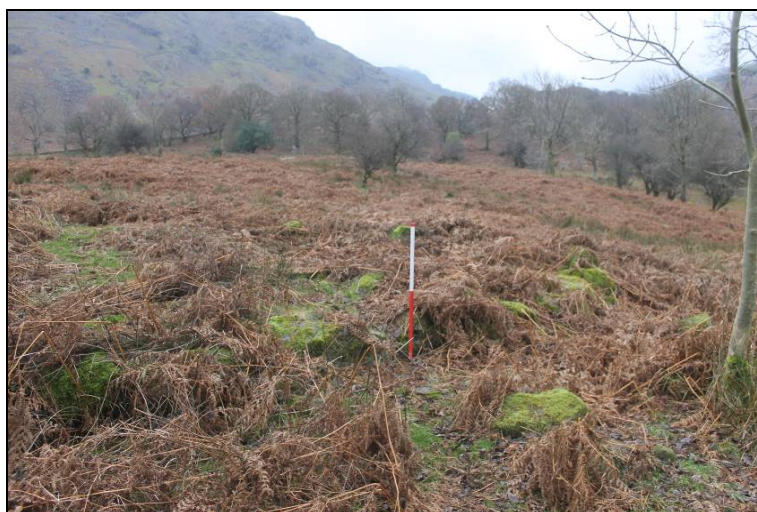
| <b>Condition</b> | Fair |
| <b>Damage Agents</b> | Bracken |
| <b>Description</b> | An L-shaped wall foundation constructed of large scree stones extending south-west/north-east for approximately 9m, it then turns south-east for approximately 10m. It is 1m wide by 0.6m high. In addition, there is a rough pile of clearance stones immediately adjacent on the upslope eastern side but with no obvious signs of structure. The wall is depicted as a fragmentary part of the west side of an enclosed field on the First Edition OS mapping, the rest of the field was depicted as a veteran treeline. The boundary was not depicted on the tithe map (1842). |

| <b>Recommendations</b> | Monitor; bracken removal as appropriate |

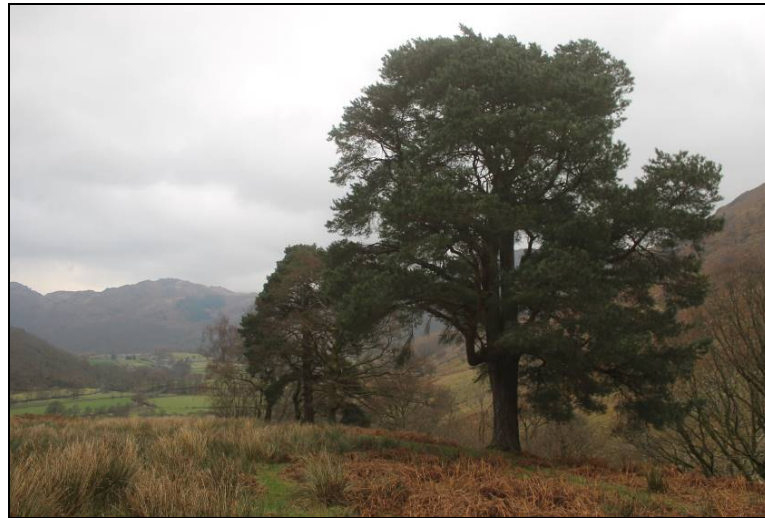
| <b>Condition</b> | Fair |
| <b>Damage Agents</b> | Bracken |

**Description** Several large fir trees to the south-west of the old saw mill (LDNPA HER 11915), comprise the last remnants of a triangular area of plantation woodland in the south-east corner of a field that was depicted on the Second Edition OS mapping.

| <b>Recommendations</b> | Monitor; bracken removal as appropriate |

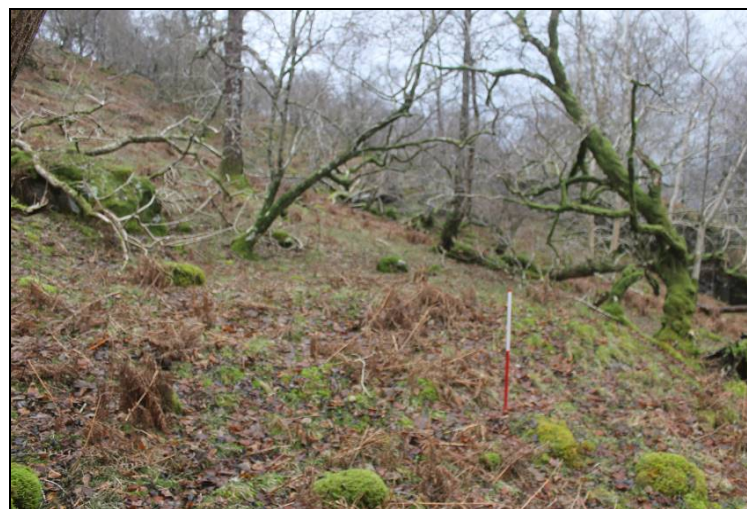
**Site Number** 3

**Condition** Fair

**Damage Agents** Bracken

**Description** An oval charcoal-burning platform, 10m long by 8m wide and 1m high downslope on the north side.

**Recommendations** Monitor; bracken removal as appropriate

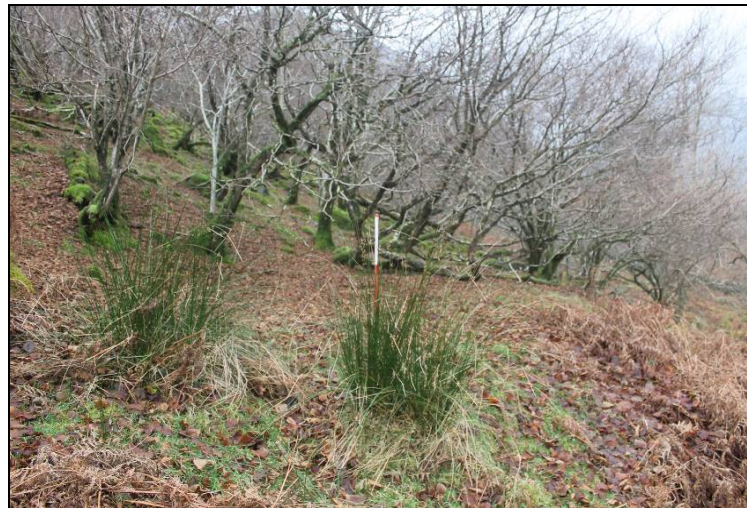
| <b>Site Number</b> | <b>4</b> |

| <b>Condition</b> | Fair |
| <b>Damage Agents</b> | Bracken |
| <b>Description</b> | An oval charcoal-burning platform, 10m long by 6m wide and 1.5m high downslope on the north side. |

| <b>Recommendations</b> | Monitor; bracken removal as appropriate |

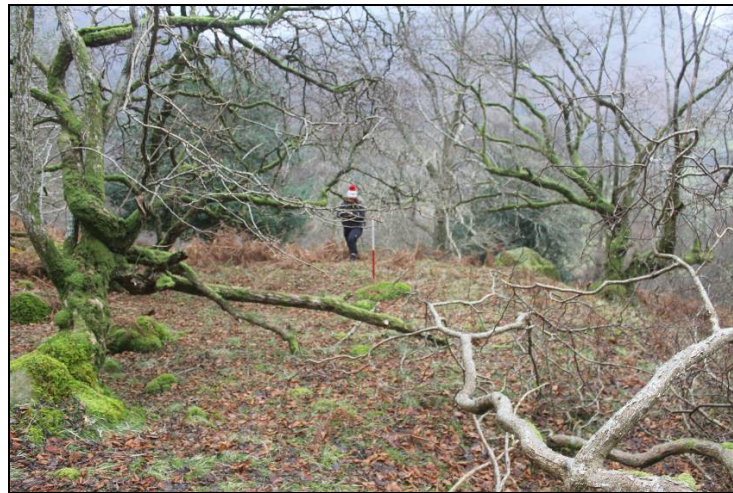
| <b>Site Number</b> | <b>5</b> |

| <b>Condition</b> | Fair |
| <b>Damage Agents</b> | Bracken |
| <b>Description</b> | An oval charcoal-burning platform, 8m long by 7m wide and 1m high downslope on the north side. It has kerbed walling on the downslope side. |

| <b>Recommendations</b> | Monitor; bracken removal as appropriate |

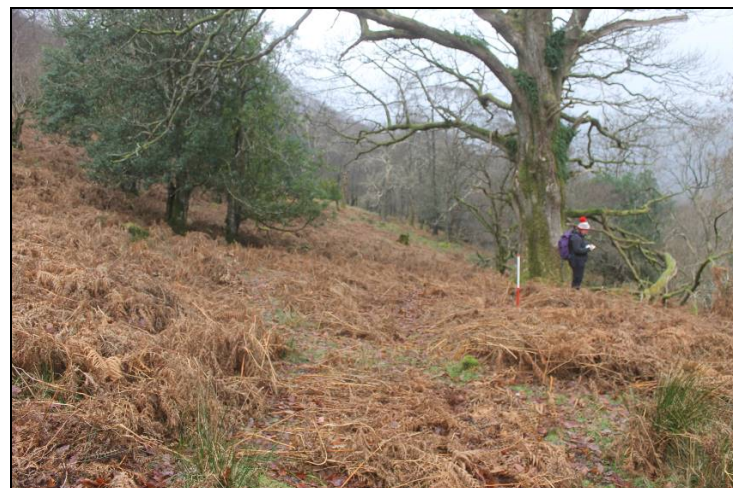
| <b>Condition</b> | Fair |
| <b>Damage Agents</b> | Bracken |
| <b>Description</b> | A circular charcoal-burning platform, 8m in diameter and 1m high downslope on the north side. It has kerbed walling on the downslope side. |

| <b>Recommendations</b> | Monitor; bracken removal as appropriate |

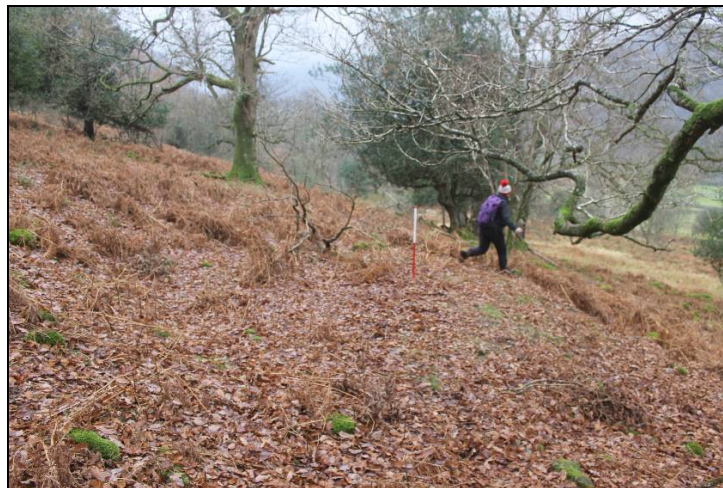
| <b>Condition</b> | Fair |
| <b>Damage Agents</b> | Bracken |
| <b>Description</b> | An oval charcoal-burning platform, 8m long by 7m wide and 1m high downslope on the north side. |

| <b>Recommendations</b> | Monitor; bracken removal as appropriate |

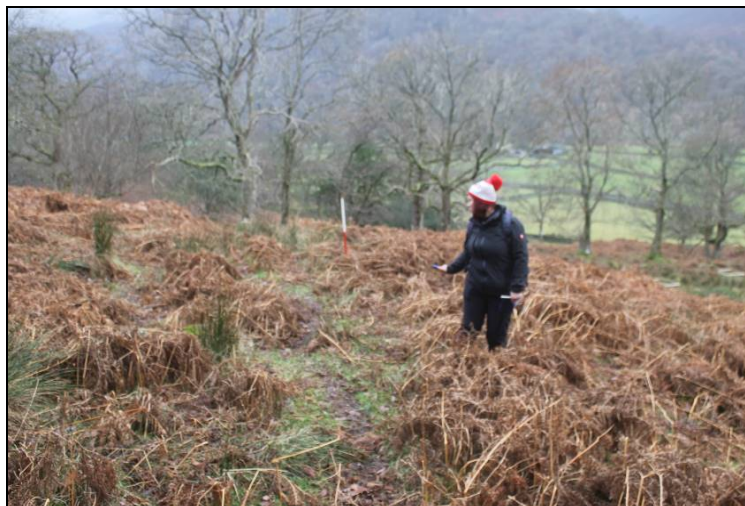
| <b>Site Number</b> | <b>8</b> |

| <b>Condition</b> | Fair |
| <b>Damage Agents</b> | Bracken |
| <b>Description</b> | An oval charcoal-burning platform, 8m long by 6m wide and 1.5m high downslope on the north side. |

| <b>Recommendations</b> | Monitor; bracken removal as appropriate |

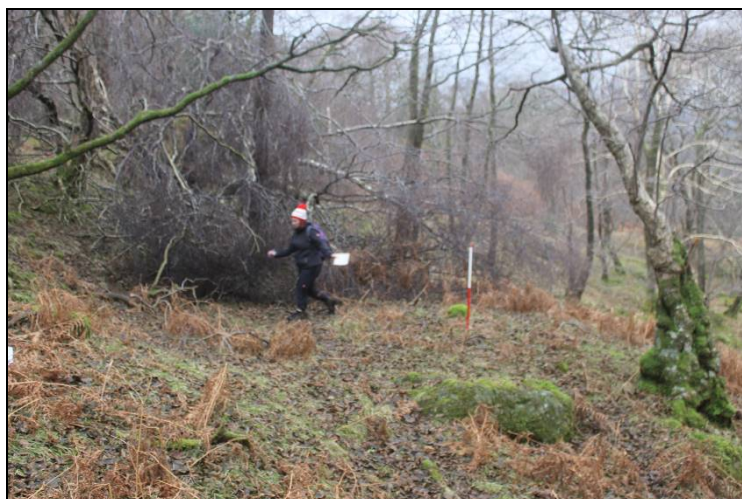
| <b>Condition</b> | Fair |
| <b>Damage Agents</b> | Bracken |
| <b>Description</b> | A circular charcoal-burning platform, 8m in diameter and 1.5m high downslope on the north side. |

| <b>Recommendations</b> | Monitor; bracken removal as appropriate |

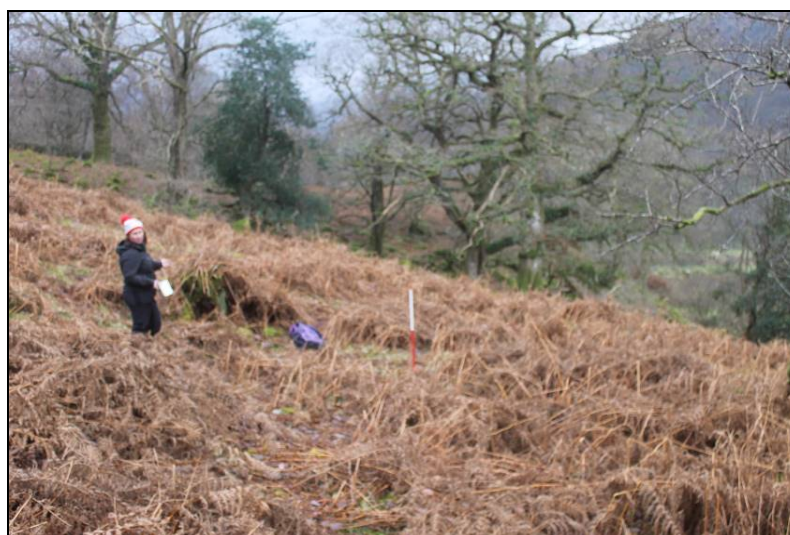
| <b>Site Number</b> | <b>10</b> |

| <b>Condition</b> | Fair |
| <b>Damage Agents</b> | Bracken |
| <b>Description</b> | A circular charcoal-burning platform, 7m in diameter and 0.5m high downslope on the north side. There is a flat-topped stone just upslope to the south, which may have been used for observation of the charcoal-making process. |

| <b>Recommendations</b> | Monitor; bracken removal as appropriate |

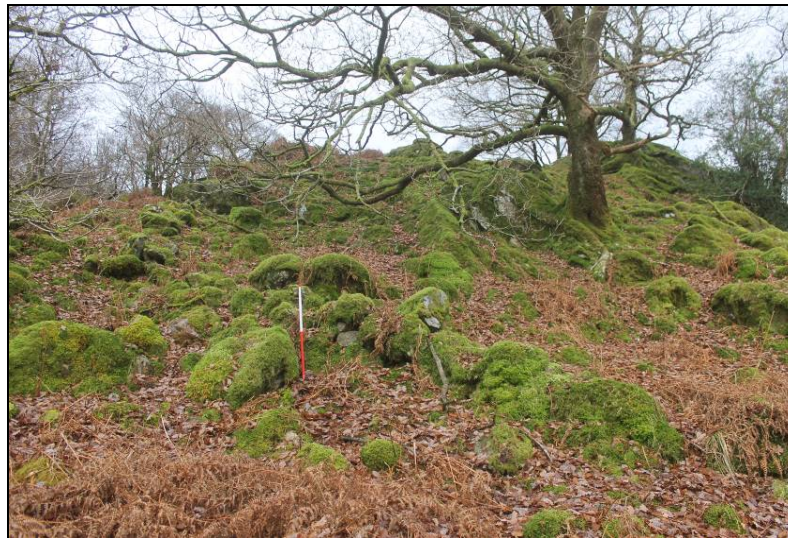
| <b>Condition</b> | Poor |
| <b>Damage Agents</b> | Bracken |
| <b>Description</b> | A fragmentary curvilinear wall foundation was identified on the north-east side of small craggy outcrop. It measures approximately 20m long by 1m wide and up to 0.7m high, though mostly collapsed. The knoll was depicted as a small coniferous plantation on the Second Edition OS mapping. |

| <b>Recommendations</b> | Monitor; bracken removal as appropriate |

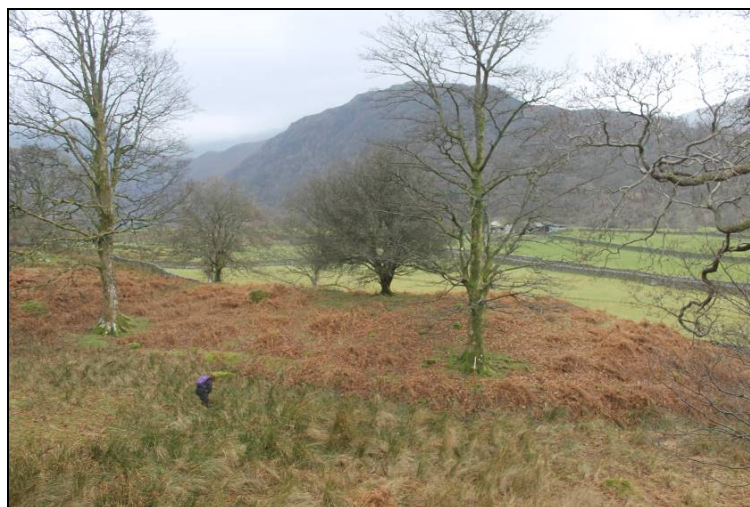
| <b>Condition</b> | Fair |
| <b>Damage Agents</b> | Bracken |

**Description** A sub-triangular enclosure with a fragmentary upcast turf boundary bank and external ditch. The boundary survives best on the east side, where it measures up to 3m wide by 0.5m high. The enclosure was depicted on the Second Edition OS mapping as a coniferous plantation, although there are no coniferous trees surviving within the enclosure. The tithe map defined this enclosure as part of a small pasture field called 'Under Wood'.

| <b>Recommendations</b> | Monitor; bracken removal as appropriate |

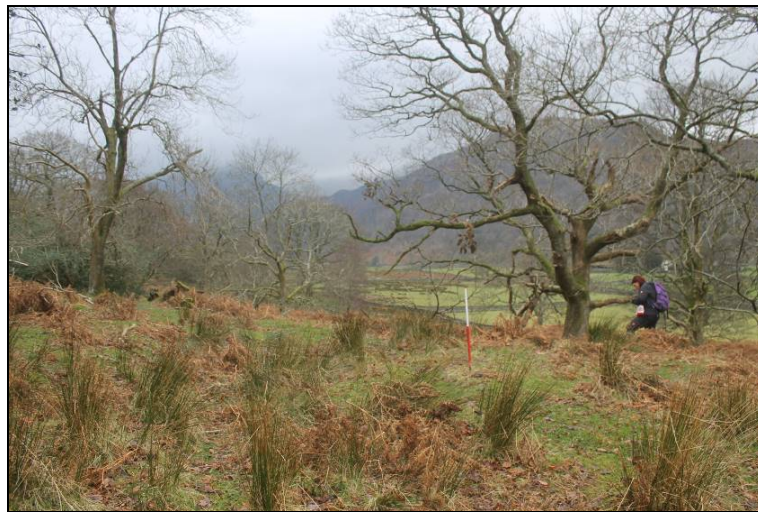
| <b>Site Number</b> | <b>13</b> |

| <b>Condition</b> | Fair |
| <b>Damage Agents</b> | Bracken |
| <b>Description</b> | An oval charcoal-burning platform, 8.5m long by 8m wide and 0.5m high downslope on the north side. The east side is not very visible. |

| <b>Recommendations</b> | Monitor; bracken removal as appropriate |

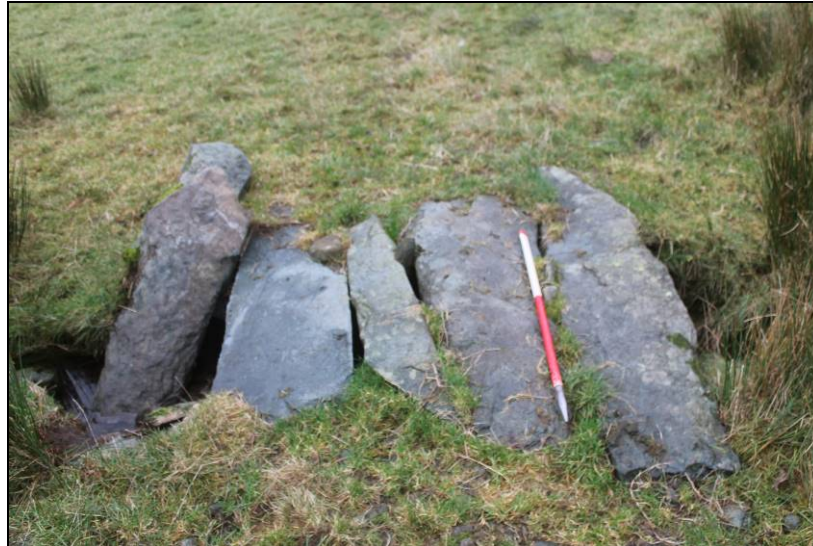
| <b>Site Number</b> | <b>14</b> |

| <b>Condition</b> | Poor |
| <b>Damage Agents</b> | Erosion, flooding |
| <b>Description</b> | A simple slab bridge across a narrow drainage gully. It consists of six angular quarried stone slabs, each measuring approximately 2 x 0.5m. In total, the bridge is 2.5m square. Two of the slabs have been displaced. |

| <b>Recommendations</b> | Monitor; visit following flood events |

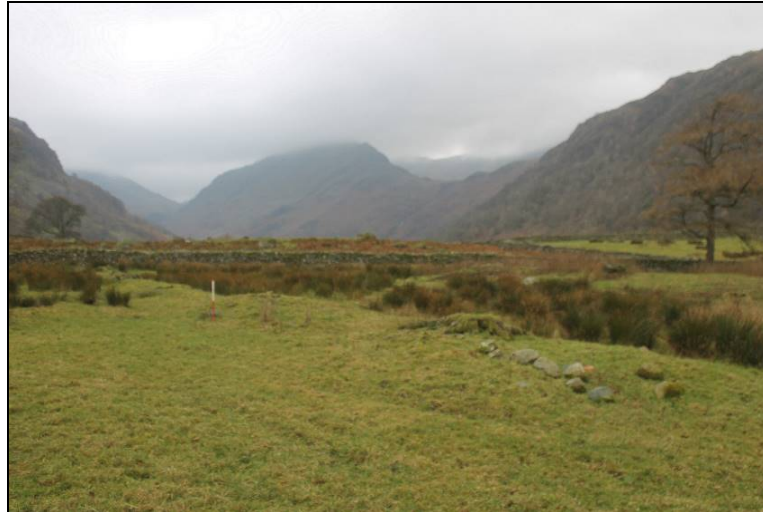
| <b>Condition</b> | Poor |
| <b>Damage Agents</b> | Modern dumping, erosion, access activity |

**Description** An enclosed farmstead/settlement site beneath the junction of four modern field boundaries immediately south-east of Thorneythwaite Farm. The well-defined enclosure bank, consisting of packed turf-covered small/medium-sized stones (with some boulders present), is D-shaped in plan, and measures at least 85 x 80m in extent. The enclosure bank is 2-3m wide by up to 0.4m high. The outer boundary is evident on the north, west and east sides and is almost intact in the north-east quadrant. The field in the west quadrant has been improved and the enclosure bank remains as a slight earthwork feature. The field to the south remains rough, unimproved pasture, with many small sections of sub-divisional walling and possible structural elements evident, including a U-shaped earthwork (6 x 6m in extent by 0.2m high) that may be the end of a rectangular structure, but this is masked by the vegetation and both this and the walling have possibly been denuded by stone-picking to create the modern field walls. The eastern side of the enclosure abuts a small stream. The settlement is located in an elevated position on the north side, and in the lee of, an end moraine. This protected it from flooding on the valley floor. The present Thorneythwaite Farm is in a similar position on the moraine, a little further to the north-west. The north-east quadrant of the enclosure was depicted as a plantation on the First Edition OS mapping. Stumps of coniferous trees remain on top of the banks, but these are clearly not contemporary with the creation of the plantation. The north-east quadrant has also been subject of modern dumping internally, which masks some of the features within. It is clear that there are several sub-divisional boundaries in this area as well as a possible large platform, up to 29m in diameter, that may have been the focal point for a domestic structure.

| <b>Recommendations</b> | Proactive conservation measures required, following which, regular monitoring |

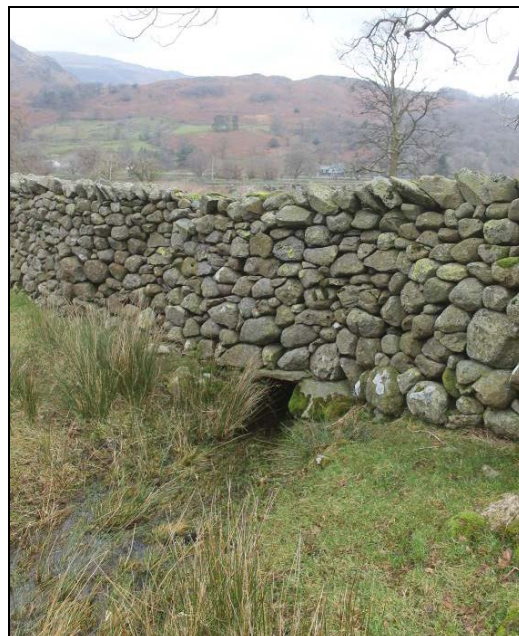
| <b>Condition</b> | Fair |
| <b>Damage Agents</b> | Flooding |
| <b>Description</b> | A small water smoot on the course of a narrow stream. It consists of a single slab forming a lintel above an aperture, and measures 0.3m wide by 0.4m high. |

| <b>Recommendations</b> | Monitor; visit following flood events |

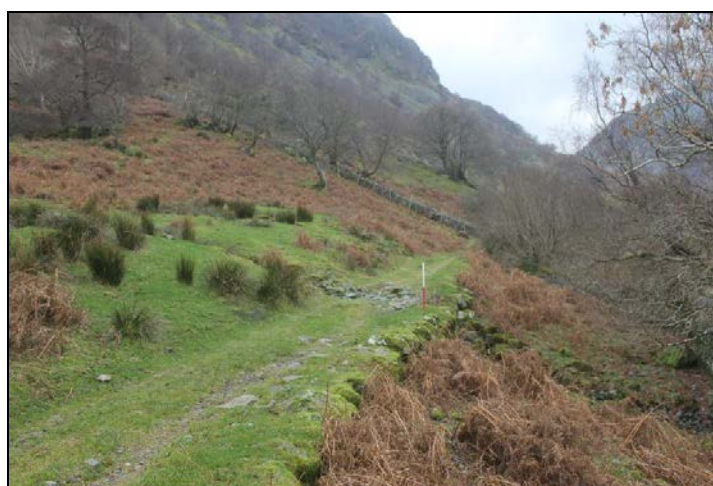
| <b>Site Number</b> | <b>17</b> |

| <b>Condition</b> | Fair |
| <b>Damage Agents</b> | Erosion |

**Description** A packhorse track follows the eastern side of the valley, just outside the enclosed lands east of the River Derwent, on the lower wooded slopes of Thorneythwaite Fell. The trackway is depicted on the historical OS mapping, extending in a north-east/south-west direction from just south of Strands Bridge, continuing opposite both Thorneythwaite Farm and Seathwaite village, further up to the head of the valley. The section within the present survey area is approximately 1050m in long. The best surviving section, located 300m south of Thorneythwaite Farm, consists of a well-defined, 2m-wide trackway, cut slightly into the hillside, with a large retaining wall up to 1m high downslope on the north-west side. The track runs in between Thorneythwaite Farm and the potentially early enclosed farmstead/settlement site (Site 15). It passes immediately adjacent to the latter farmstead, where its original route passed through a blocked gateway (Site 38).

| <b>Recommendations</b> | Monitor |

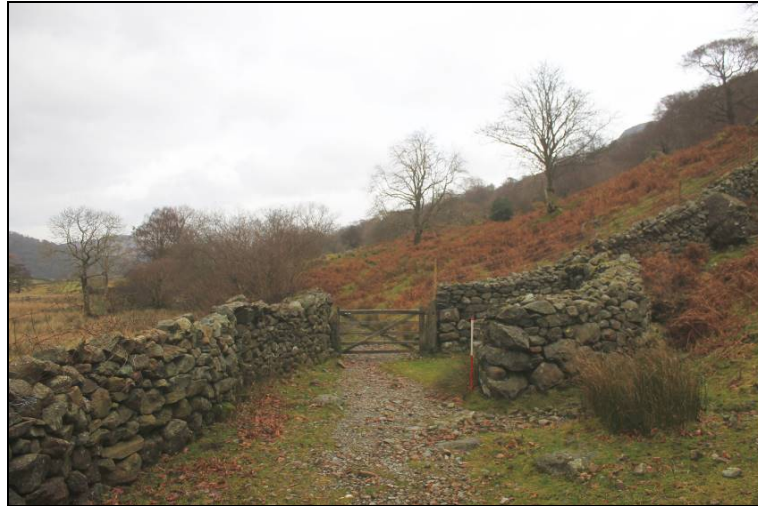
| <b>Site Number</b> | <b>18</b> |

| <b>Condition</b> | Fair |
| <b>Damage Agents</b> | Erosion, bracken |

**Description** A D-shaped sheepfold at the junction of an intake wall and the lowland enclosed fields south of Thorneythwaite Farm. The structure is depicted on the Second Edition OS mapping. It consists of well-constructed, double-thickness stone walls and is approximately 6m square. It is constructed from field clearance and scree stones, with one larger boulder in the foundations, and slanting coping stones on top. There are two angular gateposts on its northern entrance, where the packhorse track (Site 17) passes through it.

| <b>Recommendations</b> | Monitor; bracken removal as appropriate |

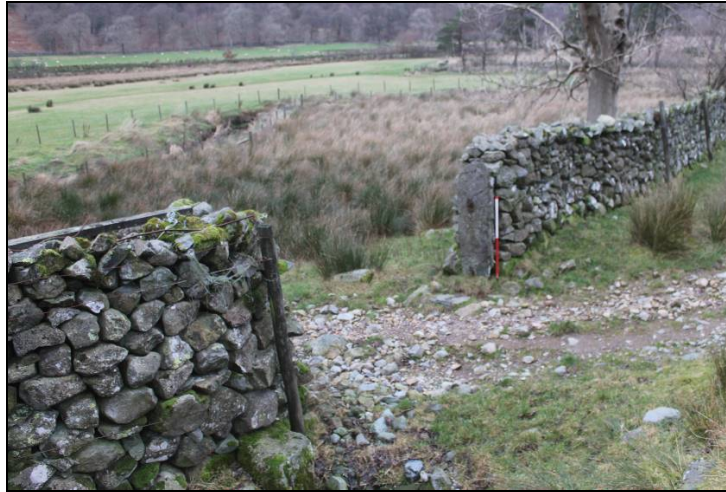
| <b>Condition</b> | Fair |
| <b>Damage Agents</b> | Erosion |

**Description** A gateway, at which a short section of trackway splits from the packhorse track (Site 17) and runs into enclosed fields. The gateway has a single, quarried slab gatepost on the north side. It measures approximately 1.5m long by 0.4m wide, and is depicted upon the historical OS mapping.

| <b>Recommendations</b> | Monitor |

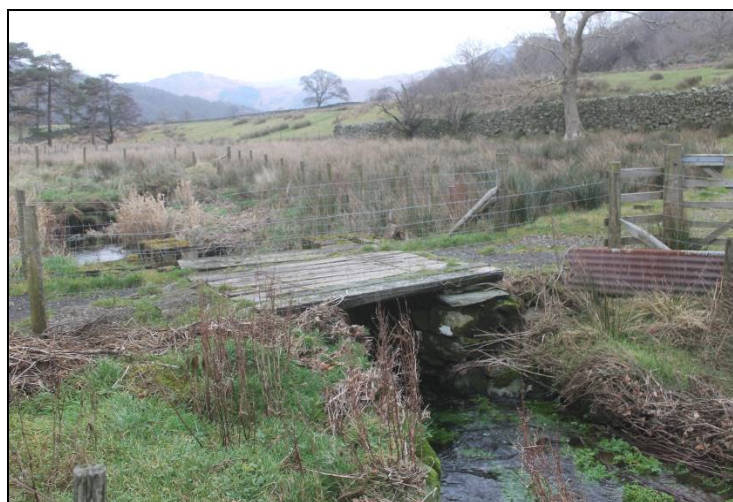
| <b>Condition</b> | Poor |
| <b>Damage Agents</b> | Flooding, erosion |
| <b>Description</b> | Abutments for a small bridge carrying part of a farm track across Black Sike. It has modern breeze blocks on the northern end but the rest has probably original stone footings. The bridge's superstructure consists of railway sleepers. It is depicted upon the historical OS mapping. |

| <b>Recommendations</b> | Monitor; visit following flood events |

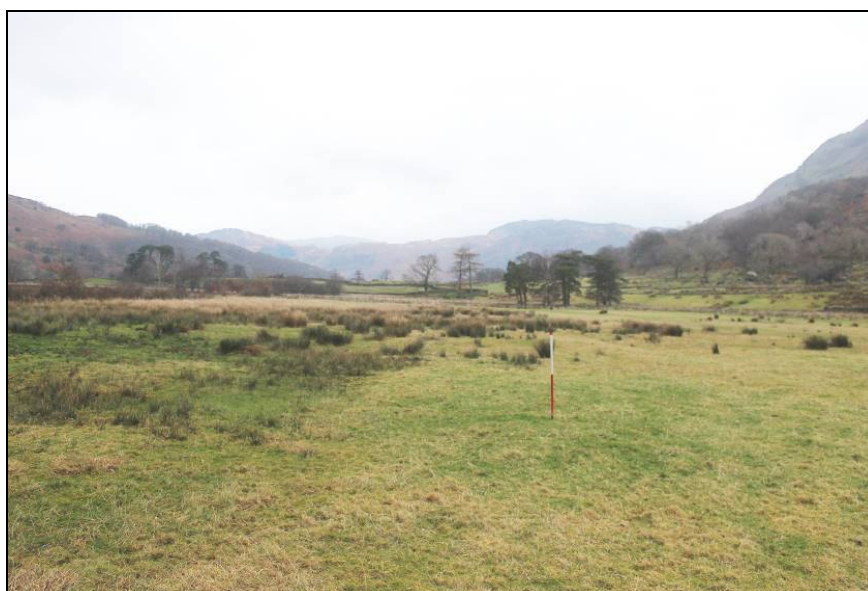
| <b>Site Number</b> | <b>21</b> |

| <b>Condition</b> | Fair |
| <b>Damage Agents</b> | Flooding |

**Description** A shallow, oval turf-covered mound on the eastern side of an oval boggy area within enclosed farmland between the River Derwent and Black Sike. The feature has a rounded top and gently sloping sides, and measures approximately 10m long by 5m wide but is only 0.25m high. The surrounding field contains obvious palaeochannels. It is probably not a burnt mound, although it is definitely more visible because of the lush green grass on the top. Aerial photography suggests that there is a possible further kidney-shaped mound on the northern end of the boggy area (just beyond the present study area), although this was not identified in the Borrowdale landscape survey (OA North 2007).

| <b>Recommendations</b> | Monitor; visit following flood events |

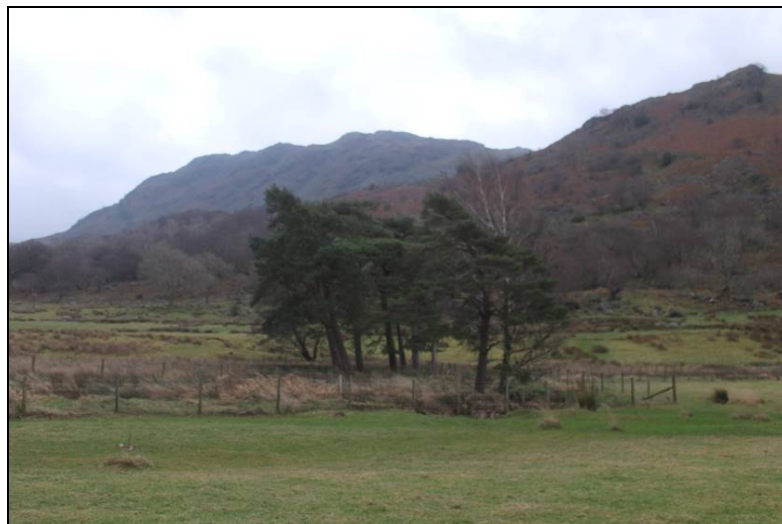
| <b>Site Number</b> | 22 |

| <b>Condition</b> | Fair |
| <b>Damage Agents</b> | Bracken |
| <b>Description</b> | A rectangular coniferous plantation adjacent to the east side of Black Sike and south of Thorneythwaite Farm. It is depicted from 1867. Several fir trees are still evident. |

| <b>Recommendations</b> | Monitor; bracken removal as appropriate |

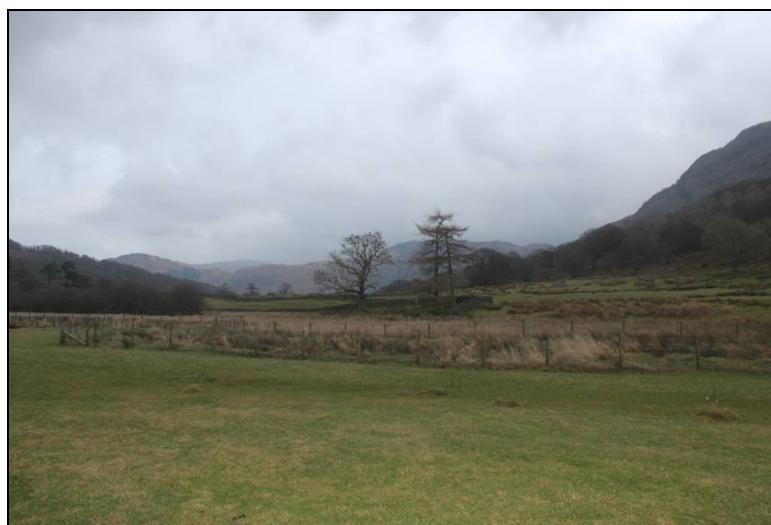
| <b>Condition</b> | Fair |
| <b>Damage Agents</b> | Bracken |
| <b>Description</b> | A small square coniferous plantation south of Thorneythwaite Farm, depicted on the OS First Edition map of 1867. Several fir trees are still evident. |

| <b>Recommendations</b> | Monitor; bracken removal as appropriate |

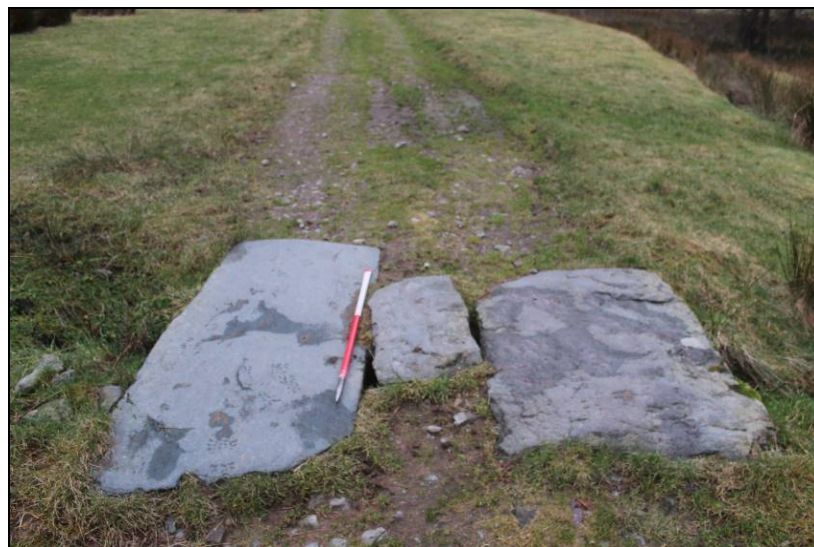
| <b>Condition</b> | Fair |
| <b>Damage Agents</b> | Flooding |
| <b>Description</b> | A small slab-topped culvert carrying the packhorse track (Site 17) over a narrow drainage gully. Two slabs have dimensions of 1.5 x 0.75m, and the smaller central slab is 0.5 x 0.45m. It is depicted on OS mapping from 1867. |

| <b>Recommendations</b> | Monitor; visit following flood events |

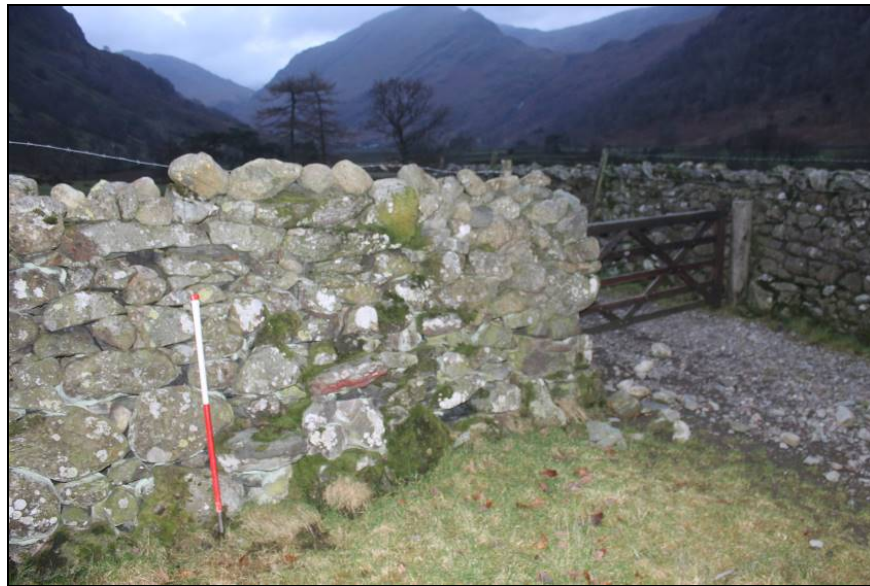
| <b>Site Number</b> | 25 |

| <b>Condition</b> | Fair |
| <b>Description</b> | A three-stepped through stile adjacent to a gateway south of Thorneythwaite Farm. |

| <b>Recommendations</b> | Monitor |

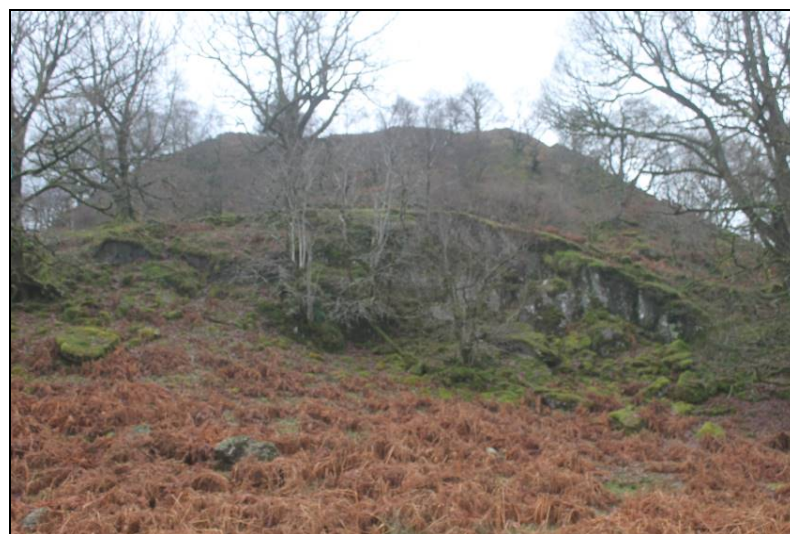
| <b>Condition</b> | Fair |
| <b>Damage Agents</b> | Bracken |

**Description** The foundations of a collapsed, curvilinear double-thickness stone wall defining the upper south side of a quarried crag face. The wall is orientated roughly west/east and measures approximately 37m long by 1.3m wide and 0.5m high. The possible quarry face measures 25m long by up to 4m high.

| <b>Recommendations</b> | Monitor; bracken removal as appropriate |

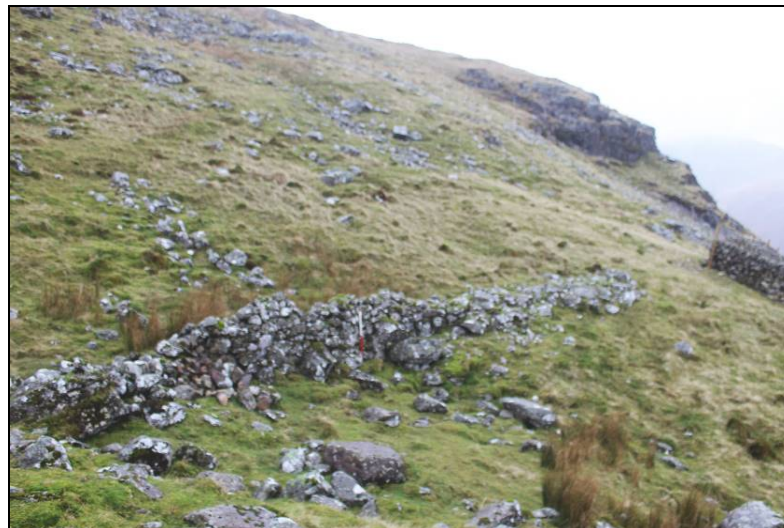
| <b>Condition</b> | Poor |
| <b>Description</b> | A slightly curvilinear wall of a sheep shelter, external to the south-east corner of the southern intake on Thorneythwaite Fell. It extends towards the corner of the intake wall and is mostly collapsed. It is a double-thickness wall constructed of scree stones, and measures approximately 20m long by 1.2m wide, surviving up to 1.4m high in places. |

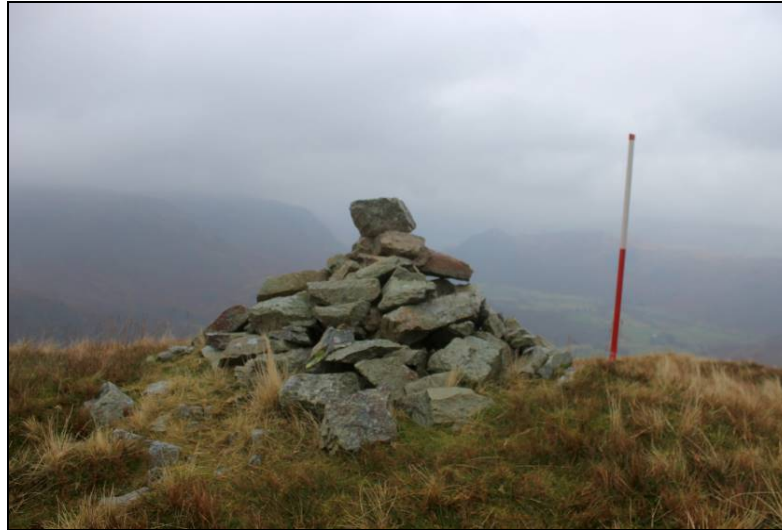
| <b>Site Number</b> | 28 |

| <b>Description</b> | A conical scree-constructed boundary marker, or walker's cairn, located on the northern flank of Capell Crag on Thorneythwaite Fell. It is relatively near to the modern footpath. It measures approximately 2m in diameter by up to 0.8m high. |

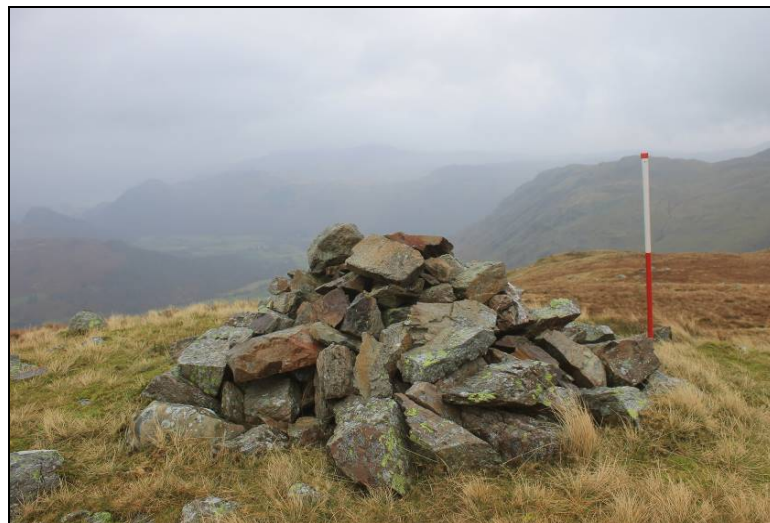
| <b>Description</b> | A conical scree-constructed boundary-marker cairn on the summit of Capell Crag on Thorneythwaite Fell. It measures approximately 2.5m in diameter by up to 0.75m high. It is depicted as a triangulation pillar on the Second Edition OS mapping. |

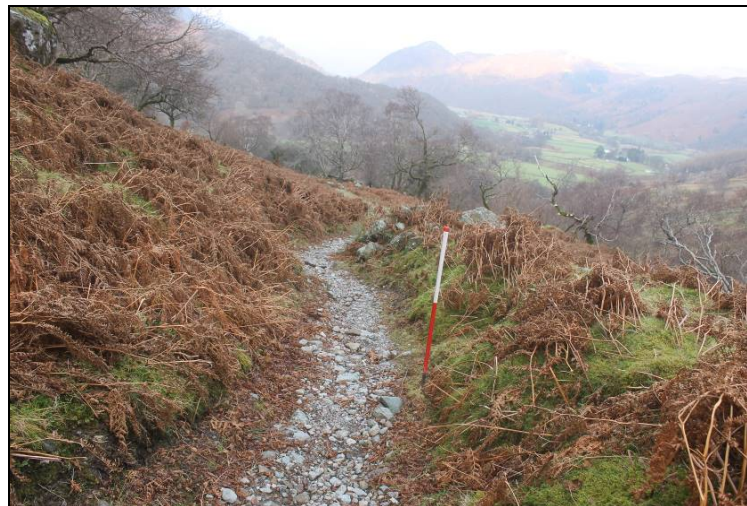
**Description** A sinuous, braided hollow-way leading upslope, on the northern flank of Thorneythwaite Fell. It ascends from Thorneythwaite Farm and reaches a series of sheepfolds/shelters nestled in Combe Gill, just outside the intakes (and beyond the present survey area). The modern footpath continues from there south up Capell Crag. The section of trackway within the present survey area measures at least 875m long and, where it is well preserved, it has a V-shaped profile up to 3m wide by 1m deep. The V-shaped profile may be indicative of its use as a peat sledway, as well as being for livestock access.

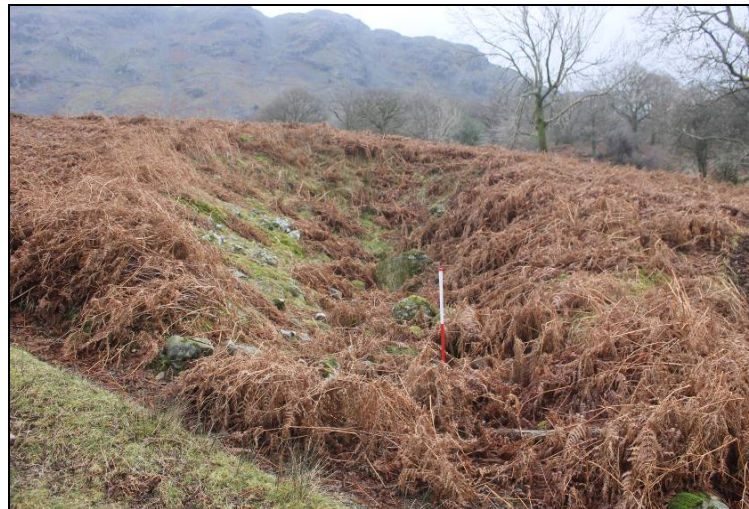
| <b>Site Number</b> | <b>31</b> |

| <b>Description</b> | Teardrop-shaped quarry adjacent to the south side of the mountain trackway leading up Thorneythwaite Fell (Site 30). It measures approximately 15m long by 9m wide and is up to 3m deep. |

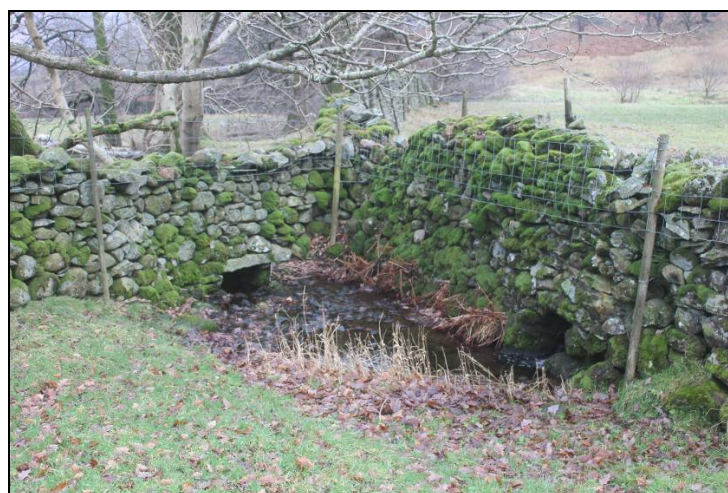
| <b>Description</b> | A pair of small water smoots located in the north-east corner of an enclosed field near the confluence of a small tributary with the River Derwent. Each measures up to 0.3m wide by 0.4m high, with a single slab lintel over a squared aperture. |

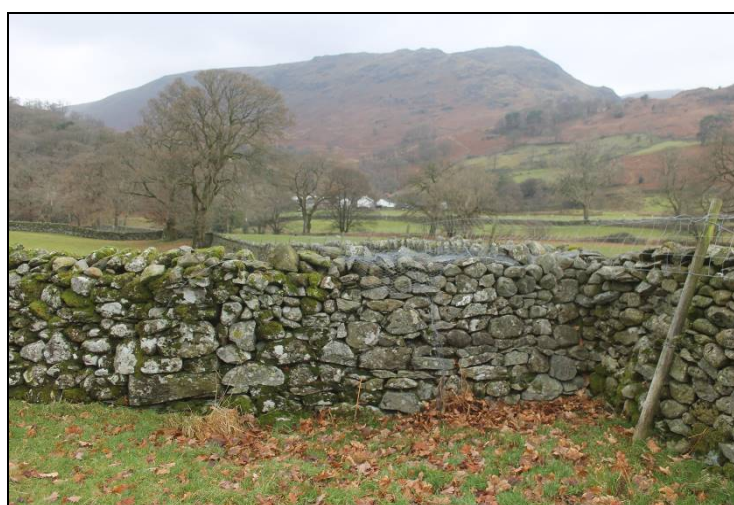
measures approximately 4m wide by 1.5m high. The wall it is within was not depicted upon the tithe map (1842) but was first shown on the First Edition OS mapping.

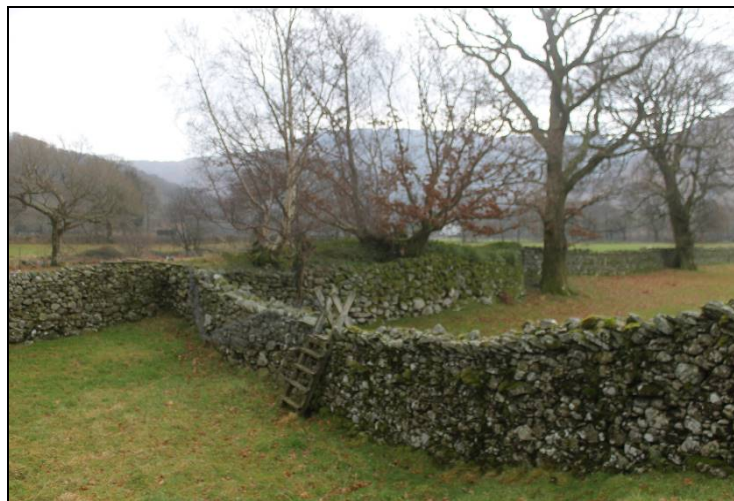
| <b>Description</b> | A teardrop-shaped consumption bank in the northern corner of a field boundary in an enclosed field north of Thorneythwaite Farm. It is almost completely infilled with cleared stone in the centre and there are several scrubby trees growing through it. It measures approximately 25m long by up to 1.5m high. |

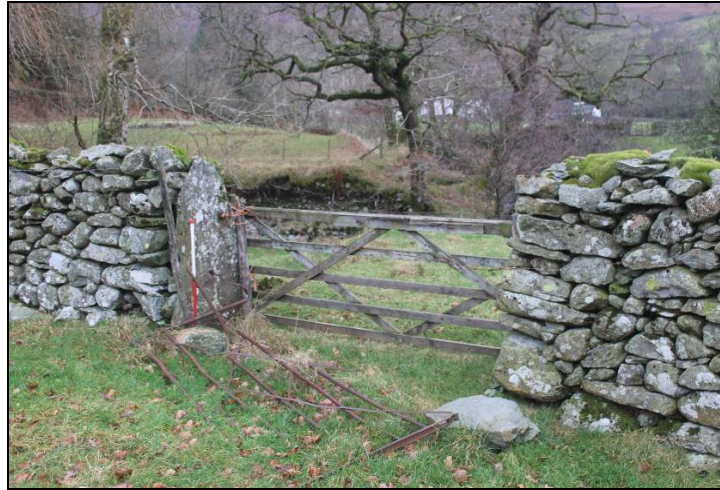
| <b>Site Number</b> | 37 |

| <b>Description</b> | A gateway leading to the site of the original farm/footbridge over the River Derwent at Nichol Dub. There is a single large slab gatepost on the west side. It measures 1.5m high by 1m wide. |

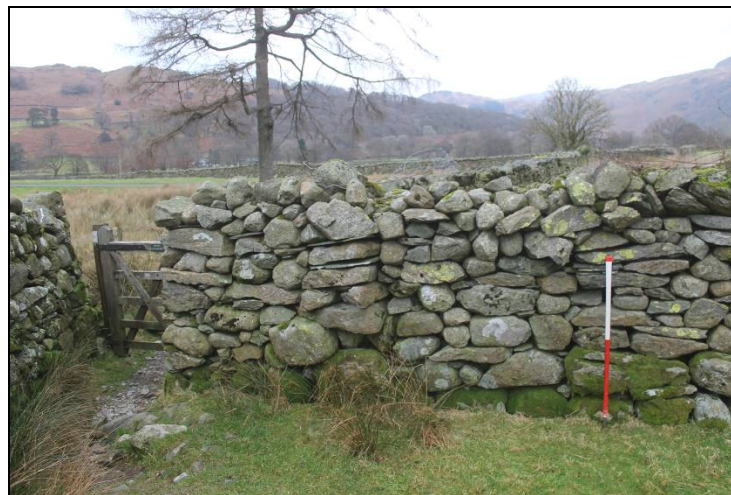
| <b>Description</b> | A narrow blocked field gate (not modern farm-vehicle width) located on the original alignment of the packhorse track (Site 17) where it passes the enclosed settlement/farmstead (Site 15). The route, now a public footpath, has been diverted north of the adjacent field wall. It measures approximately 1.25m wide by 1.5m high. |

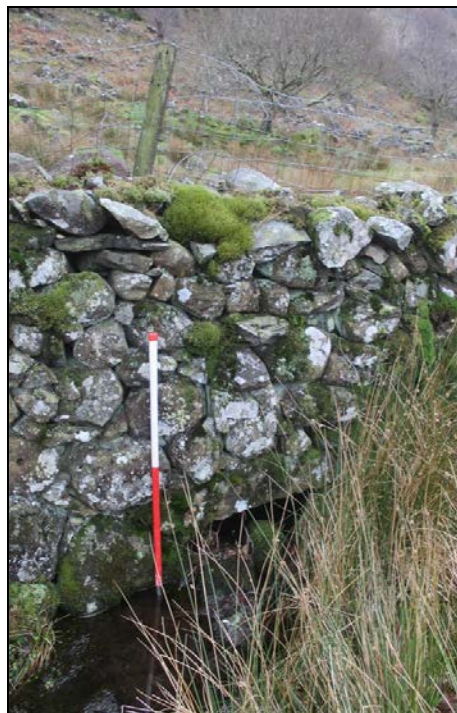
| <b>Description</b> | A single small water smoot on the alignment of a stream flowing down Thorneythwaite Fell and into enclosed fields south-east of Thorneythwaite Farm. It consists of a single slab lintel over a small squared aperture, and is 0.6m wide by 0.3m high. |

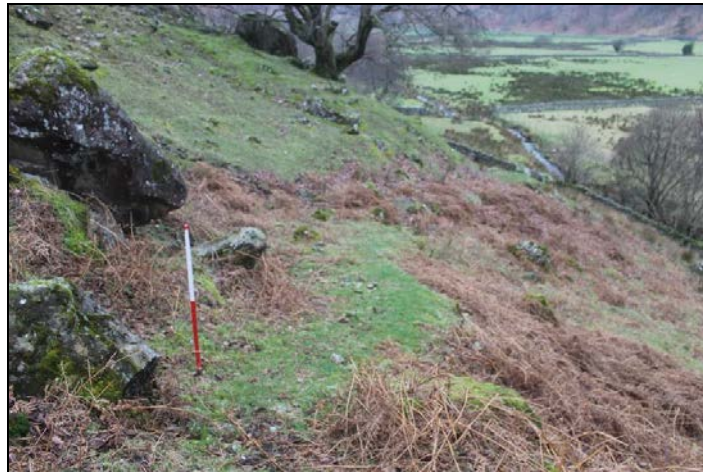
| <b>Site Number</b> | <b>40</b> |

Fell. The damaged southern end would have originally met the packhorse track running along the foot of this side of the valley (Site 17). It leads upslope south-west/north-east and possibly zig-zags past a structure (Site 63), although the route there is unclear. There is a definite continuation beyond the point where the track is crossed by a later intake wall and it turns north and descends back down to the packhorse track. The visible route is approximately 136m long by 2.5m wide.

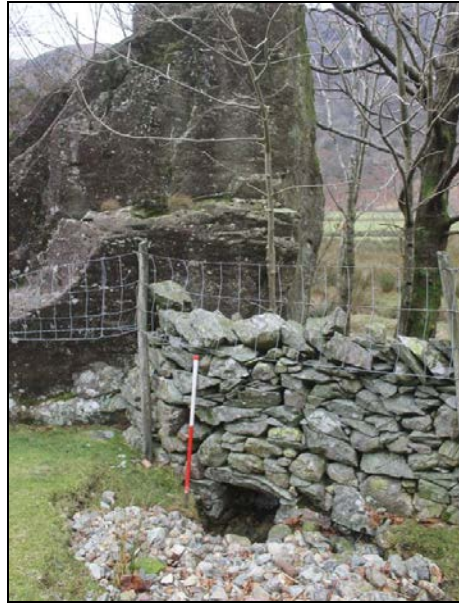
| <b>Description</b> | A small (0.6m wide by 0.3m high) water smoot; a single slab lintel over a small squared aperture. It is situated on a stream flowing down Thorneythwaite Fell and into Black Sike. |

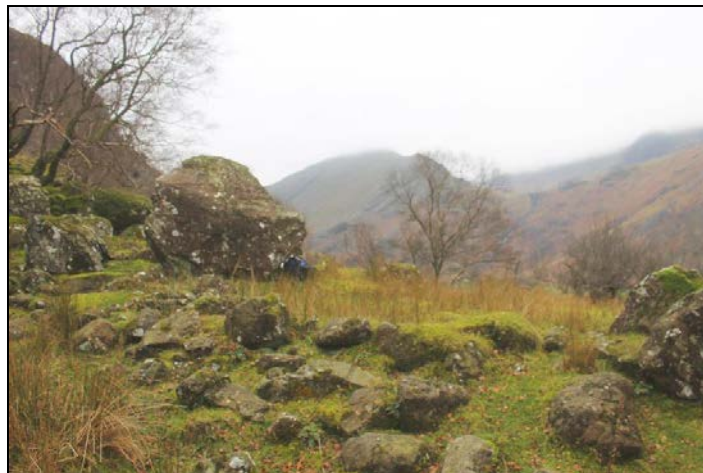
**Description** A small double-cell stone platformed structure in a figure-of-eight pattern. It is on a north/south alignment, to the west of both an intake wall and a small stream. It consists of two conjoined circular cells with small dwarf wall foundations, one 9m and one 8m in diameter. The smaller southern cell is 0.4m higher than the northern cell. The structure is slightly revetted on the western downslope side and the east side is much more fragmentary. There is an earthfast boulder on the east side of the central sub-dividing wall.

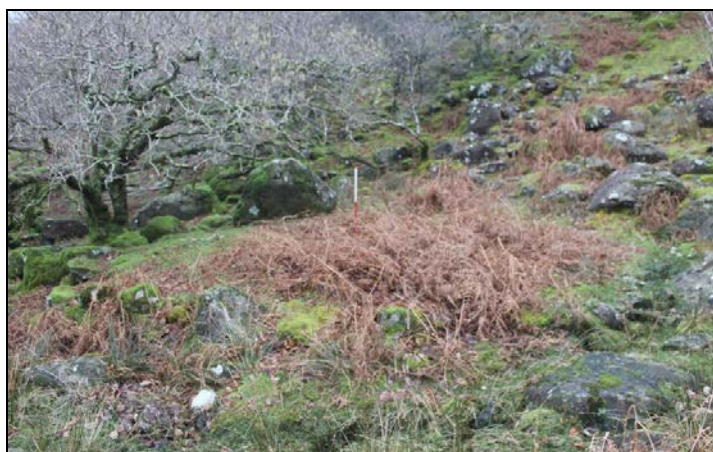
| <b>Site Number</b> | <b>43</b> |

| <b>Description</b> | A circular charcoal-burning platform, 7m in diameter and 0.8m high downslope on the north side. It has kerbed walling on the downslope side. |

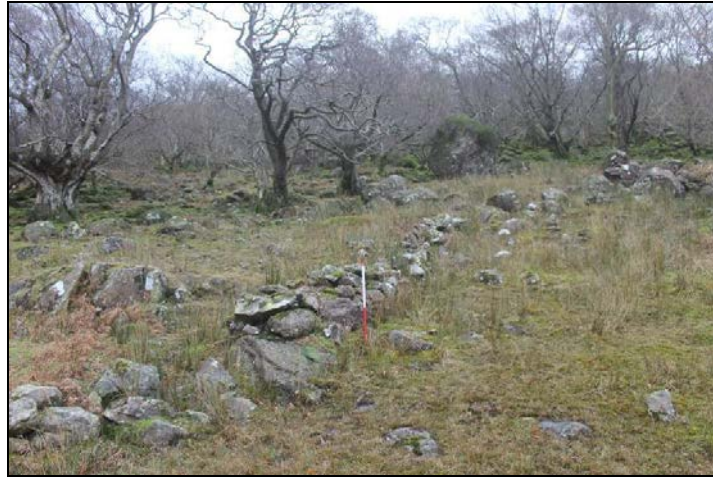
| <b>Site Number</b> | <b>44</b> |

| <b>Description</b> | The fragmentary foundations of a linear intake wall running directly upslope (north-west/south-east) from the junction of lower enclosed fields. The boundary measures at least 83m long by up to 1m high in places. It is not depicted on any historical mapping. |

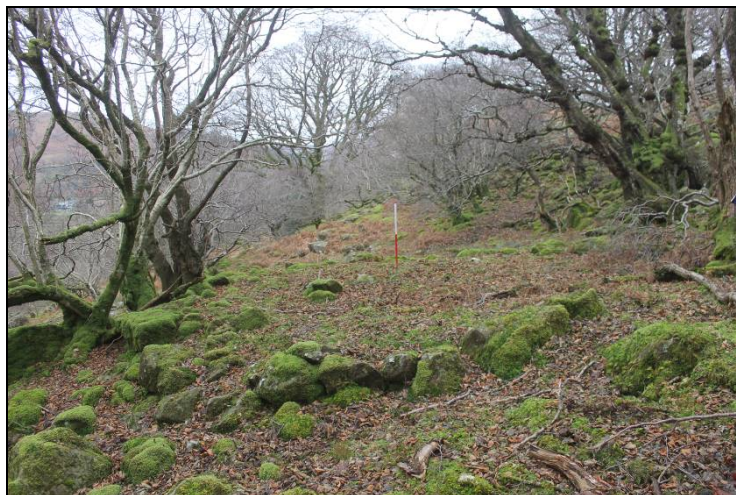
| <b>Description</b> | An oval charcoal-burning platform measuring 8m long by 7m wide and 0.6m high on the northern downslope side. It has kerbed walling on that side. |

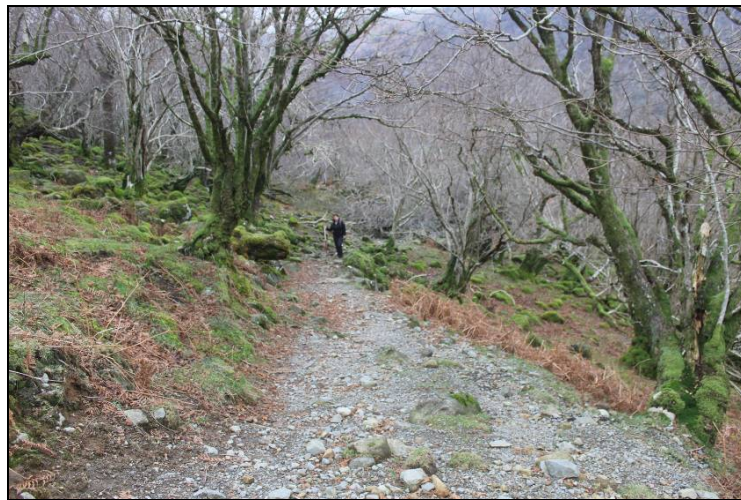
| <b>Description</b> | A sinuous trackway extending upslope and passing through two woodland intakes. The trackway gave access to several charcoal-burning platforms. It measures at least 420m in length, the southern end remaining a part of a footpath, but north of a field gate that it passes through, it is harder to discern, but it meets with another trackway at its northern end (Site <b>61</b> ). |

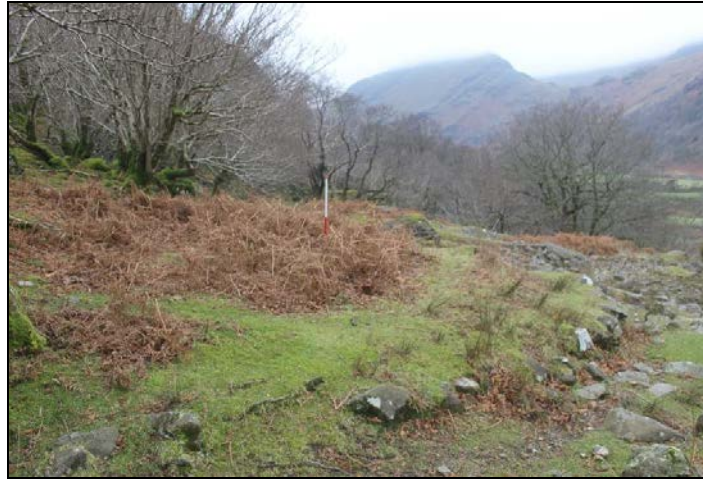
| <b>Site Number</b> | <b>47</b> |

| <b>Description</b> | An oval charcoal-burning platform measuring 7m long by 6.5m wide and 0.5m high on the northern downslope side. It has kerbed walling on that side and a trackway (Site <b>46</b> ) curves around the western side. |
