## APPENDIX 1: PROJECT DESIGN

- 1.1.1 The National Trust has invited Oxford Archaeology North to submit proposals for a historic landscape survey and condition assessment of their holdings at Thorneythwaite Farm, Borrowdale, which was purchased in 2016. This is intended to record and evaluate the archaeological and historical features, which will inform the management of the estate, and in particular will serve to inform the compilation of an overall masterplan. It is also required to undertake a condition survey to establish a baseline for future archaeological monitoring. The aim of the survey is to identify the landscape character and significance of the landscape. It will examine the archaeological history and landscape development as part of this process and will present the results of the survey, allowing the National Trust a comprehensive understanding of the overall landscape. The study area is owned by the National Trust and is 1.2 sq km in extent.

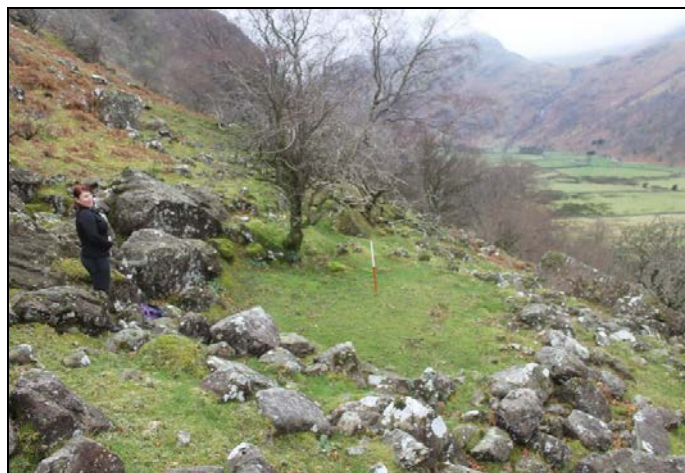
| <b>Description</b> | An oval charcoal-burning platform measuring 7m long by 6m wide and 0.5m high on the northern downslope side. It has kerbed walling on that side. |

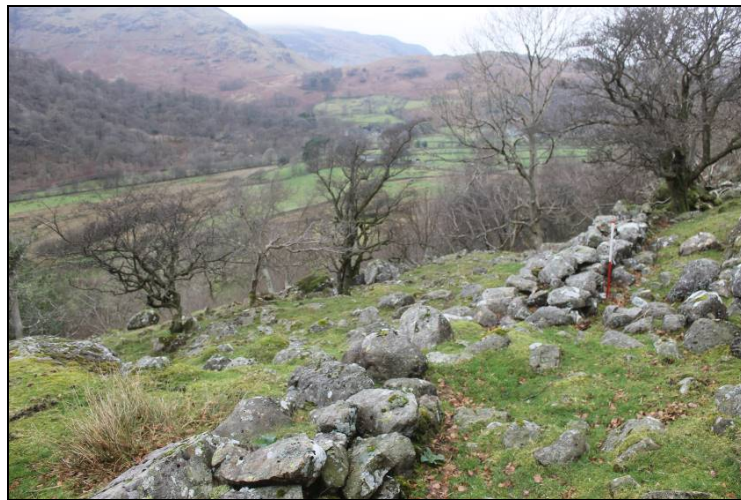
| <b>Description</b> | Two sections of a well-defined linear intake wall running along the slope (north-north-east/south-south-west). The sections measure 69m and 95m in length and the better-preserved northern section consists of large, double-thickness wall foundations up to 1m wide by 0.6m high. The boundary is not depicted on any historical mapping. |

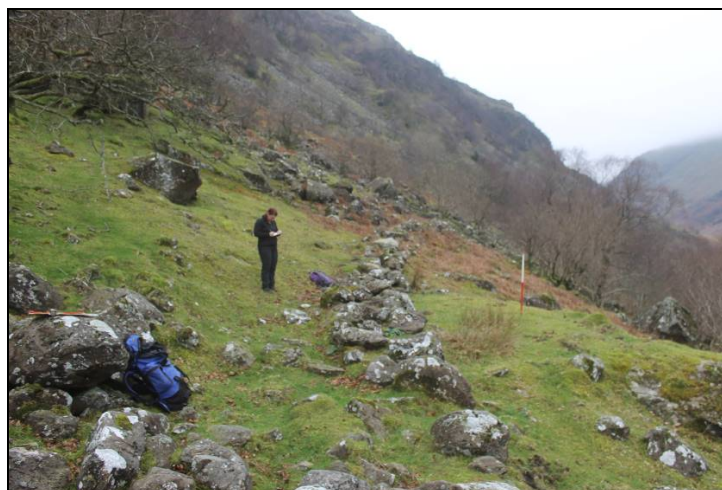
| <b>Condition</b> | Fair |
| <b>Damage Agents</b> | Bracken |
| <b>Description</b> | An oval charcoal-burning platform measuring 8m long by 6m wide and 0.5m high on the northern downslope side. The platform is constructed on top of a natural knoll and is cut into the hillside at the rear. There is no visible retaining wall. The site is crossed by a later field wall (Site 49). |

| <b>Recommendations</b> | Monitor; bracken removal as appropriate |

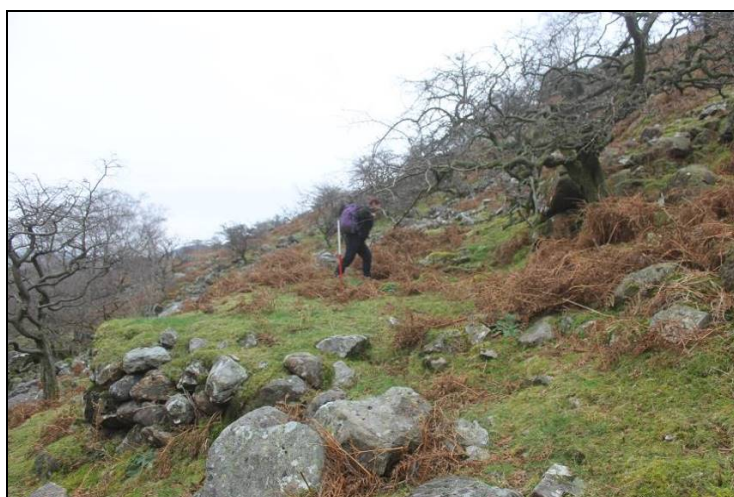
| <b>Photo Ref</b> | 5528 |

| <b>Condition</b> | Fair |
| <b>Damage Agents</b> | Bracken |
| <b>Description</b> | An oval charcoal-burning platform measuring 7m long by 6m wide and 0.75m high on the northern downslope side. It has kerbed walling on that side. |

| <b>Recommendations</b> | Monitor; bracken removal as appropriate |

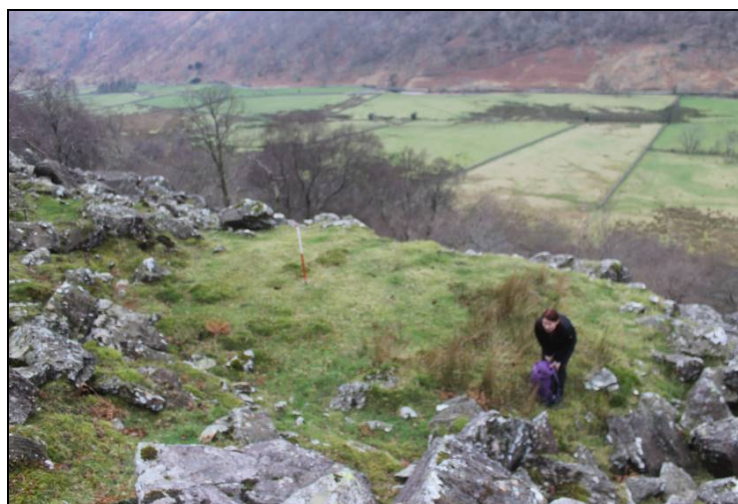
| <b>Photo Ref</b> | 5536 |

| <b>Condition</b> | Fair |
| <b>Description</b> | An oval charcoal-burning platform measuring 9m long by 6m wide and 1m high on the northern downslope side. It has kerbed walling on that side. |

| <b>Recommendations</b> | Monitor; bracken removal as appropriate |

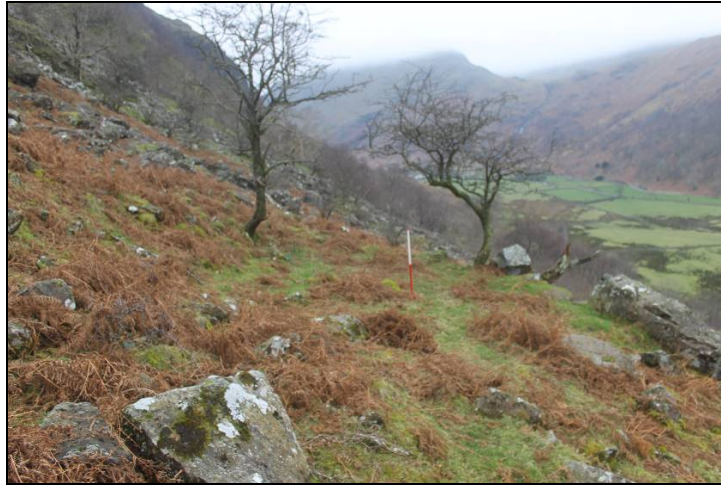
| <b>Photo Ref</b> | 5537 |

| <b>Condition</b> | Fair |
| <b>Damage Agents</b> | Bracken |
| <b>Description</b> | An oval charcoal-burning platform measuring 7m long by 5m wide and 0.5m high on the northern downslope side. It has kerbed walling on that side. |

| <b>Recommendations</b> | Monitor; bracken removal as appropriate |

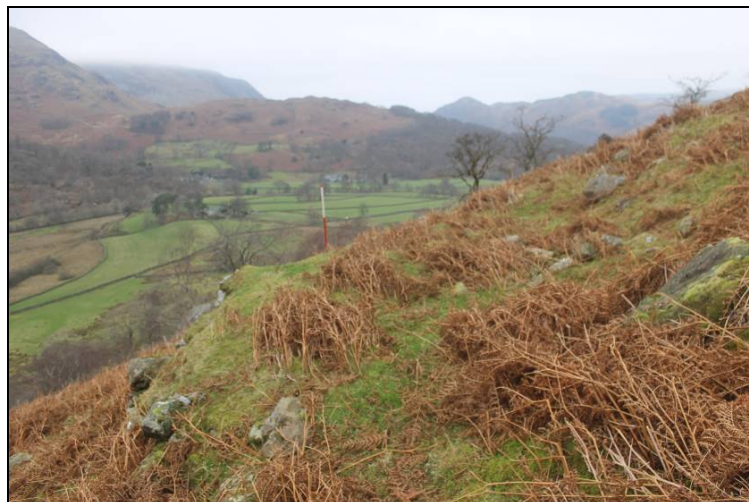
| <b>Photo Ref</b> | 5538 |

| <b>Condition</b> | Fair |
| <b>Damage Agents</b> | Bracken |
| <b>Description</b> | An oval charcoal-burning platform measuring 8m long by 6m wide and 0.4m high on the northern downslope side. The site is built on top of a craggy knoll and there is no visible retaining wall. |

| <b>Recommendations</b> | Monitor; bracken removal as appropriate |

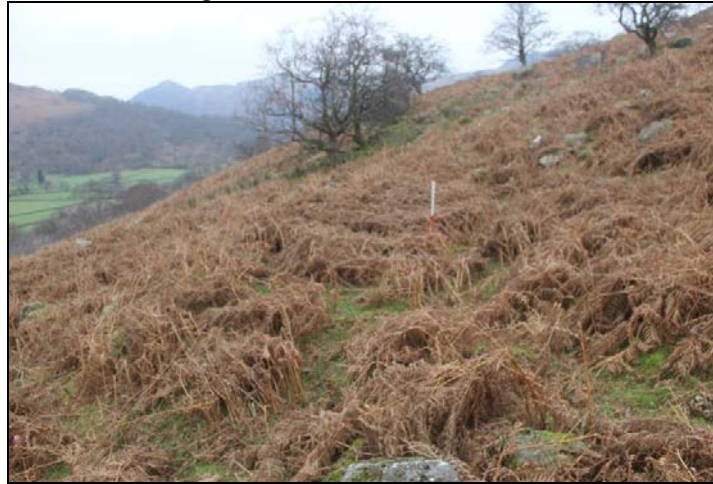
| <b>Photo Ref</b> | 5539 |

| <b>Condition</b> | Fair |
| <b>Damage Agents</b> | Bracken |
| <b>Description</b> | An oval charcoal-burning platform measuring 10m long by 7m wide and 0.5m high on the northern downslope side. It has kerbed walling on that side. |

| <b>Recommendations</b> | Monitor; bracken removal as appropriate |

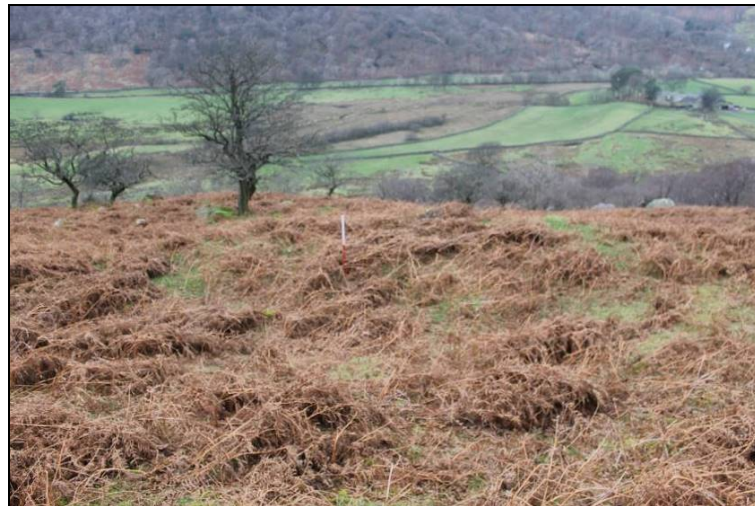
| <b>Photo Ref</b> | 5540 |

| <b>Condition</b> | Fair |
| <b>Damage Agents</b> | Bracken |
| <b>Description</b> | An oval charcoal-burning platform measuring 12m long by 6.5m wide and 0.4m high on the northern downslope side. It has possible kerbed walling on that side. |

| <b>Recommendations</b> | Monitor; bracken removal as appropriate |

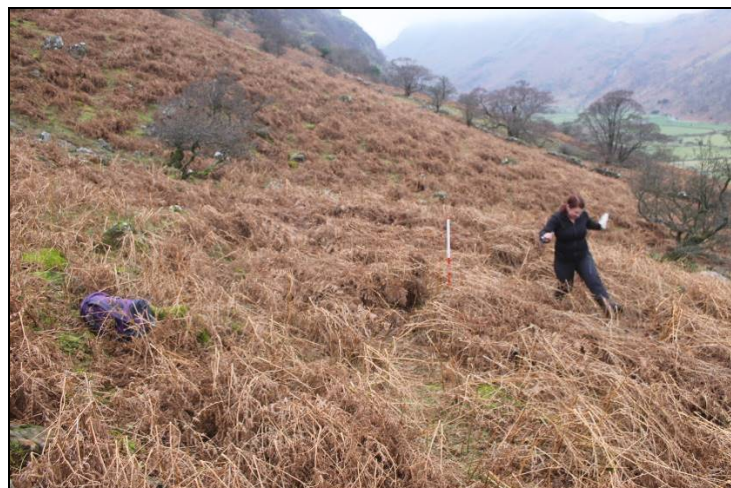
| <b>Description</b> | An oval charcoal-burning platform measuring 10m long by 7m wide and 0.4m high on the northern downslope side. |

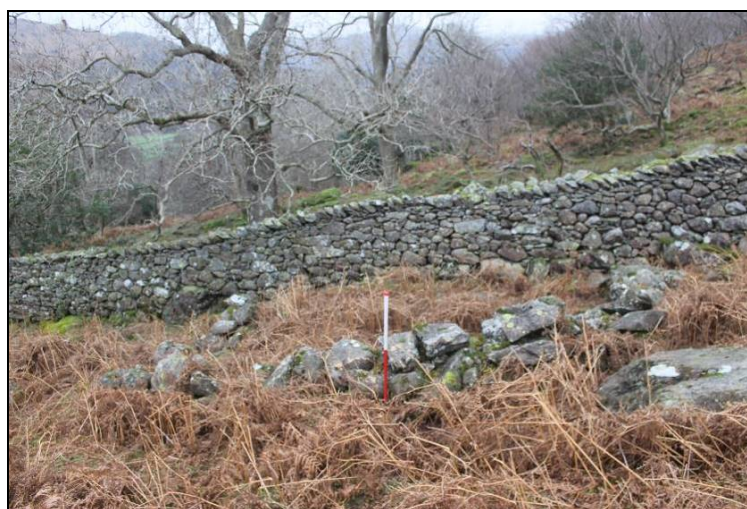
| <b>Condition</b> | Fair |
| <b>Damage Agents</b> | Bracken |
| <b>Description</b> | A D-shaped sheepfold at the junction of an intake wall running straight upslope and a perpendicular sub-divisional boundary wall. The structure is mostly intact and measures 6m long by 5m wide, surviving up to 1m high in places. The structure is depicted on the First Edition OS mapping. |

| <b>Recommendations</b> | Monitor; bracken removal as appropriate |
