## Assignment Part 1 - Case Study: Fundamentals of Construction Technology

### Abstract

## Assignment Part 2 - Labelled Sketches of Pre-1900, 1950s and 2000s Houses

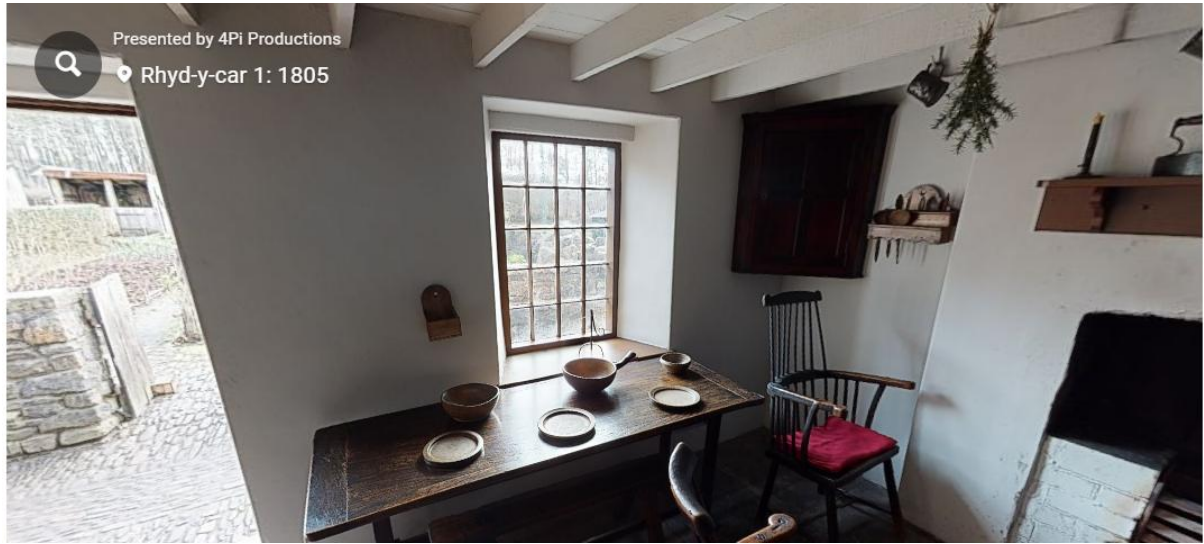
Figure 1

The 1805 house has traditional casement windows as shown in Figure 1. These windows are made up of crown glass. The windows have small panes and more glazing bars as windowmakers at the time did not often make large panes because the glass type, crown glass, was brittle and it would be more expensive to produce larger panes and

quite likely that most glass manufacturers lacked the technology to do this. Because of the relatively high brittleness of crown glass in comparison with modern alternatives, these windows are more likely to get damaged in harsh weather conditions such as storms. Also, the glass in these panes is relatively less smooth in comparison with modern alternatives and therefore produces an optical effect in the form of ripples. These ripples cause a smaller amount of natural light to enter the house. The sashes are likely made of oak or pine.

The windows of this era were not especially good insulators. The amount of joins due to the glazing bars would potentially result in a larger amount of heat transmitted externally because they were not sealed or weatherproof. These windows were also prone to leaks due to the fact that they didn't have cills designed to stop water seeping underneath the window. It is clear from Figure 1, Figure 2 and Figure 4 that insulation was also not a priority for construction projects during the 19<sup>th</sup> century. The window glass is not glazed, the joints are not sealed and the doors are not flush to the floor and there is no stripping around the doors in these houses. Modern construction projects place a large emphasis on insulation to improve the value of the house and reduce the need for the use of central heating.

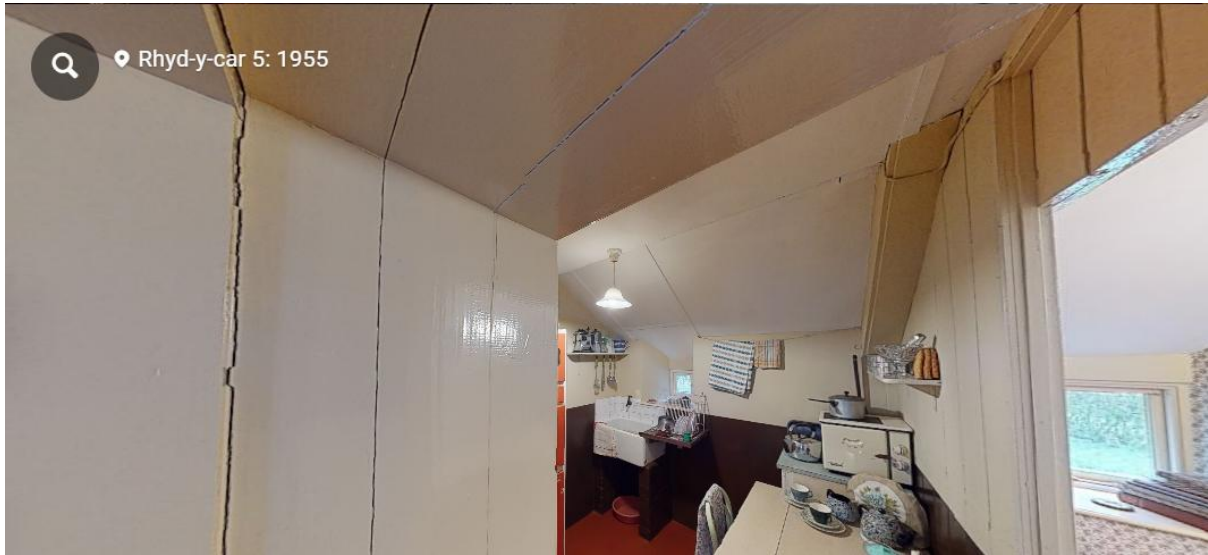
Figure 7

The floors in the houses are all composed of natural stone, which was likely sourced locally except from the 1955 house and the 1985 house where you can see different flooring materials used. There is a manufactured flooring material in the 1955 kitchen as shown by Figure 7. This material appears to be linoleum. The use of different materials for flooring can prevent heat loss as well as prevent moisture from the ground rising upwards. Style preferences and comfortability are also factors as to why materials used for flooring changed over time. Moreover, the same factor applies to every component of these housing projects which evolved over this time period, which is that supply chains and procurement methods became vastly different in terms of cost, efficiency and optionality. While the construction industry in the 19<sup>th</sup> century would have been forced to source more materials locally because there was limited infrastructure to transport materials from elsewhere and it was likely more costly to do so if you were able to. The construction industry in 1955 and 1985 did not have this same barrier to using non-locally sourced materials.

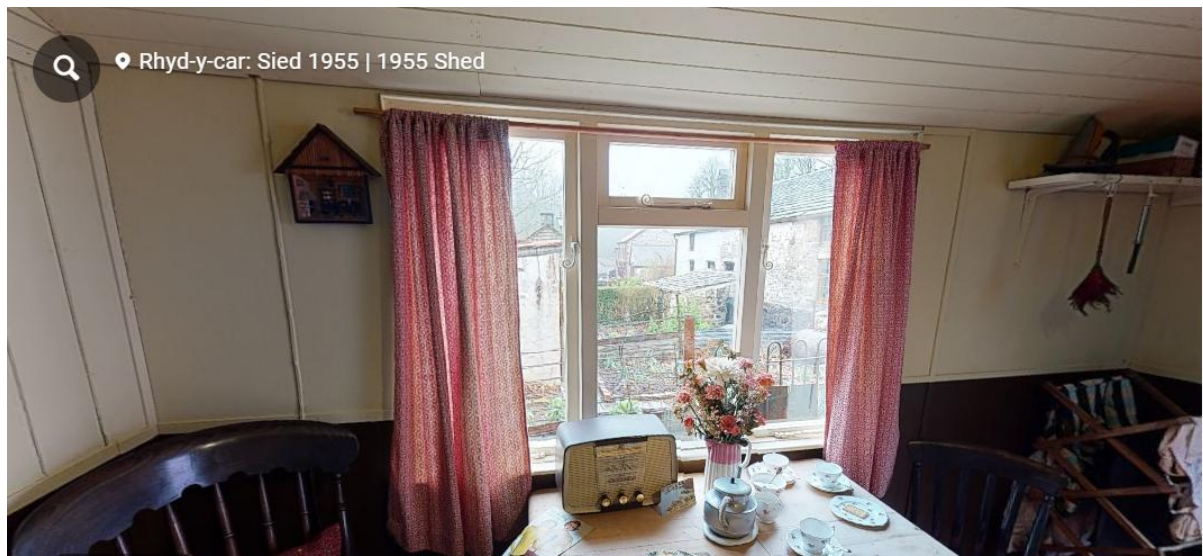
The 1955 house has a side hinged window that uses less panes that is storm proof and likely uses a type of glass called Pilkinton glass which allowed larger pane manufacture, was a smoother glass and more weatherproof than glass of previous generations. As seen in Figure 8 the window in this era has now been side-hinged to allow it to open freely without having two separate panes like the box and frame design. This makes it a more insulated window as the seals are now only found in the seals of the frame instead of having a seal between the stationary and moveable pane in the box and frame window. In Figure 10 and Figure 8, you can see that the window now has iron handles added to the window.

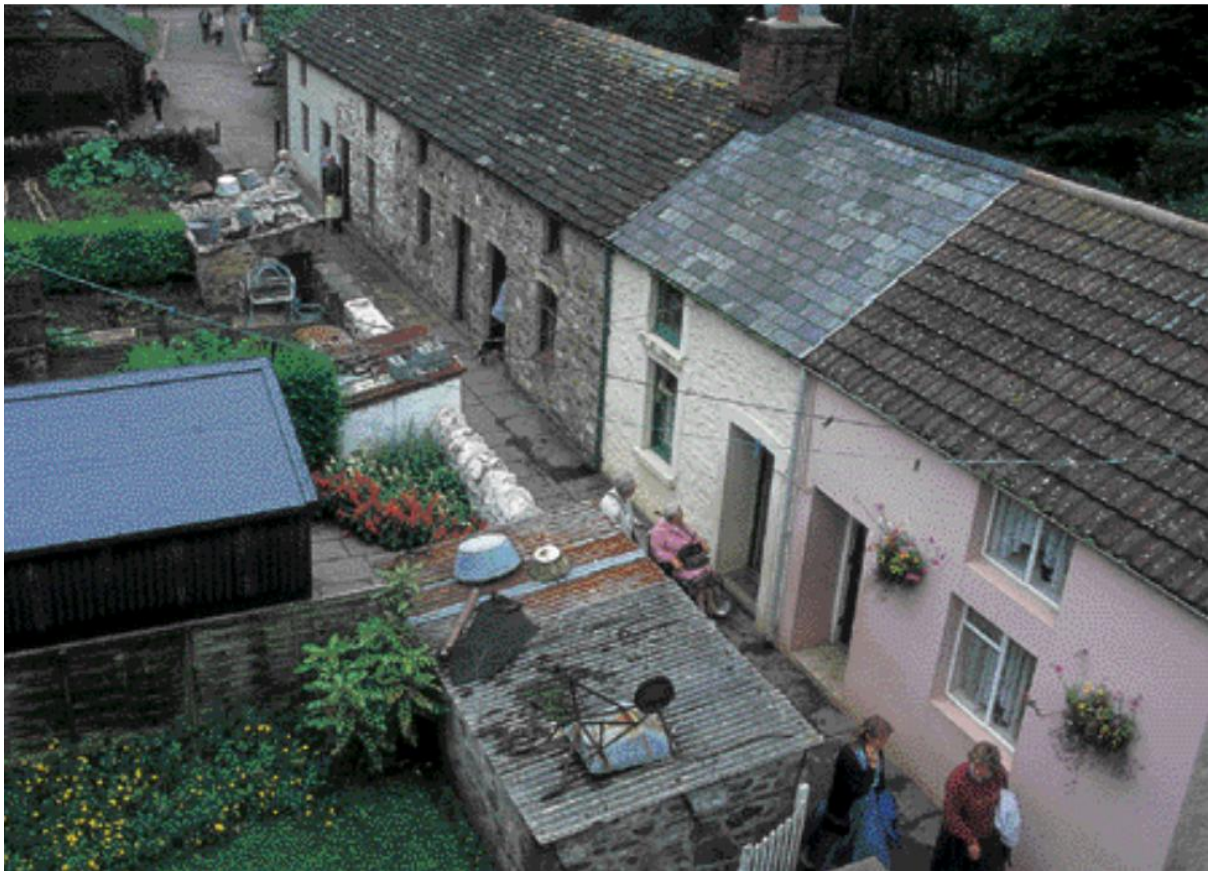
The doors in the houses in the 19<sup>th</sup> century are less effective than the ones seen in the latter part of the 20<sup>th</sup> century as insulators. In Figure 10, you can see that the door is one whole piece of timber with panels as opposed to earlier doors like in the 1855 house (Figure 4). The door in the 1855 house is made up of several pieces of wood planks joined together. This is a less durable door design because there is more joins. A higher number of joins in the door also allows more areas where heat energy can be lost from within the house. Figure 11 also shows how earlier houses used a lintel built into the masonry, likely made of locally sourced hardwood, mortared into a brick archway above it. The lintel on the most modern house in Figure 11 is not incorporated into the

structure in this way. The lintel in that house is most likely a concrete lintel which is more durable than hardwood because it does not rot.

The manufacturing of materials such as: PVC, which is used in modern windows; concrete, which would be used on roof tiles in post-war houses more frequently and effectively (Figure 11) than roof tiles used on 19<sup>th</sup> century houses (which were more likely to use slate); or reinforced concrete, which would be used in foundations in the more modern houses instead of locally sourced hardcore stone which would be used in 19<sup>th</sup> century foundations is something which developed over this time period. This is a major driver behind the changes visible in Rhyd-Y Car. The manufacturing industry, especially during the post-World War 2 era where you can see its effect on Rhyd-Y-Car, standardized materials in the factory production of them. This should decrease the time
