# **Case Study: Energy Survey**

## **ENERGY EFFICIENCY IN BUILDINGS (ACBA5011)**

**ADAM MEYRICK (1706760)**  
UNIVERSITY OF WALES TRINITY SAINT DAVID  
Project & Construction Management

This report provides a record of the internal and external condition of the building at UWTSD's Business Campus, High Street, Swansea, City & County of Swansea, SA11NE. The survey was undertaken by Adam Meyrick and assistant surveyor Lewis Williams of University of Wales Trinity Saint David on Tuesday 30th October 2018.

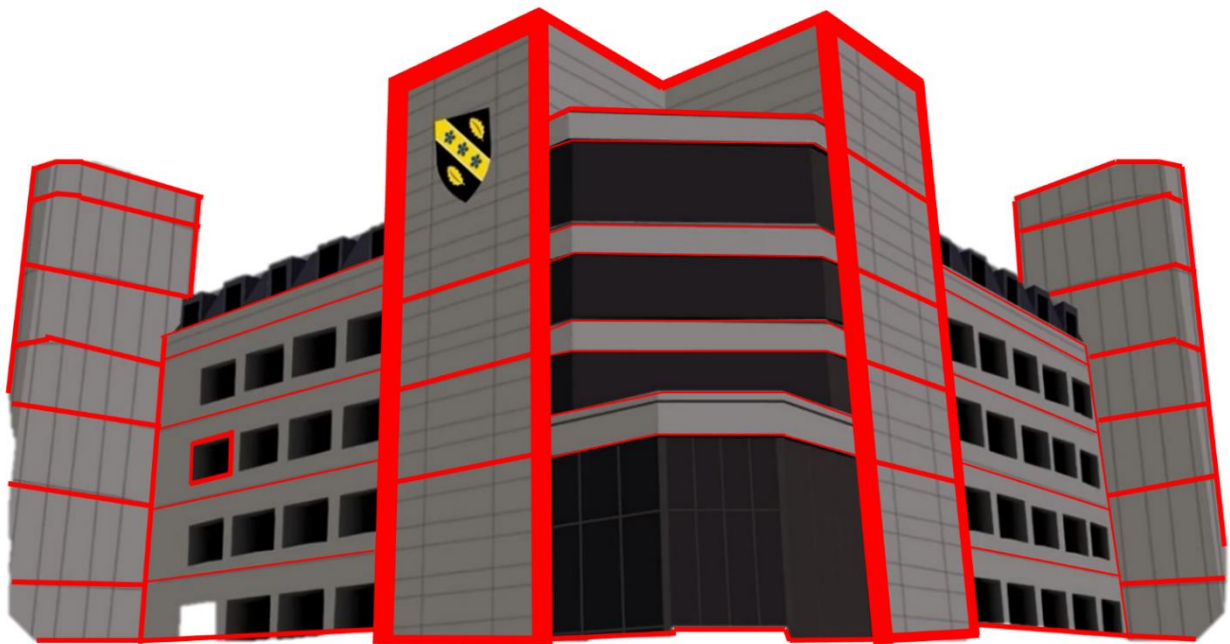
**Figure 2.1:** **RED** indicates areas susceptible to cold bridging at the UWTSO Business Campus (Meyrick, 2019)

Non-repeating cold bridges are often caused by discontinuities in the thermal envelope, for example:

- Geometry, e.g. corners which provide additional heat flow paths.
- Building borders (window sills, jambs and headers),
- Structural borders (floor to wall & wall to roof junctions),
- Penetration of the building envelope (fixings and structural elements),
- Structural support (lintels and cladding supports),
- Poor construction practice (gaps in insulation and debris in wall cavity).
