Habitat Management & GIS

# HABITAT MANAGEMENT PLAN

Llyn Llech Owain Country Park

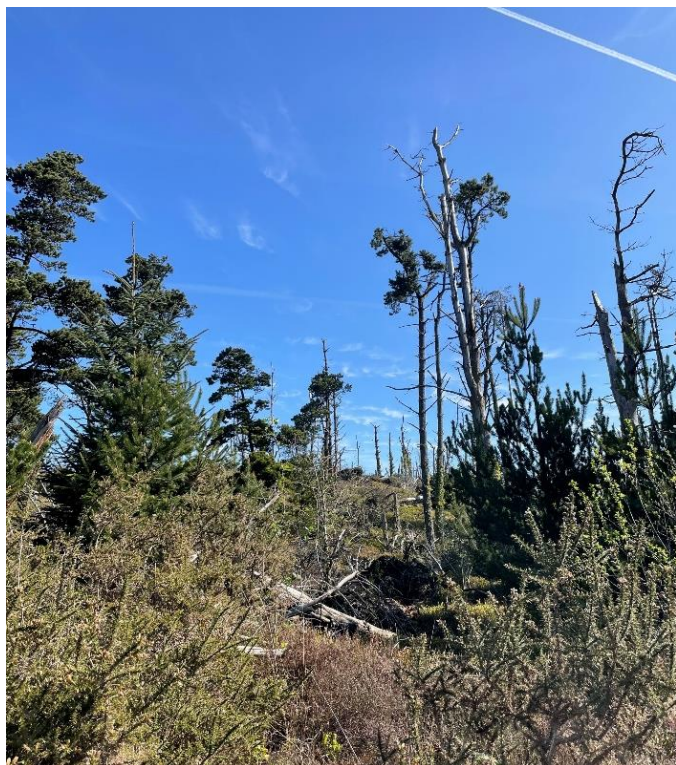
*Figure 4 Polygon 22 (Egan 2023)*

During an April site visit, it was evident that the woodland is a crucial element of the site. As indicated by polygon 22 in Figure 3, the whole region that was formerly planted is now mostly empty, with only dead trees remaining, as shown in Figures 4 and 5. These dead trees now provide a habitat for more birds, bats, and insects. As exhibited in Figure 5, there is clear evidence of woodpeckers. Underneath all the fallen timber is European Dry Heath (*Calluna vulgaris*), an Annex I habitat type. This habitat type is high quality, unique to the area, and needs effective management. In a conversation with the Carmarthenshire County Council Conservation Co-ordinator, he claimed that a recent funding proposal to clear the site of fallen timber and adequately manage the habitat had been denied. Without this financial support, the necessary work cannot be completed (Audrey, P, Pers-Comms).

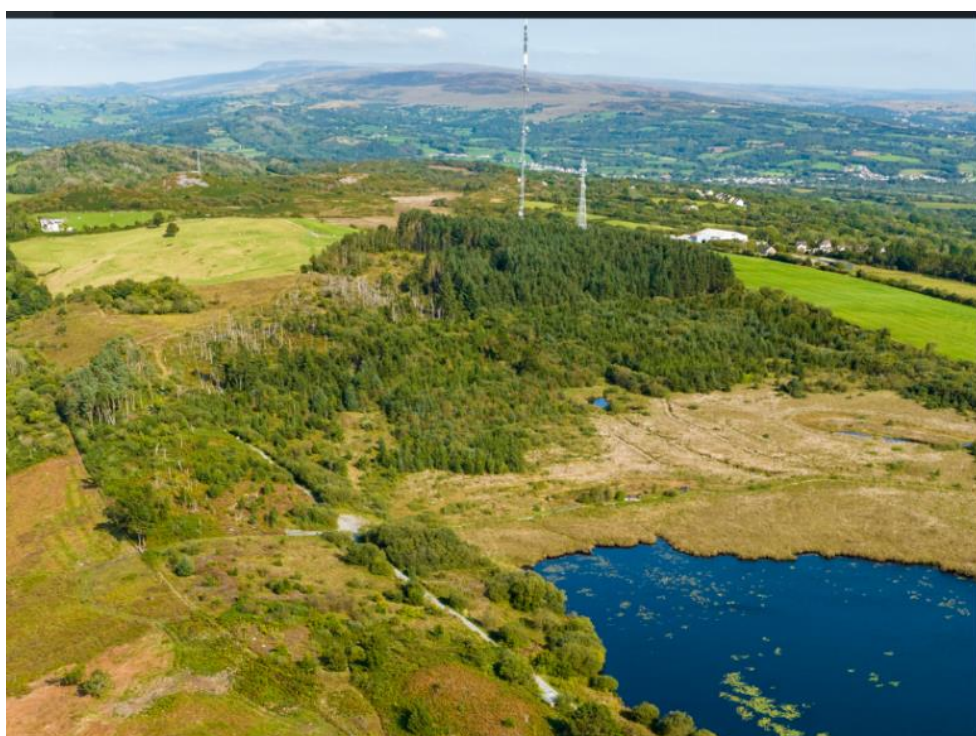
*Figure 6 Aerial view of polygons 22 & 14*

Similarly, the current conifer woodland represented by polygon 14 would ideally be felled. However, it would dramatically impact the landscape and should be done in phases over 50 years. It is also likely to be on top of European dry heath care must be taken to restore the ecosystem to its former state. The recommendation would be to thin the space to renew the floor gradually. Figures 7 and 8 illustrate that the current state is rather bare and devoid of vegetation.

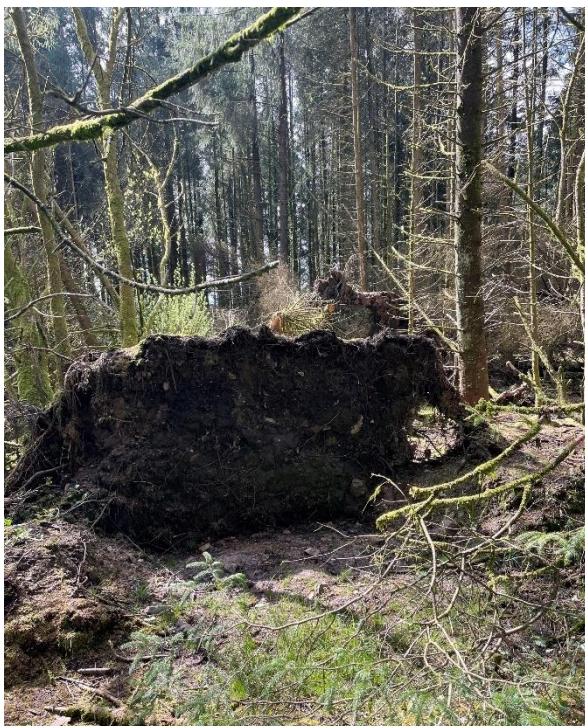
Figure 9 Example of windblown trees (Egan, 2023)

damp and boggy site. Upon a site inspection, many of the Sitka spruces had been windblown due to the poor soil in the area; the roots had not developed well. A woodland edge mix should be planted as a short-term solution to provide some protection. Some examples would be holly (*Ilex aquifolium*) or common hazel (*Corylus avellana*), as both thrive in wet conditions and provide food for wildlife. This aligns with the Woodlands for Wales policy (2021) to enhance the landscape and have diverse species and habitats.

The woodland in area 11 should be managed as coppice with standards at varying stages at a fifteen-year rotation, achieved by clear-felling and replacing with broadleaf species planted in a mosaic. Using the brash from clear-felling to suppress weeds and improve ground conditions on the

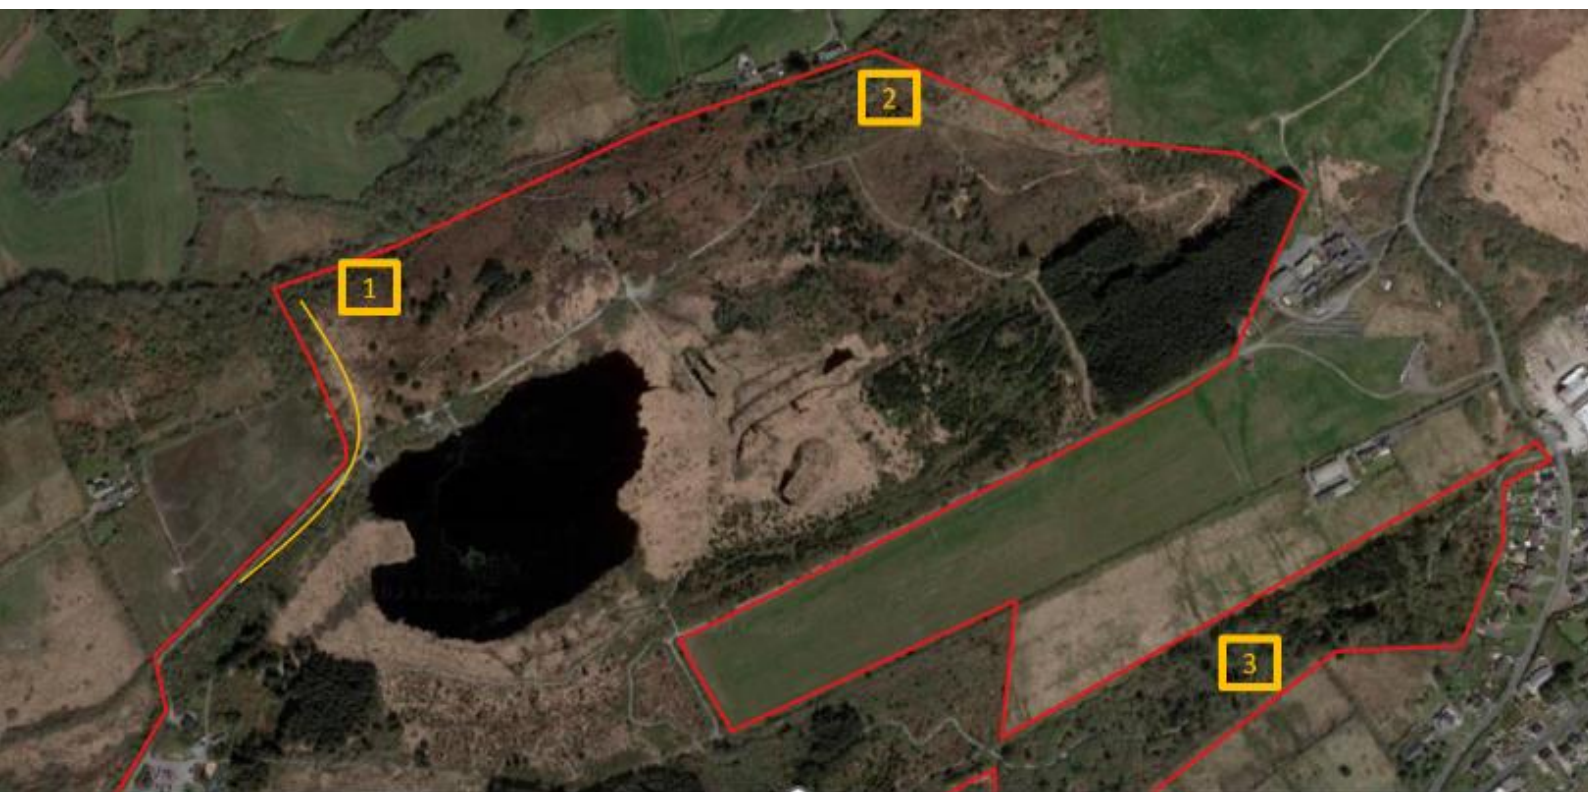
Figure 10 Amber Environmental Survey areas and recommendation for additional boxes to be placed Image Source: Google Satellite. Annotations: Egan (2023)

In 2022, a dormouse survey was undertaken by Amber Environmental Consultancy at Llyn Llech Owain to gather information and inform woodland management. The surveyed areas are shown in Figure 10, as 1 and 2, including two woodland areas along the hedgerow by the visitor centre. The study deduced that dormice (*Muscardinus avellanarius*) are present, making it essential to gain a conservation licence from NRW before any management work is undertaken. The management recommended retaining coppiced wood to allow climbers to grow and provide structural and species diversity, the arboreal connection from the ground to the canopy, shelter, food, and hibernation sites. While conducting a site visit, area 3 was spotted as a potential site to introduce similar methods. As it is currently a broadleaf woodland with different ages of trees, dead wood, ground flora, and an abundance of hazel trees, this makes for a suitable dormice habitat. Therefore, a suitability assessment should be conducted by placing boxes and monitoring activity.

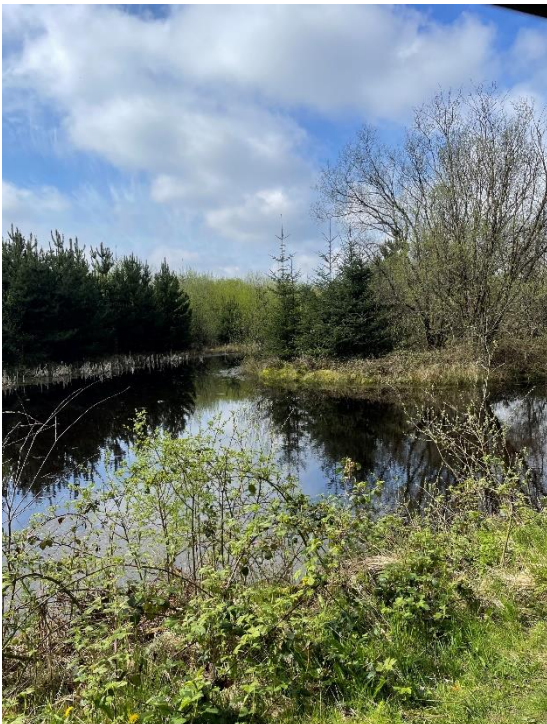
Figure 11 View of pond from birdwatching hut (Egan, 2023)

was not there in 1993; however, there is no record of when it was constructed. Figure 11 was taken at a site visit from a bird-watching hut where three male Mallard ducks (*Anas platyrhynchos*) were spotted. This feature aligns with the aims of the original management plan, as the island provides a habitat for the ducks with protection from predators. This is an example of successful management within the park, as very few wildfowl can be found at the site due to the acidity of the water and lack of food. Creating areas in which they can thrive demonstrates habitat enhancement.

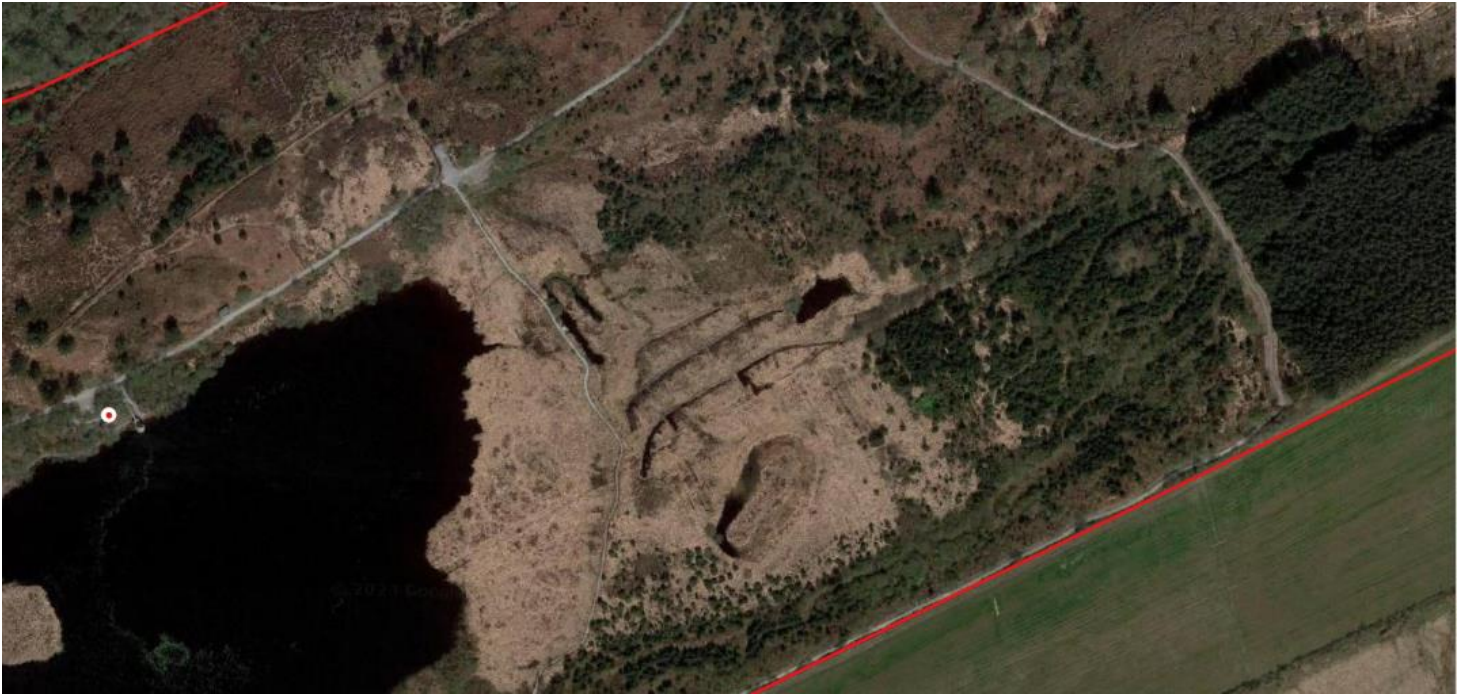
Figure 13 Aerial view of bunds Source: Google Satellite

bunds within the bog are visible. This was completed in 2019 to manage the peat bog to ensure it does not drain and water is retained. The integrity of the peat is closely related to water retention when compared with its natural state (Lowe, 2021). In a study done by Lowe, it was observed that forestry had harmed the peat due to the prolonged desiccation increasing permeability alongside the presence of tree root networks. In addition to this, the bunds that were installed are not parallel to the ground surface contour. As illustrated in Figure 14, the bunds should run in line with the yellow lines to hold the water back. The bunds are running against the contours, forcing the bog to drain in areas.

Interestingly, the bunds did not dry out during the 2022 drought, which is thought to be due to the curved edges (Audrey, P, 2023. Pers-Comms). Moving forward, remedying the bund system must be considered to fulfil its intended purpose. This must be done knowledgeably and carefully (Lowe, 2021).

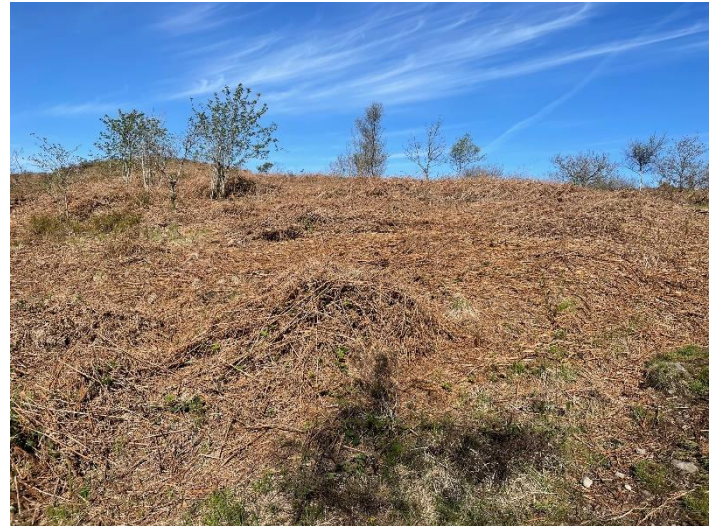
*Figure 21 Example of bracken beating (Egan, 2023)*

At the site visit, it was clear that the heathland was managed correctly by bracken beating, as shown in Figure 21. This method weakens the plant to ensure it does not grow back. The pines mentioned along the ridge were felled in 2020 (Audrey, P. 2023 Pers-Comms) to restore the habitat.

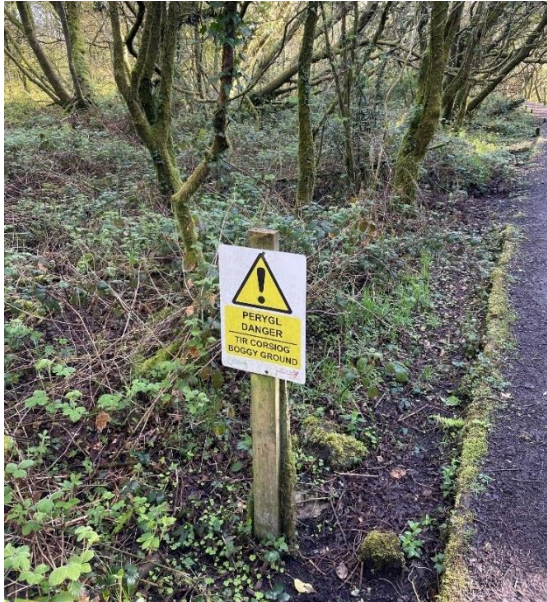
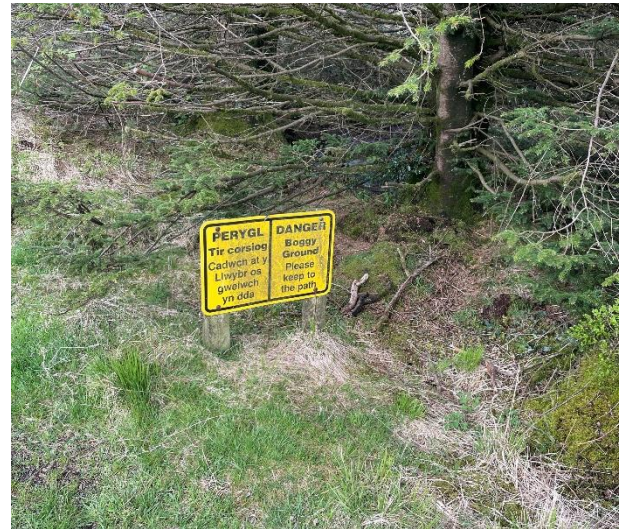
Figure 23 Example of warning sign 1 (Egan, 2023)

As previously mentioned, the area surrounding the stream is boggy. While signs are placed to warn visitors, only two were spotted in Figures 23 and 24. Ideally, five should be placed throughout the park in boggy sites.

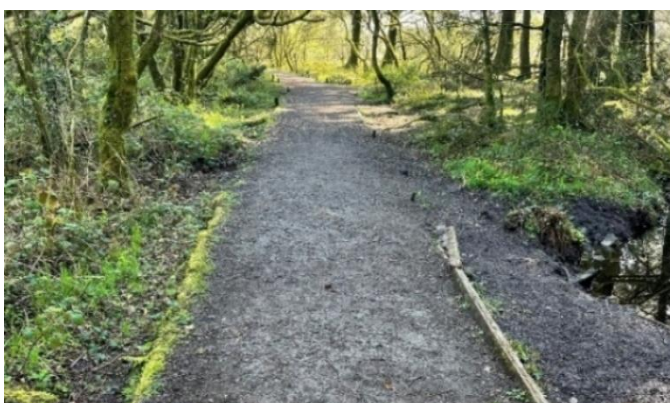
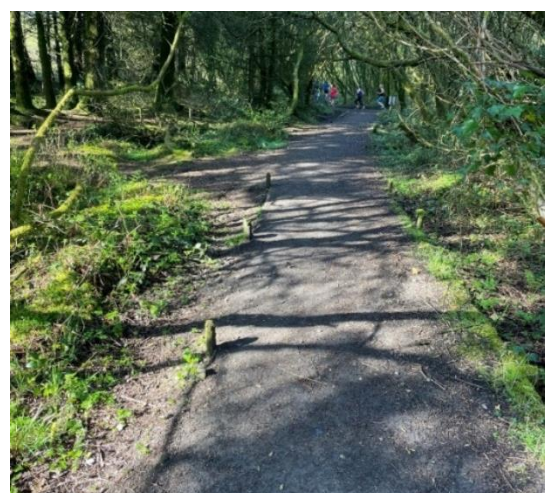
Figure 25 Path next to stream damage (Egan, 2023)

As shown in Figures 25 and 26, the wooden planks boarding the path have been removed, which is unclear why, leaving exposed wooden spikes that pose a trip hazard. Immediate action needs to be taken to ensure the site is safe, either by replacing, removing, or temporarily placing caution signs.

| 4. Recreation and Infrastructure | | | |
|---|---|---|---|
| 4.4 | Replace path by stream or remove wooden spikes | Trip hazard | 2024 |

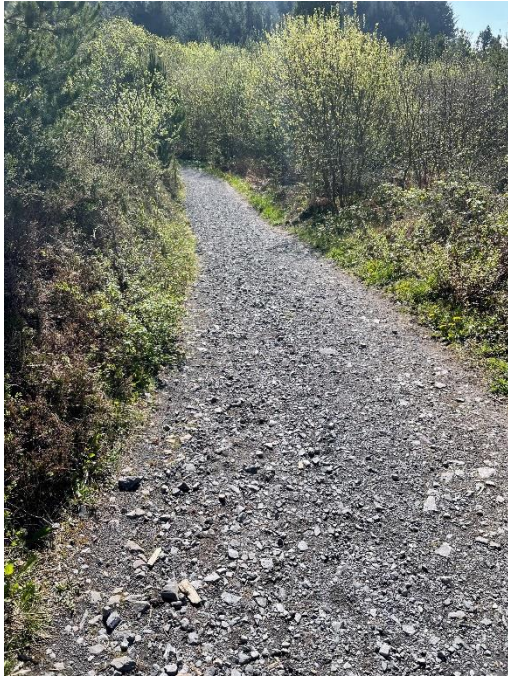
*Figure 27 Example of path damage from water run off (Egan, 2023)*

Furthermore, while walking near the conifer plantation represented by Polygon 14, it was observed that the gravel dust on the path had been washed away due to the downhill slope. This area, while not unsafe, could pose a problem to mothers with prams or wheelchairs due to the uneven ground. Figure 27 shows the current state, and Figure 28 depicts the desired state.

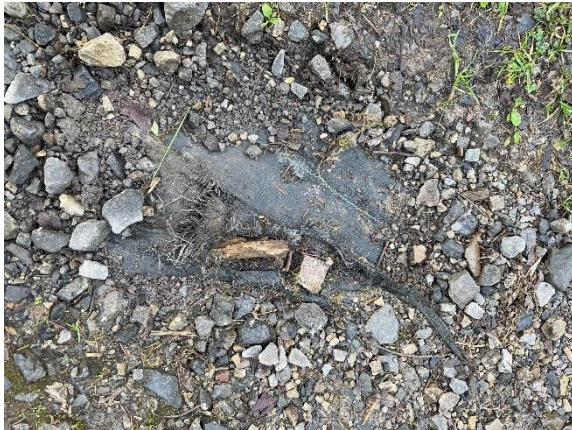
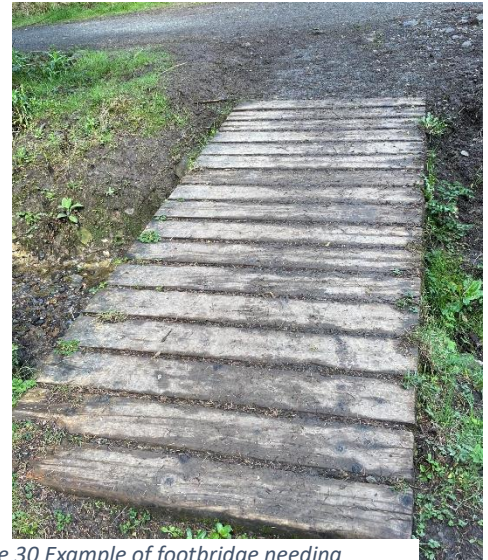
*Figure 29 Example of damaged path in need of repair (Egan, 2023)*

Additionally, to ensure the safety of visitors, a layer of chicken wire should be placed across all wooden boardwalks and bridges to cross safely in wet weather and avoid slipping. The footbridge in Figure 30 below missed this feature. As the original management plan stated, a layer of eco textiles lines all gravel tracks. During the site visit, areas of damage were observed. These should also be remedied to avoid visitors tripping.

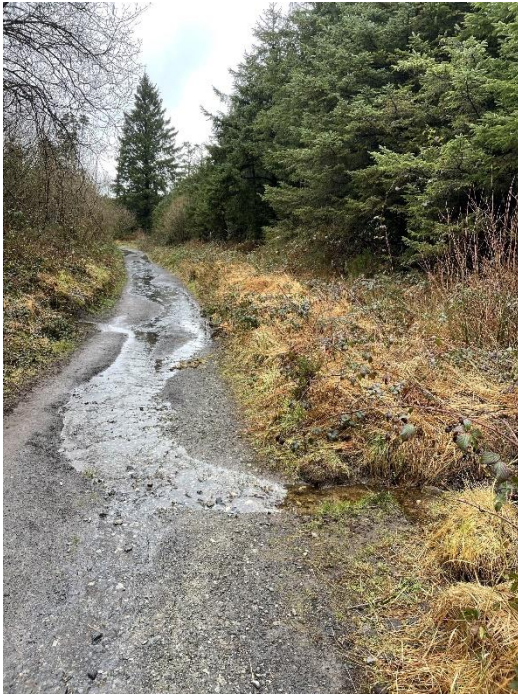
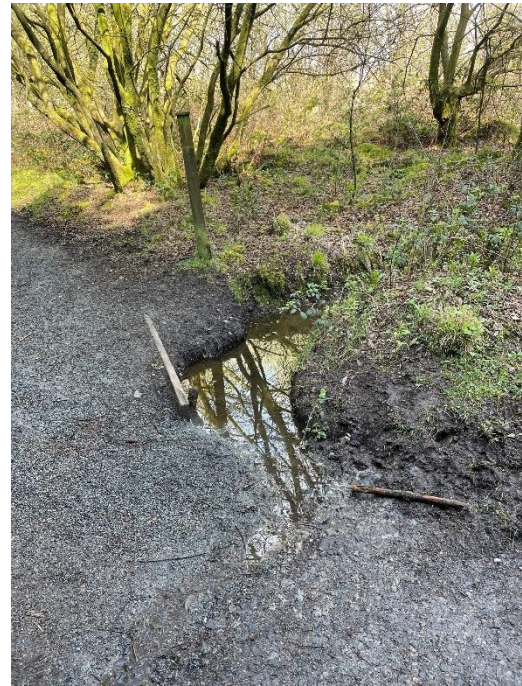
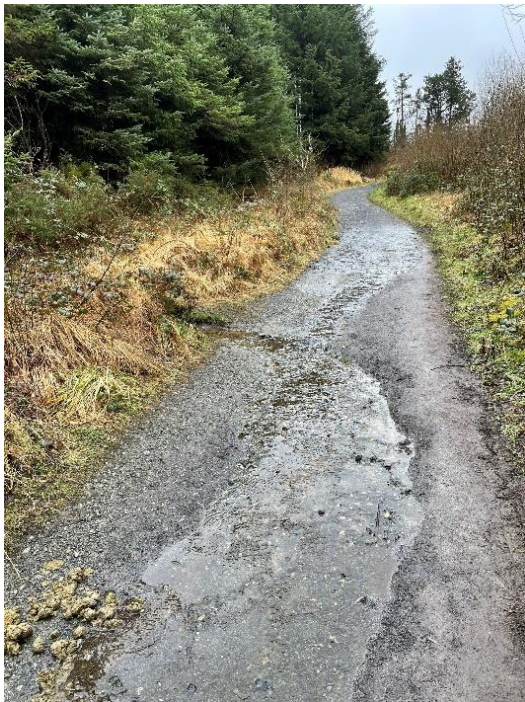
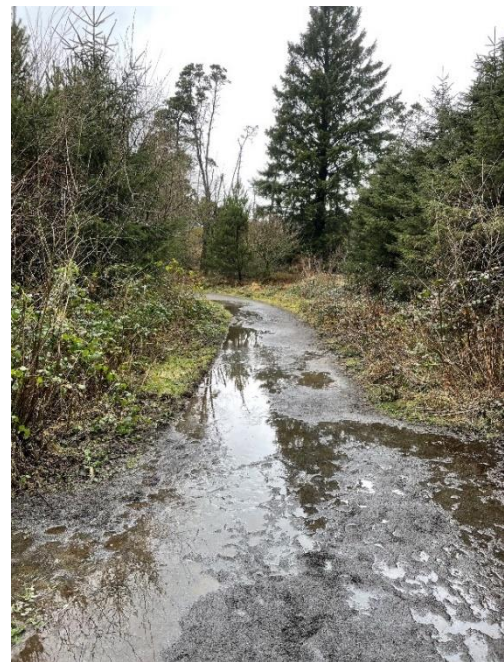
*Figure 31 Example of surface water on path 1 (Egan, 2023)*

Furthermore, drainage at the site needs improvement. The drainage infrastructure needs to be improved as the site consists of boggy, wet soils. The original management plan stated that drainage was installed when planting the conifers in the 1960s. Therefore, an upgrade is well overdue. As shown in the figures below, the footpaths are becoming damaged due to the water run-off, with some sections being completely washed away.

| 4. Recreation and Infrastructure | | | |
|---|---|---|---|
| 4.6 | Repair/ replace drainage | Areas of water runoff causing damage because of drainage | 2030 |

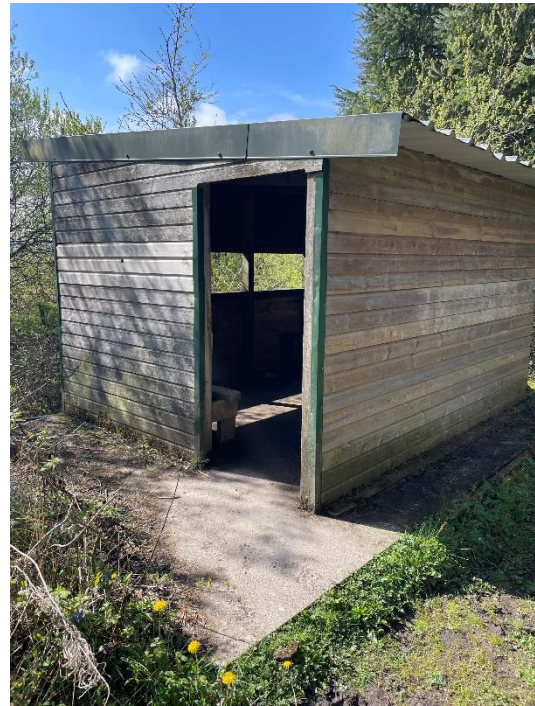
*Figure 36 Example of bird watching hut (Egan, 2023)*

Six bird-watching shelters have been installed across the park to avoid animal disturbance, represented by polygons 9, 10, 13, 15, 17, and 19. All five are in excellent condition and show no signs of deterioration. However, over the next 5 years, these will need to be inspected for signs of wear and tear.

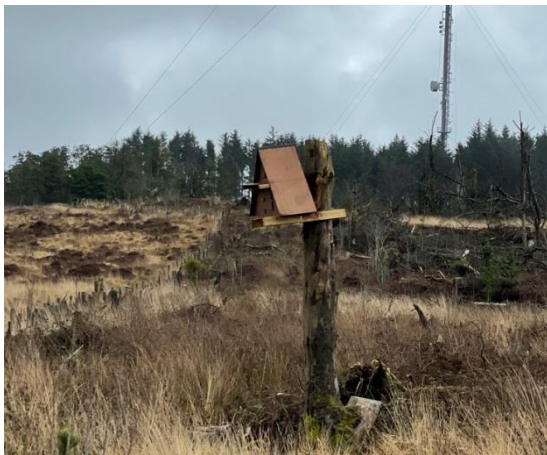
Figure 37 Example of owl box (Egan, 2023)

To encourage more wildlife into the area, there is room for improvement. While at the site visit, several small bird boxes were placed on trees, and a large owl box had been placed in what was once a conifer plantation north of the park, as shown in Figure 37.

Moving forward, bird, owl and bat boxes should be placed in the newly replanted broadleaf woodland and existing conifer woodland to encourage apex predators. Surveys should be conducted on an annual basis to log progress.

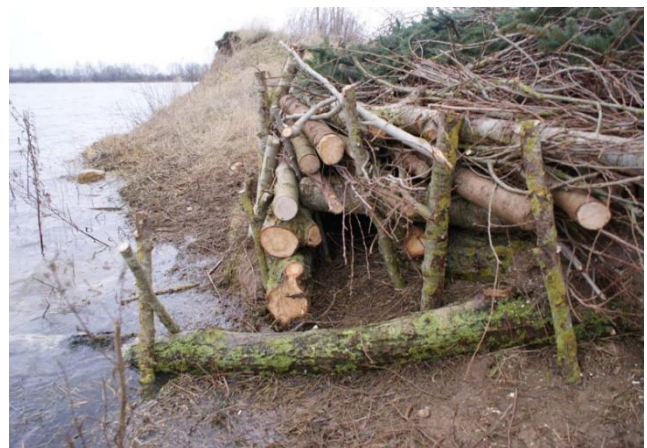
Figure 38 Example of otter holt (BSG Ecology, n.d)

Furthermore, a natural otter holt is currently placed within the Molinia bog, as there is limited food supply for otters; they tend to only stay for the winter. More otter holds are planned to be installed in the bog during the next few years. (Audrey, P. 2023, Pers-Comms).

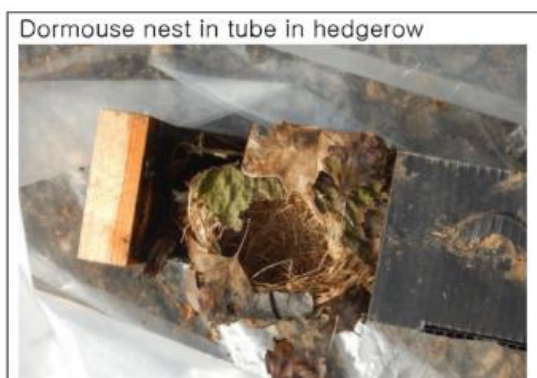
Figure 39 Example of bos (Amber Environmental, 2022)

As previously mentioned, boxes were placed for monitoring while surveying the dormice. To encourage dormice in other site areas, they should be placed in wooded areas and monitored.
