# Building Survey

MEASURED SURVEY OF THE FIRST-FLOOR CORRIDORS  
WITHIN THE IQ BUILDING, UWTSD SWANSEA.

BSC QUANTITY SURVEYING | MODULE: ACBA4017

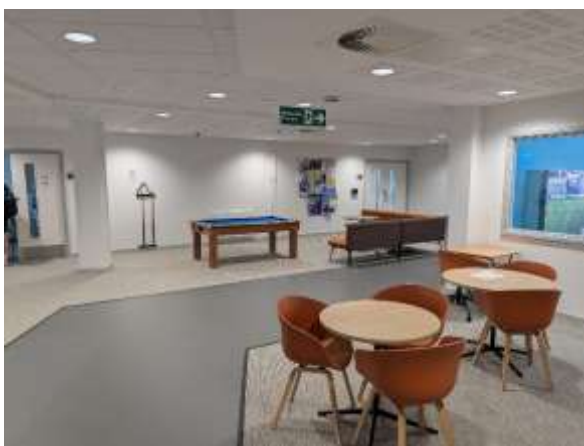
Figure A1 – Communal breakout area

Figure A1: First-floor communal breakout area included within the measured survey.

The survey included the accessible main corridors and the communal breakout area serving the lecture rooms. The communal space contained tables, chairs, sofas, a pool table and columns, which affected the scanning route but were not all required as permanent measured features.

Furniture was the main obstruction in the communal area. The route was adjusted around tables, chairs, sofas and the pool table without moving university property.

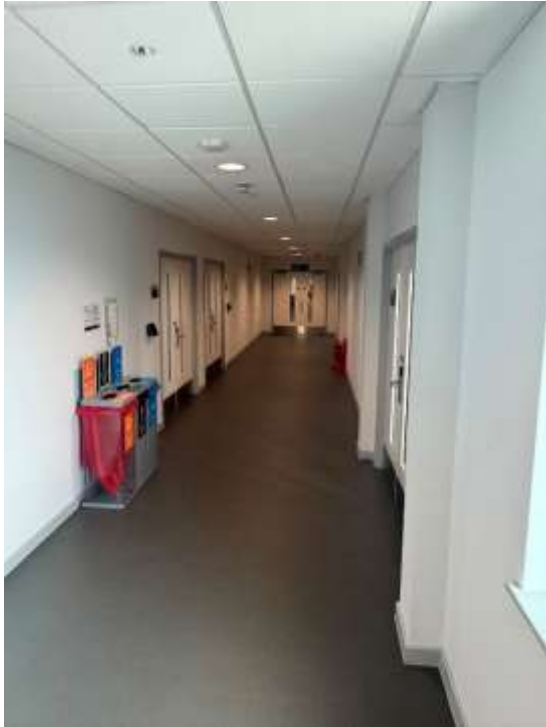
Figure A2 – Main Corridor

*Figure A2: Main first-floor corridor forming part of the handheld survey route.*

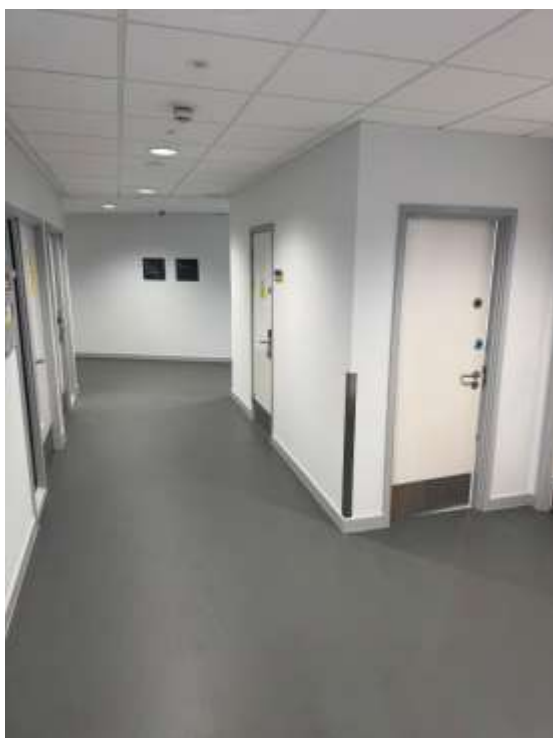
Figure A3 – Corridor junction

Figure A3: Corridor junction and change in direction included within the survey.
