# Cwrt y Bettws Watching Brief

Trysor Project No. 2009/143

# CWRT Y BETTWS WATCHING BRIEF

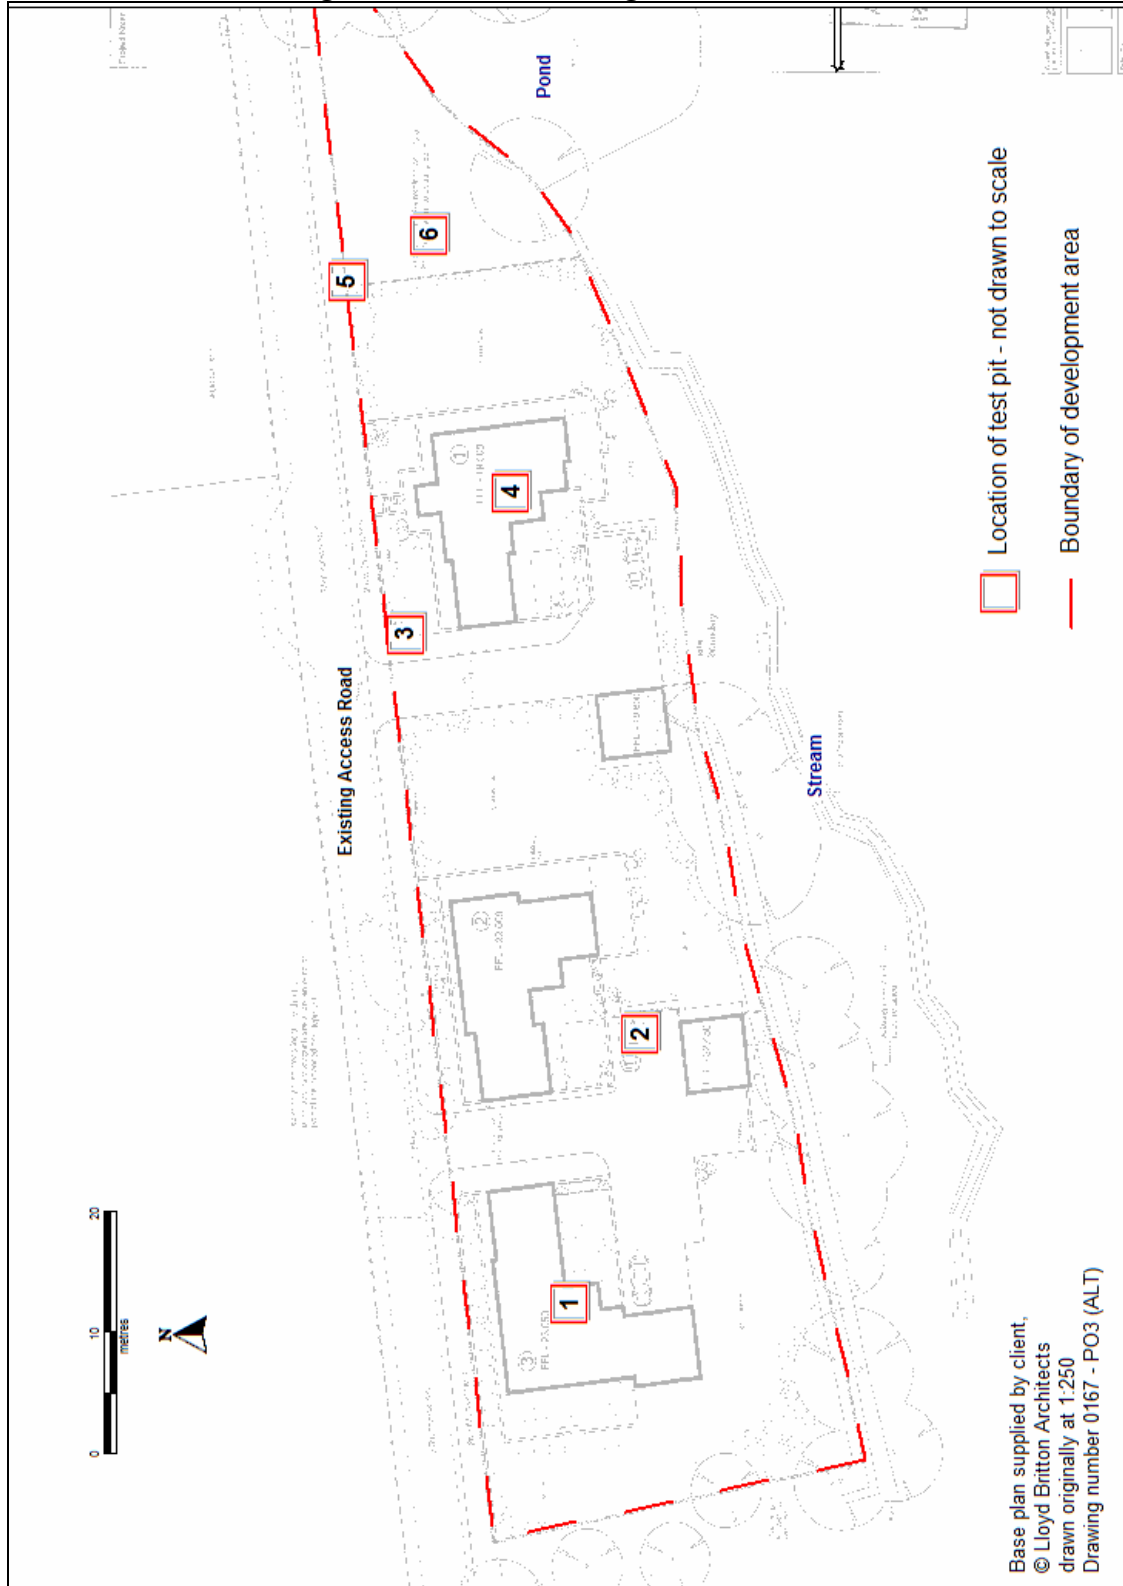
Figure 3: Location of the test pits, based on client's plans and verified in the field.

Six test pits were excavated by the client across the development plot, and each inspected by Trysor. The footings for the house at the western end of the plot were mechanically excavated under archaeological observation, see figures 3 & 4.

Six test pits were dug by the client in order to establish the load bearing capacity of the subsoil, see figure 3. The pits were examined by Trydor and a written and photographic record made. Test pits 1 – 4 lay within the area on which houses were to be built, test pits 5 & 6 lay within the development area but outside the area on which houses were to be built, see figure 3.

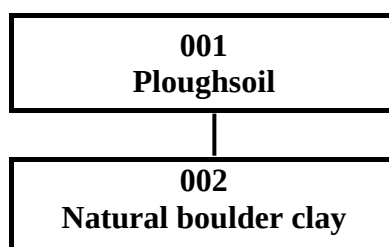
Test pit 1 was 2m north-south x 1m, excavated to a depth of 1m, see photo CYB07. Water had collected in the bottom of the pit to a depth of 0.25m.

| Context Number | Depth | Description | Interpretation |
|---|---|---|---|
| 001 | 0.20m | Dark brown clay/loam | Ploughsoil |
| 002 | – | Orange clay with grey patches | Boulder clay with gleyed patches |

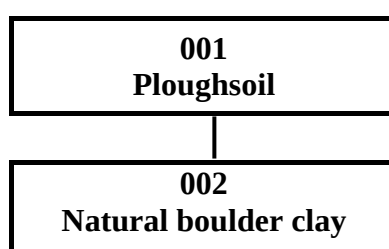
Test pit 2 was a 2m x 1.2m test pit excavated to a depth of 1.5m, see photo CYB08. Water had collected in the bottom of the pit to a depth of 0.5m.

| Context Number | Depth | Description | Interpretation |
|---|---|---|---|
| 001 | 0.25m | Dark brown clay/loam | Ploughsoil |
| 002 | - | Orange clay with grey patches | Boulder clay with gleyed patches |

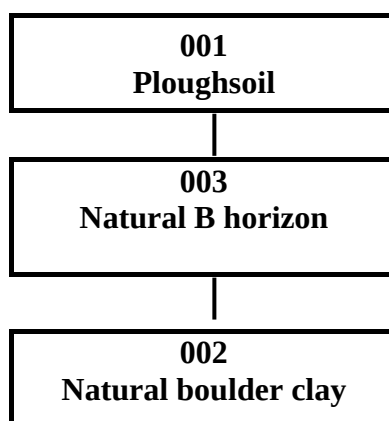
Test pit 3 was a 2m x 1.2m test pit excavated to a maximum depth of 1.0m, see photo CYB09. No water had collected in the base of the pit.

| Context Number | Depth | Description | Interpretation |
|---|---|---|---|
| 001 | 0.25m | Dark brown clay/loam | Ploughsoil |
| 003 | 0.35-0.40m | Red brown loam/clay | Natural B horizon |
| 002 | - | Orange clay with grey patches | Boulder clay with gleyed patches |

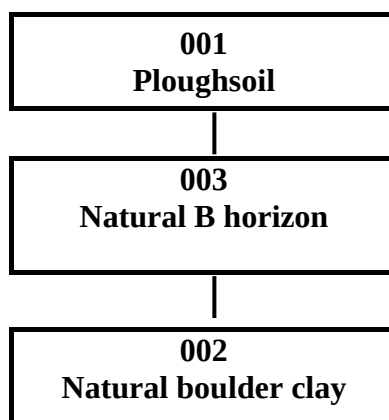
Test pit 4 was a 2.0m x 1.0m test pit excavated to a depth of 0.9m, see photos CYB10 & CYB11. Water had collected in the bottom of the pit to a depth of 0.1m.

| Context Number | Depth | Description | Interpretation |
|---|---|---|---|
| 001 | 0.35m | Dark brown clay/loam | Ploughsoil |
| 003 | 0.25m | Red brown loam/clay | Natural B horizon |
| 002 | - | Orange clay with grey patches | Boulder clay with gleyed patches |

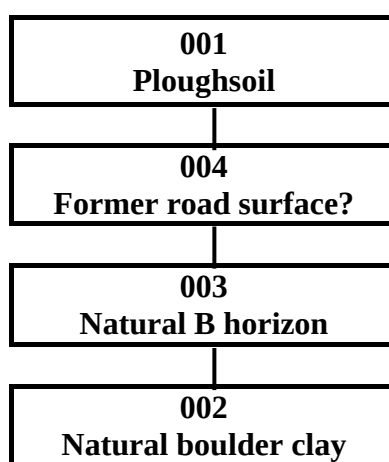
Test pit 5 was a 2.5m ENE to WSW x 1.0m test pit excavated to a depth of 1.5m, see photos CYB12. Water had collected in the bottom of the pit to a depth of less than 0.1m. It lay inside the development area but outside the area to be built on.

| Context Number | Depth | Description | Interpretation |
|---|---|---|---|
| 001 | 0.3m | Dark brown clay/loam | Ploughsoil |
| 004 | Up to 0.30m | Stone/clay layer in the northern part of the test pit | Former road surface? |
| 003 | 0.25m – 0.30m | Red brown loam/clay | Natural B horizon |
| 002 | | Orange clay with grey patches | Boulder clay with gleyed patches |

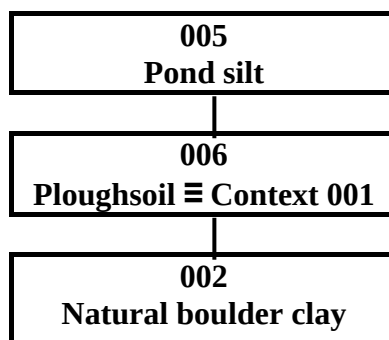
Test pit 6 was a 2.5m x 1.0m test pit excavated to a depth of 1.5m. It lay inside the development area but outside the area to be built on.

| Context Number | Depth | Description | Interpretation |
|---|---|---|---|
| 005 | 0.40m | Black silt with flecks of red, very little stone, no artefacts | Material from cleaning out of the adjacent pond |
| 006 | 0.40m | Mid brown clay loam | Ploughsoil ≡ Context 001 |
| 002 | | Orange clay with grey patches | Boulder clay with gleyed patches |

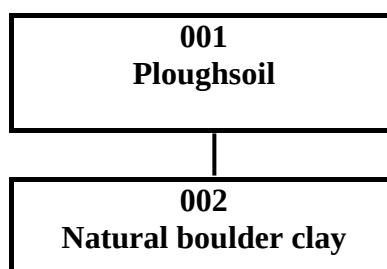
Footings for House 3 were mechanically excavated on 30<sup>th</sup> June 2009 and again the process was watched by Trysor, see figure 4. None of the trenches revealed any archaeological features. The ploughsoil, where it hadn't been previously removed, overlay a mixed natural boulder clay.

| Context Number | Depth | Description | Interpretation |
|---|---|---|---|
| 001 | 0.20m – 0.50m | Dark brown clay/loam | Ploughsoil |
| 002 | - | Orange clay with grey patches | Natural boulder clay |

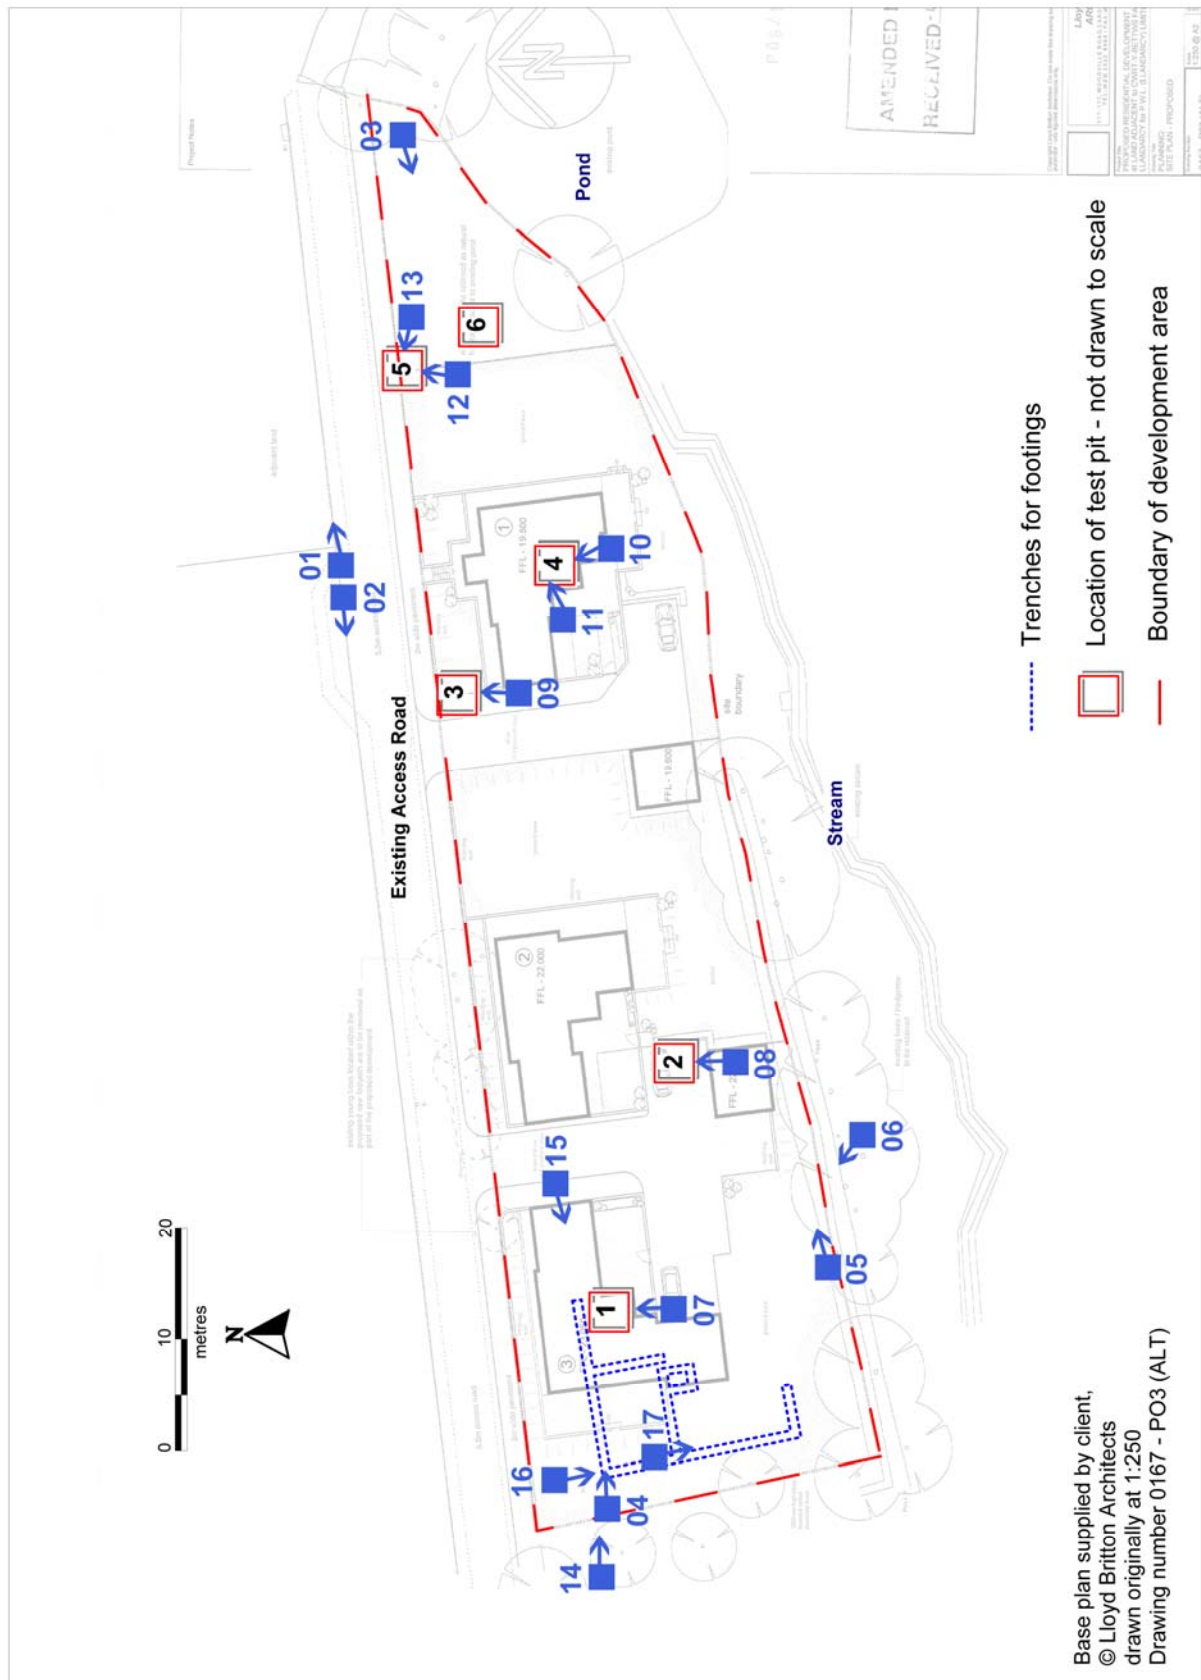
Figure 5: Location of photographs

Colour digital photographs were taken of mechanically excavated areas using a 12M pixel camera. The following table describes the content of each photograph included in the project archive and their locations are provided in the following map, see Figure 5. The photographs are included in Appendix 2 at the end of the report.

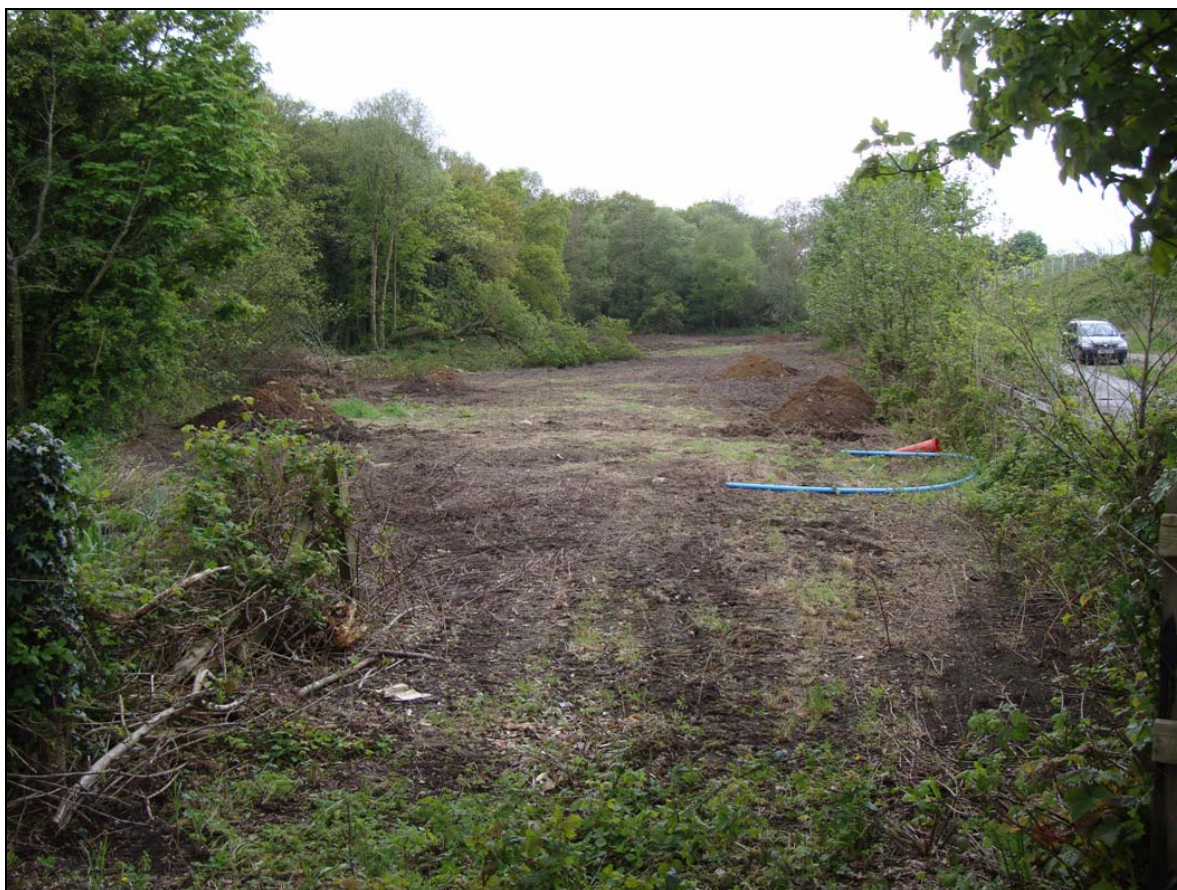
Plate 3: CYB03 – Development plot showing test pits looking west

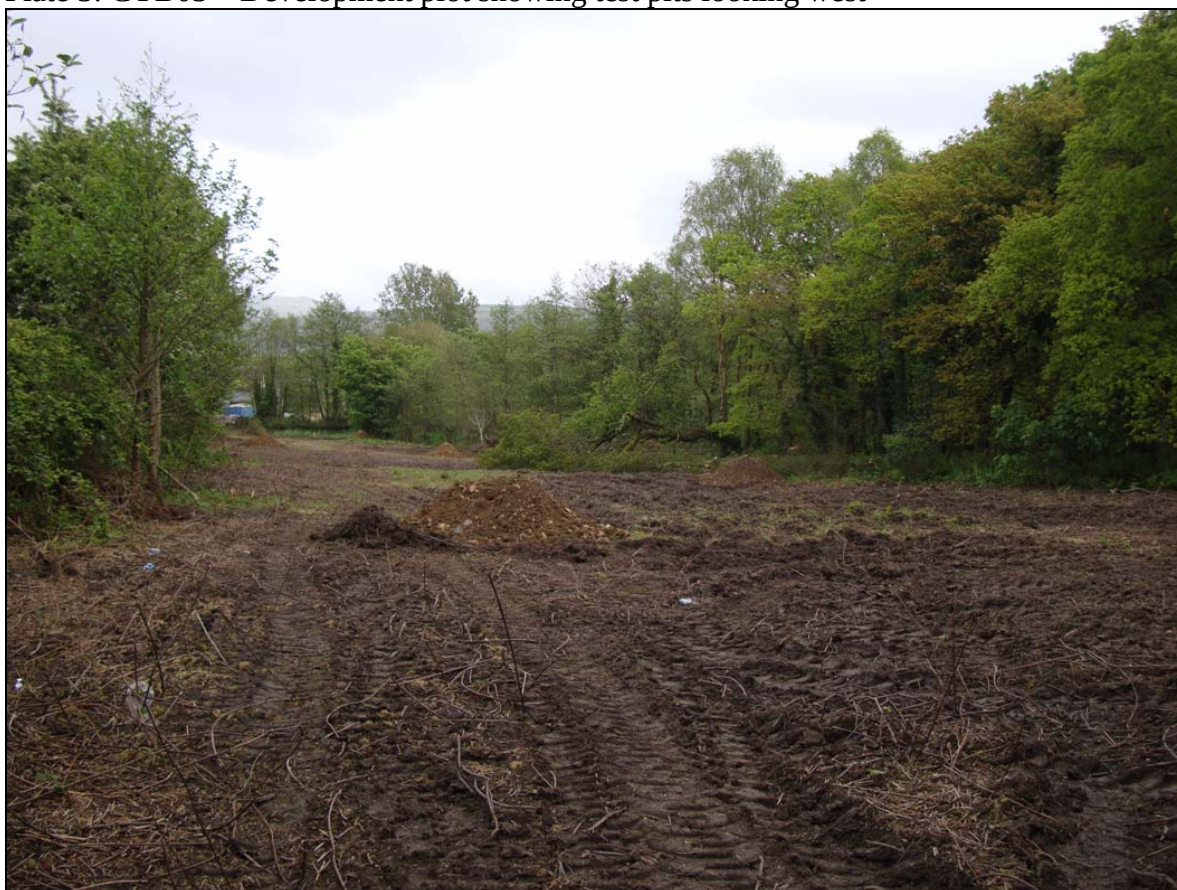
Plate 4: CYB04 – Development plot showing test pits, looking east.

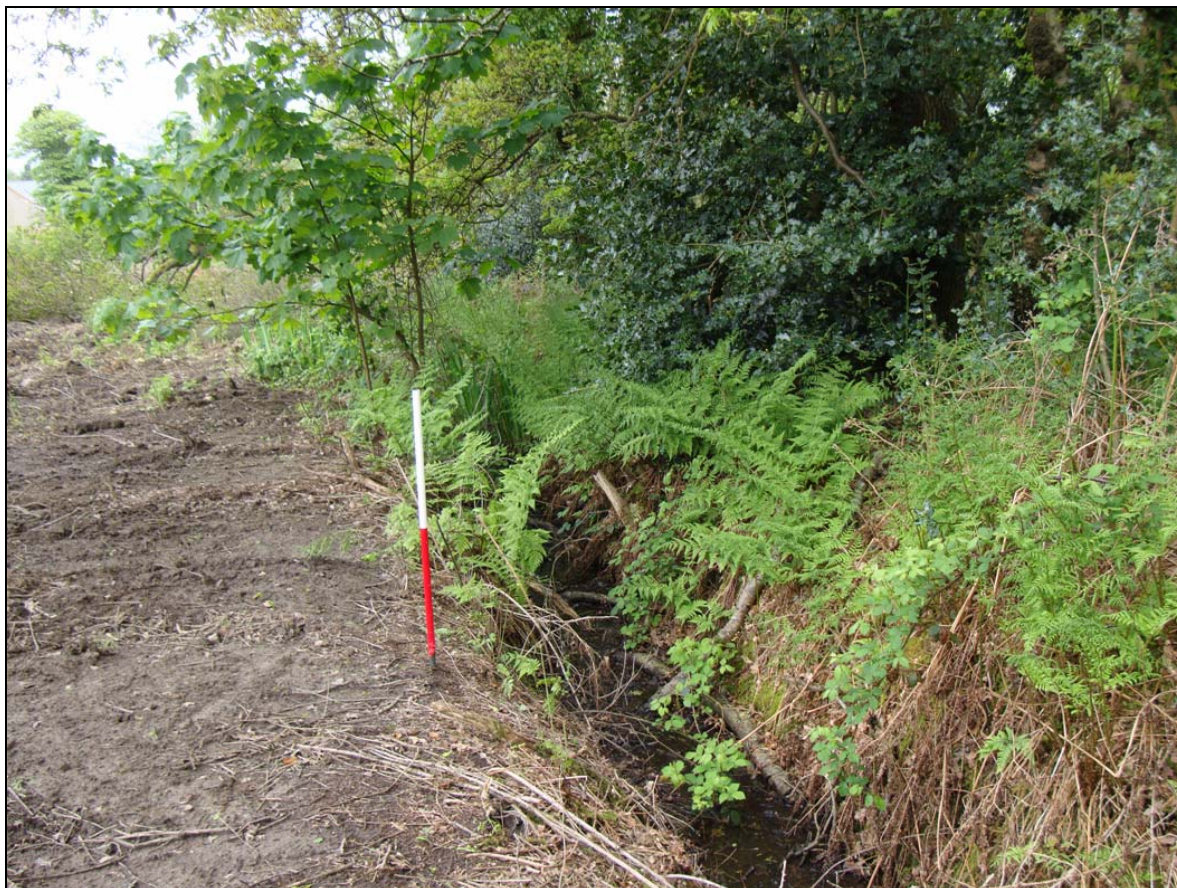
Plate 5: CYB05 – Modern gully along southern side of development plot

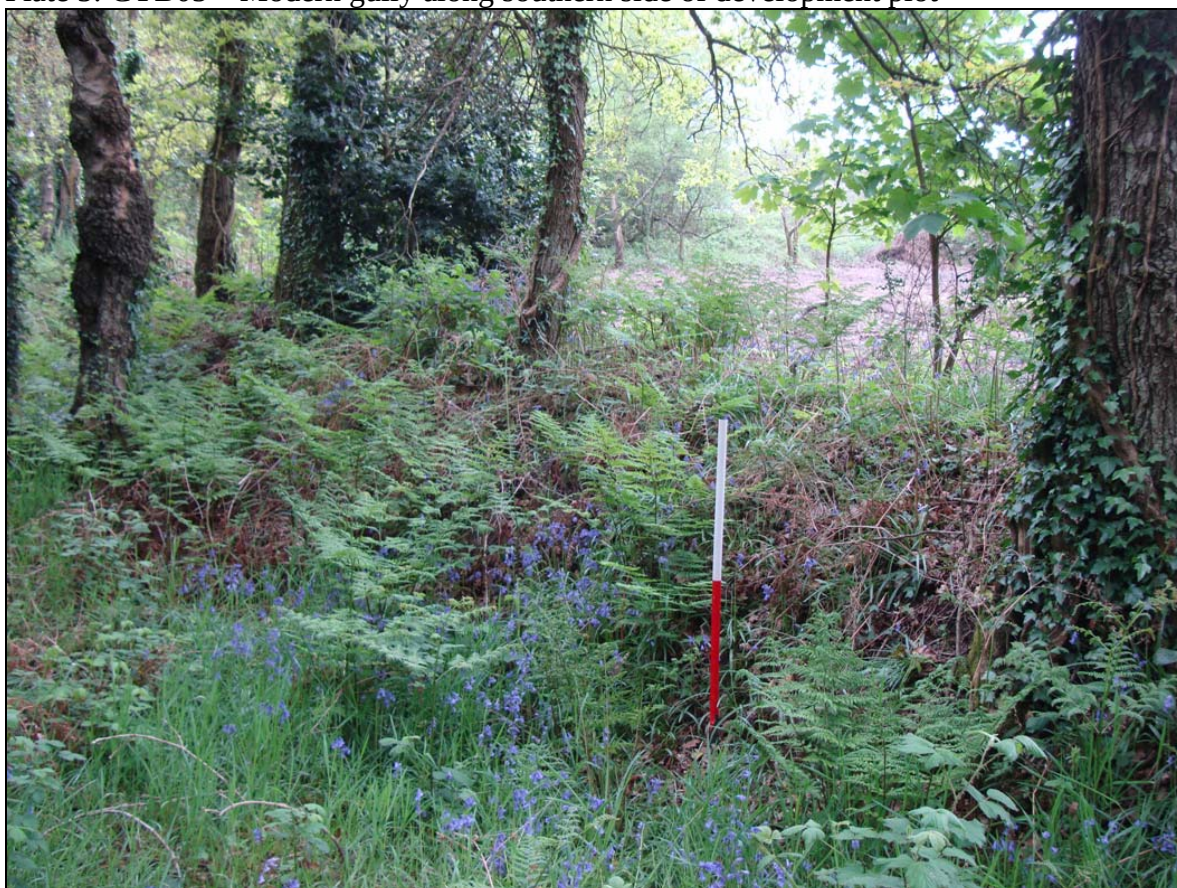
Plate 6: CYB06 – Bank just outside development area

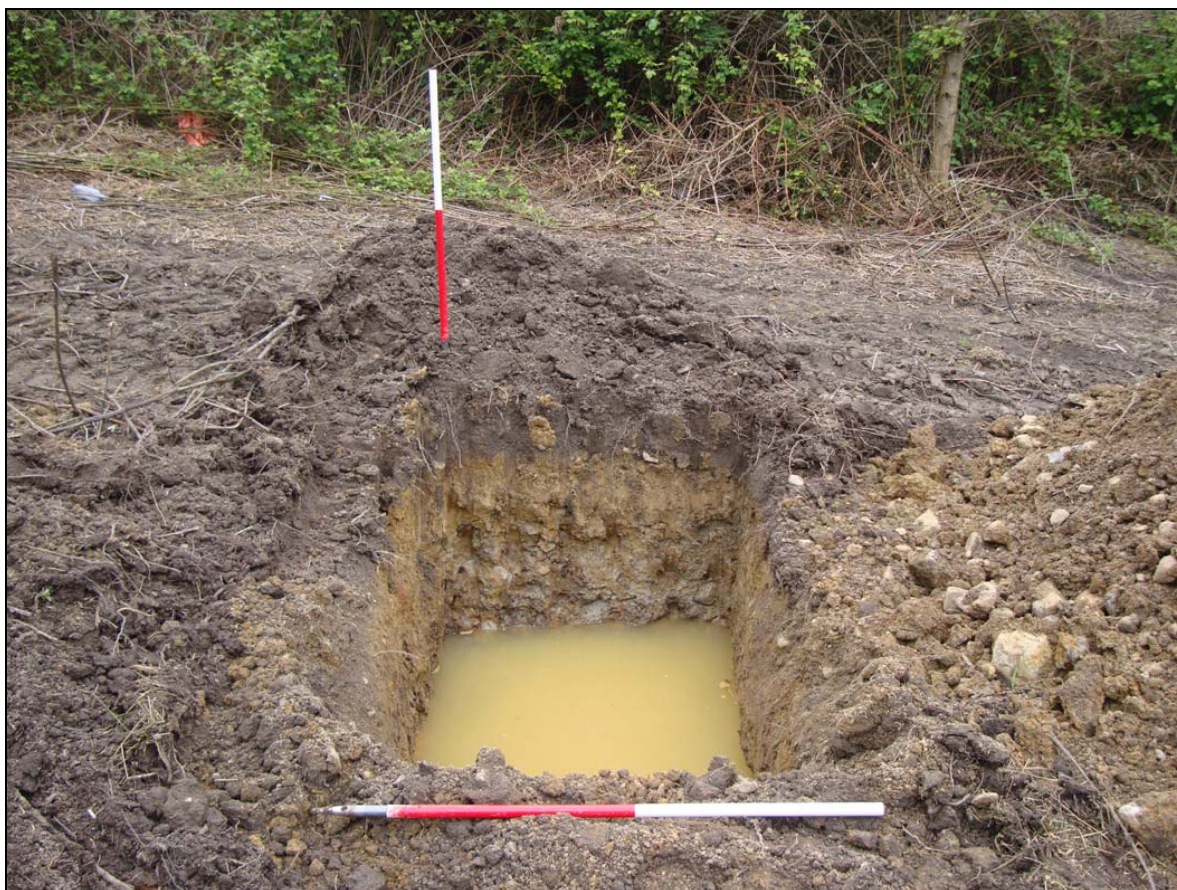
Plate 7: CYB07 – Test pit 1, looking north

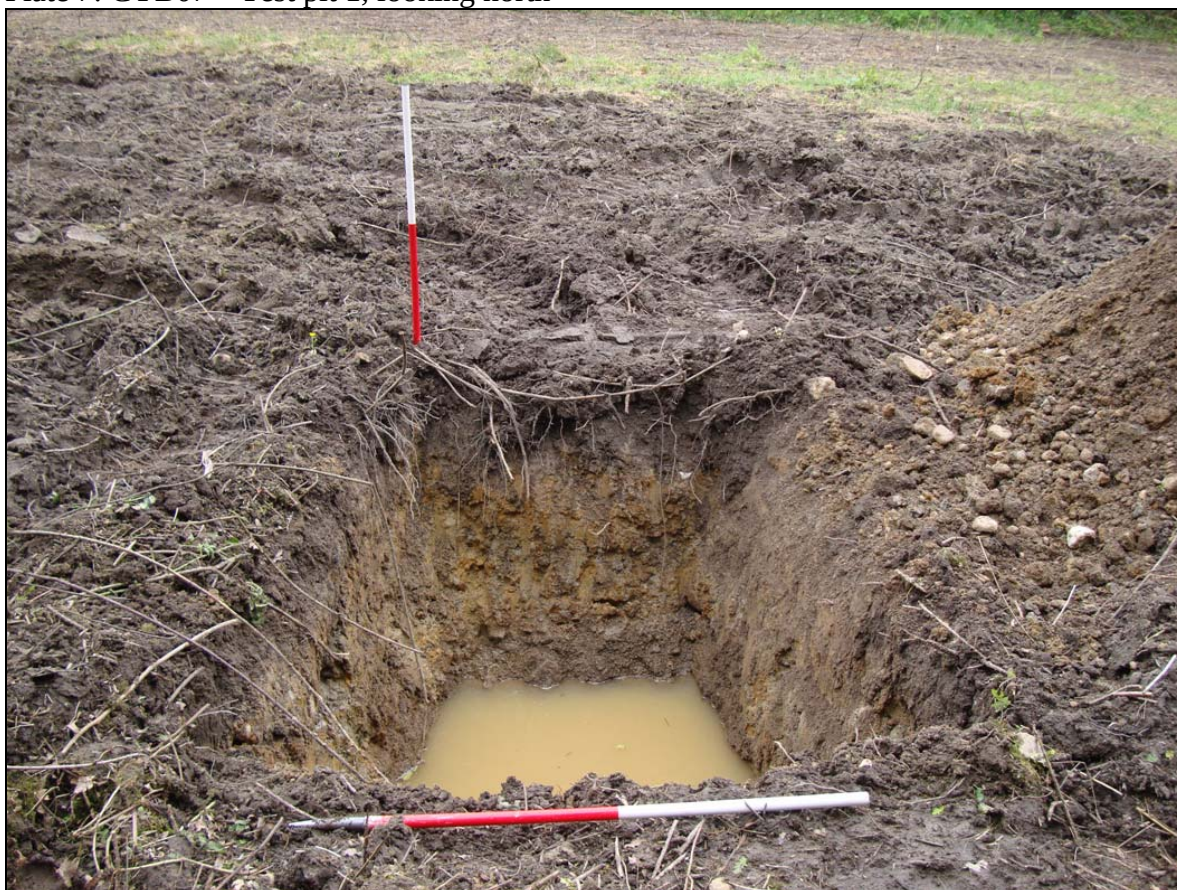
Plate 8: CYB08 – Test pit 2, looking north

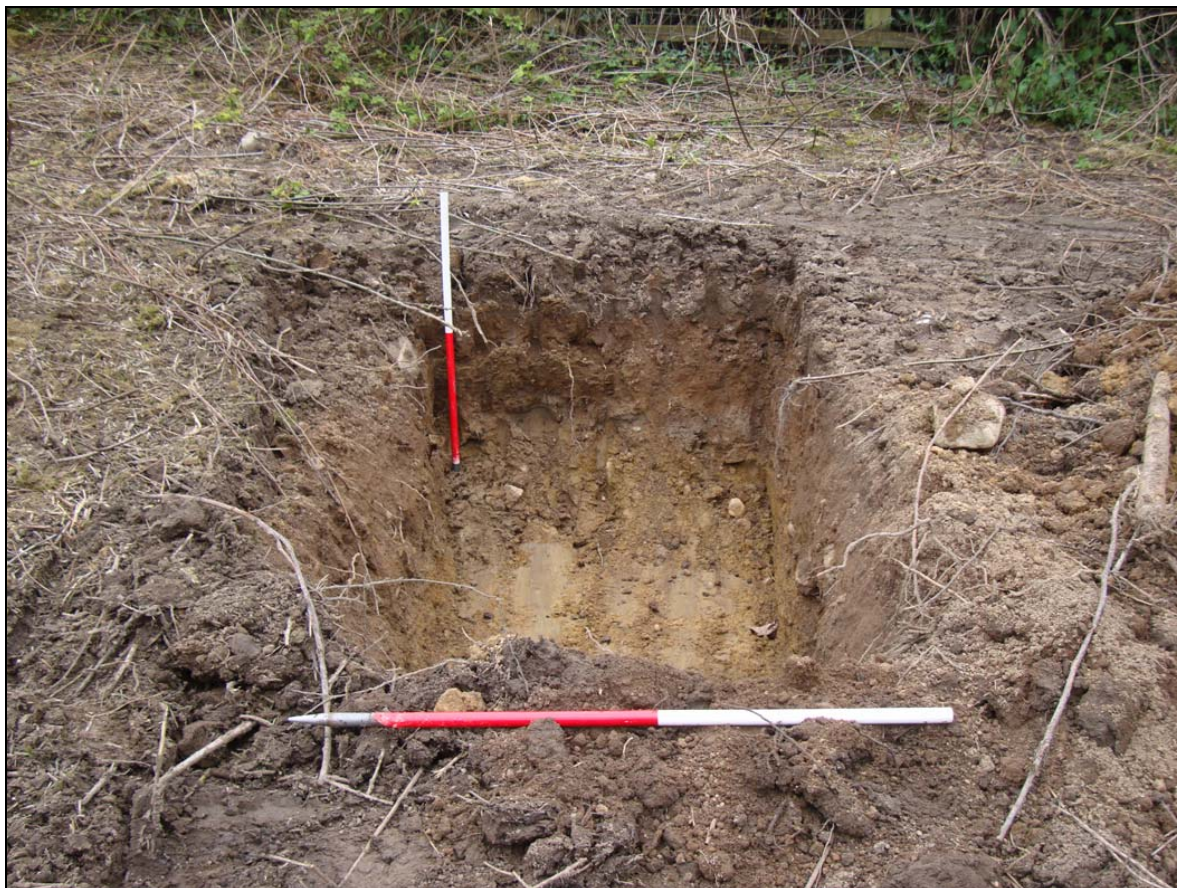
Plate 9: CYB09 – Test pit 3, looking north

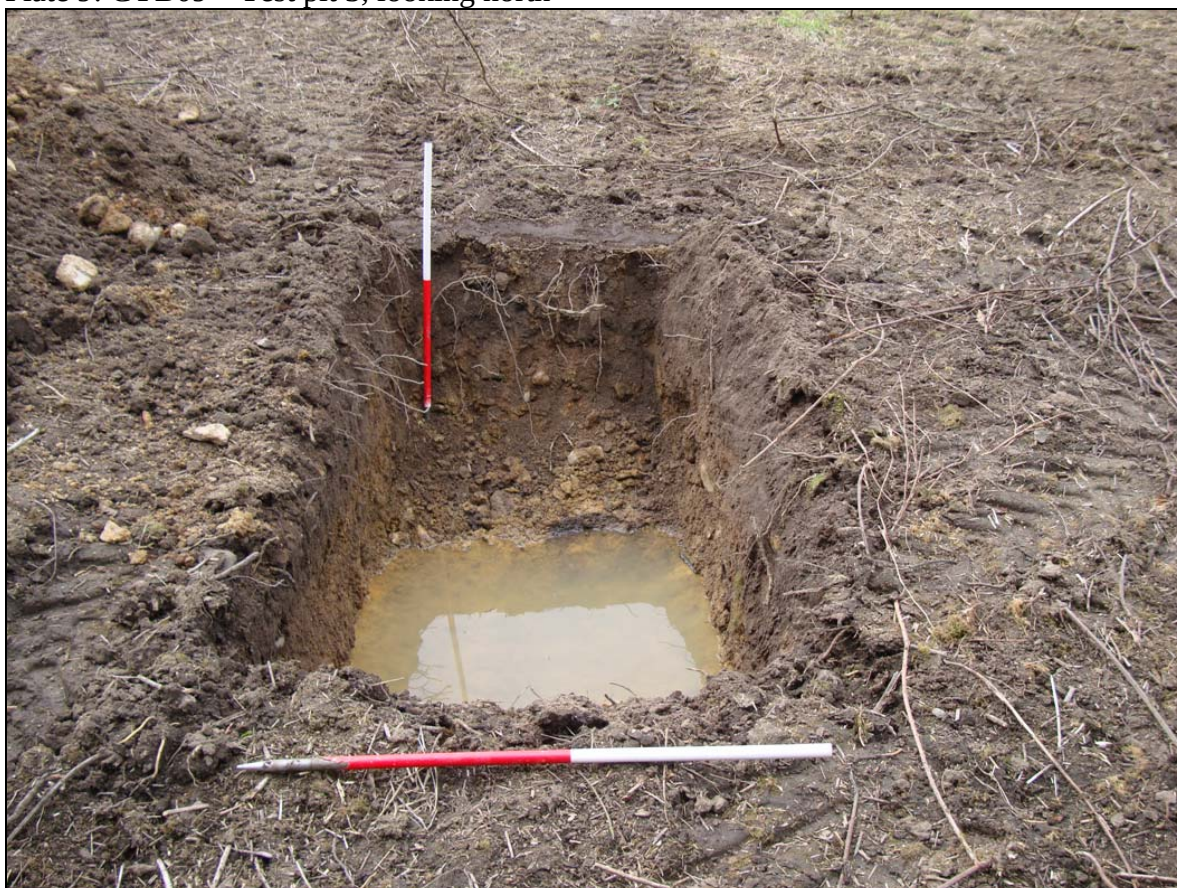
Plate 10: CYB10 – Test pit 4, looking northwest

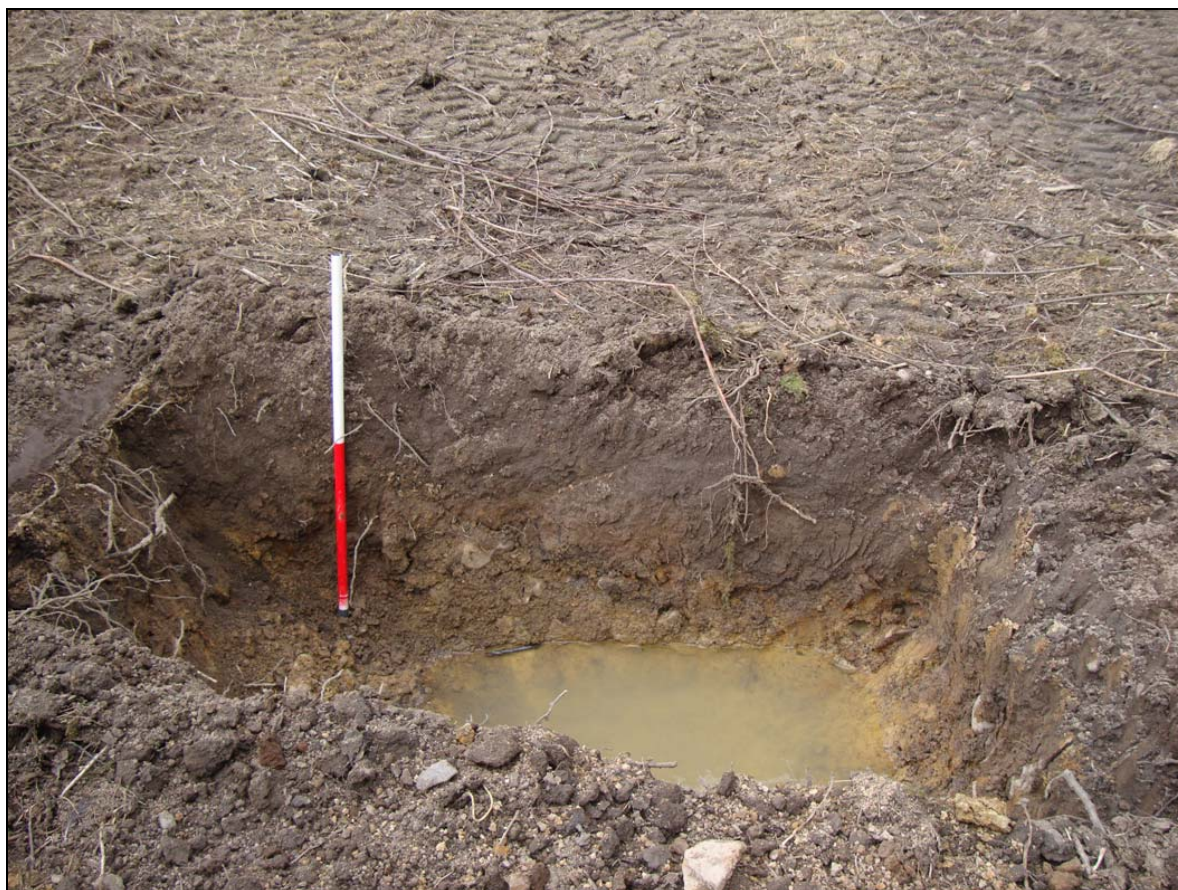
Plate 11: CYB11 – Test pit 4, looking northeast.

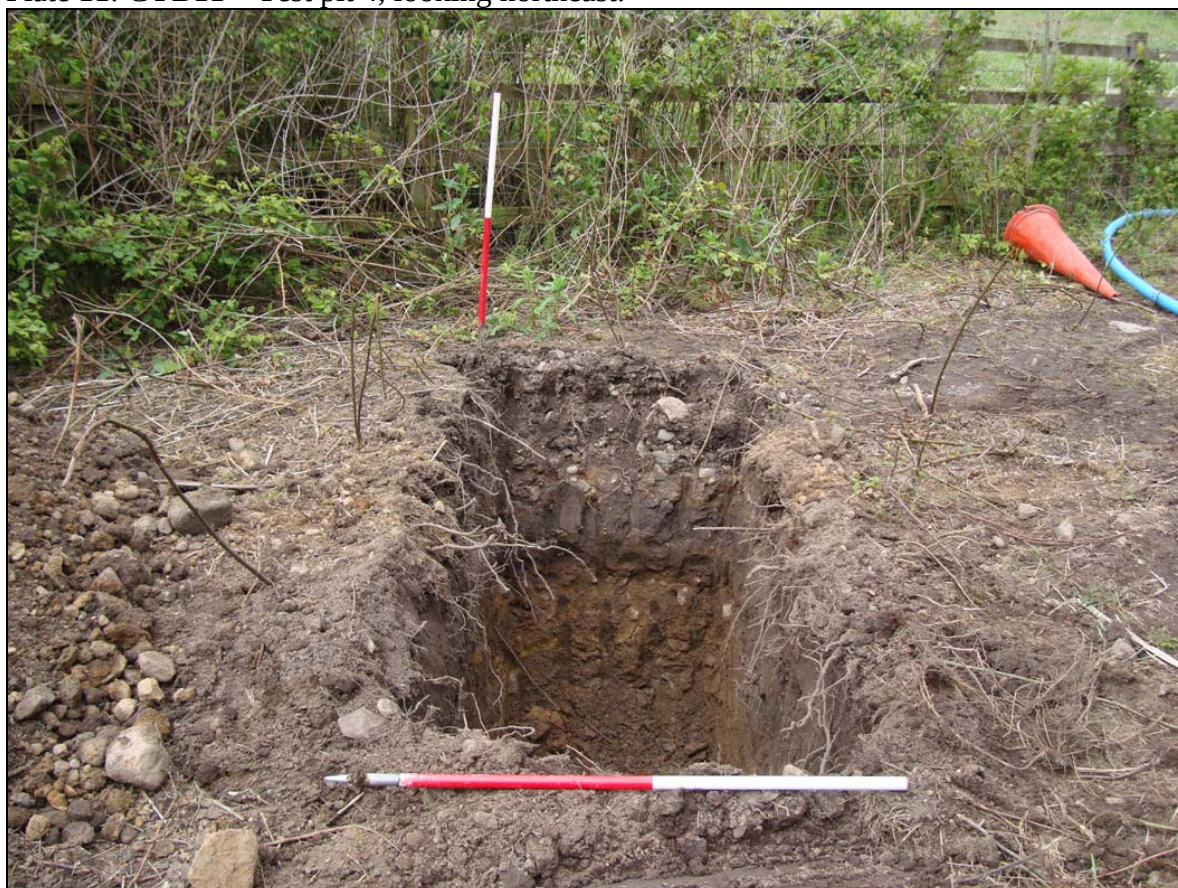
Plate 12: CYB12 – Test pit 5, looking north northeast

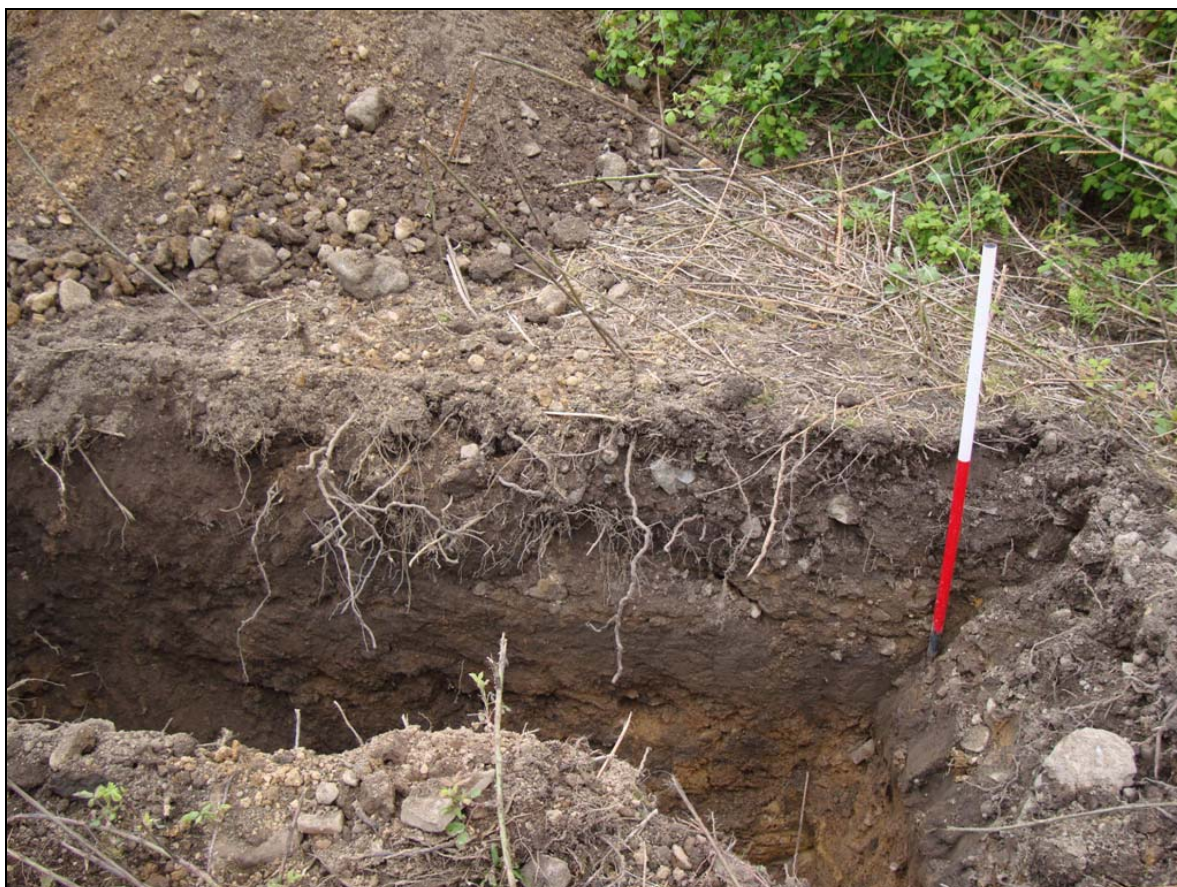
No significant deposits were encountered within the area to be built on. A stone layer in the northern part of test pit 5 may be a former track surface. The layer of black silt overlying the plough soil in test pit 6 was thought to be material cleaned out from the adjacent pond. No artefacts were recovered other than 20<sup>th</sup> century pottery.

Plate 13: CYB13 –NW corner of test pit 5, looking west northwest showing stony band.

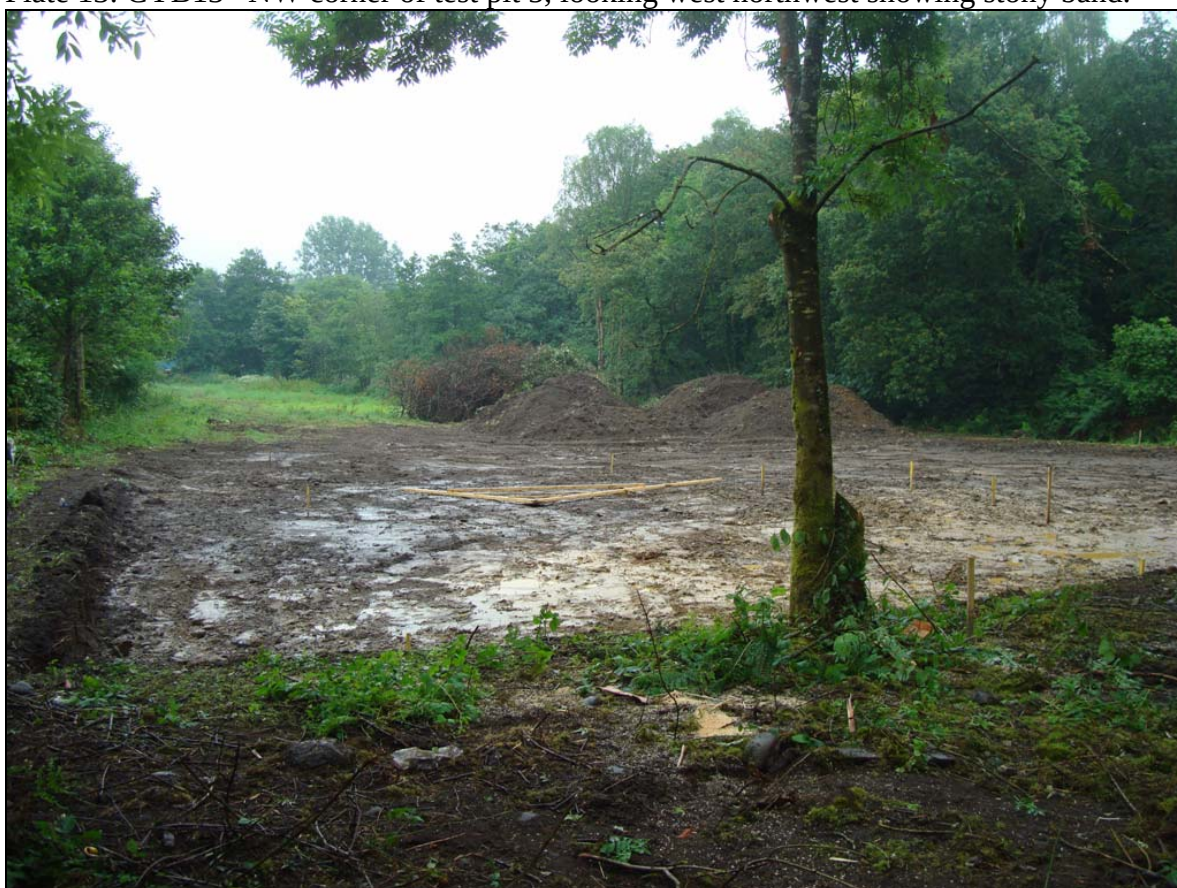
The ground surface for the western house on the development, House 3, was levelled on 26<sup>th</sup> June 2009 and the process watched by Trysor. Natural boulder clay became visible towards the centre of the western edge of the area as can be seen in Plate 15. The rest of the area remained covered by context 001, the Ploughsoil. No archaeological features were seen during this process.

Plate 14: CYB14 –The western development area after levelling of ground, looking east

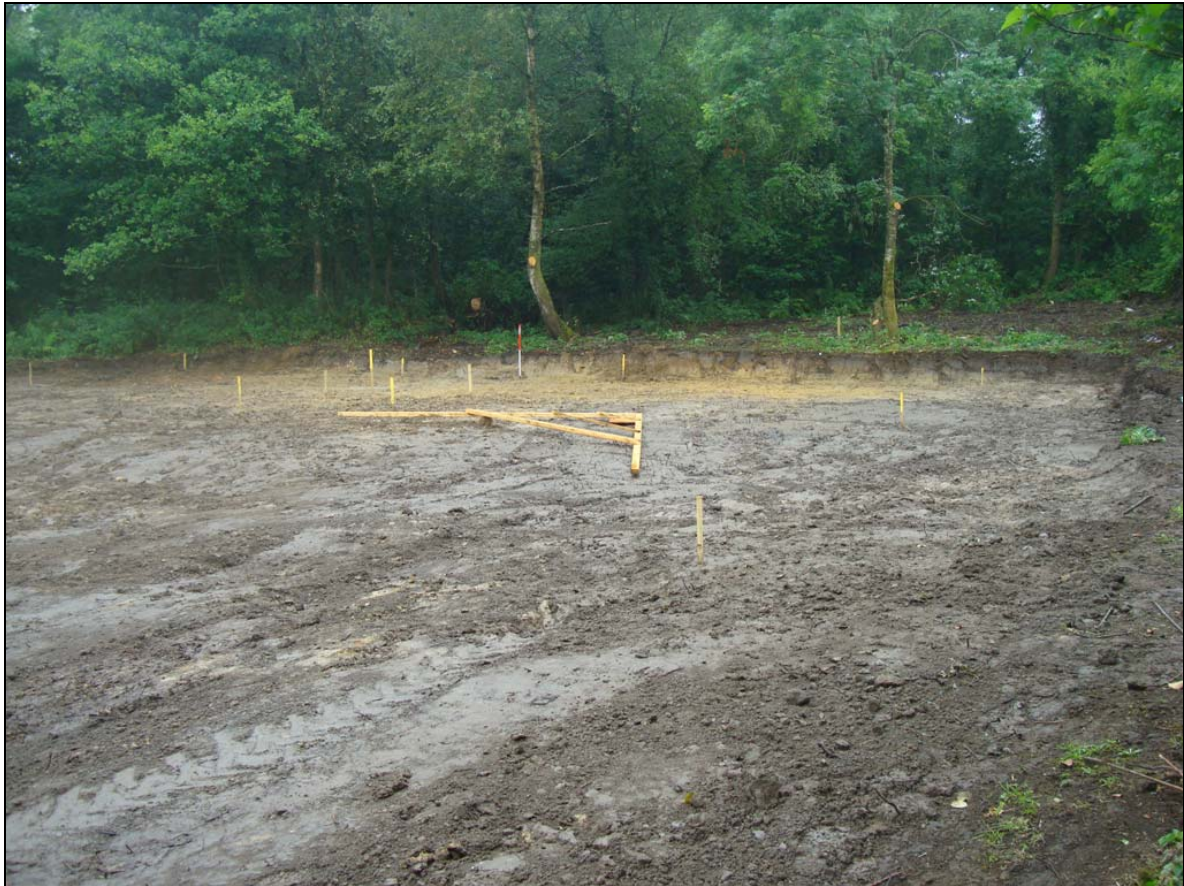
Plate 15: CYB15 – The western development area after levelling of ground, looking east

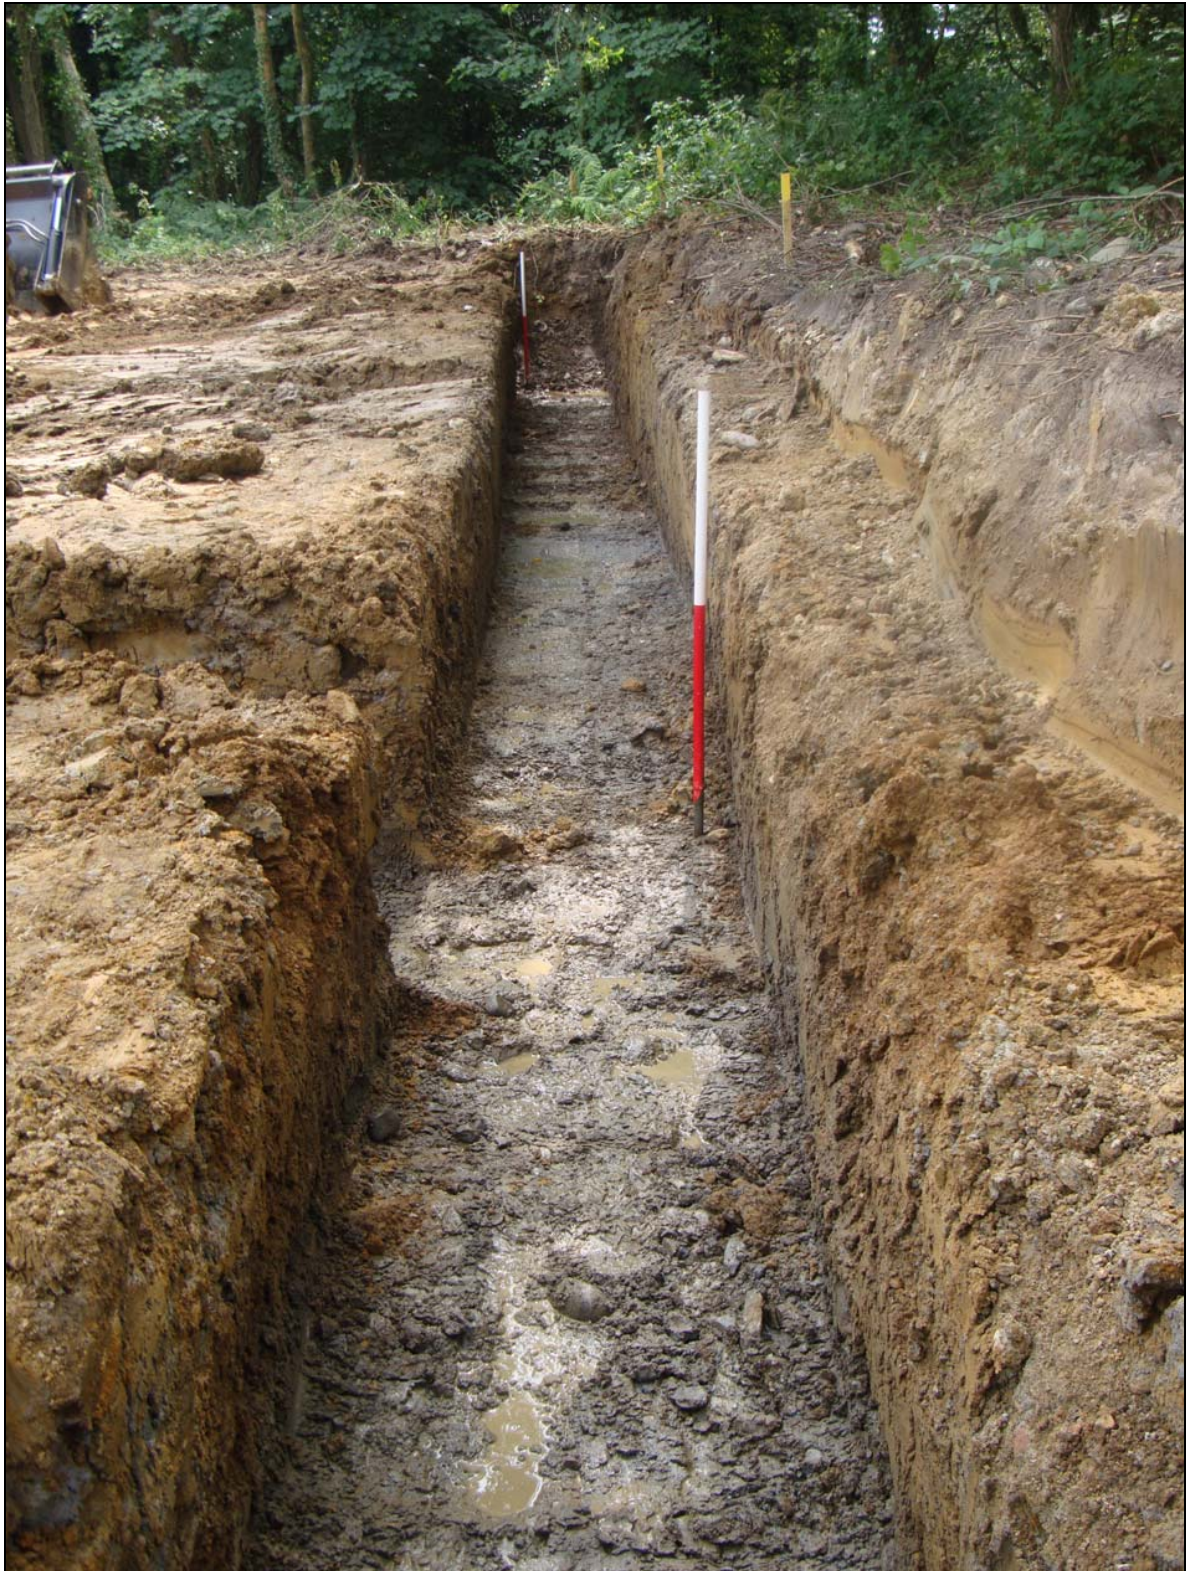
Plate 16: CYB16 – Footings for House 3, looking east
