# Cwrt y Bettws Watching Brief

Trysor Project No. 2009/143

# CWRT Y BETTWS WATCHING BRIEF

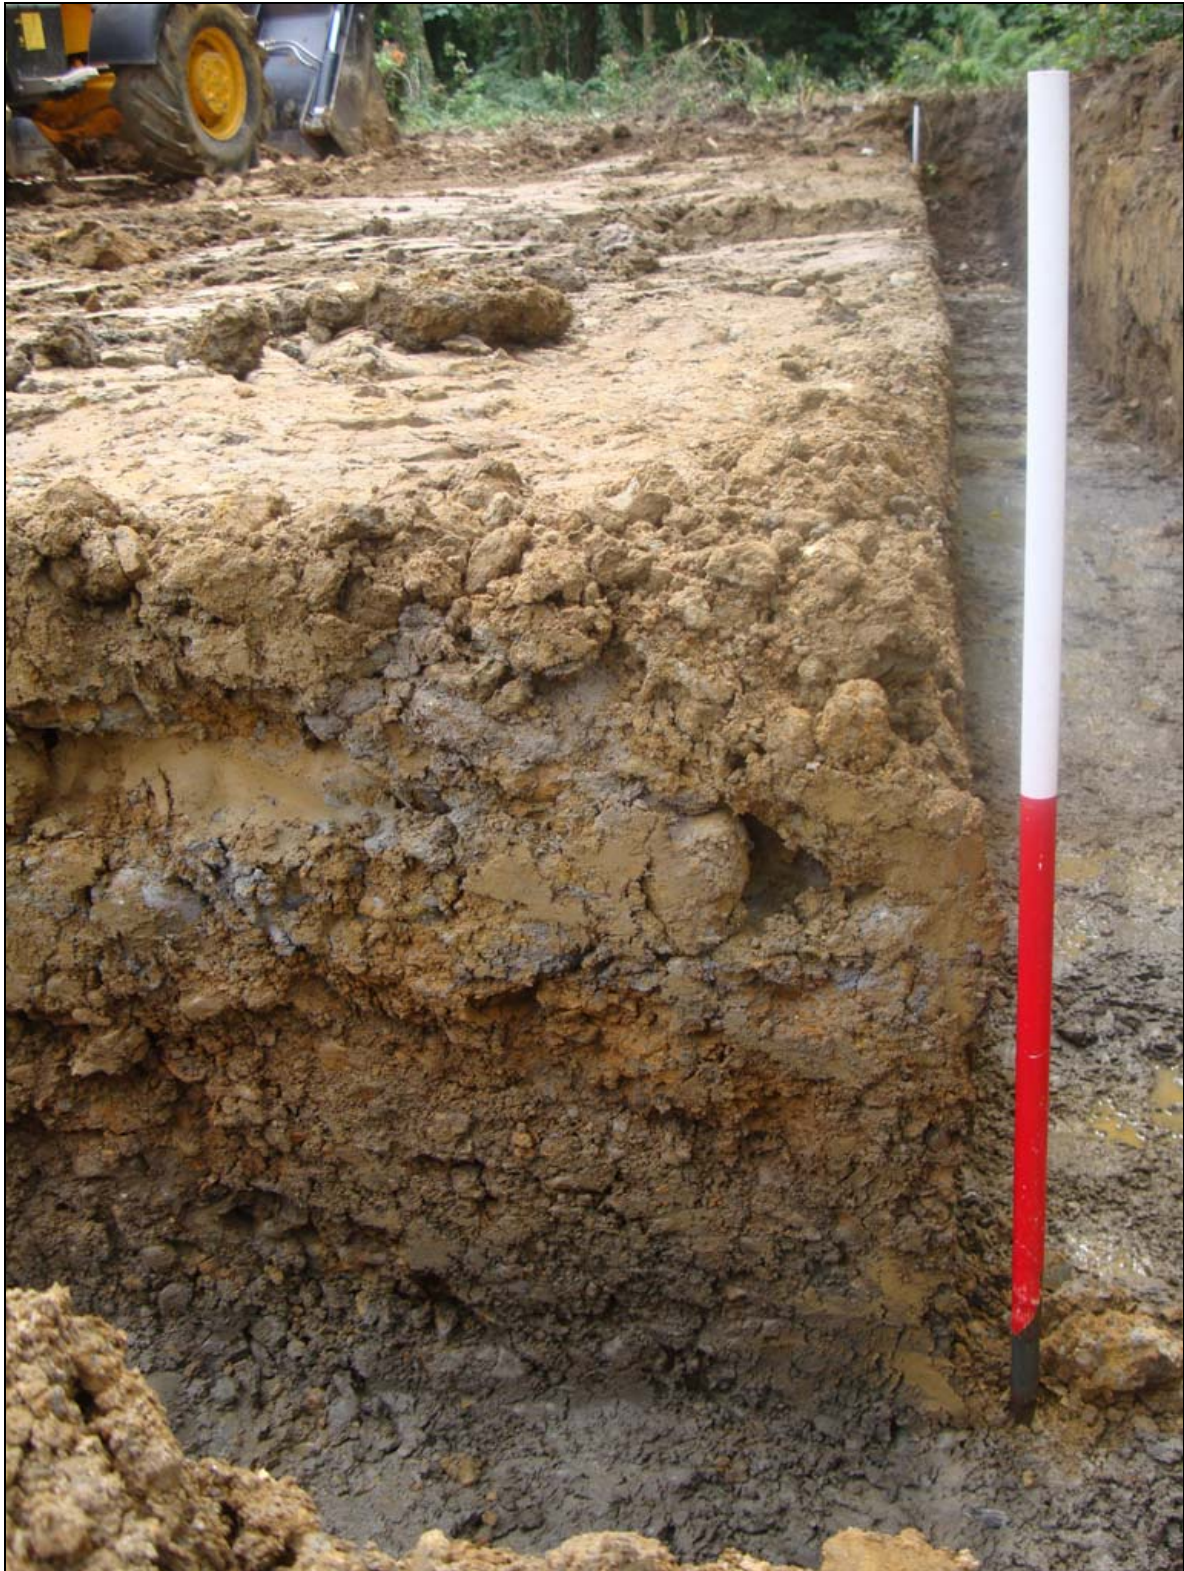
Footings for House 3 were mechanically excavated on 30<sup>th</sup> June 2009 and again the process was watched by Trysor, see figure 4. None of the trenches revealed any archaeological features. The ploughsoil, where it hadn't been previously removed, overlay a mixed natural boulder clay.

Plate 17: CYB17 – The western development area after levelling of ground, looking east
