ACBA7005 GIS and Habitat Management

# Evaluation of Oxwich Bay National Nature Reserve

10<sup>th</sup> May 2020

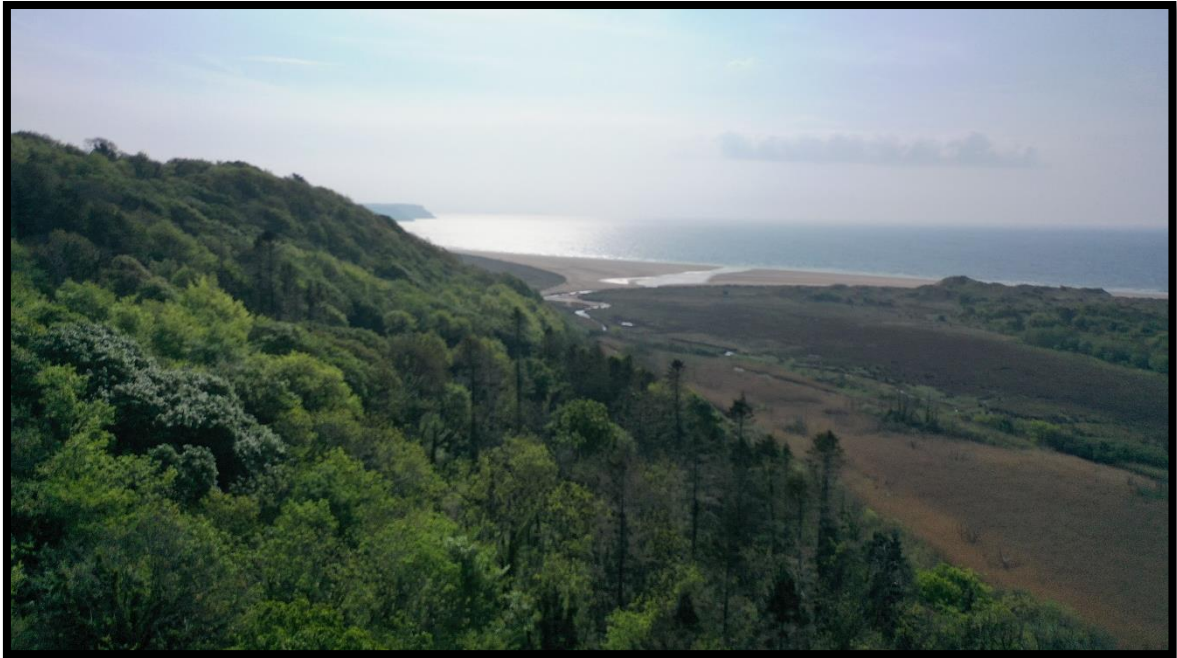
Figure 2.5 - Ariel shot of Nicholaston Woods (Drummond, 2022)

The woodland located on the cliffs in the northern part of the site (see Figure 2.5) can be generally defined as *Tilio-Acerion* and largely consists of semi-natural broadleaved woodland, with small sections of planted broadleaved woodland and planted mixed woodland. The main species of trees that can be found here are Common Ash (*Fraxinus excelsior*), Sycamore (*Acer pseudoplatanus*), European Beech (*Fagus sylvatica*), Common Hazel (*Corylus avellana*) and English Oak (*Quercus robur*). Small populations of Giant Fir (*Abies grandis*), Wych Elm (*Ulmus glabra*), Common Hawthorn (*Crataegus monogyna*), Blackthorn (*Prunus spinosa*) and Elder (*Sambucus nigra*) can also be found. Rare Rock Whitebeam (*Sorbus rupicola*) trees can also be found in small numbers within the woodland. Although a rare tree, it is categorised as *Least Concern* by the IUCN Red List (IUCN, 2015).

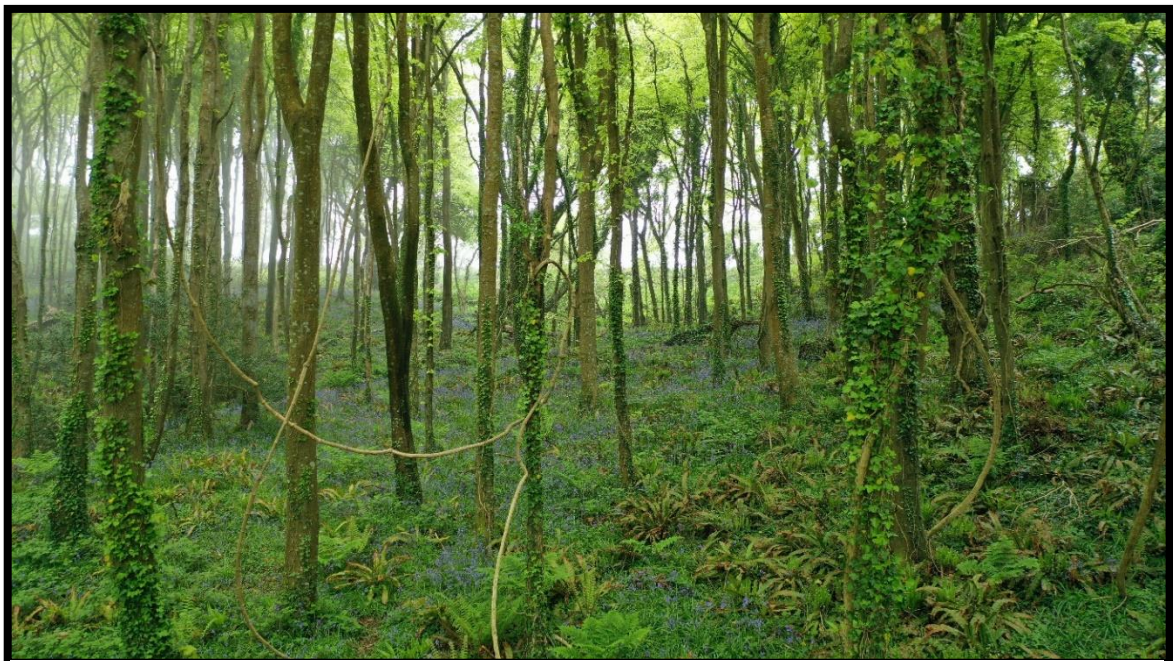
Figure 2.6 - English Bluebells amongst the Harts-Tongue, Common Lady and Male Ferns under the Ash canopy along the woodland slopes (Drummond, 2022)

The woodland floor is dominated by English ivy (*Hedera helix*), Hart's-Tongue Fern (*Asplenium scolopendrium*) and both Common Lady and Male Ferns (*Athyrium filix-femina* and *Dryopteris filix-mas*). As can be seen in Figure 2.6, late spring brings a thick carpet of Bluebells (*Hyacinthoides non-scripta*) and swathes of fragrant Wild Garlic (*Allium ursinum*), with some less prevalent Garlic Mustard (*Alliaria petiolata*). Other flowers that can be found interspersed between the garlic and bluebells from spring through to summer are Robert Geranium (*Geranium robertianum*), Red Campion (*Silene dioica*), Wood Anemone (*Anemone nemorosa*), English Primrose (*Primula acaulis*), lesser celandine (*Ficaria verna*), Blue Bugle (*Ajuga reptans*) and Wood Speedwell (*Veronica montana*).

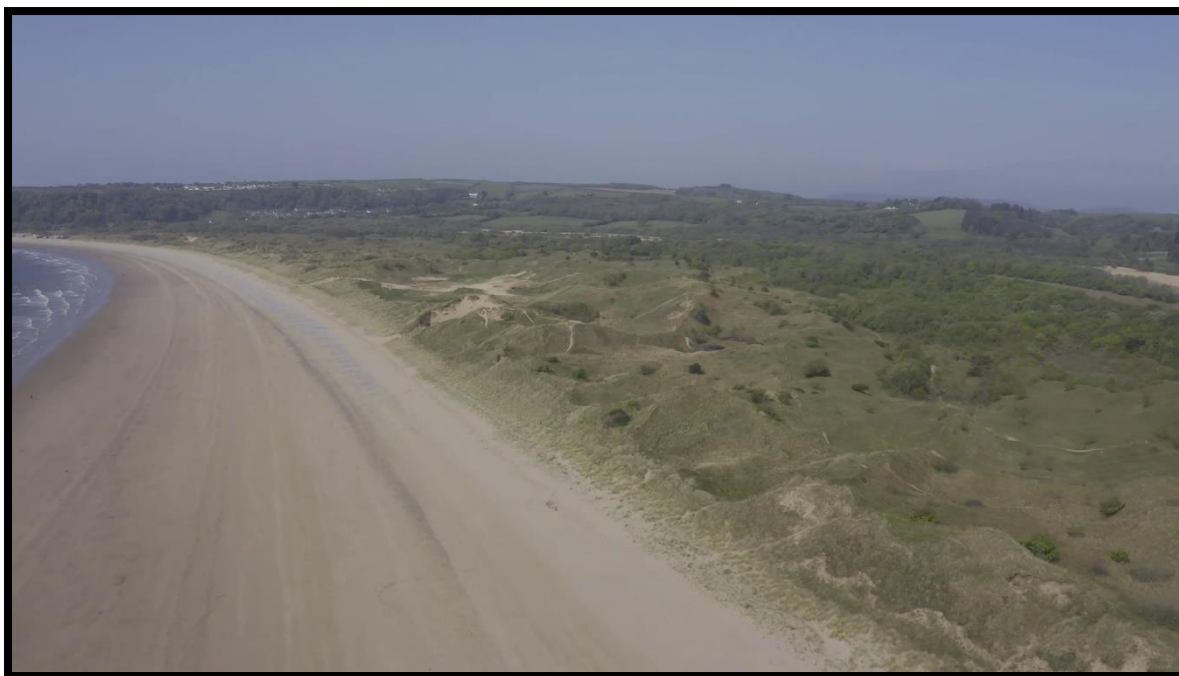
Figure 2.7 - Oxwich beach and burrows as seen from the eastern end of the reserve (Drummond, 2022)

The NRW phase one habitat survey classifies the vast majority of the dune system as *open dune*, with small pockets of *dune slack* and one small area of *dune grassland* (see Figure 2.7). Large areas of *dense scrub* and *semi natural broadleaved woodland* lie on the northern periphery of the burrows and non-native trees of Monterey Cypress (*Cupressus Macrocarpa*) can be found occasionally throughout the dunes. Sea Holly (*Eryngium maritimum*), Seaside Sandplant (*Honckenya peploides*), and Oxford Ragwort (*Senecio squadlidus*) are prevalent throughout the burrows and several species of wild orchid can be found within the dunes such as Common Twayblade (*neottia Ovata*), Bee Orchid (*Ophrys apifera*), Pyramidal Orchid (*Anacamptis pyramidal*) and Southern Marsh Orchid (*Dactylorhiza praetermissa*). The rare and endangered Fen Orchid (*Liparis loeselii*) had previously been known to grow amongst the dunes but has not been seen in a number of years and is thought to now be extinct in this area.

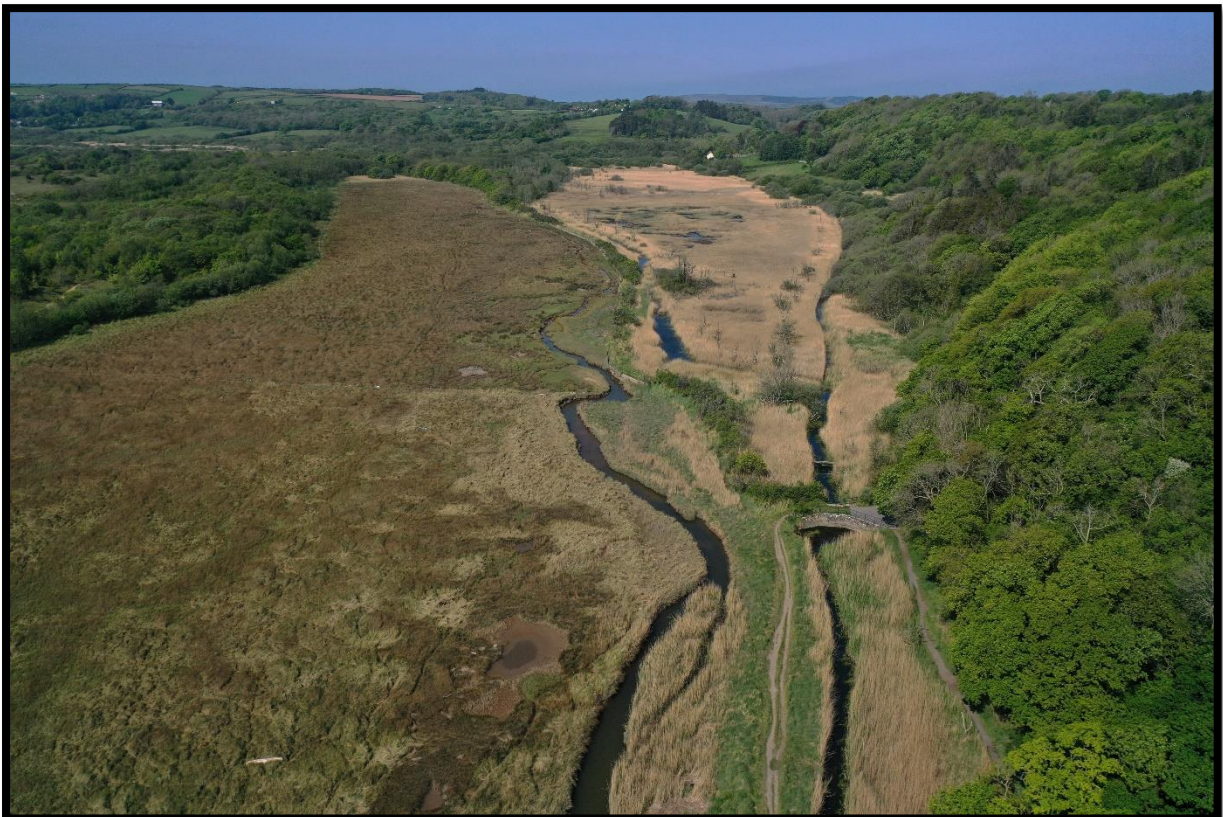
Figure 2.8 - Ariel Photograph of Oxwich Marsh. Saltmarsh is on the left (south), freshwater swamp on the right (north). (Drummond, 2022)

Oxwich Marsh forms a meandering sinuous lagoon that leads from the mouth of Nicholaston Pill and continues behind the dunes of Oxwich Burrows and around the western flank of the nature reserve. Supporting extensive reed beds, wet woodland and scrub, it is noted in the Gower Woods SAC Core Management Plan as an important wetland habitat. As can be seen in Figure 2.8, This wetland is split into two distinctive habitat types, most of the area consists of freshwater swamp in the north and west with a small saltmarsh in the southeast area. The saltwater marsh and freshwater swamp are segregated by a sea wall which had been originally constructed in 1790 to facilitate the creation of freshwater lake and water meadows for grazing. Nicholaston Pill was partially trained and re-routed to its present position to achieve this. Prior to this re-engineering of the wetland, this entire low-lying area behind the dunes would have been entirely saltmarsh (Halcrow, 2012), lack of active management and maintenance of the constructed water meadows have led to the freshwater swampy conditions that are present today.

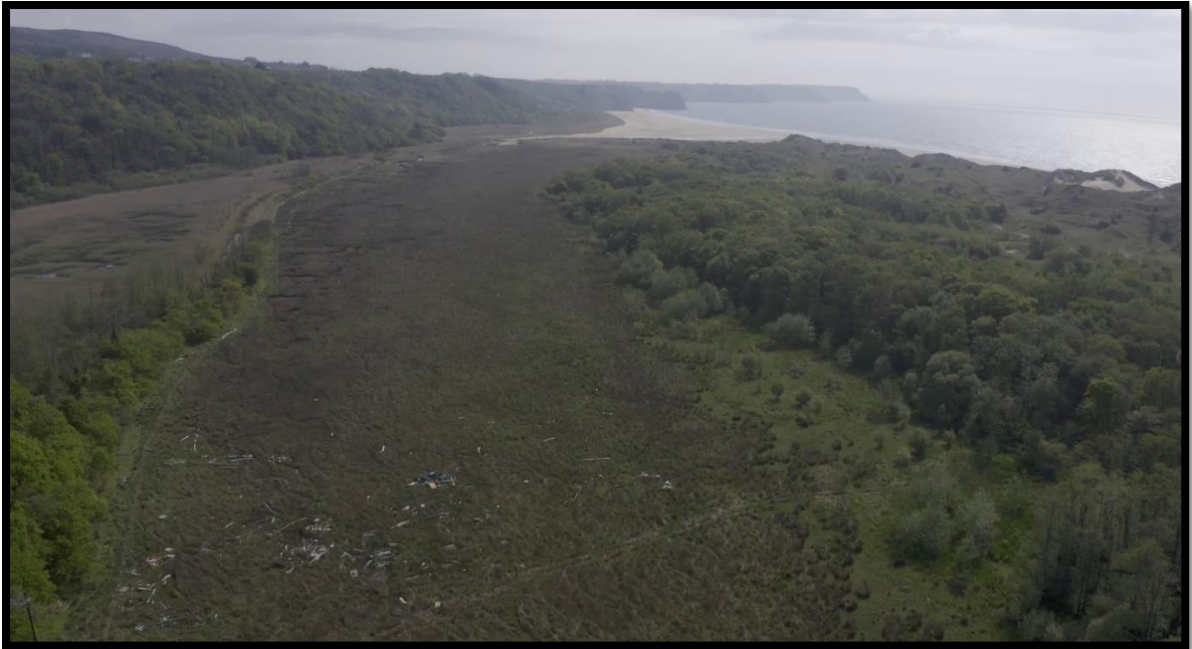
**Figure 2.9 - Marine debris deposited on the saltmarsh (Drummond, 2022)**

Storm surges and swells can flood the saltmarsh and large pieces of plastic and timber debris have been left deposited far into the saltmarsh by the retreating sea water. Figure 2.9 below shows the encroachment of sea debris far into the salt marsh.

cause the marsh to flood with seawater, often carrying with it a deluge of debris that ends up being deposited far inland on the wetland plain (See Figure 2.9). The 5m resolution Digital Terrain Model (DTM) in Figure 3.1 shows the topography of the reserve and reveals the vulnerability of the road and local community to localised flooding within the Oxwich bay and valley area, particularly as the primary road that leads down to the beach and village divides a large body of standing water.

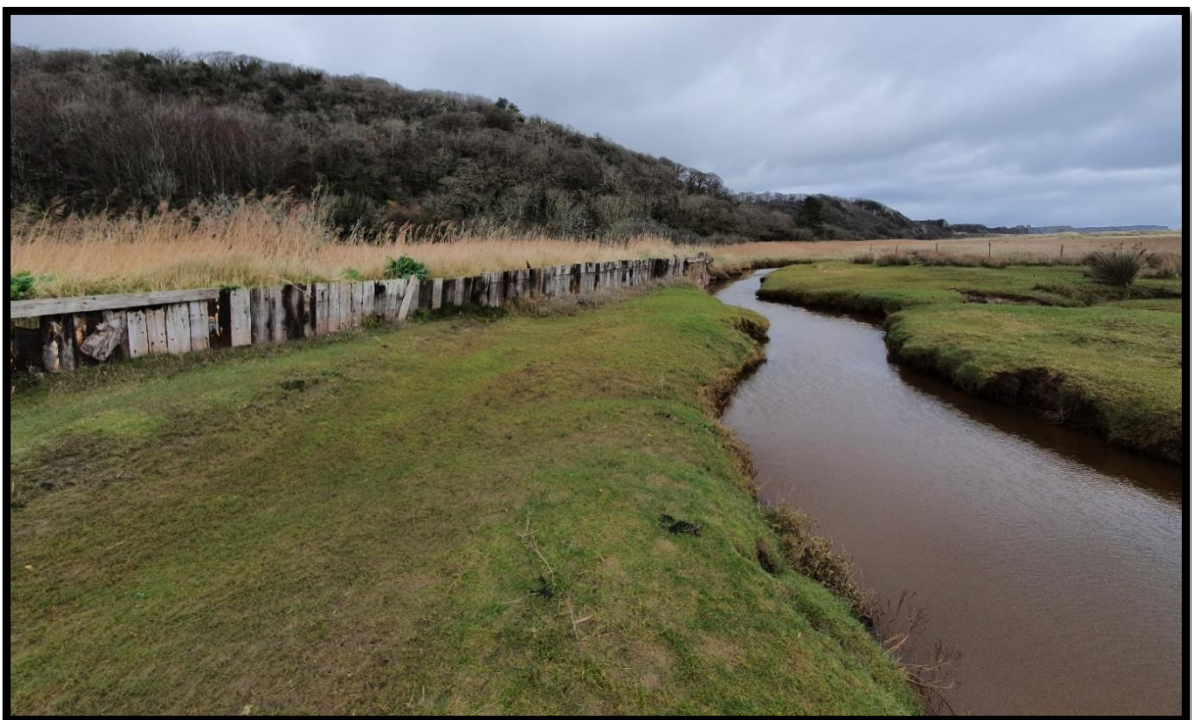
**Figure 2.10 - Bund embankment between freshwater swamp and saltmarsh (Drummond, 2022)**

The freshwater swamp is separated from the saltmarsh by a bund embankment which is reinforced by a combination of concrete walling and wooden barricade (Figure 2.10). The smaller watercourses within the freshwater wetland converge with the Nicholaston pill and form a single channel that leaves the freshwater marsh through a submerged tidal gate (Figure 2.11). This engineered feature acts to prevent sea water from progressing upstream at high tide and back into the freshwater marshland.

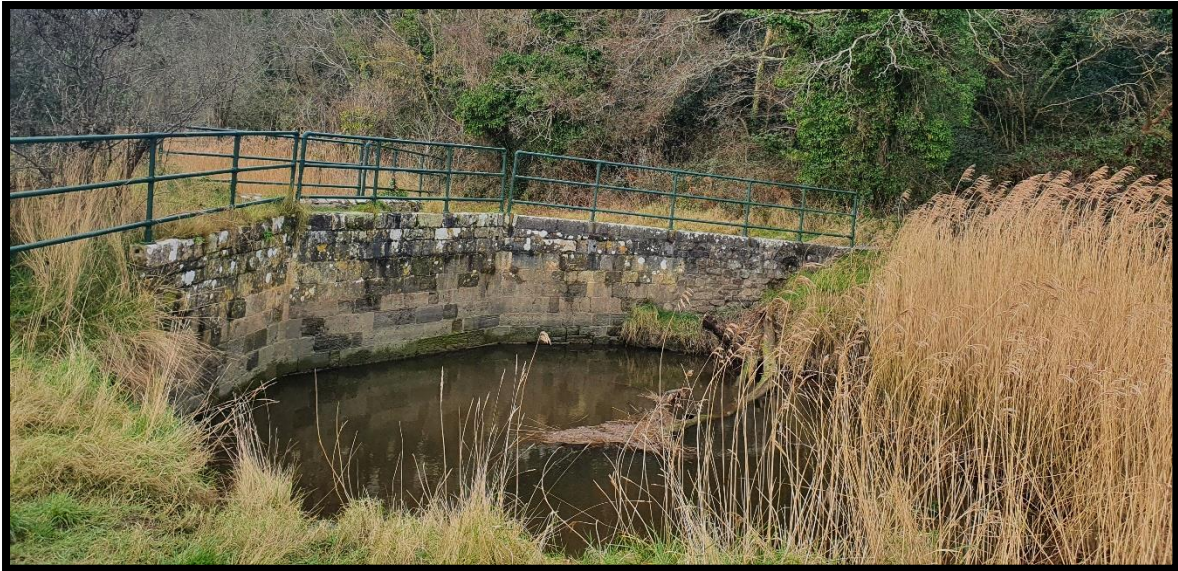
Figure 2.111 - Tidal gate to prevent back flow of sea water into freshwater wetland (Drummond, 2022)

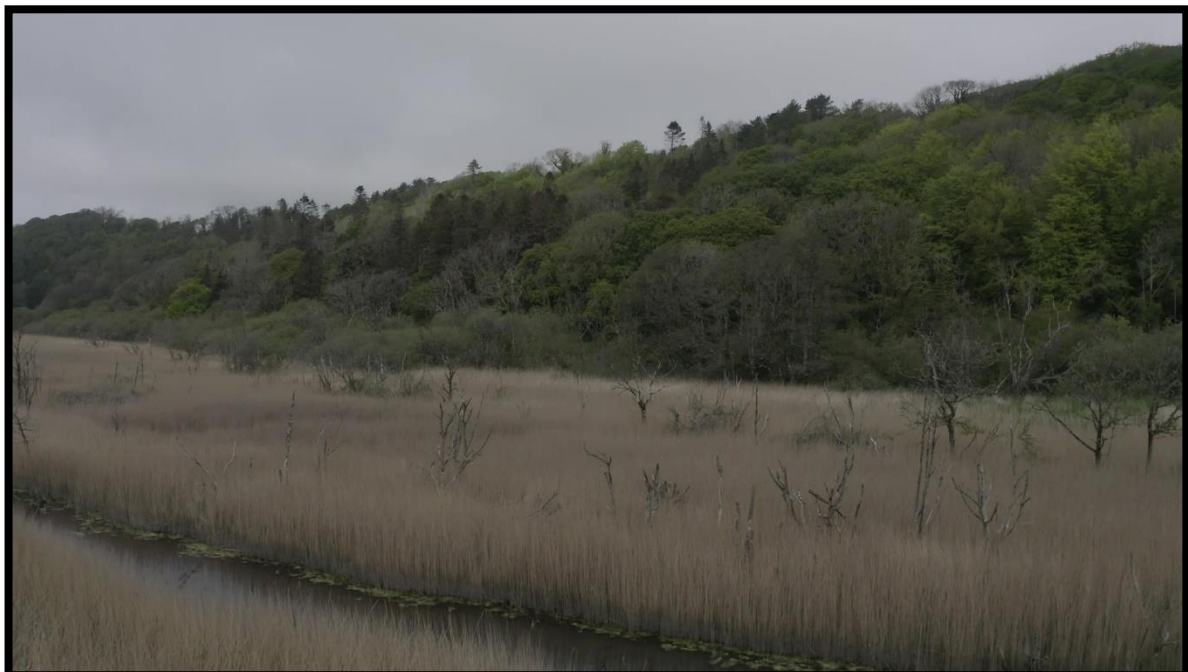
Figure 2.12 - Ash snags throughout the freshwater swamp (Drummond, 2022)

The freshwater marsh is dominated by Common reed (*Phragmites australis*). Present in smaller numbers around water bodies are Bulrush (*Typha latifolia*) and Lesser Bulrush (*Typha angustifolia*) and wetland flowers like Bogbean (*Menyanthes trifoliata*), Red Rattle (*Pedicularis palustris*) and Yellow Iris (*Iris pseudacorus*) can be found amongst the reed and rush. Soft Hornwort (*Ceratophyllum submersum*) which is uncommon to Wales can be found within the ponds in the swamp. The main pill channel runs alongside the southern boundary of Nicholaston woods with a slim strip of a wet woodland forming an interface between the woodland and wetland. Along here Sweet Flag (*Acorus calamus*) is shaded by young trees of Grey Willow (*Salix cinerea*) and Ash (*Fraxinus excelsior*). The bund embankment that runs alongside one of the large watercourses has sections of densely planted Blackthorn (*Prunus spinosa*) and Wild Cherry (*Prunus avium*) but is largely bare and unwooded. There are many degraded Ash snags veiled in the fungus *Parmeliaceae* scattered throughout the swamp with signs indicating that these trees may have succumbed to Ash dieback disease (see Figure 2.12).

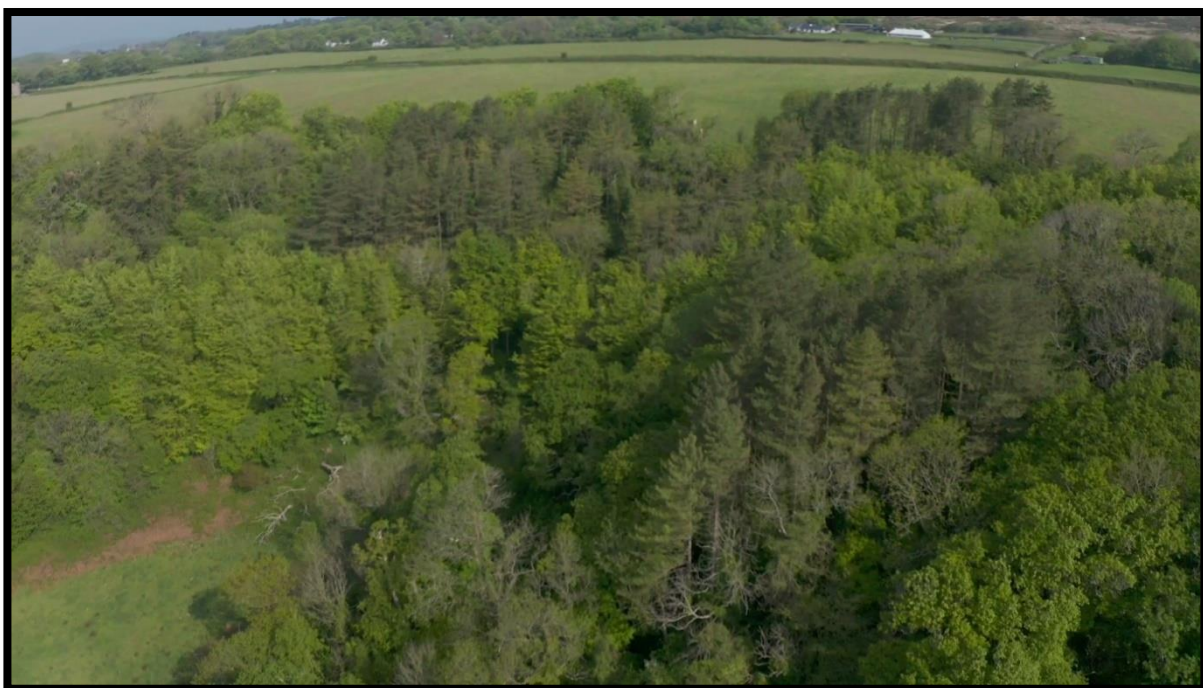
**Figure 4.1 - Ariel Shot of Nicholaston Woods. Planted Conifer stands nestled amongst broadleaved species (Drummond, 2022)**

Nicholaston Woods is covered by the Gower Ash Woods SAC Core Management (Gjerlov, 2011). The woodland is managed by NRW who in previous years have removed some of the non-native trees, leaving others to fall naturally. Management of the woods is minimal and mostly consists of maintaining the footpaths and ensuring routes are free from fallen trees and debris. The Core Management plan produced by NRW (then CCW) in 2011 outlined the then current state of the woodland and its future conservation objectives. The report identifies Ash woodland as the key habitat to be prioritised in this SAC. The overall vision for the woodland is to allow the ash to dominate the canopy, complimented by some Sycamore, Oak and the remaining population of planted Beeches. Hawthorn, Spindle and Hazel will ideally fill the void between the canopy and Hart's tongue, Fern and Ramson. A 2008 survey of the woodland found it to be in an unfavourable condition. There was an over dominance of Sycamore and an excess of non-native species such as Beech, Spruce and Conifer. Proposed solutions to remedy the unfavourable condition of the woodland were the slow removal of Beech trees, allowing non-natives to fall naturally whilst removing any saplings that may sprout. Felling of Sycamores where possible is preferred over ringbarking as the latter has a tendency to cause Sycamores to produce a final flush of seeds that could propagate and further increase in their population. Regeneration of Ash was found to be poor, with too many gaps in the canopy identified.

Ash dieback was not a prominent issue in the UK at the time the core management plan was created. Signs of Ash die-back can be observed throughout Nicholaston woods and extensively within the areas of semi natural broadleaved woodlands within the low-lying dune and marsh areas. A good indication that an Ash tree is suffering from Dieback is the very late emergence of its leaves compared to other species

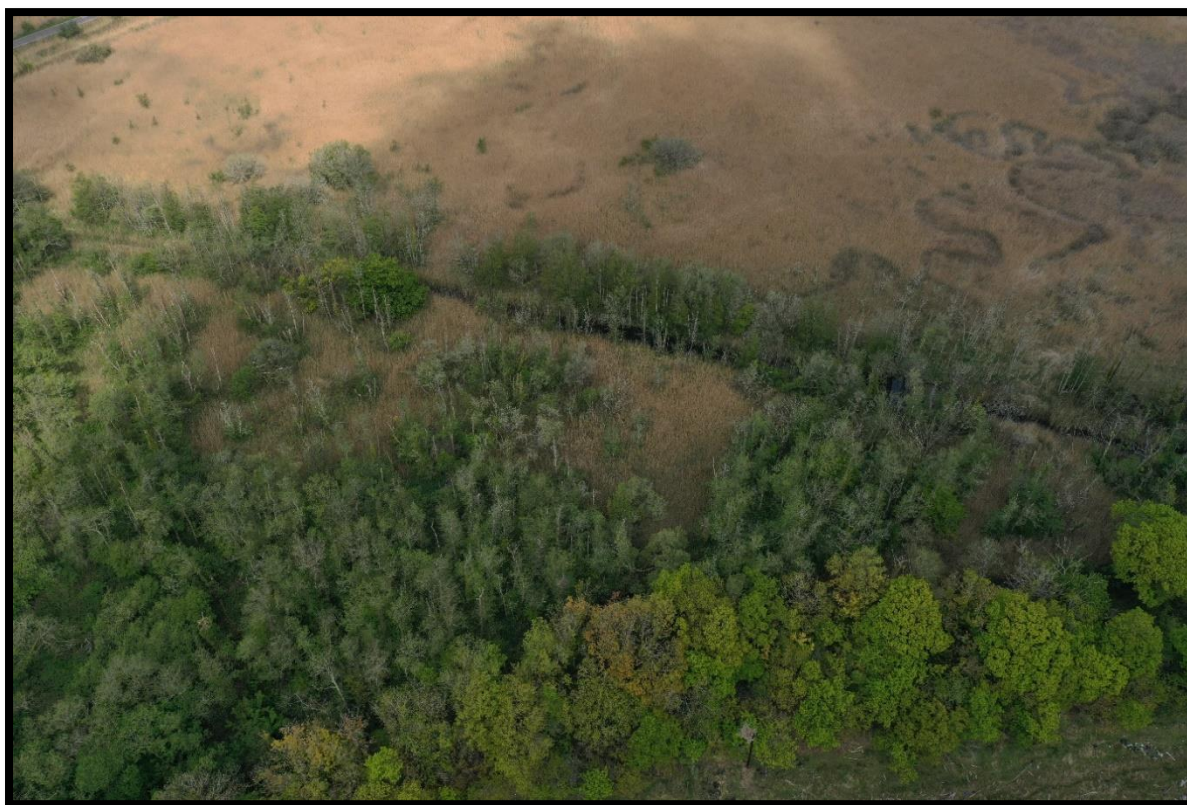
**Figure 4.2 - Ash trees showing signs of Dieback amongst the Semi Natural Broadleaved Woodland along the dune and marsh (Drummond 2022)**

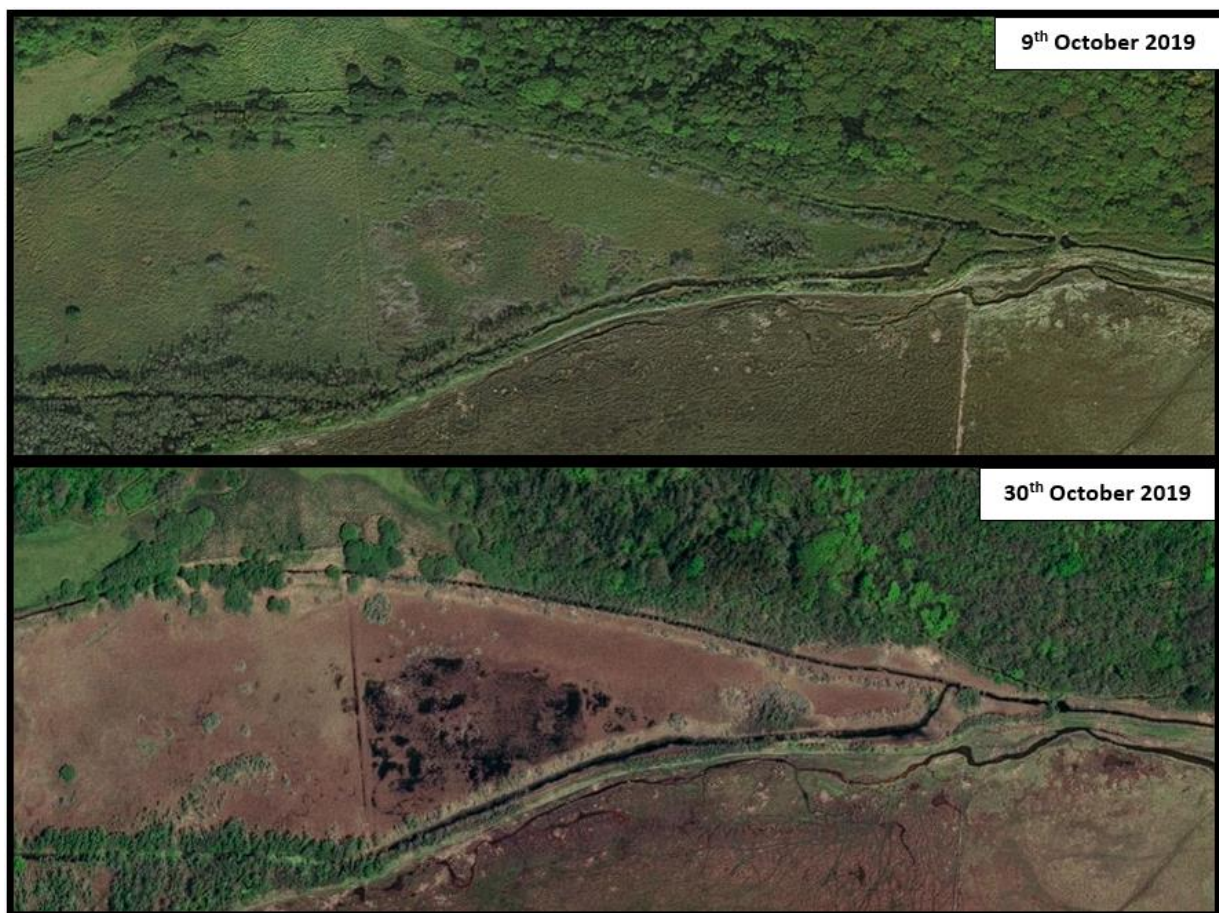
Figure 4.3 - Comparison of satellite imagery showing a marked difference in the appearance of the freshwater swamp (Living Atlas, 2022)

Not currently identified in the NRW phase one habitat survey map are a number of pools of standing water in varying sizes that appeared rapidly within the swamp over the course of October 2019 (See Figure 4.3). It is not clear what the cause of this change is, but a preliminary assessment of Important Areas for Ponds report published in 2008 references reed cutting and silt removal works within the Oxwich wetlands in order to preserve and enhance standing water features that have been recognised as BAP Priority Habitats (Nicolet et al., 2008). There is a striking contrast between the two satellite images in the colouration of the Common reed within the freshwater swamp and coupled with the degradation of the trees this could indicate seawater ingress into the freshwater wetland.
