# **Analysis and Recommendations for the Minimisation of Material Failure**

Mechanism of Material Failure

ACEA7010

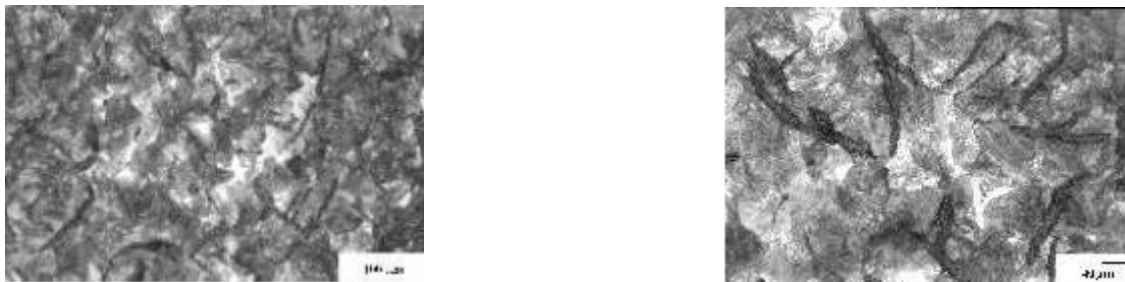
Figure 2 - Microscopic Structure of Grey Iron (Cambridge University, 2001)

Figure 2 show how the microscopic structure of grey iron can differ depending on the graphite content and the process used to manufacture it.

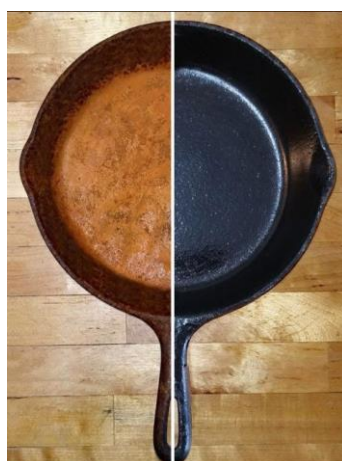
Figure 3 - Corrosion of Cast Iron

Figure 3 (Lodge Cast Iron, 2020) shows an example of corroded vs non corroded cast iron. One example of corrosion prevention in iron is galvanizing. This is when a layer of zinc is applied to the outer layer of the iron to prevent the effects of corrosion. The most common method is hot-dip

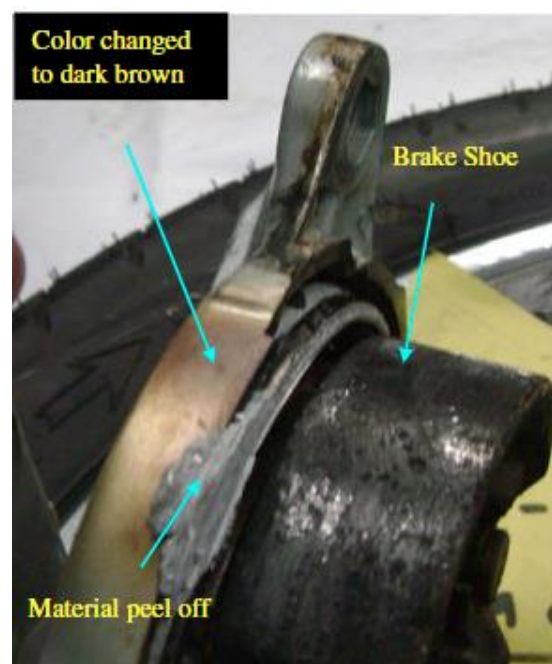
Figure 5 - Seized Drum Brake

Figure 5 shows a drum brake which has seized and damaged the drum.

Three main factors were investigated as to why the system had a thermal failure. The first was the chemical composition of the metals, the second being the hardness of the materials and the final factor being excess free ferrite in the drum. As previously discussed, the graphite content and structure in grey iron can affect its properties. It was discovered that graphite content was below the recommended amount for this application. A test to find the hardness of the drum liner was conducted using a Brinell hardness tester. (N. Dowling, 1993) This test involves indenting a test piece with a hardened steel or carbide sphere with a 1mm diameter. A load of 10kg was placed on the test piece. The diameter of the indent is measured with a microscope and equation 1 is used to calculate the hardness of the test piece.
