# Mariupol Theatre Bombing

University of Wales Trinity of St David:  
Ordnance Munitions and Explosives

Scientific Principals of OME Design  
Supervisor: Gareth Collett

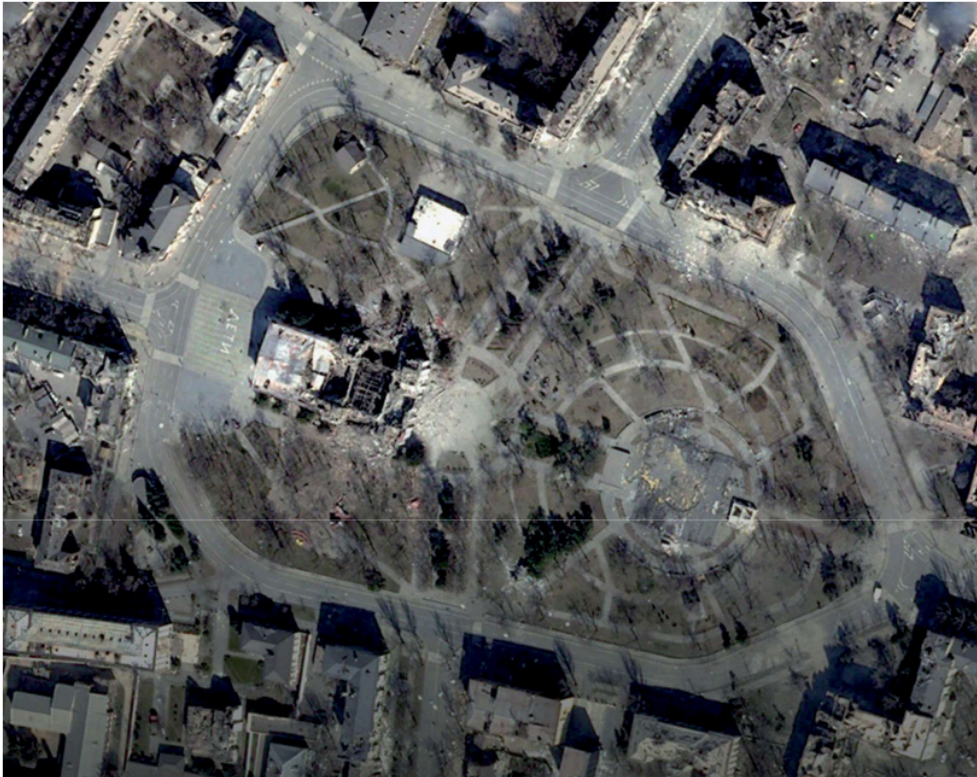
*Figure 1: Location of Theatre in the Square*

As can be seen in Figure 1, there are no buildings attached to or are in close proximity to the theatre, suggesting that the theatre was targeted deliberately by Russian aerospace forces.

4. I really liked figure 1, which shows the isolation of the theatre compared to other structures and the markings that say 'children'.

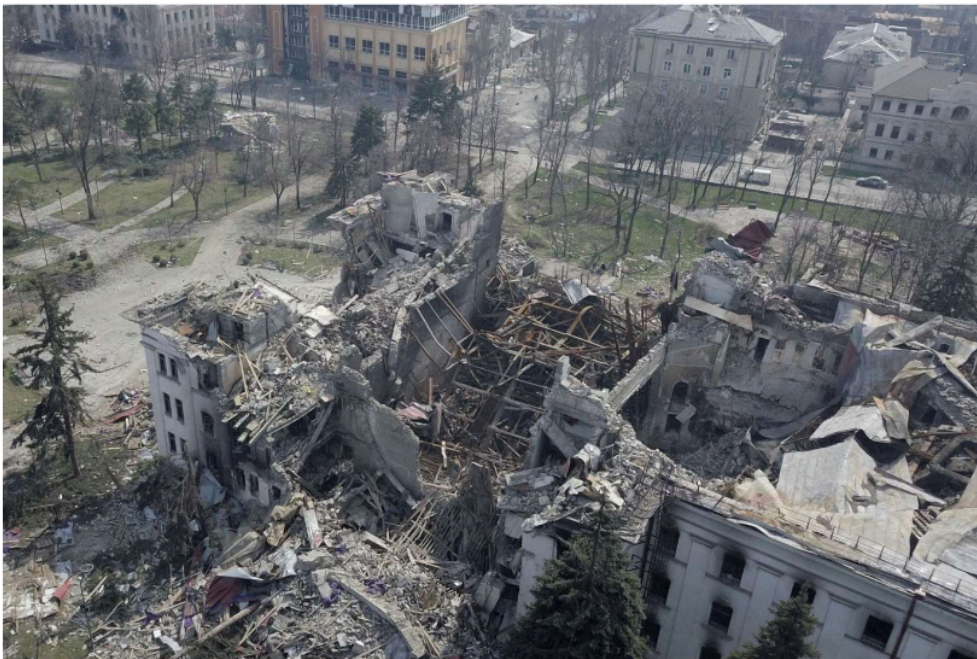
*Figure 3: Debris Field Being Cast Northerly and Southerly from Centre of Auditorium*

Witness testimony corroborate that the roof of the theatre was lifted up rather than caved in, meaning the munition punched through the sheet metal roof and detonated within the building itself. This is further confirmed by photographic evidence of the pattern of debris surrounding the theatre being blown out from the centre of the auditorium as opposed to being spread along one axis of origin.

The images detailing the scale of the destruction clearly indicate a large munition capable of delivering 10psi (69.8Kpa) at one half of the building width. It should be noted that reflected blast

overpressures are in excess of incident overpressures, contributing to further damage to the structure.
