# Analysis of Potential Munitions Used in the Attack on Mariupol Theatre

An Explosive Engineering Assessment of Visual Evidence

Ryan Garry (2024366)  
Scientific Principles of OME  
Design: ACDB6008

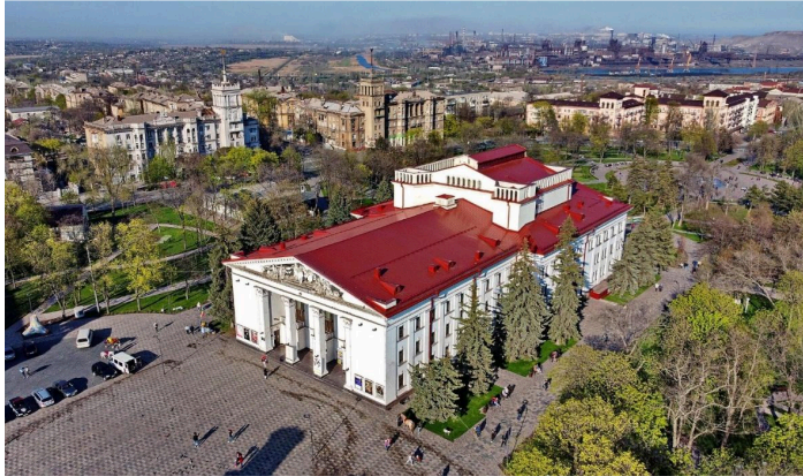
The building is approximately East facing, and situated within a largely open area in the Tsentralnyi District of Mariupol. An open paved area at the front serves as a car-park, and the theatre is surrounded on all other sides by trees and green space. The area is bounded by a roadway at a distance of approximately 100m from the theatre at it's closest point, as seen in

figure 4 below, taken 10 months prior to the attack. The building is therefore sufficiently isolated from neighbouring buildings to suggest that any munitions impacting the theatre are targeted to do so, whether they be unguided or precision weapons.

*Figure 2: Mariupol Theatre in May 2021 [2]*

2. I liked figures 2 and 5, which supported the humanitarian and isolation aspects of the structure.

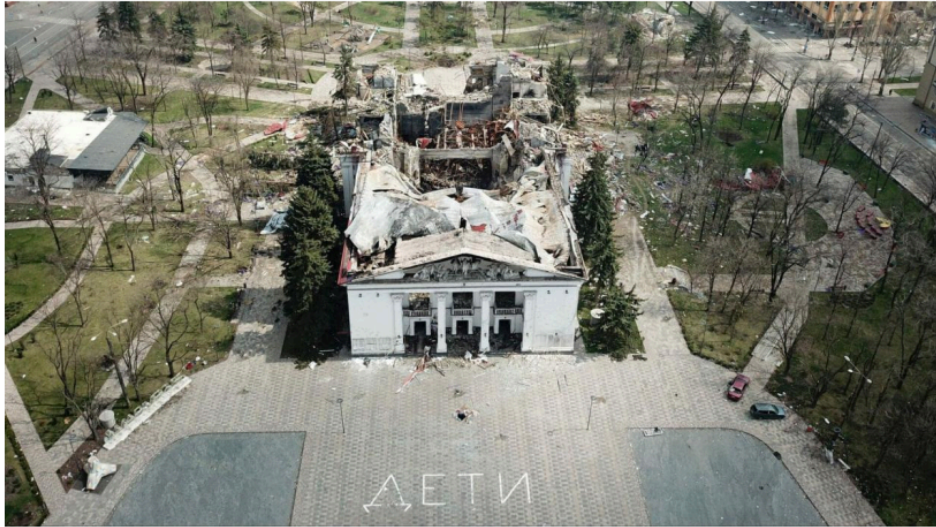
caused, The blast seems to have centred on the stage of the concert hall, largely destroying the internal walls and levelling exterior walls to either side. The debris field from the blast extends some distance from the building with elements of the displaced structure visible almost to the distance of the road on the southern-side of the building. Figure 5 below shows an aerial view of the damage following the attack.

*Figure 5: Aerial view of damage caused in the attack from front of building*

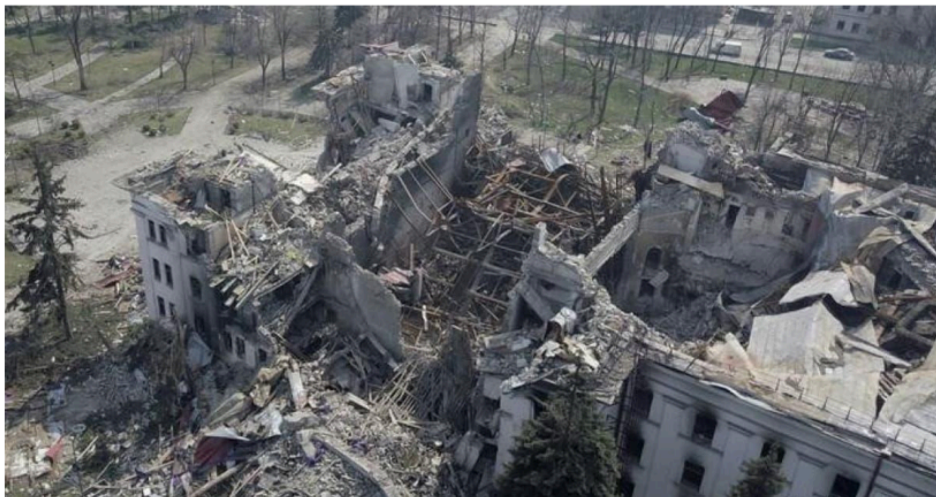
*Figure 6: Aerial view of damage to wings of concert hall taken from Northerly direction*

From the spread of damage visible in figure 6, it seems likely that the damage was caused by a likely cylindrical charge detonating in roughly the centre of the performing space, not far from stage level. Photos illustrating the damage to the roof show that the roof forward of the audience area remained roughly intact, albeit with significant damage. More damage can be seen to the Southerly side of the building, and it is likely that overpressures experienced, either incidental or reflective, were somewhat higher than on the Northern side.

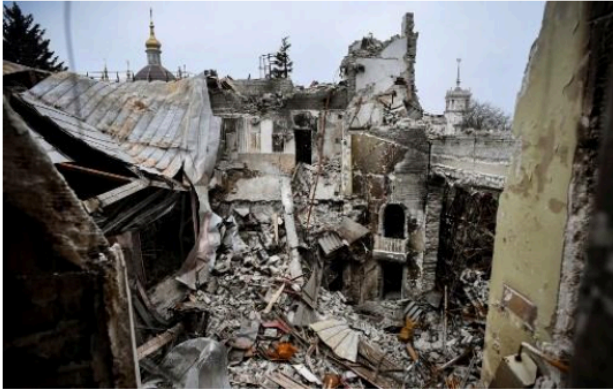
*Figure 7: Photo showing damage to structure above audience viewing area*

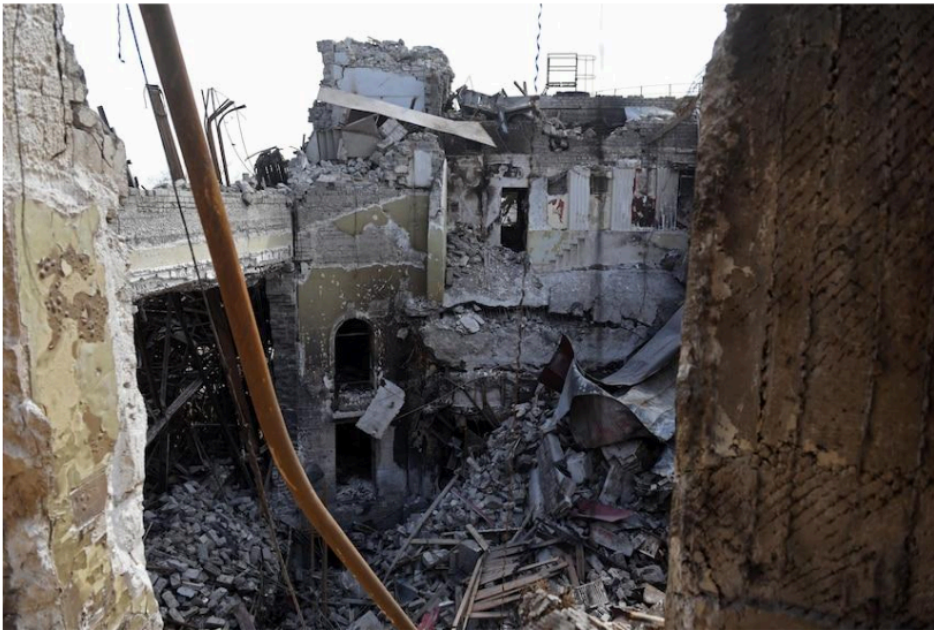
*Figure 8: View from opposite side of audience viewing area*

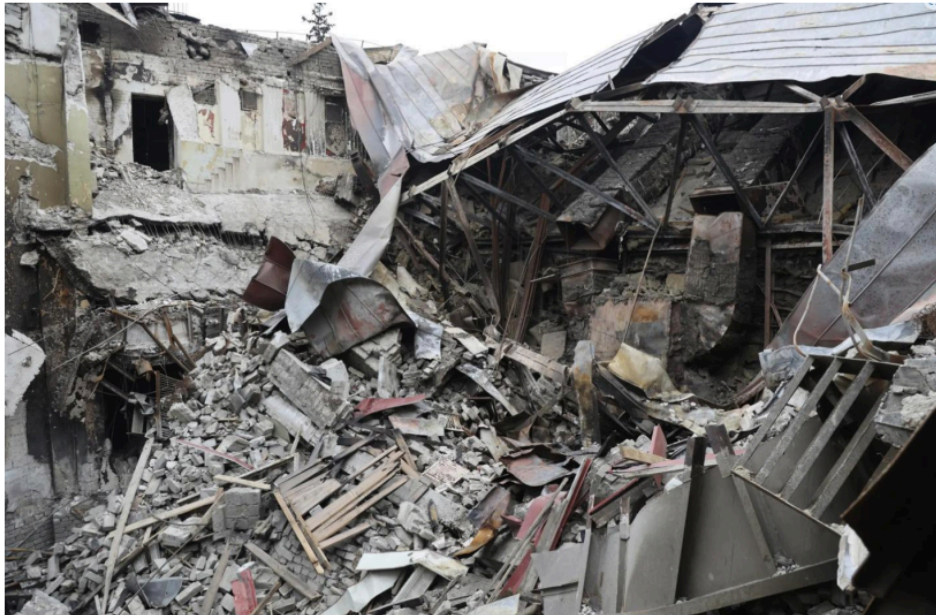
*Figure 9: Close up of damage to audience area*
