# SA1 Tesco Redevelopment – Preliminary Study for a Full Site Investigation – Feasibility Stage

*FUNDAMENTALS OF CONSTRUCTION TECHNOLOGY  
(ACBA4022)  
CHLOE WATKINS 2407375*

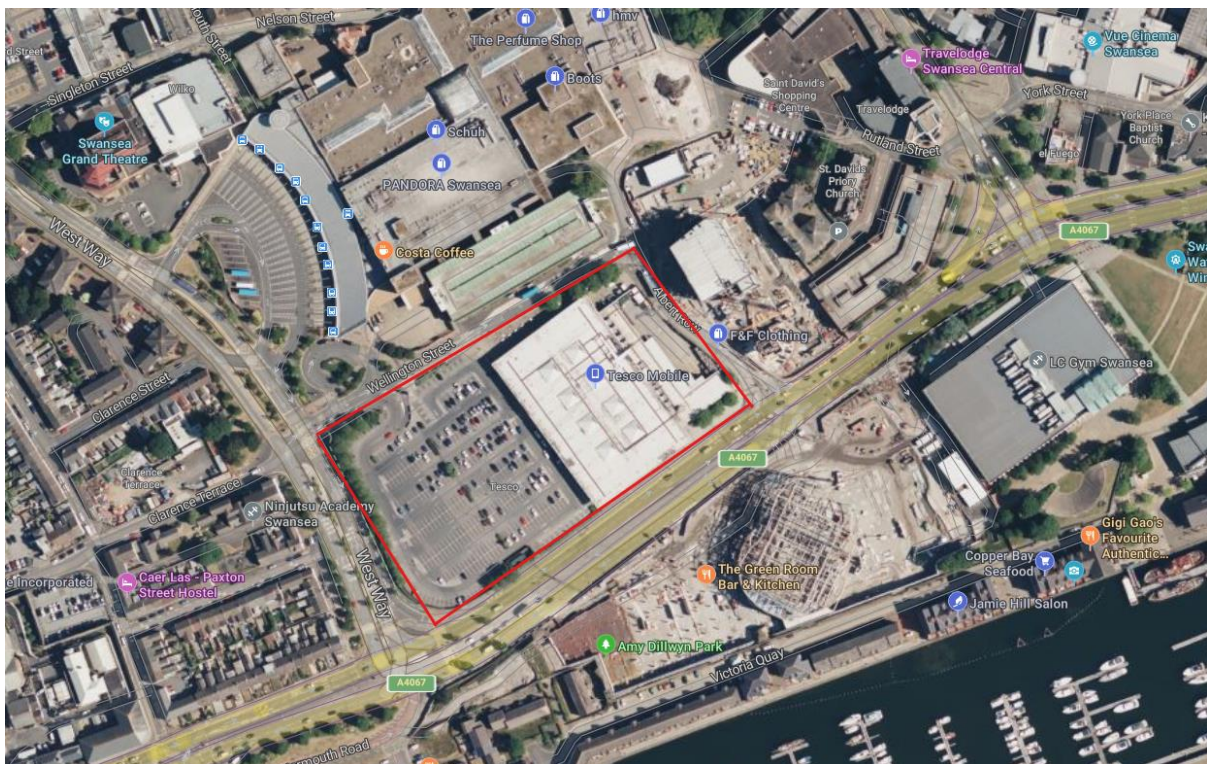
Figure 1: Google Maps

The City and County of Swansea have chosen to enter into a joint agreement with Jarvis Hotels to create a new five storey hotel, bar, restaurant and conference centre on the site of the Tesco superstore and car park, located on Oystermouth Road by opposite Swansea Marina. (See figure 1)

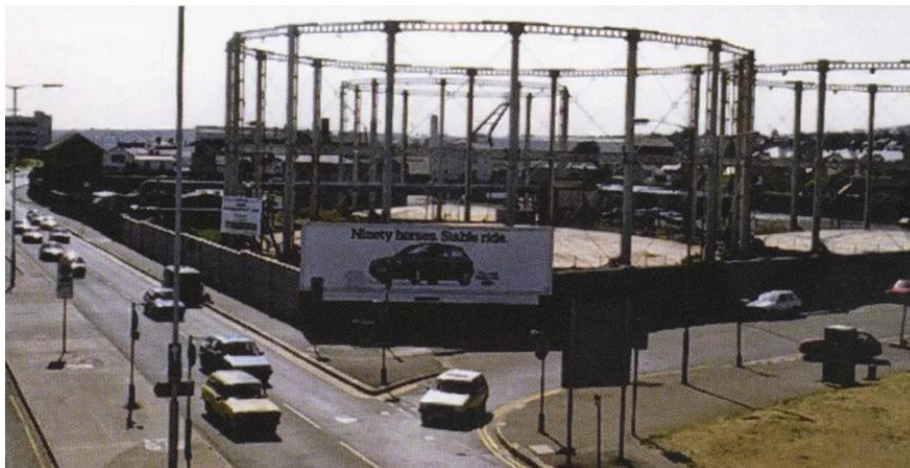
Prior to Tesco's building a £13.5 million new super store in 2000, the land was owned by a gas company who constructed their gas works. Production at the site dates back to 1841 when Swansea Gas Light Company began making gas by burning coal. Once the production of gas stopped in 1922, the facility was used for gas distribution up until 1949. (*WalesOnline*, 20/05/2020)

*Figure 2: Gas holders alongside Oystermouth Road (1989) (WalesOnline, 20<sup>th</sup> May 2020)*

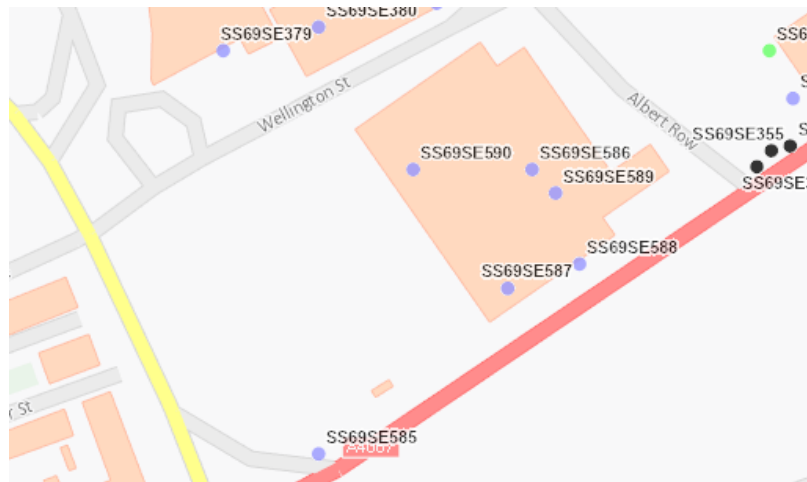
Figure 10: BGS ( Location of boreholes, nd)

As you can see below 5 boreholes were conducted beneath the main structure and one at the rear of the carpark. (To see Borehole logs 1-6 please refer to Appendix 1,2,3,4,5 and 6)

Having reviewed the borehole logs, it's noted they were conducted in between January - June 1999. The logs all show very similar results, down to roughly 0.3/ 0.4 meters indicates the ground is made up of solid materials such as stones, tiles and rubber film. Further down, from 0.4 meters to roughly the 4 meter mark, the ground is compiled if various types of clay. Numerous fields such as hydrogeology, environmental science, and geotechnical engineering gain significant insights from detecting clay in borehole logs.
