## Kenfig Dune Rejuvenation Project 2013

During December January and February a Welsh Government funded project took place to rejuvenate sand dune habitats on the Kenfig SAC. In December 2012 work took place at Merthyr Mawr. CCW site warden, Duncan Ludlow described the work in an internal document, 'Merthyr Mawr Warren Dune Rejuvenation Work Report December 2012'.

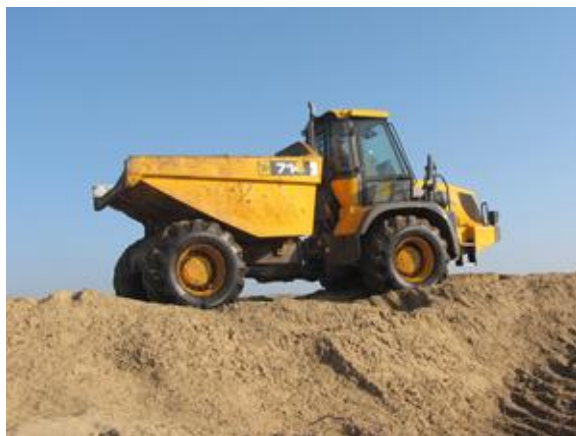
One of two dumper trucks used throughout the contract to move sand and spoil.

Four machines each with a driver were used during the contract. A 20 tonne and a 14 tonne excavator using digger buckets and grading buckets dug sand, stripped turf, loaded dumper trucks and profiled spoil heaps. Both excavators stayed at the worksite throughout the contract. Two 14 tonne articulated dumper trucks were used to move material to spoil heaps. They were brought back to the reserve centre each day and parked overnight on grass next to the road under a street light so as to be clearly visible at night to deter damage and diesel theft. These two dumper trucks were used to transport drivers to and from the worksite. A tractor with diesel bowser was stored in the reserve centre's courtyard and used to transport fuel out to the machines. A mobile toilet block was parked outside the reserve centre throughout the contract for use by the workers. The contract included the cost of a supervisor who drove one of the vehicles but was in charge of the other workers and liaised with the nature reserve manager over the work.

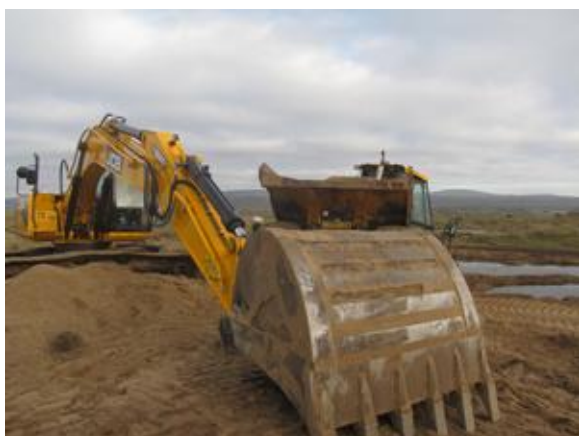
Tracked excavator with digger bucket and dumper truck during trough digging work on 11 January 2013

Positions for the four trough excavations were marked by driving in posts at each end. Red and white plastic ribbon was tied to the tops to blow about helping drivers see the posts. An excavator and dumper truck worked from the top of the foredune with filled loads being tipped down the eastern inland side of the foredune ridge. Existing vegetation was buried under about a metre of sand. As the trough excavations deepened, the excavator and dumper trucks worked from the base of the trough excavations. Sand was transported to bury turves stripped during clearance work in the deflation corridor. It was not clear from the plans how deep the trough excavations should be cut other than 'deep'. It was decided to keep digging as deep as reasonably possible without endangering the safety of the drivers working in the troughs. Creating long-term sand mobility was the primary objective of the winter's work so it was felt that it was important to prioritise work on the trough excavations.

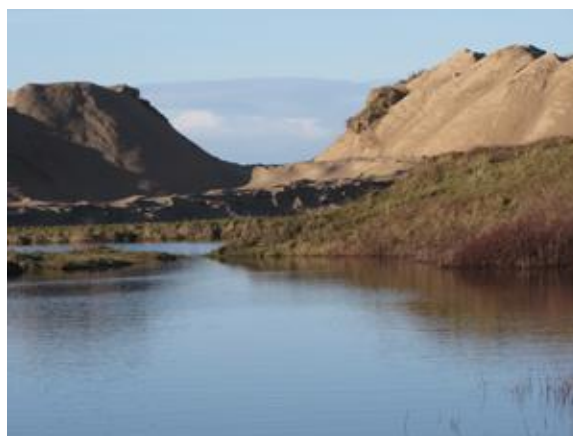
Trough excavation A4 cut into tall foredunes. Flooding in foreground is in area E. Taken about a fortnight after completion on 2 February 2013

The two trough excavations cut at the northern end of the work area both linked onto existing foredune blowout hollows. This allowed the trough excavations to be completed quicker than the first two as less sand needed to be moved.

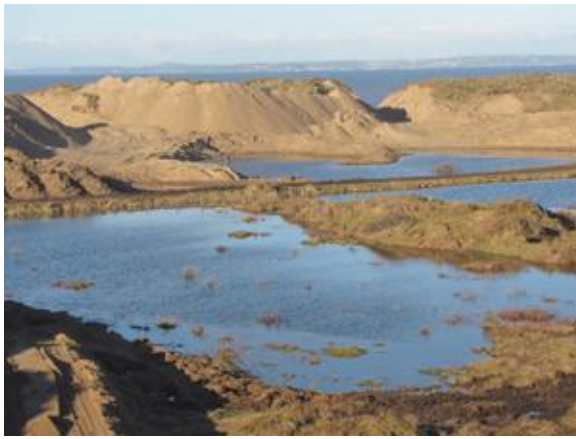
Trough excavations A3 and A4 on 2 February 2013. Tipped sand extracted from trough excavations can be seen on the near (east) side of foredunes. Flooding in areas E and C.

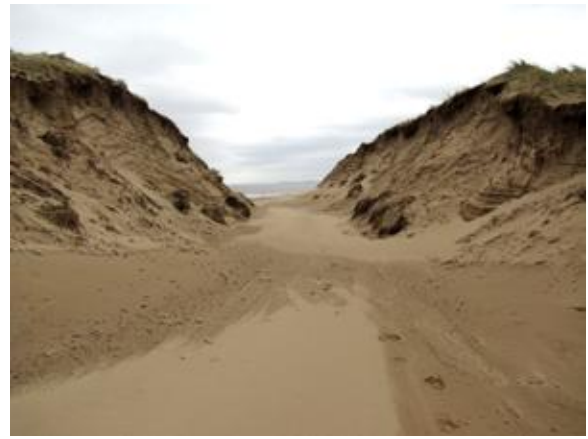
Trough A3. Picture taken on 10 March 2013

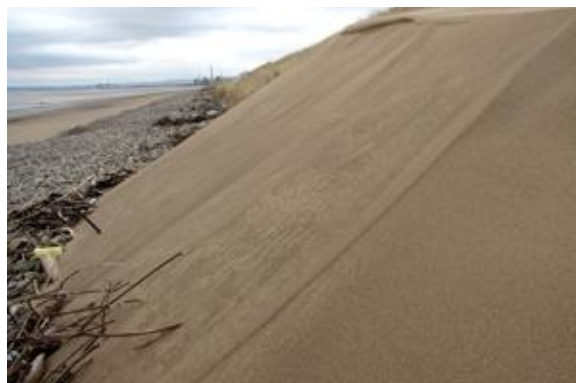
Slip face on trough A3 on 10 March 2013 after several days of north-easterly wind. A sand nose building out onto the upper beach.

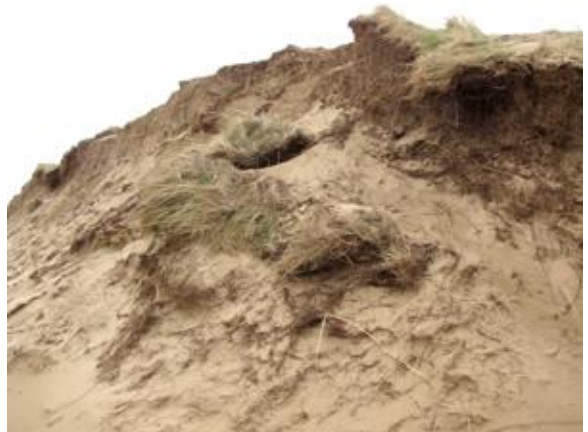
Turf that has sloughed from the top of the dune and slid down side of trough A4. Picture taken on 10 March 2013.

As sand shifted after steep sided troughs had been excavated, turves from the top started sliding down. These mats of vegetation are likely to root into the sand and hamper the blowing of sand. To encourage the long-term success of the work done, such turves probably need to be removed on a regular basis. Some experimental work with the reserve's tractor and silage grab will be tried to see how feasible it will be to control this problem.

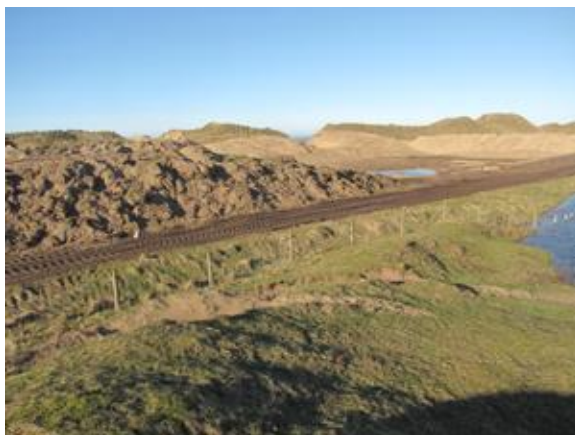
Turf-striped deflation plain in centre rear with spoil piled to left and far right. Picture taken on 2 February 2013.

Turf was stripped to the east (inland) side of the trough excavations in areas C, D and E. These were low-lying areas between the sand deposition zones (B1 and B2) from the trough excavations and the old haulage road. In the past these would have been sandy deflation corridors left behind by mobile dunes but they have long since vegetated over. The intension of this clearance was to allow saltation clouds of bouncing sand grains to continue moving inland from the trough excavations without being impeded by vegetation. Flooding prevented about half of this area being cleared and prevented the sand ridge in Area E being excavated and shifted to the north. Instead the ridge had all vegetation removed.

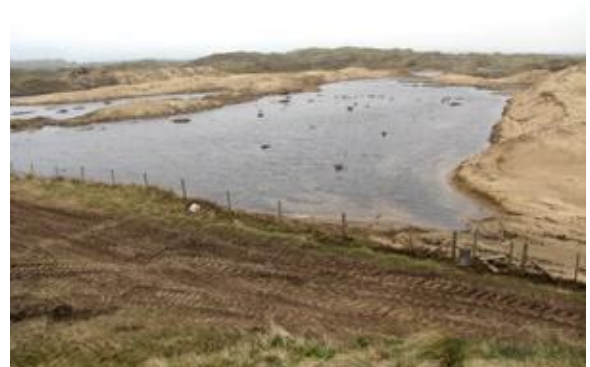
Turf-striped deflation plain, Area E. Winter flooding prevented much of this area being cleared. A central sand ridge had turf removed. Spoil can be seen piled on far left enlarging the existing side arm. Picture taken on 3 March 2013.

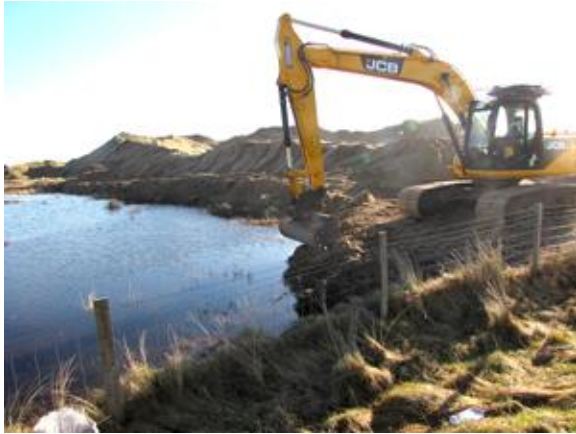
Cleared northern dune side arm behind excavator with temporary platform at its base.

Turf was stripped from a side arm between points 7 and 8. A tracked excavator pulled vegetation down and used the material to make a temporary platform above a flooded area for the dumper trucks to be able to gain access. Once the dune had been cleared, the excavator dug out the platform loading spoil onto the dumper trucks which transported material to the south on a turf and sand side arm created artificially in March 2012 (SS783822). The clearance of the north side of this side arm married up with clearance that had taken place the previous winter on the south side so that the side arm constituted bare sand on both sides for about 100 metres.

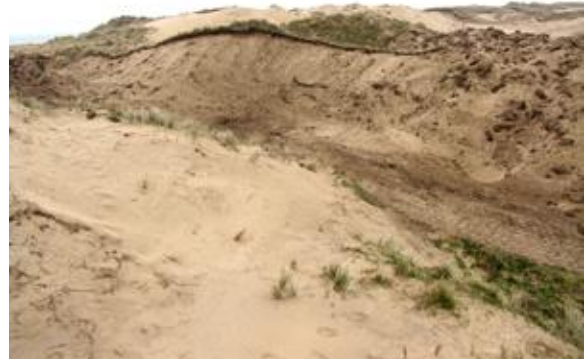
Dune side arm on the south side of area on the coast side of old haulage area. This was the last work carried out during the contract.

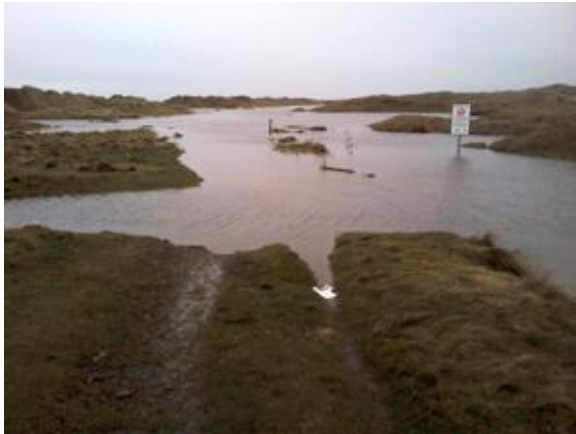
Old haulage road blocked by flooding. The wettest the reserve had been in living memory.

The project ran extremely well with very few problems. However, the site experienced the deepest flooding since records began and according to some locals the deepest in living memory. This was due to a wet summer followed by wet autumn and very wet weather around Christmas. Access to the work area appeared to be blocked by flooding. On the first day of work, a tracked excavator made two cuts at low points in foredunes to let more water flow out onto the beach. This worked to a certain degree and the large machines were able to drive along the flooded haulage road but the reserve's Landrover had to drive up onto the shingle beach to get round the flooding throughout the contract period. Several low-lying areas on the main tracks from the reserve centre to the haulage road became deeply rutted and several truck loads of sand had to be transported from the work area to keep the track usable for the machines.

and the general public. This took a day or so out of the contract but the improved surfacing on the track will last for many years and was a good investment for future projects.

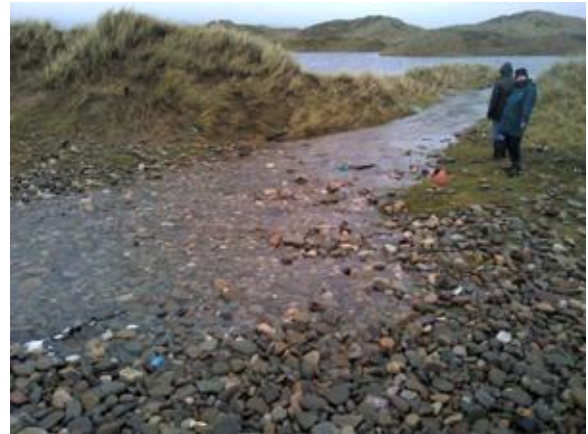
Excess water flowing out onto beach on 29 December 2012 before a cuts were made in foredunes.
