# University of Wales Trinity Saint David School of Engineering

## Undertaking a Green Belt Project Six Sigma Green Belt ACMA 5005

Gethin Dyer Davies  
2307576  
02/2026

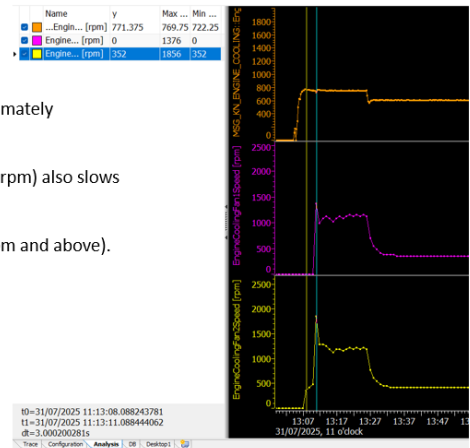
**Observation 3:** Slowing down the engine from idle speed (750 rpm) to stealth speed (600 rpm) also slows down the fans to around 350-400 rpm, which completely negates the noise.

**Observation 4:** Similarly, revving up the engine also clears the high-pitched noise (1500 rpm and above).
