# Investigating the influence of machining variables and defects on Machined components tensile properties.

BEng (Hons) Mechanical Engineering

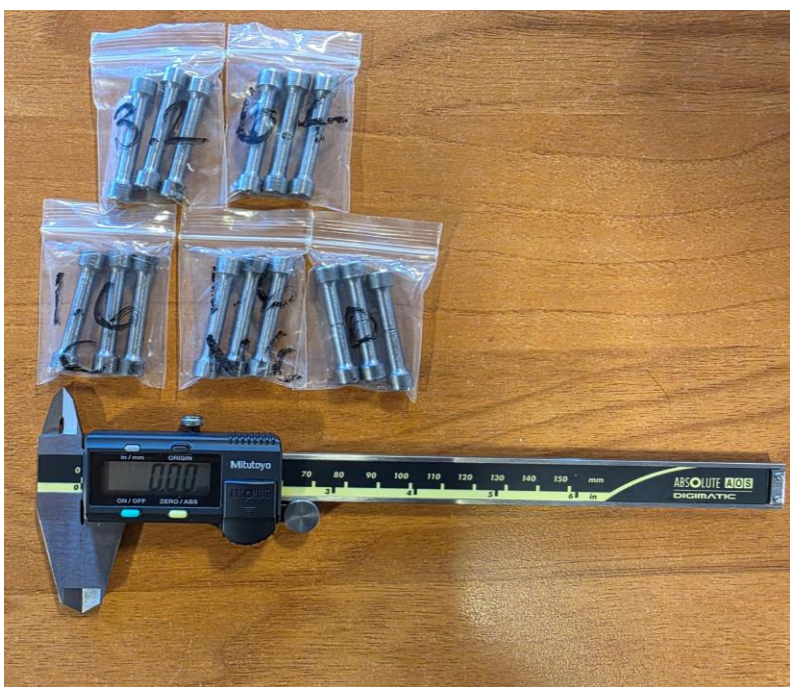
Image showing Tensile Testing specimens.

- Driven primarily from ISO 6892-1 Tensile testing standards (ISO,2019)
- 15 specimens were prepared and their quality assessed using metrological principles and tested to fracture.
- Microscopic analysis processes (cutting, mounting, polishing and acid etching) to reveal surface grain structure (Obondo and Nyangoye, 2019).

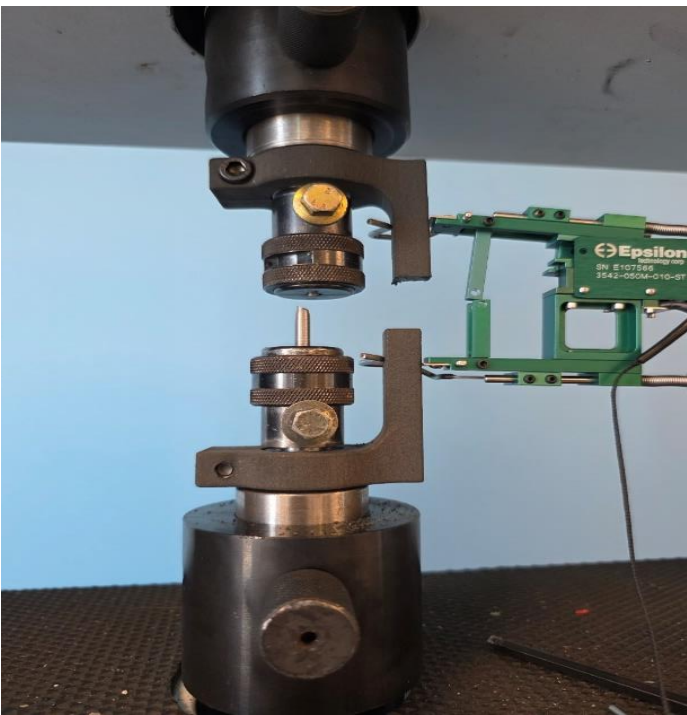
Image showing the tensile testing grip assembly.

- Examine the effects and causes of the instrumental error.
- Evidence suggests a combination of slippage within the grips and instrumental error may be responsible (Womack,2024).

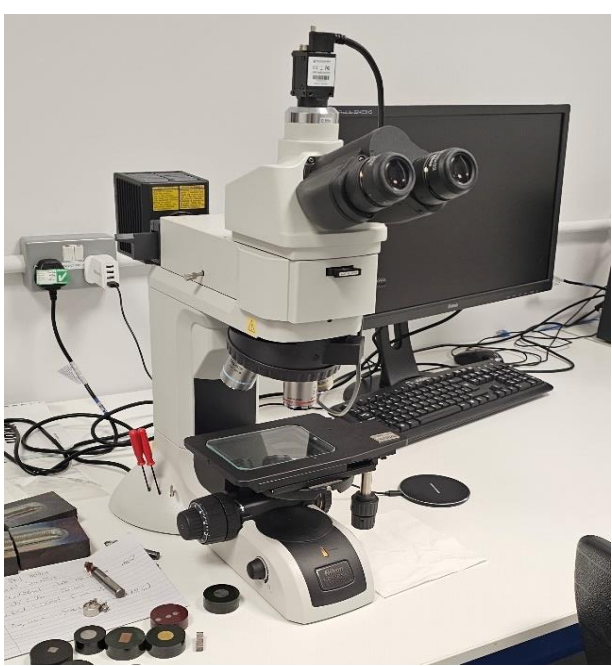
Nikon optical microscope.

- Limited magnification (60x)
- Improvised camera-over-eyepiece setup.
