# A Remote Rapid Assessment of Coastal Erosion for the Isle of Sheppey, South-East England

Marie West

University of Wales Trinity Saint David

10/8/2021

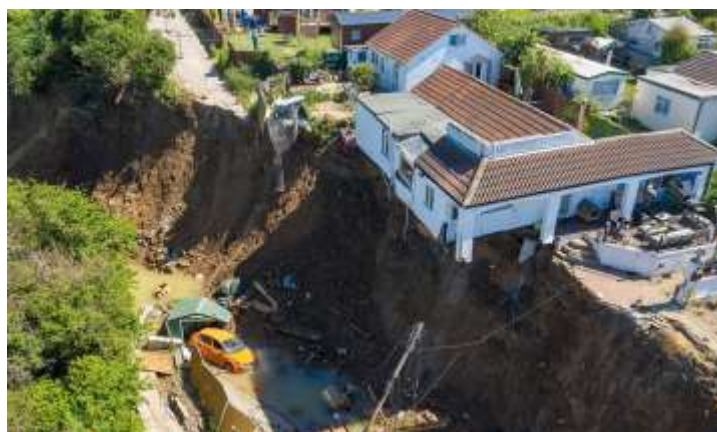
Figure 1.3: The position of the House on the 1st of June 2020

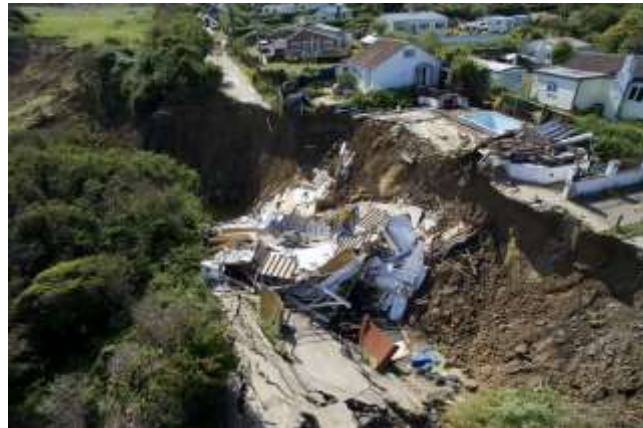
Figure 1.4: The House at Surf Crescent Road over the Cliff, sat on top of the landslide, 2nd of June 2020

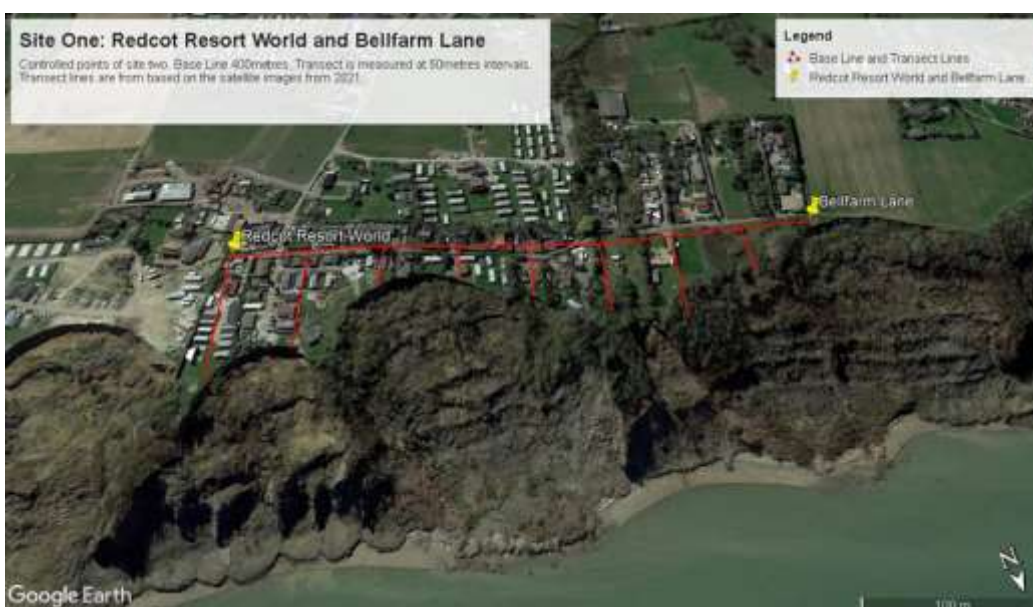
Figure 4.5: Control Points of Redcot Resort World to Bellfarm Lane

Figures 4.5, 4.6 and 4.7 show the three sites with the controlled points outlined using images from the year 2021. These controlled points then set the president for the measurement for the historical images, allowing erosion rate to be measured ranging from 1940 to 2021.

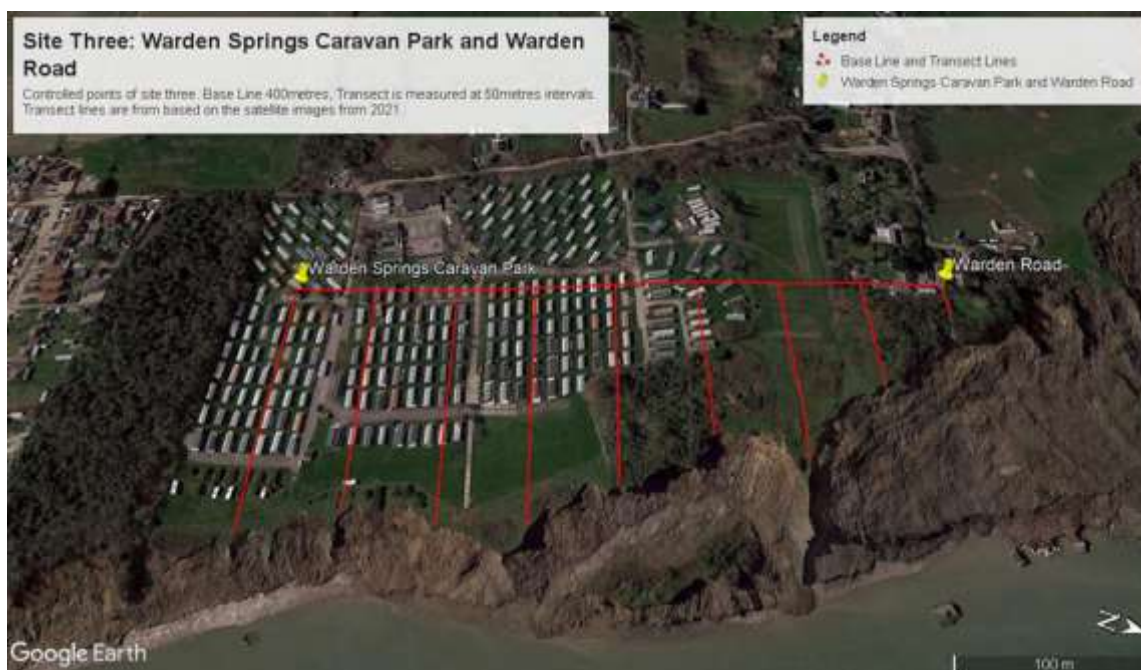
Figure 4.7 Control Points of Warden Springs Caravan Park to Warden Road

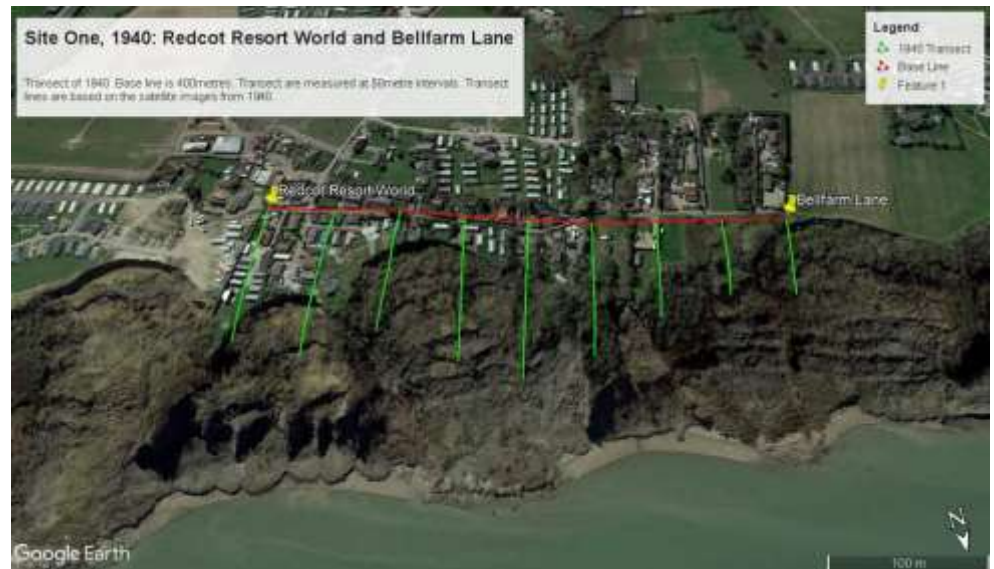
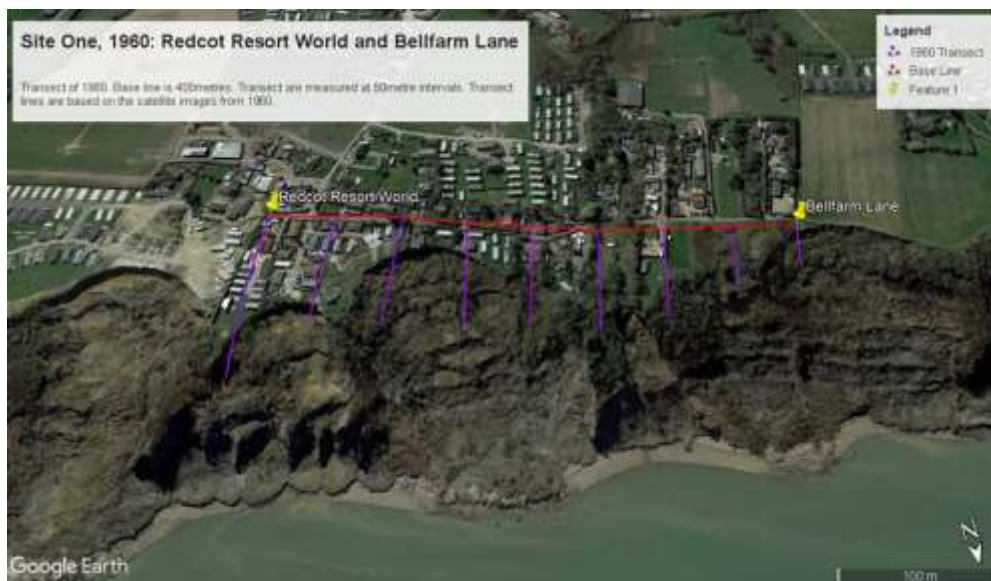
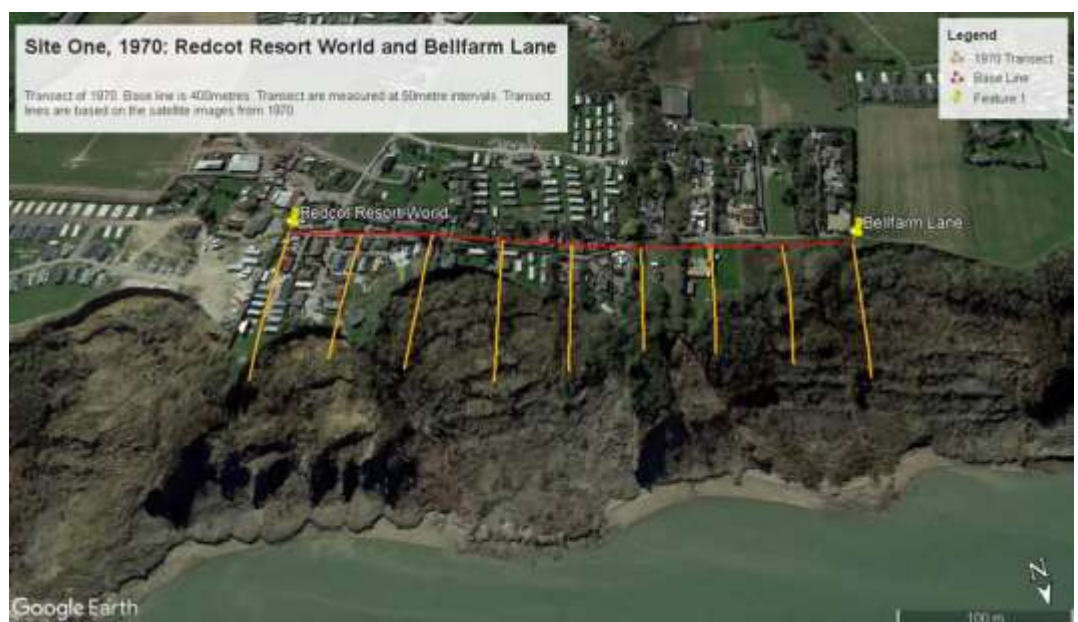
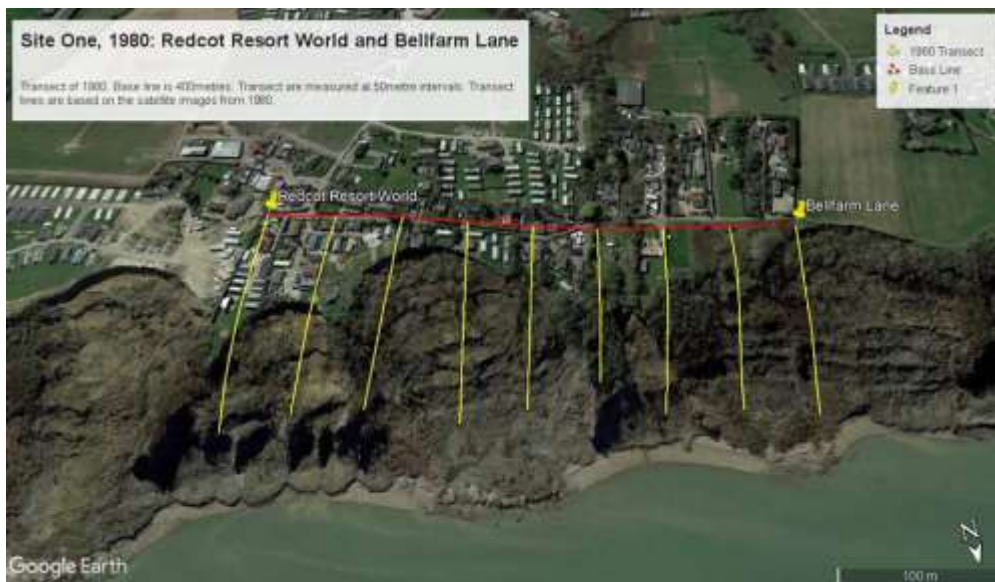
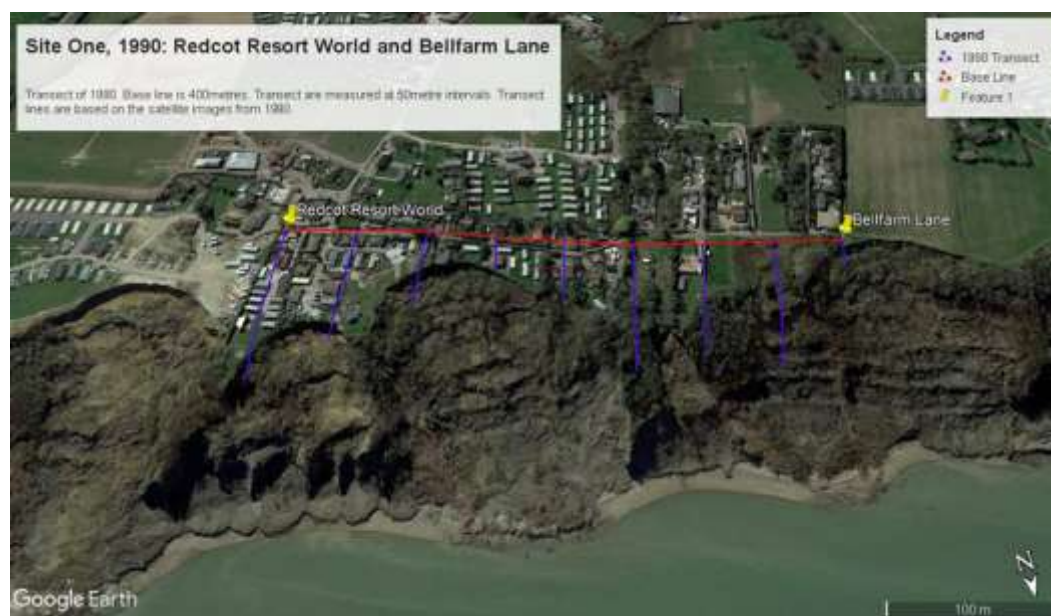
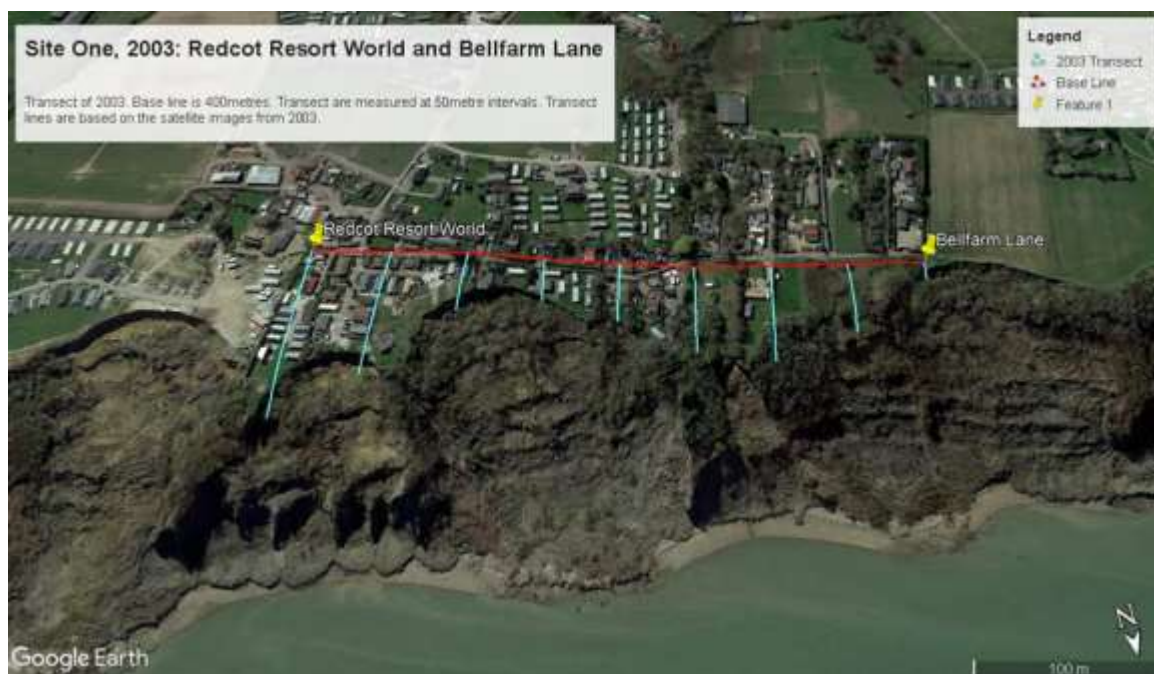
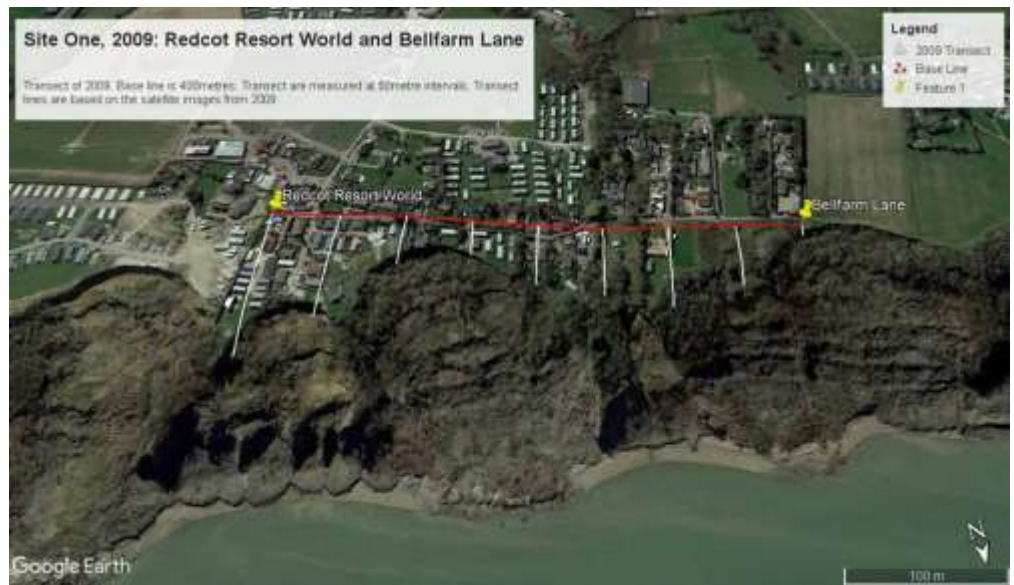
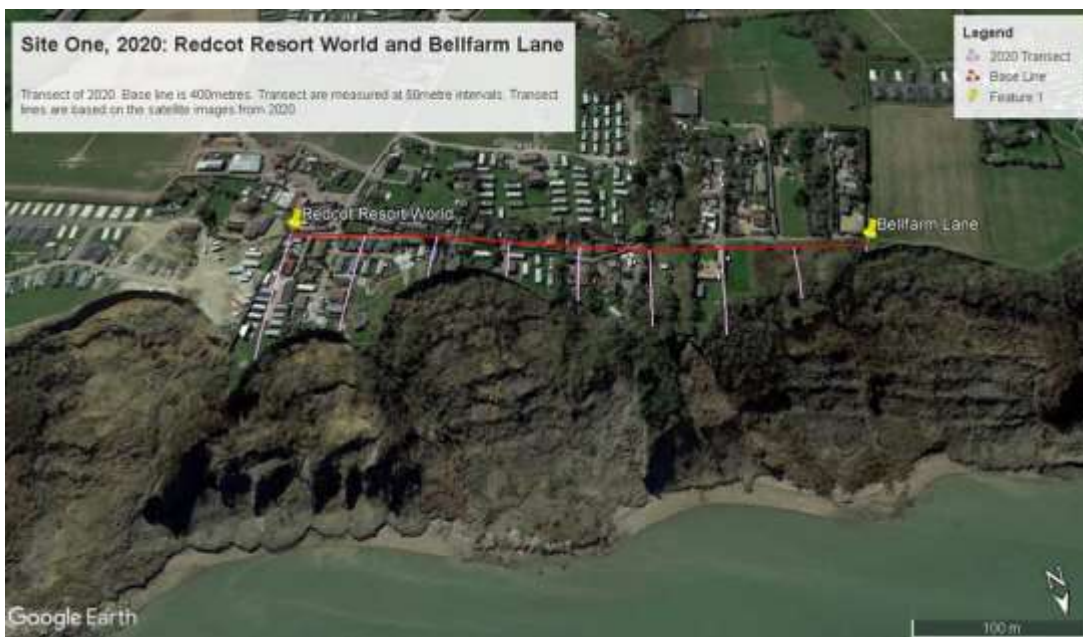
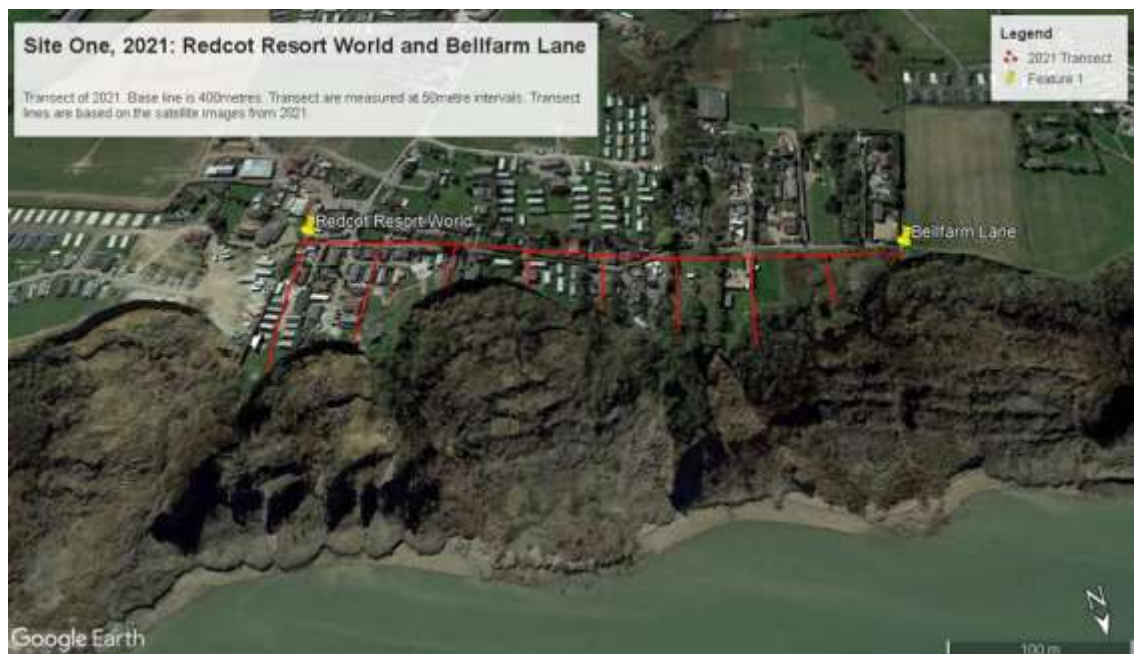
Figure 4.8: Site 1 Transect Line Measuring to the Cliff Edge in 1940

Figure 4.9: Site 1 Transect Line Measuring to the Cliff Edge in 1960

Figure 4.10: Site 1 Transect Line Measuring to the Cliff Edge in 1970

Figure 4.11: Site 1 Transect Line Measuring to the Cliff Edge in 1980

Figure 4.12: Site 1 Transect Line Measuring to the Cliff Edge in 1990

Figure 4.13: Site 1 Transect Line Measuring to the Cliff Edge in 2003

Figure 4.14: Site 1 Transect Line Measuring to the Cliff Edge in 2009

Figure 4.15: Site 1 Transect Line Measuring to the Cliff Edge in 2020

Laying out the controlled points allowed for changes in the distance to the cliff edge to be measured while also being to visually see the change. Although it is clear to see in Table, 4.1, 4.2 and 4.3 that in some of the selected years that the cliff distance appears to grow, for example Transect Line (TL) 1 1970 the distance from the controlled point is 101m but in

Figure 4.16: Site 1 Transect Line Measuring to the Cliff Edge in 2021

1980 the distance is 147m; this is clearly impossible, these type of changes in distance from the controlled points can be seen at all three sites (Section 4.2.2 and 4.2.3). However, due to the digitalising of historic images the resolution can be impacted, along with some of the data within the image to make it a better standard (University of Michigan, 2021). Due to this change in image standards the RMSE was calculated to allow for a margining of error in distance; this margining of error will be discussed later in the chapter.

Each site had measurements taken from 1940, 1960, 1970, 1980, 1990, 2003, 2009, 2020 and 2021. In Figures 4.8 to 4.34 show the base and transect lines for each site in each of the above stated years.

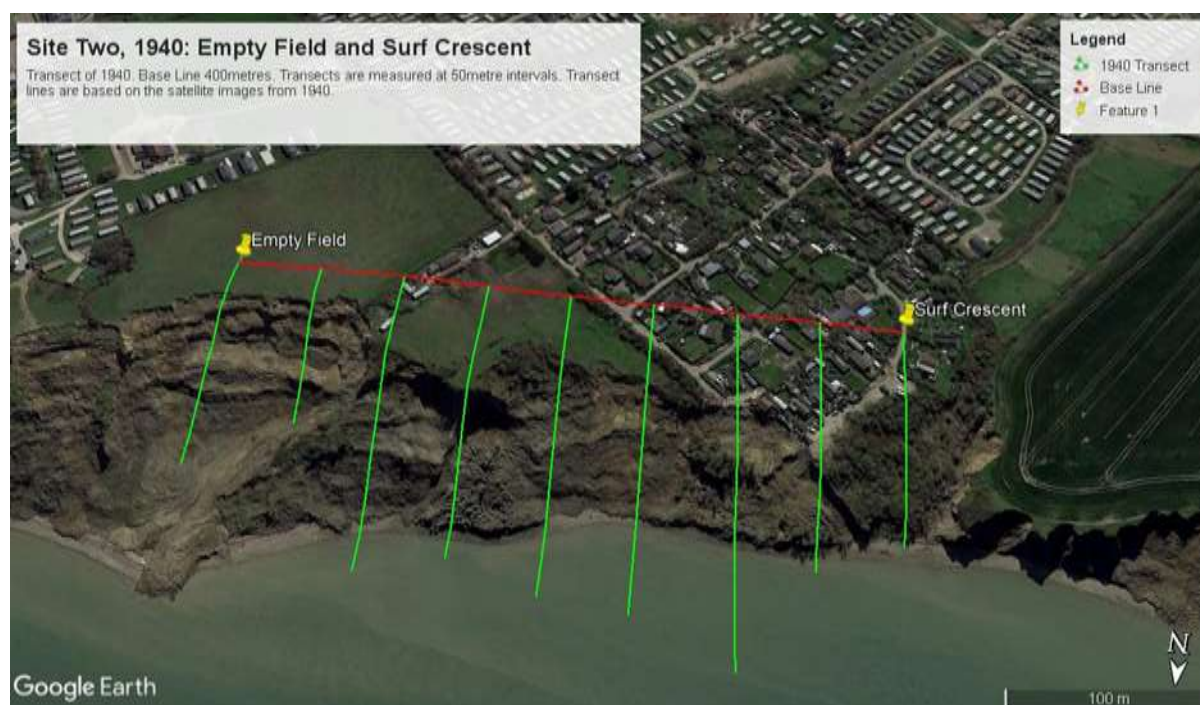
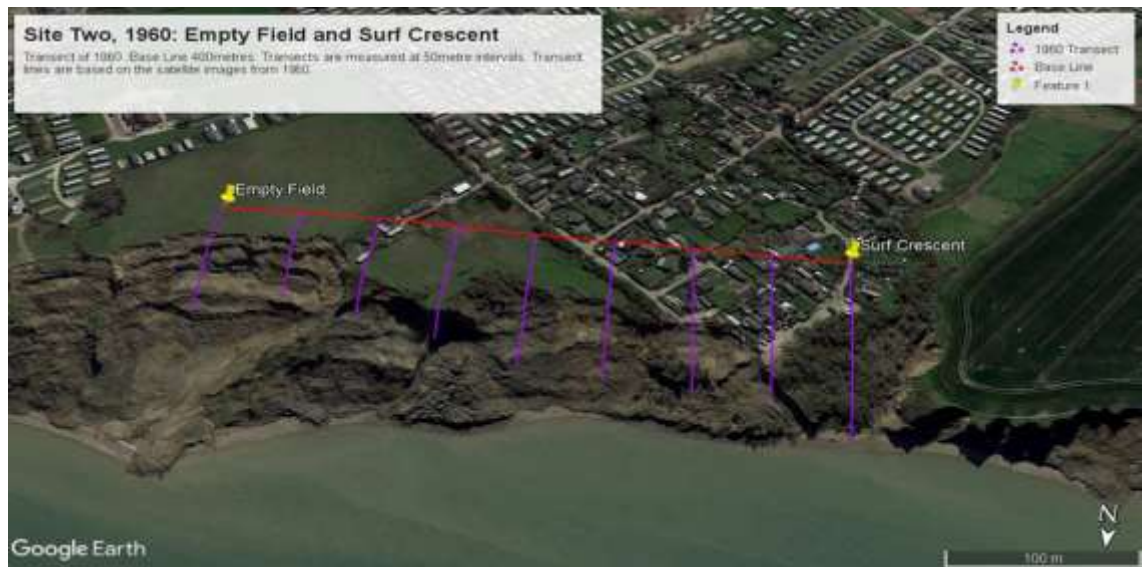
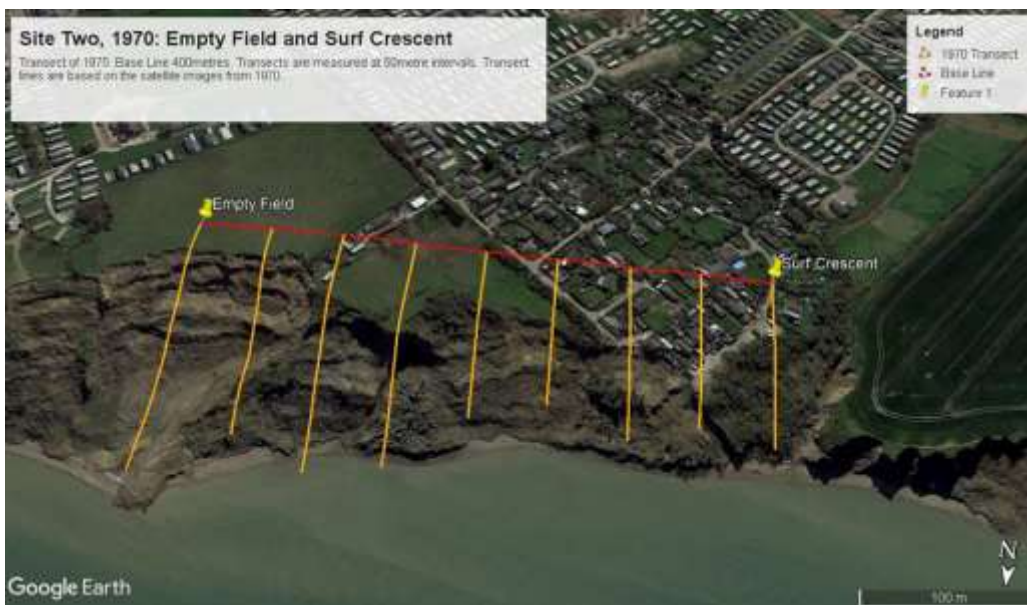
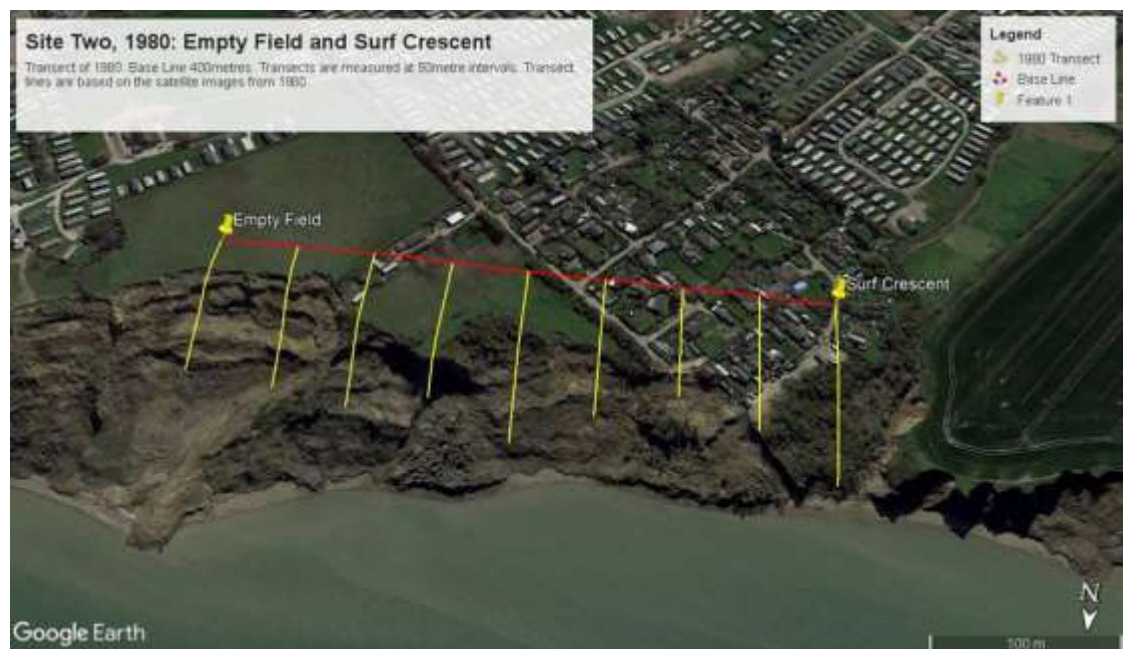
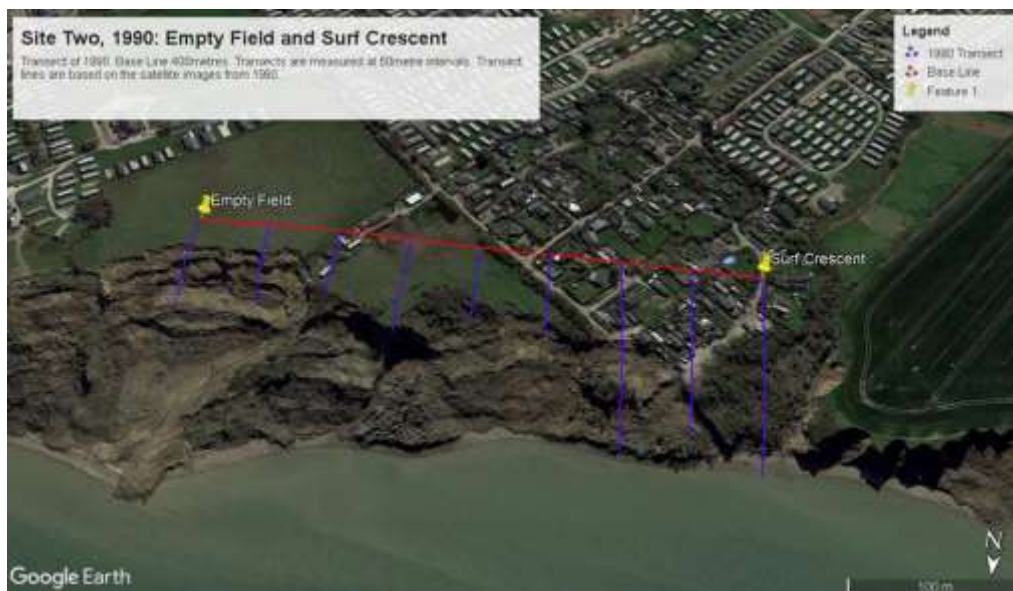
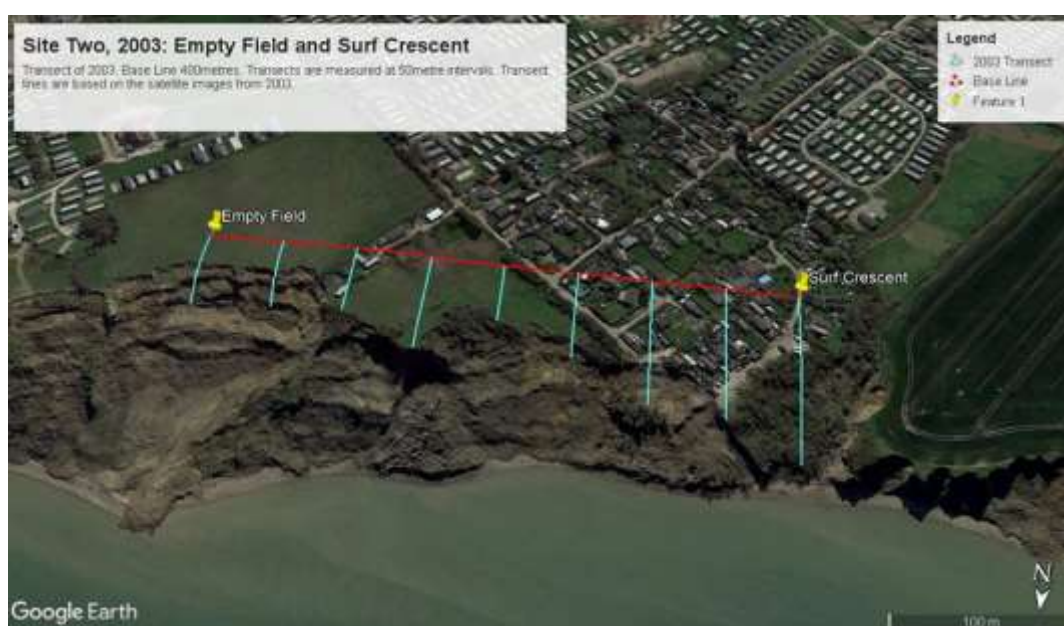
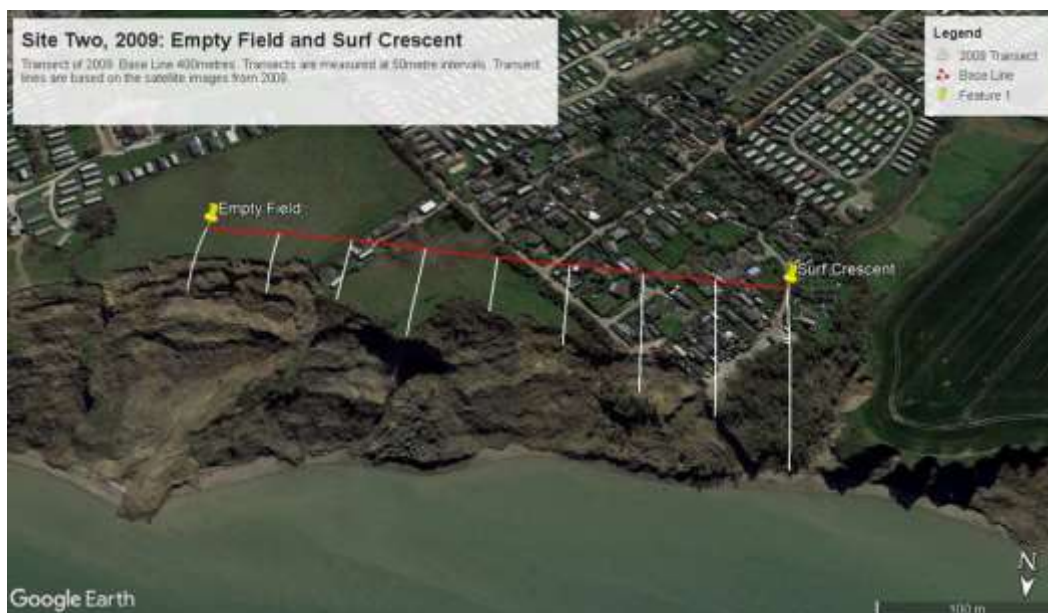
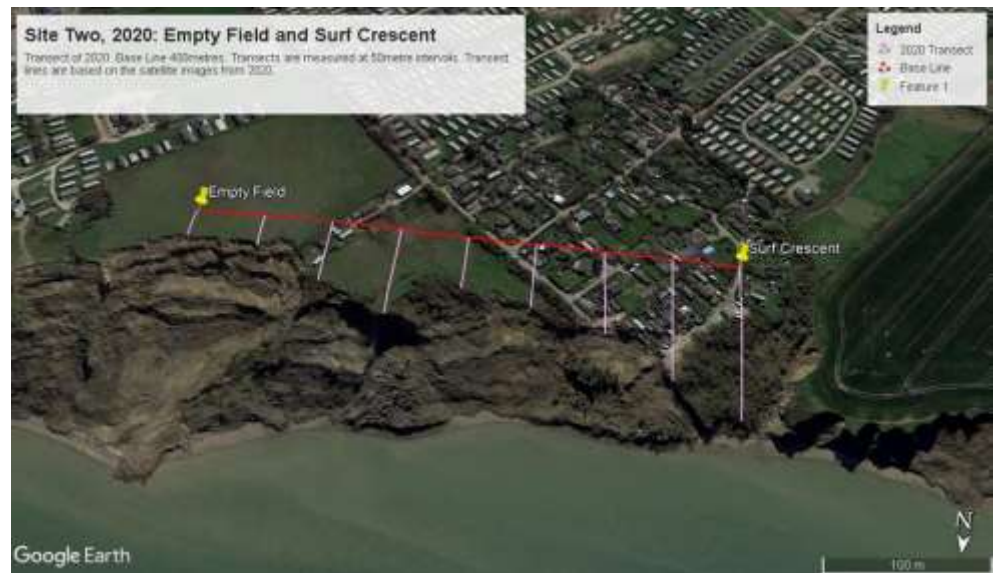
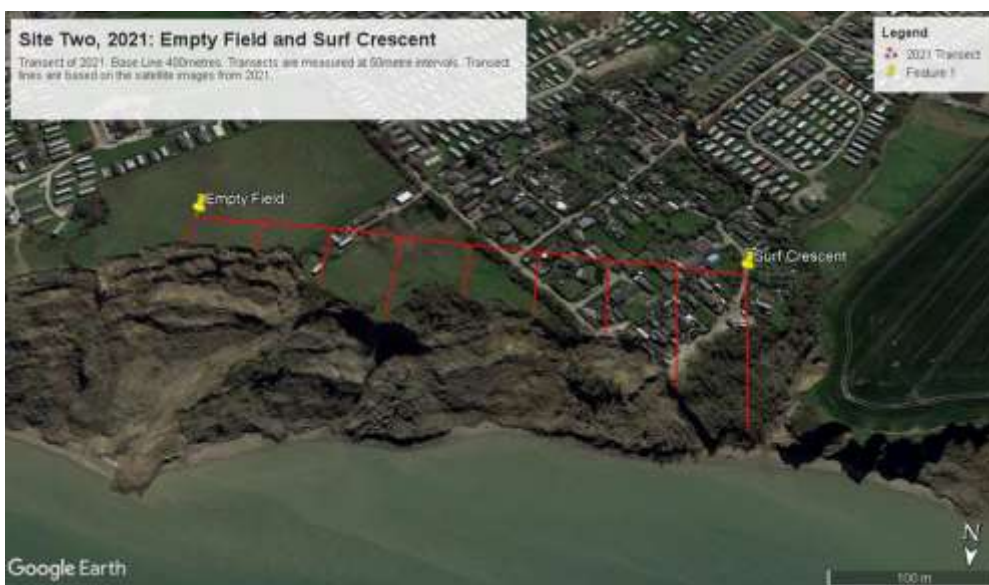
Figure 4.17: Site 2 Transect Line Measuring to the Cliff Edge in 1940

Figure 4.18: Site 2 Transect Line Measuring to the Cliff Edge in 1960

Figure 4.19: Site 2 Transect Line Measuring to the Cliff Edge in 1970

Figure 4.20: Site 2 Transect Line Measuring to the Cliff Edge in 1980

Figure 4.21: Site 2 Transect Line Measuring to the Cliff Edge in 1990

Figure 4.22: Site 2 Transect Line Measuring to the Cliff Edge in 2003

Figure 4.23: Site 2 Transect Line Measuring to the Cliff Edge in 2009

Figure 4.24: Site 2 Transect Line Measuring to the Cliff Edge in 2020

Figure 4.25: Site 2 Transect Line Measuring to the Cliff Edge in 2021

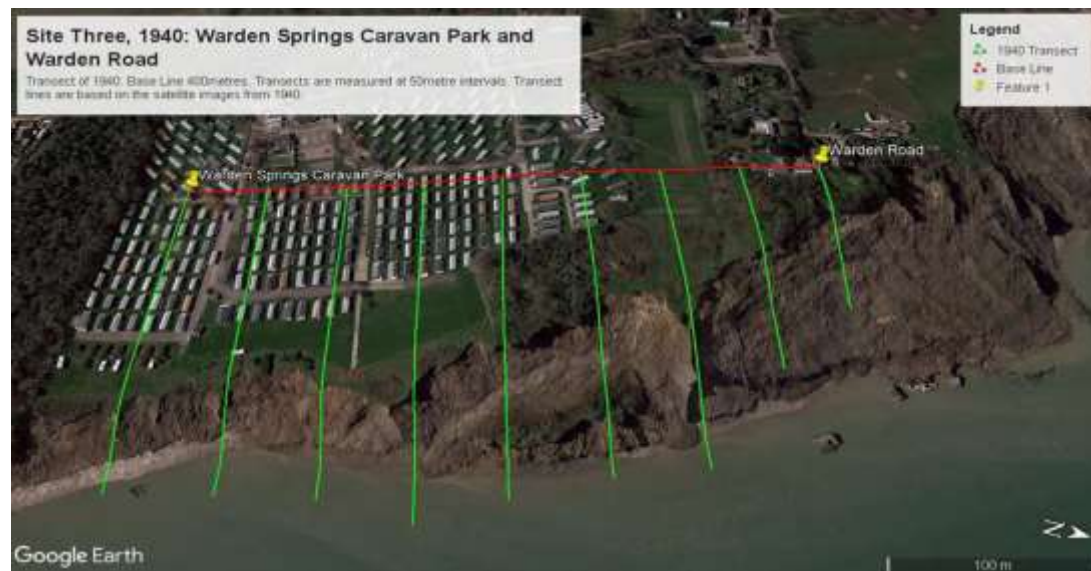
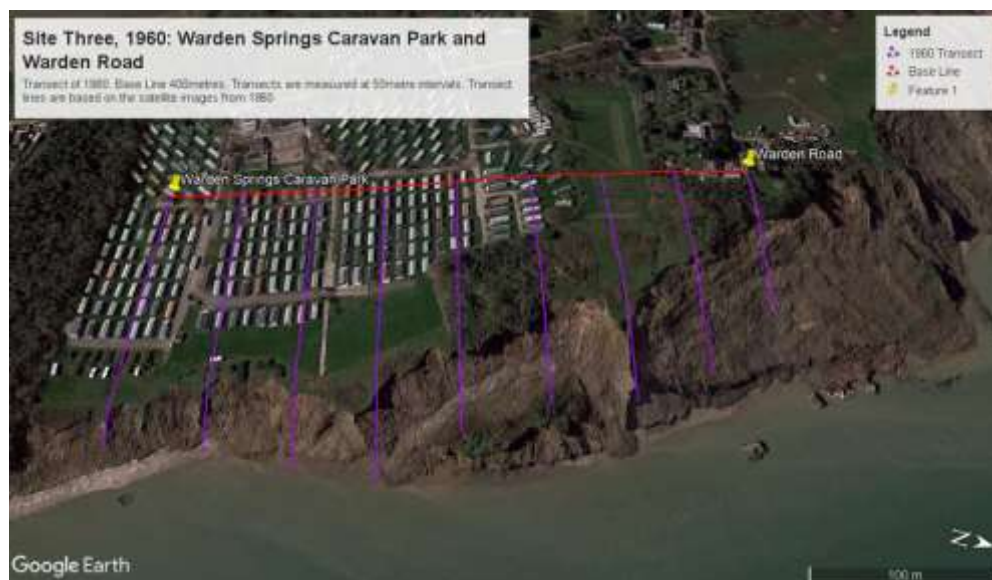
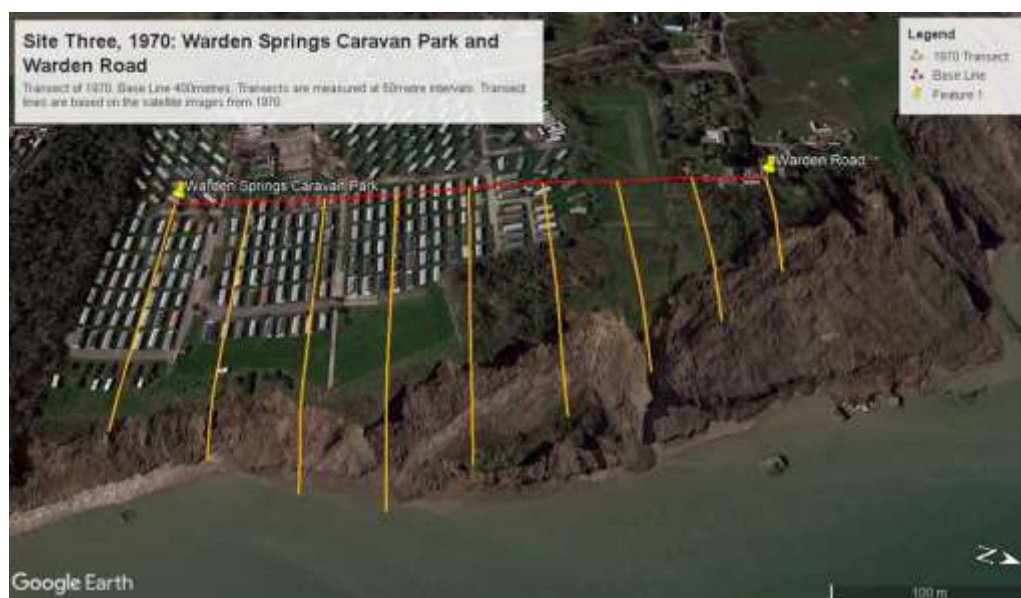
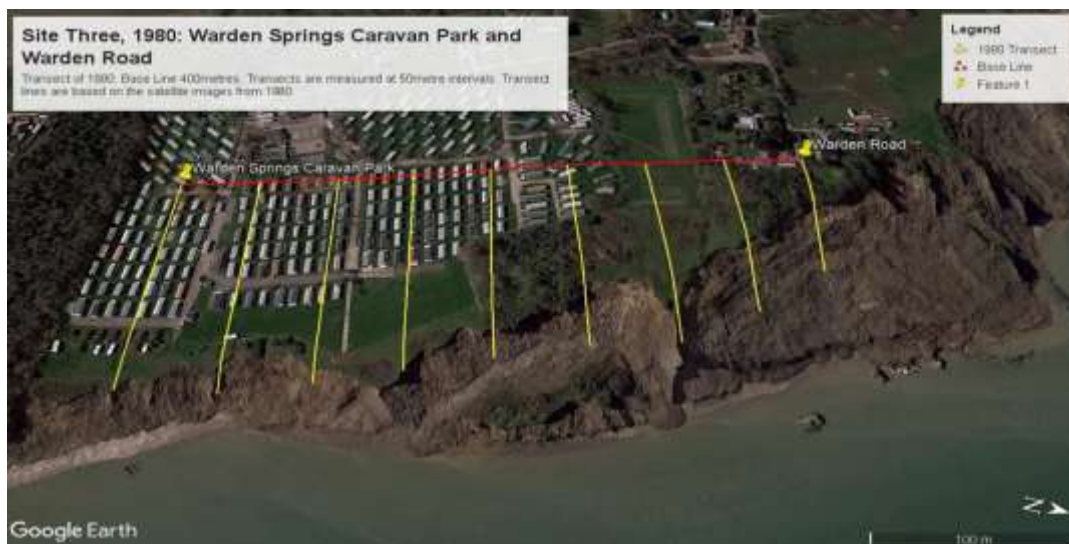
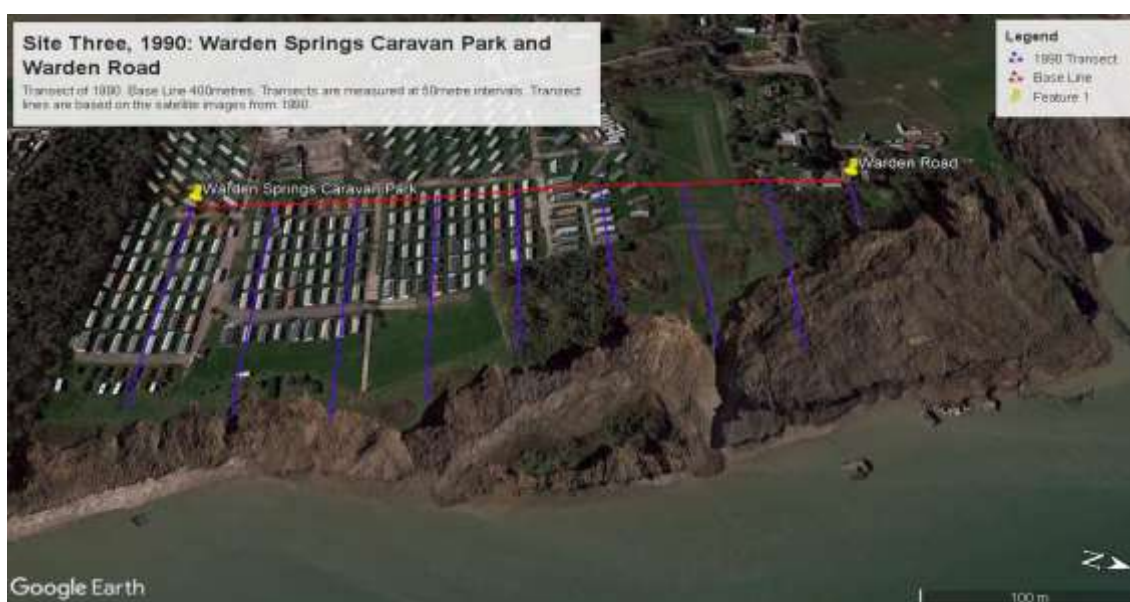
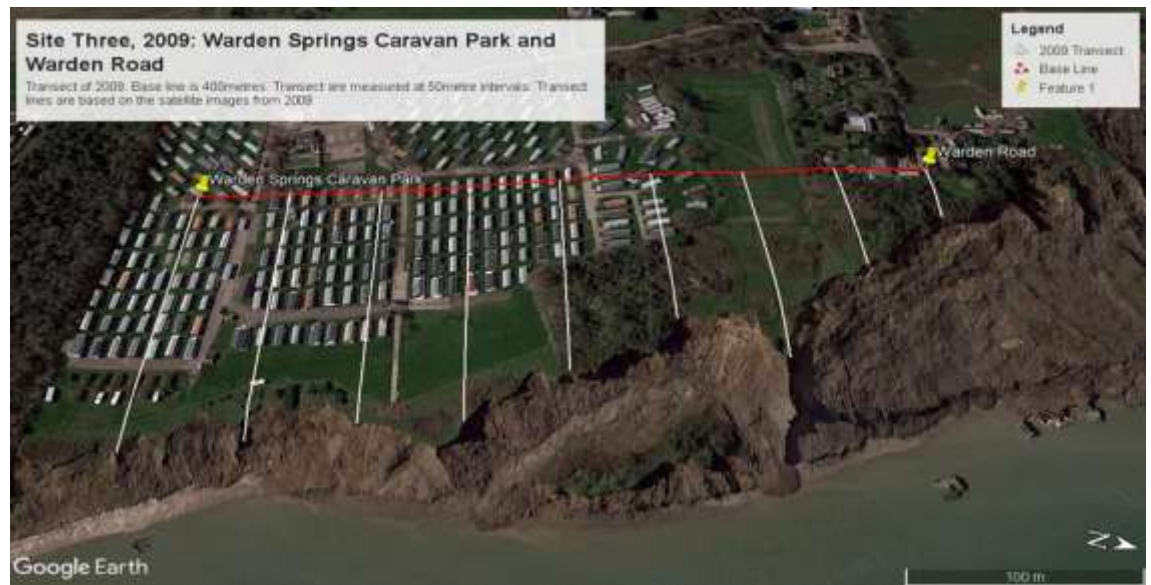
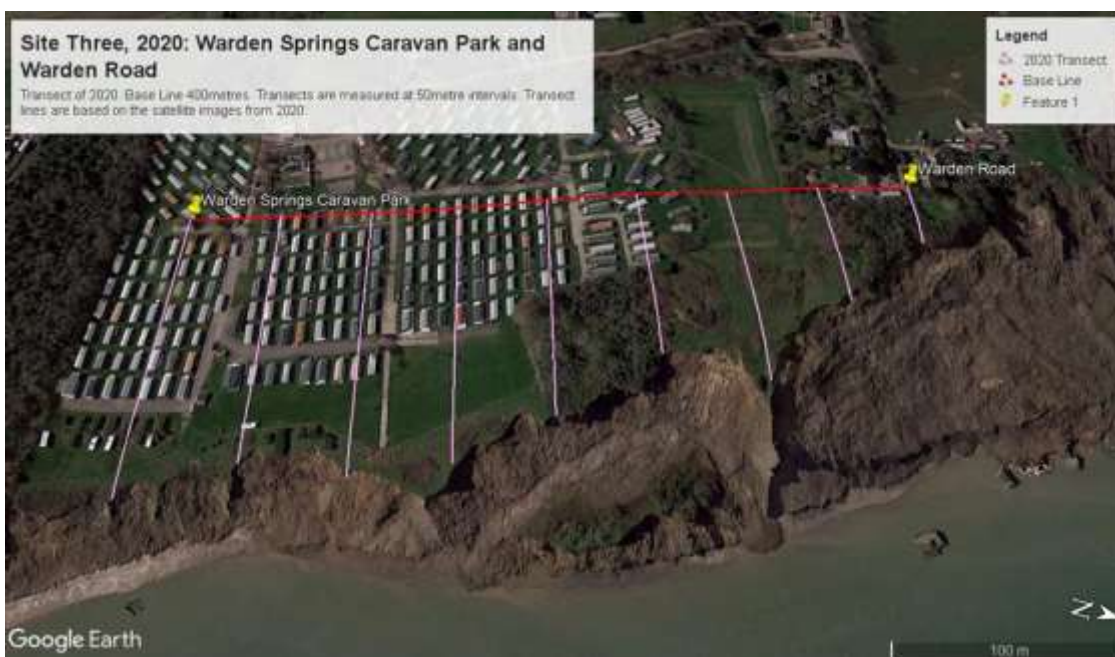
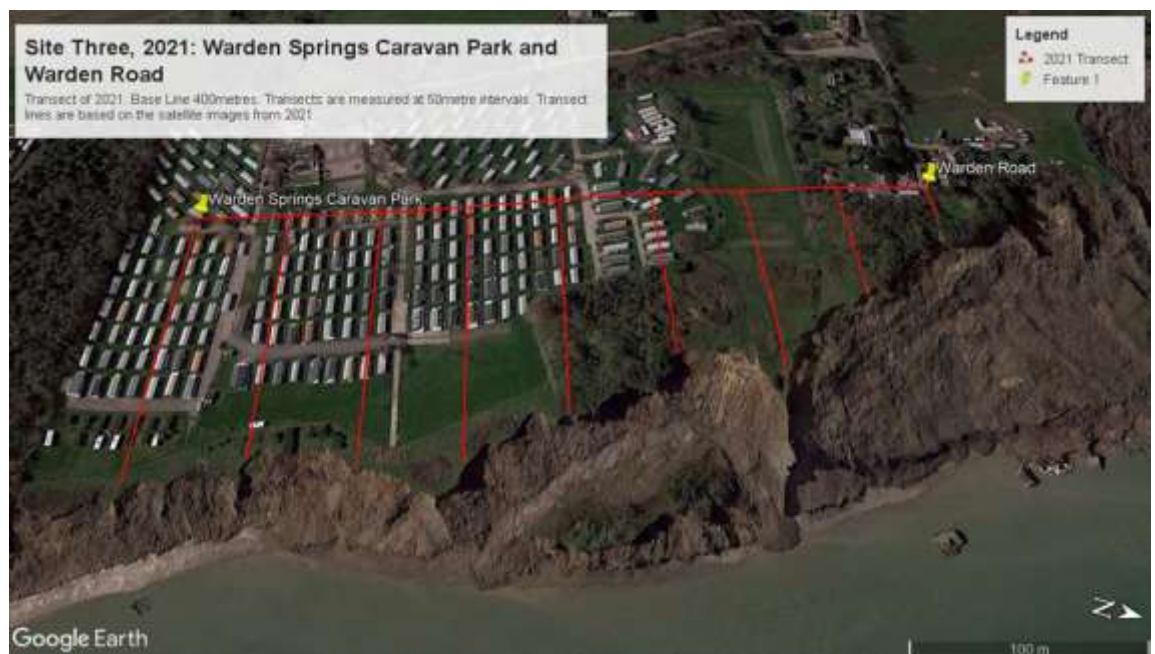
Figure 4.26: Site 3 Transect Line Measuring to the Cliff Edge in 1940.

Figure 4.27: Site 3 Transect Line Measuring to the Cliff Edge in 1960

Figure 4.28: Site 3 Transect Line Measuring to the Cliff Edge in 1970

Figure 4.29: Site 3 Transect Line Measuring to the Cliff Edge in 1980

Figure 4.30: Site 3 Transect Line Measuring to the Cliff Edge in 1990

Figure 4.31: Site 3 Transect Line Measuring to the Cliff Edge in 2003

Figure 4.32: Site 3 Transect Line Measuring to the Cliff Edge in 2009

Figure 4.33: Site 3 Transect Line Measuring to the Cliff Edge in 2020

Figure 4.34: Site 3 Transect Line Measuring to the Cliff Edge in 2021.

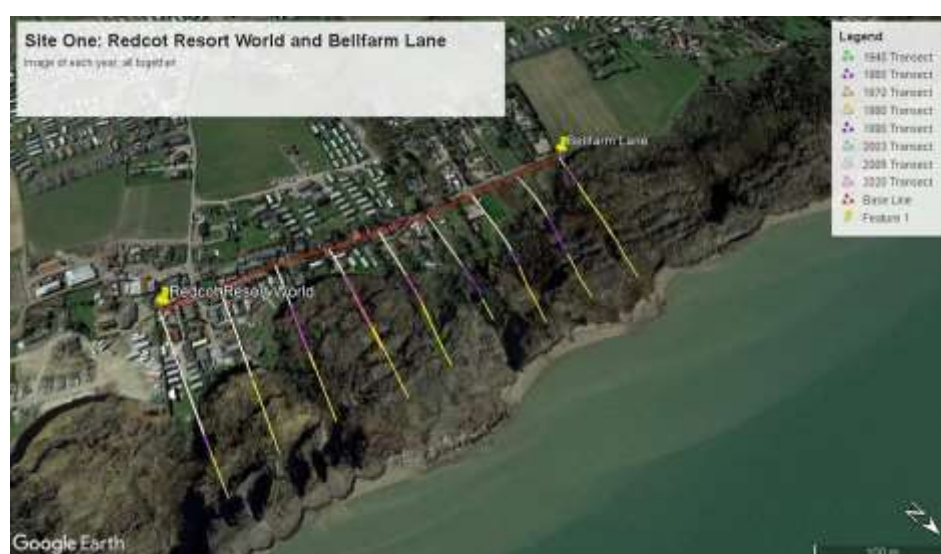
Figure 4.35 Redcot Resort World to Bellfarm Lane with Each Years Transect Lines

Each of the site's TL were then layered on to one image to visually illustrate show the differences in the distance from the controlled base line. Figures 4.35, 4.36 and 4.37 illustrate this. From these images it is clear to see that there has been a large amount of erosion to each site. Table 4.4 shows the total loss of land on each site for each year, due to image movement some of the land loss is in the minuses. The data for 2021 has not been recorded due to the year not yet being at the end.

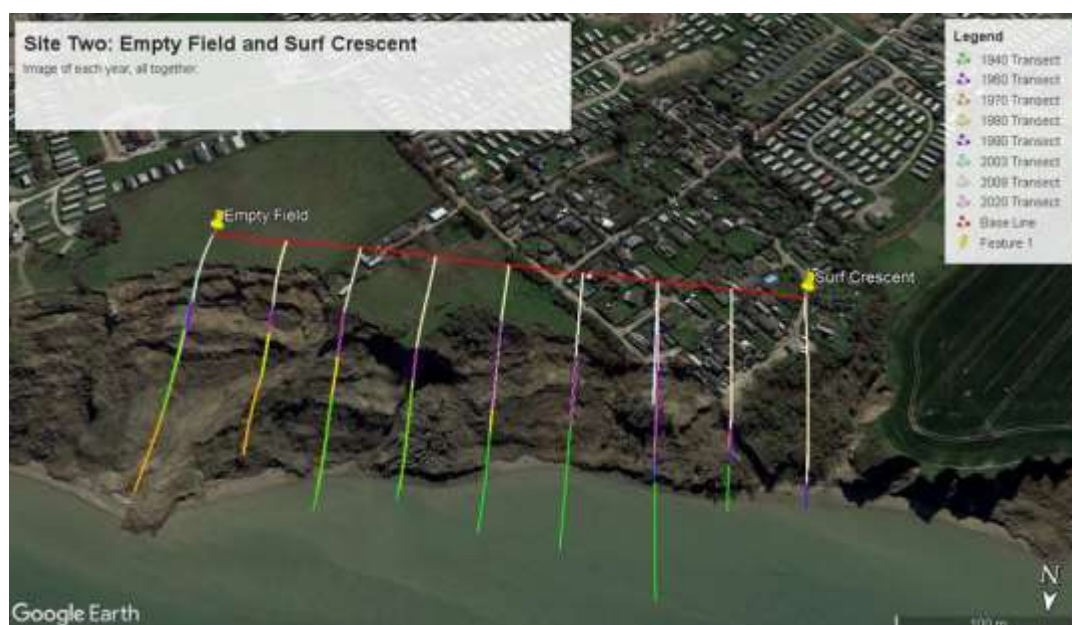
Figure 4.36: Empty Field to Surf Crescent with Each Years Transect Lines

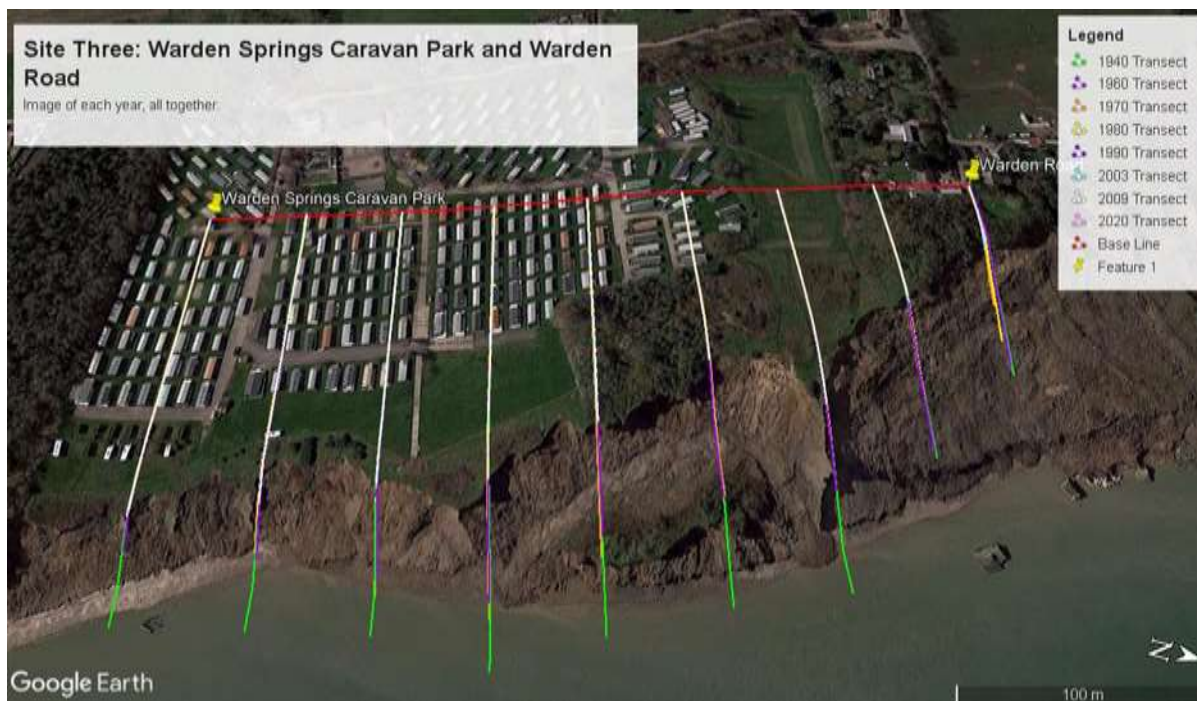
Figure 4.37: Warden Springs Caravan Park to Warden Road with Each Years Transect Lines
