Hydrogen Embrittlement

Mechanisms of Material Failure ACEA7010

Diego Alexander Valencia Flores  
2405760  
January 2025

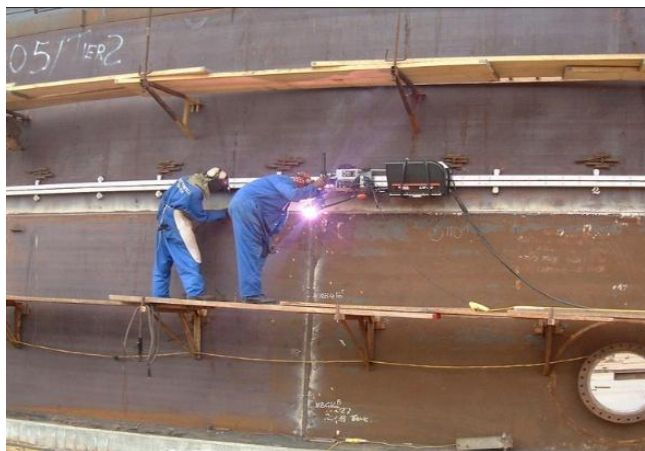
*Figure 5 Tank Joint Welding - Oil Storage Tanks (Casagrande Júnior, 2025)*

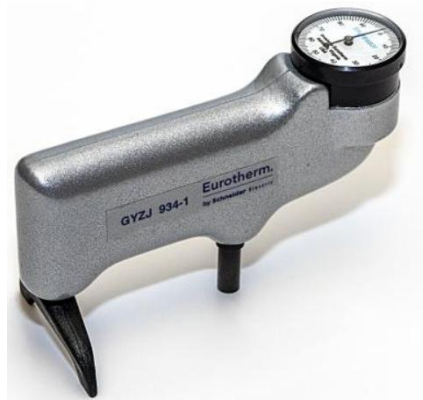
2. Barcol hardness test: By applying a load on the sample and then measuring the hardness, observe whether there are abnormal hardness values. Hydrogen embrittlement usually results in an abnormal increase in hardness.

*Figure 10 Field Hardness Tester for GRP and FRP Composites (Moisturemeters.co.uk, 2025)*
